Landslip McCrae Jan 25

3 Penny Lane and 10-12 View Point

Owners – Actions Items

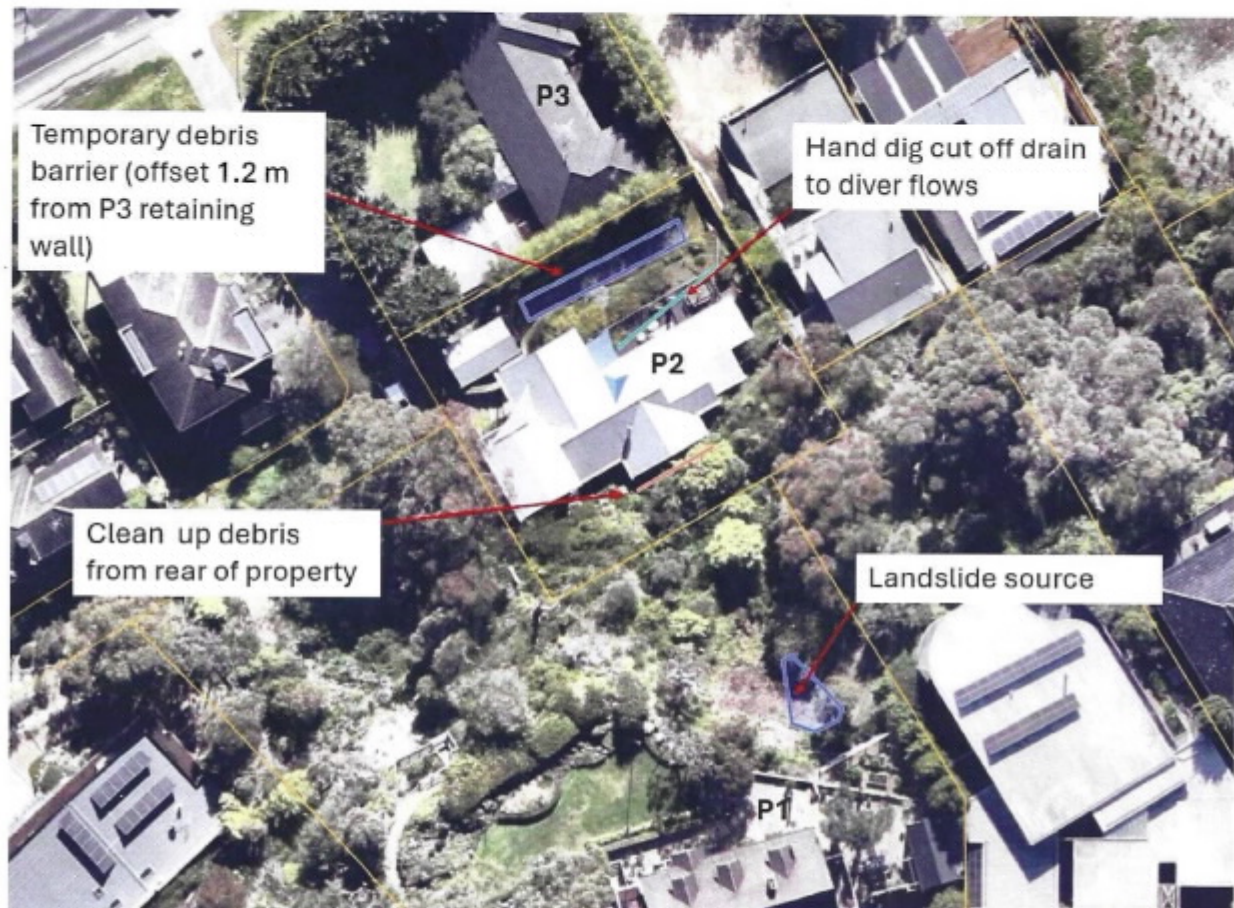
- Initiated from in front of a recently constructed retaining wall on P1 and has impacted the rear of P2, Photo 1.
- The Landslide was initiated on the night of Sunday, 5th January 2025, following two days of dry, hot weather. Rainfall **followed** the event.
- Translational slide which has evacuated materials down to the natural granitic soils at the base of the Landslide.
- A sub-vertical head scarp up to 1.5 m high, Photo 2.
- A significant portion of the headscarp was saturated and with measurable flow of water (0.15-0.2 L/s) flowing along the base and down the hill. The seepage was observed at the contact with surficial soils (fills/ancient landslide debris) and the underlying natural soils.
- Volume in the range of 15 to 20 m³.

Property	Actions
P1	<ul style="list-style-type: none"> • Monitor slopes immediately behind the failure for signs of change and or deterioration. • Cease all garden watering in the vicinity of the Landslide. • Surficial cut off bund with Coir logs or sandbags behind the retaining wall to direct surface water away from the head scarp. • Seek advice from their engaged Geotechnical engineer to make safe as best as is practical.

P2	<ul style="list-style-type: none"> • Monitor slopes immediately behind the house for signs of change and or deterioration. • Remove mud from between the house and the rear retaining wall. Do not disturb mud upslope of the retaining wall unless cutting temporary cut off drains. If the retaining wall has collapsed, seek further advice. Caution in areas of potentially unstable walls of the dwelling. This may require a spotter to monitor uphill slope behaviour. • Divert surface water around the dwelling (use hand cut off drains, Coir logs/sand bags). • Install a secondary cut off drain under the deck (hand dig, divert to east, Figure 1 • Install weep holes in northern most retaining wall as required (following installation and assessment of hand dug cut off drains/Coir logs) • Install one to two x ballasted shipping containers (2 x 20 ft or 1 x 40 ft containers), 2.44 m wide) in the northern most section of lawn, Figure 1. These should be offset from the P3 retaining wall by at least the height of that retaining wall (~1.2m) and be aligned to protect P3. Ballast may be soil, F type barriers or plastic crash barriers filled with water. Temporary tie downs may be required (screw piles or equivalent). The containers should be back tilted into the slope without undercutting the existing retaining walls. This may require local cut/fill to achieve a 5 to 10% back tilt. Where bulk earthworks or retaining wall loading constraints apply, the containers may need to sit on screw piles or equivalent. Further advice should be sought to detail the design.
