# Leak Report

4 Waller Place McCrae Victoria 3938 Australia

📁 Service Stream

| Job Ref | 1295094/003 |

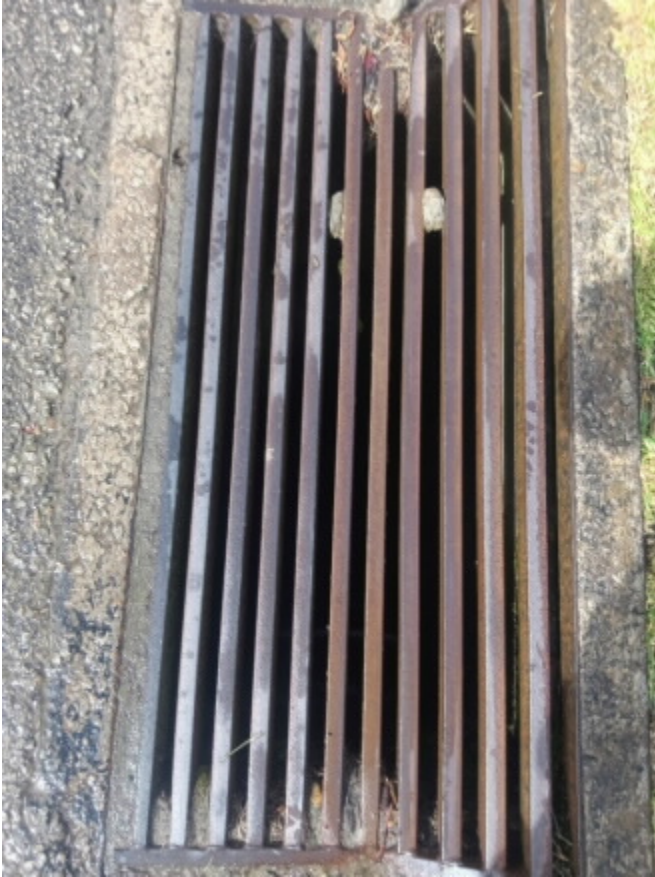
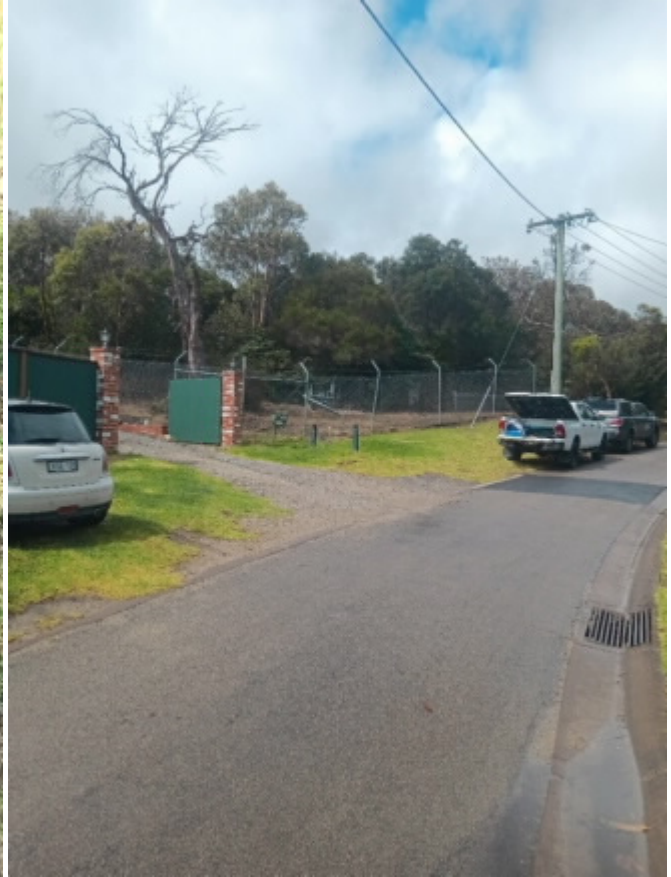
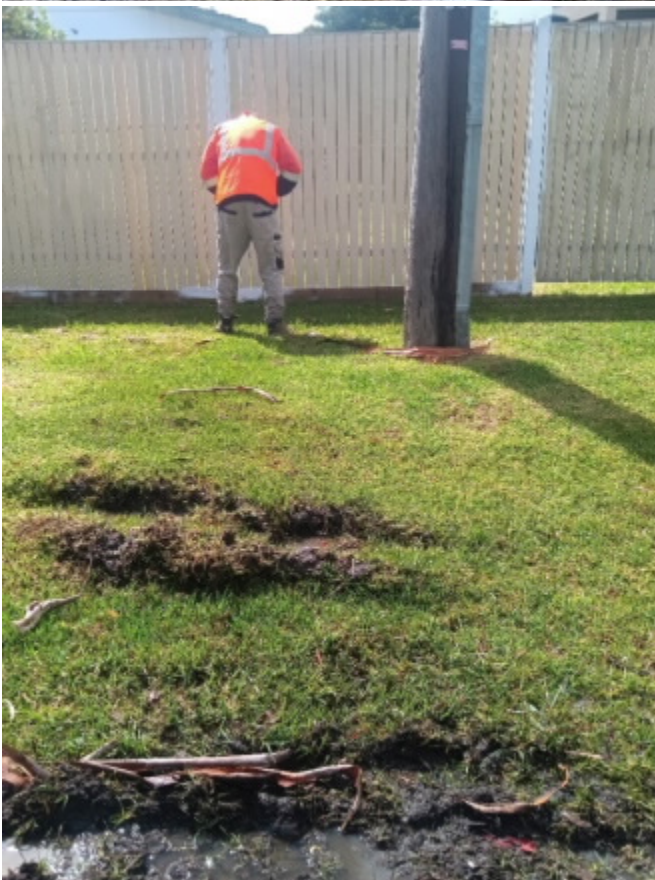
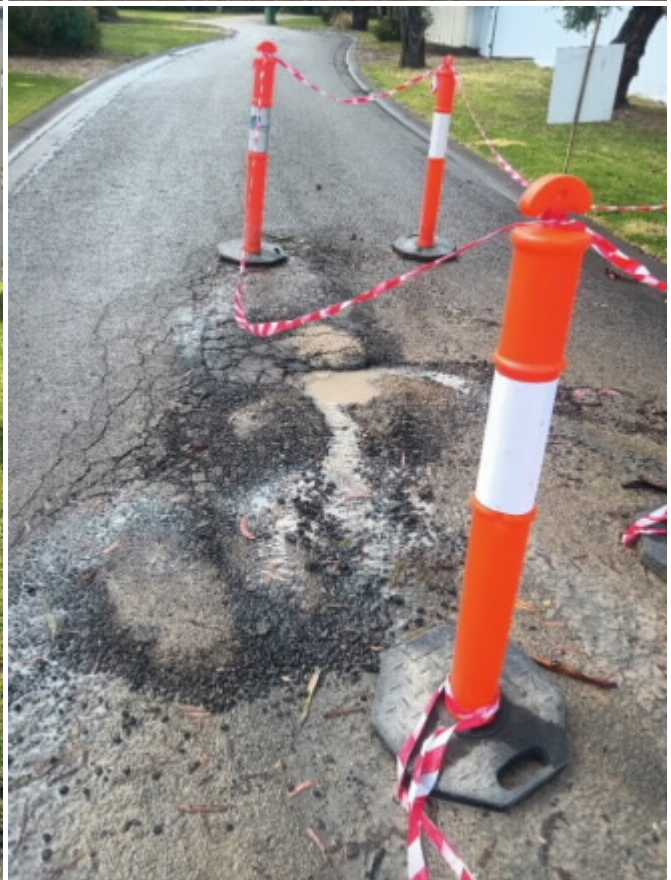
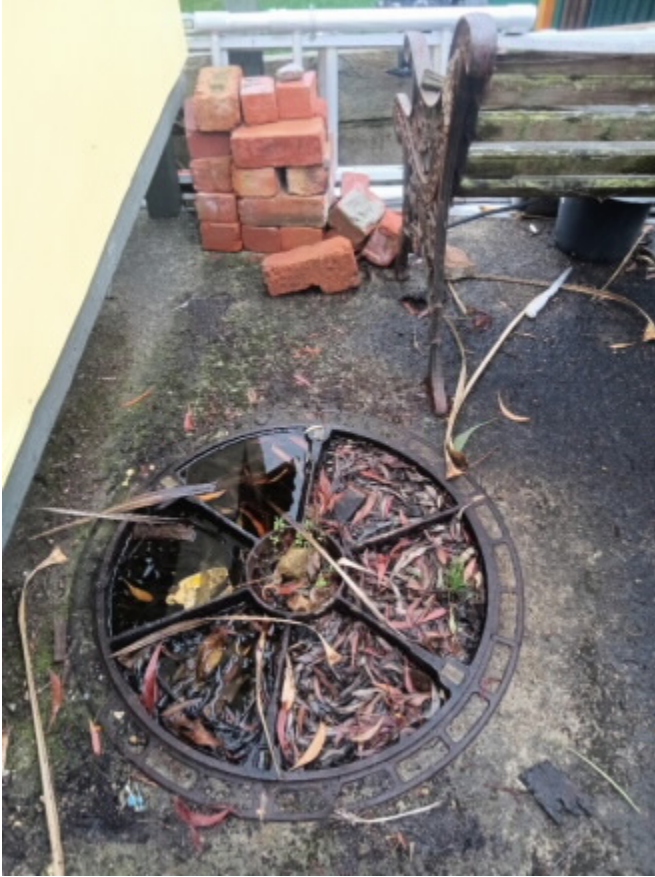
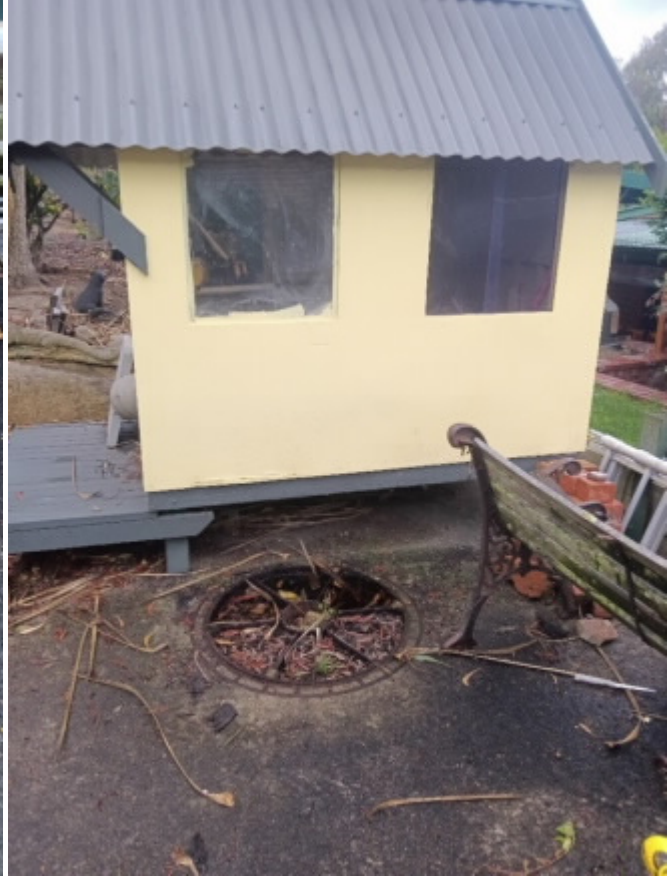
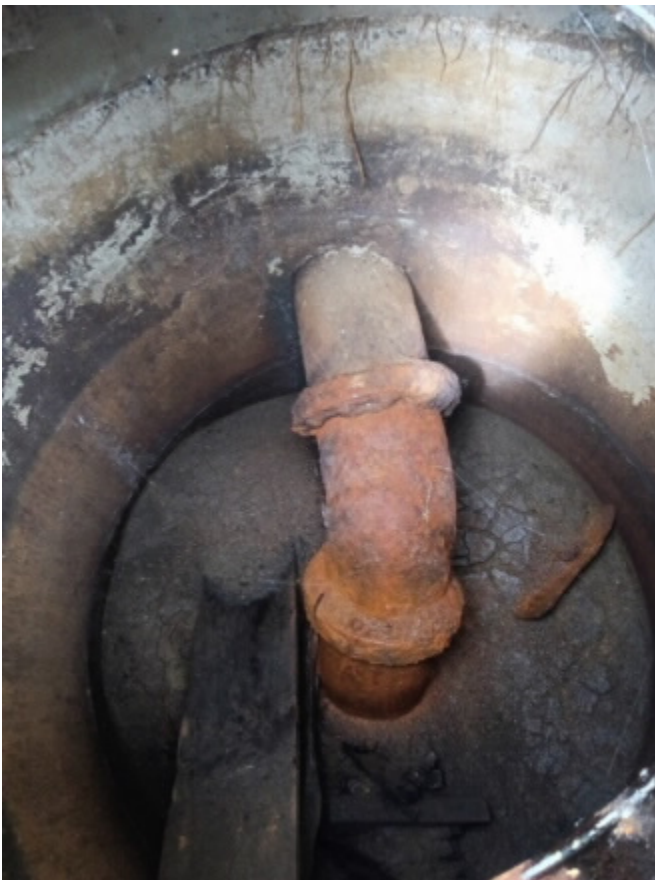
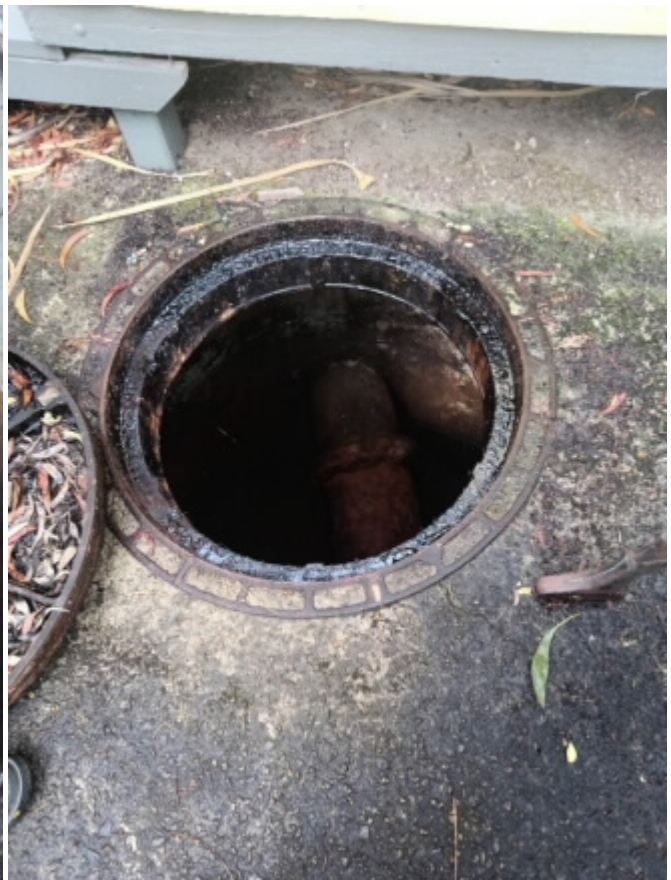
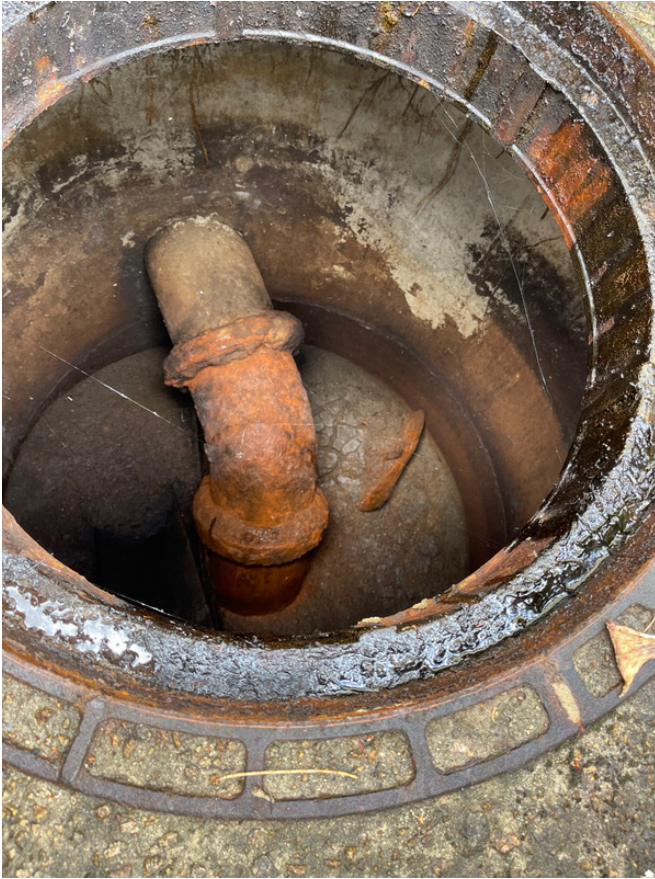
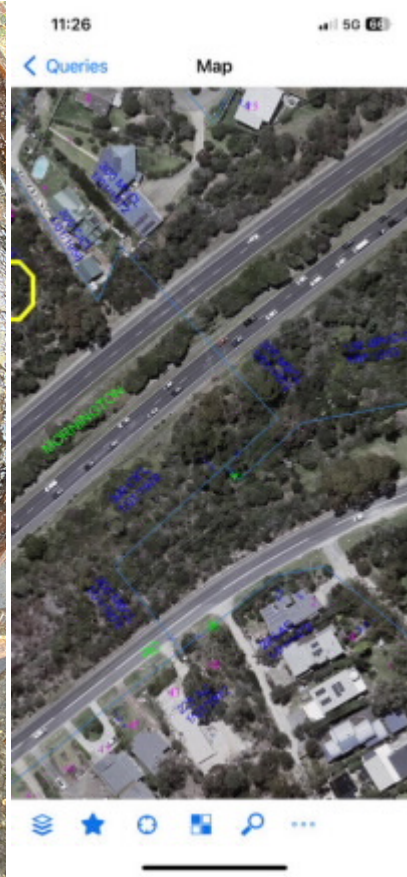
Sounded all assets in the area, followed suspect 300mm main and no leaks were detected. Chlorine sample needs to be taken when rain stops.

The new owners at 4 Waller and the owner Bret of number 5 (has lived here for the past 20 years) has let us at the back of his block where he has an old Water style lid cover (see attached photos) it houses the 14" main elbow it's very deep 4m is actually not on his property, although it's fencing inside his property, we just popped the and sounded it directly, no noise at all. Apparently the drains run all year round, but the water has got a lot worse and it's affected on the roadways and two locations bubbling up and damaging the road. It been partially barricaded of.

I don't believe there's any leaks on the mains but still some of the smaller pipes really haven't checked out. Jason Marsh will return take samples when it's not raining for a few days.
