# Leak Report

# 30 Somers Avenue McCrae Victoria 3938 Australia

Service Stream

Leak Address	McCrae Victoria 3938 Australia
Zone	South East Water ► Reactive Leaks
Leak Asset Type	Ferrule
Flow Rate (L/min)	2
Has the leak been called in by DS Technician?	No
Job Ref	1316822/001
Leak Visible	No

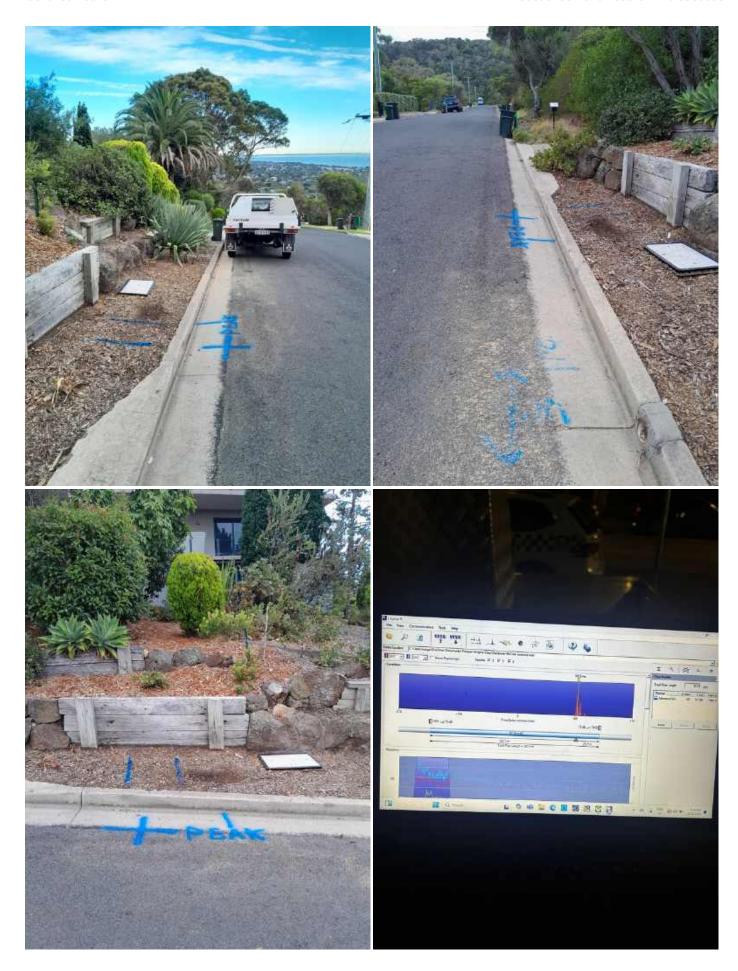
DETECTION

Returned to site and checked the results from yesterday, and it gave me a peak 25m from the hydrant in naturestrip, which is near number 9. Frequency levels here aren't best, but it was a long correlation I did, and also it being AC here didn't help as well.

Measured out the peak, and it's peak me near enough on number 9 service/ferrule. Sounded service again, and I quickly isolated the supply and noise stays on the meter. This is also about 0.5m from the telstra pit as well. Main has been marked up in the roadway, but my plans are showing it to be in naturestrip as that's where also the assets are located and they are showing to be direct on the plans as well.

Unable to trace out the main due to it being AC. Tried to listen for surface noise but was unable to pick up any noise.

Suggestions here would be exposed and excavate my markup location and expose the ferrule as well for number 9 to try and capture leak.
