**PLANNING APPLICATION P08/1163**  
**14-16 VIEW POINT ROAD, MCCRAE**

### **REVIEW OF SCHEMATIC FOOTING DESIGN**

**Proposed Residential Dwelling: 14-16 View Point Road McCRAE VIC.**

**PROPOSED RESIDENTIAL DWELLING  
14-16 VIEW POINT ROAD  
McCRAE VIC**

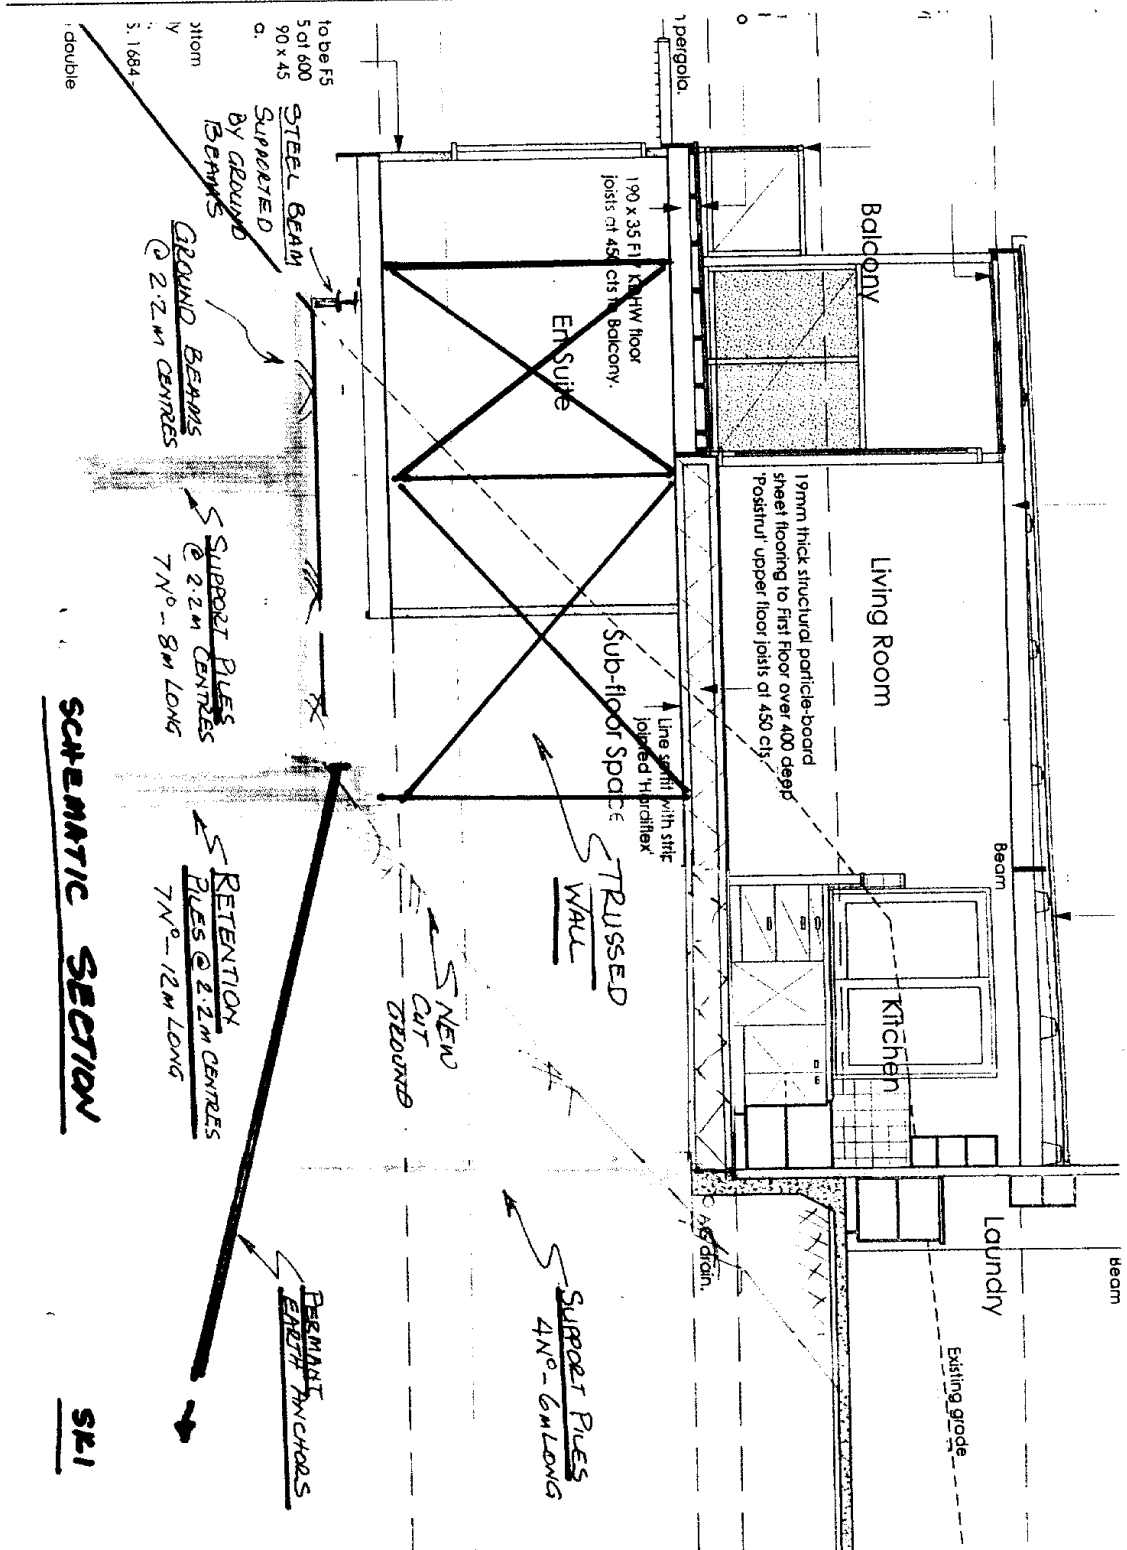
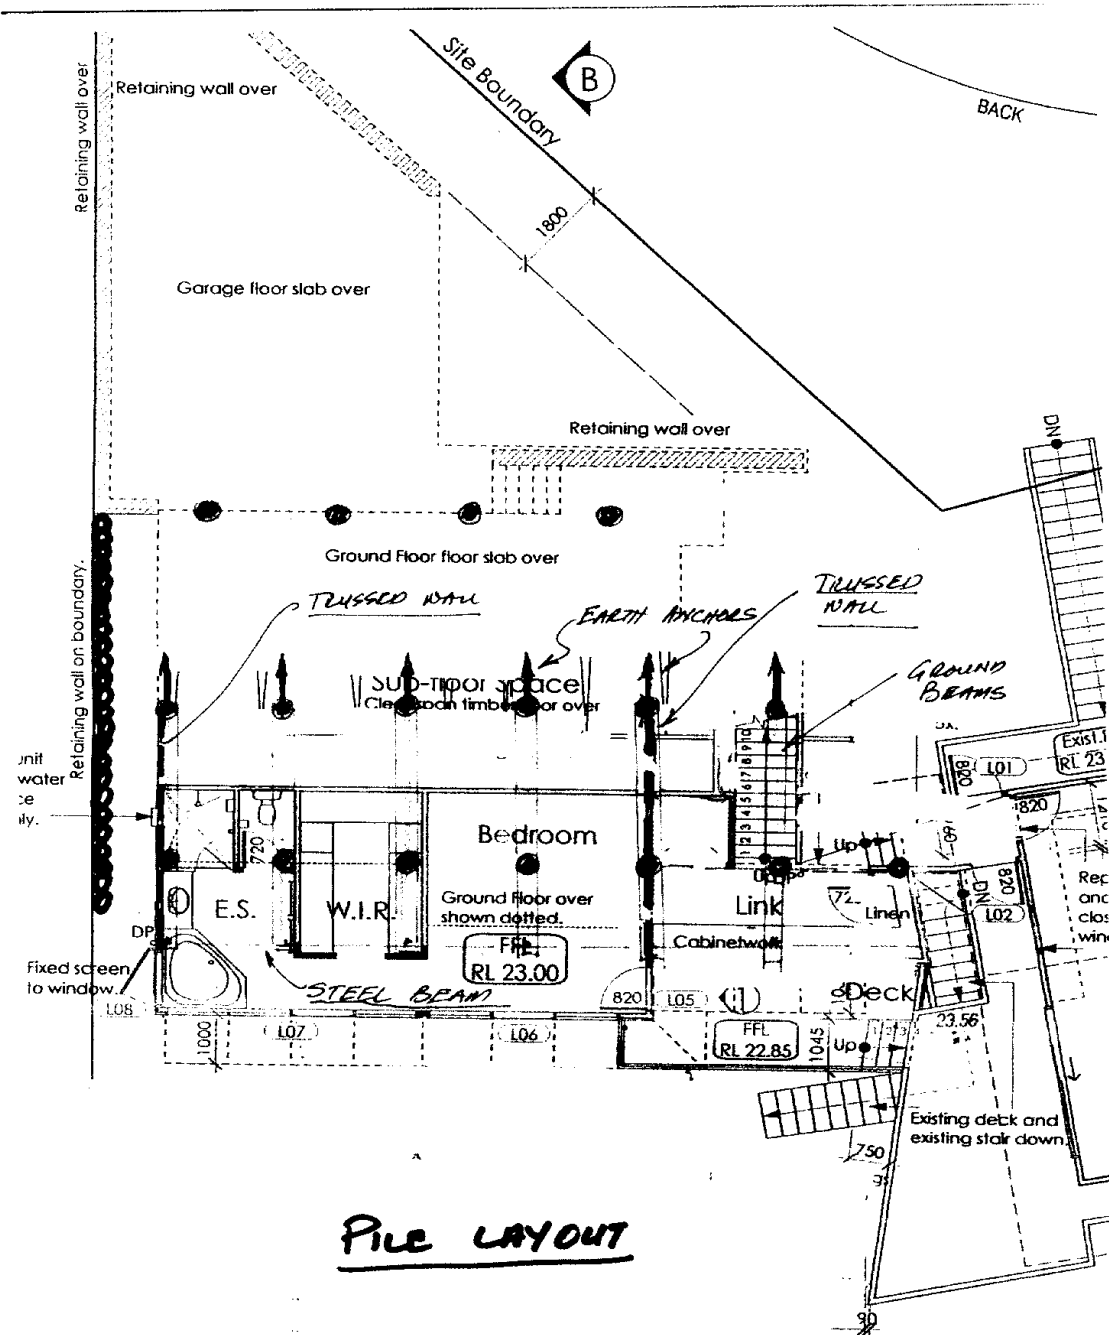
We confirm receipt of schematic section (SK1) and plan (SK2) from Eckhaus Story and Partners Pty Ltd relating to the conceptual footing system for the proposed dwelling at the above site. Copies of the sketches are attached.

We understand the footing design will be further refined once the design of the proposed structure is progressed. However, in concept the proposed schematic footing system is consistent with the recommendations contained within our geotechnical report. On this basis the risk to property for the proposed dwelling is low and the risk to life for the occupants of the proposed dwelling is tolerable, based on a landslide risk assessment in accordance with The Australian Geomechanics Society 'Practice Note Guidelines for Landslide Risk Management', 2007.
