3 Penny Lane and 10-12 View Point Rd

MBS Actions

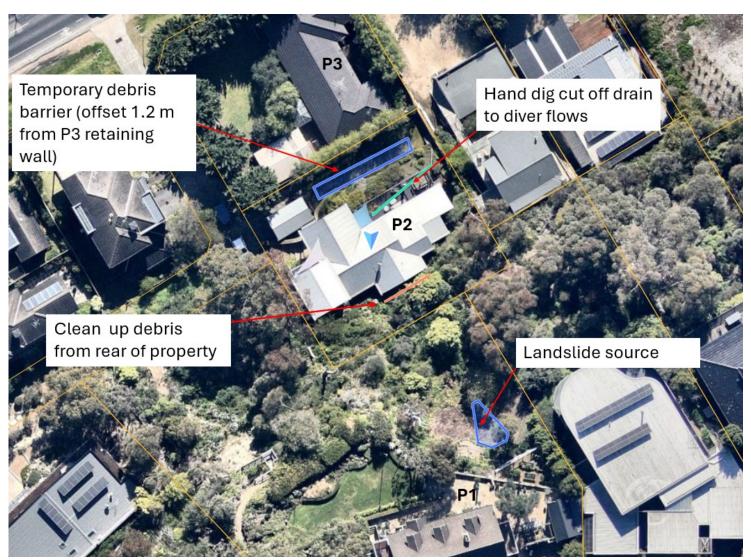
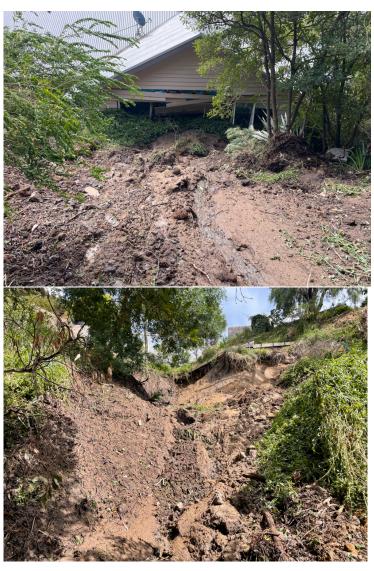
A preliminary risk assessment has been completed for volumes in the order of 5 to 10 m³. These volumes represent unstable volumes observed on site and do not reflect long-term volumes that are assessed for the life of the properties. The results indicate, over the immediate short term (where temporary controls are introduced and repairs are made):

- · Risk to life for P1 is tolerable.
- Risk to life for P2 is unacceptable. PSM supports the actions/advice of the MPSC Building Surveyors that the house must not be occupied.
- Risk to life for P3 varies from unacceptable to tolerable depending on the conditions of the Landslide and with what energy it strikes the dwelling.

To mitigate the risk of further landslide activity while the cause/repairs are investigated further and insurers respond, the owners of the affected properties need to address the below. Each property owner should do so with the support of Geotechnical Engineers who are experienced in mitigation of landslide hazards.

Property	Actions
P1	 Monitor slopes immediately behind the failure for signs of change and or deterioration. Cease all garden watering in the vicinity of the Landslide. Surficial cut off bund with Coir logs or sandbags behind the retaining wall to direct surface water away from the head scarp. Seek advice from their engaged Geotechnical engineer to make safe as best as is practical.
P2	 Monitor slopes immediately behind the house for signs of change and or deterioration. Remove mud from between the house and the rear retaining wall. Do not disturb mud upslope of the retaining wall unless cutting temporary cut off drains. If the retaining wall has collapsed, seek further advice. Caution in areas of potentially unstable walls of the dwelling. This may require a spotter to monitor uphill slope behaviour. Divert surface water around the dwelling (use hand cut off drains, Coir logs/sand bags). Install a secondary cut off drain under the deck (hand dig, divert to east, Figure 1 Install weep holes in northern most retaining wall as required (following installation and assessment of hand dug cut off drains/Coir logs) Install one to two x ballasted shipping containers (2 x 20 ft or 1 x40 ft containers), 2.44 m wide) in the northern most section of lawn, Figure 1. These should be offset from the P3 retaining wall by at least the height of that retaining wall (~1.2m) and be aligned to protect P3. Ballast may be soil, F type barriers or plastic crash barriers filled with water. Temporary tie downs may be required (screw piles or equivalent). The containers should be back tilted into the slope without undercutting the existing retaining walls. This may require local cut/fill to achieve a 5 to 10% back tilt. Where bulk earthworks or retaining wall loading constraints apply, the containers may need to sit on screw piles or equivalent. Further advice should be sought to detail the design.
