# McCrae Landslide - Evacuation Order Area

## Geotechnical Factual Report

PSM5665-GFR REV0      9 April 2025

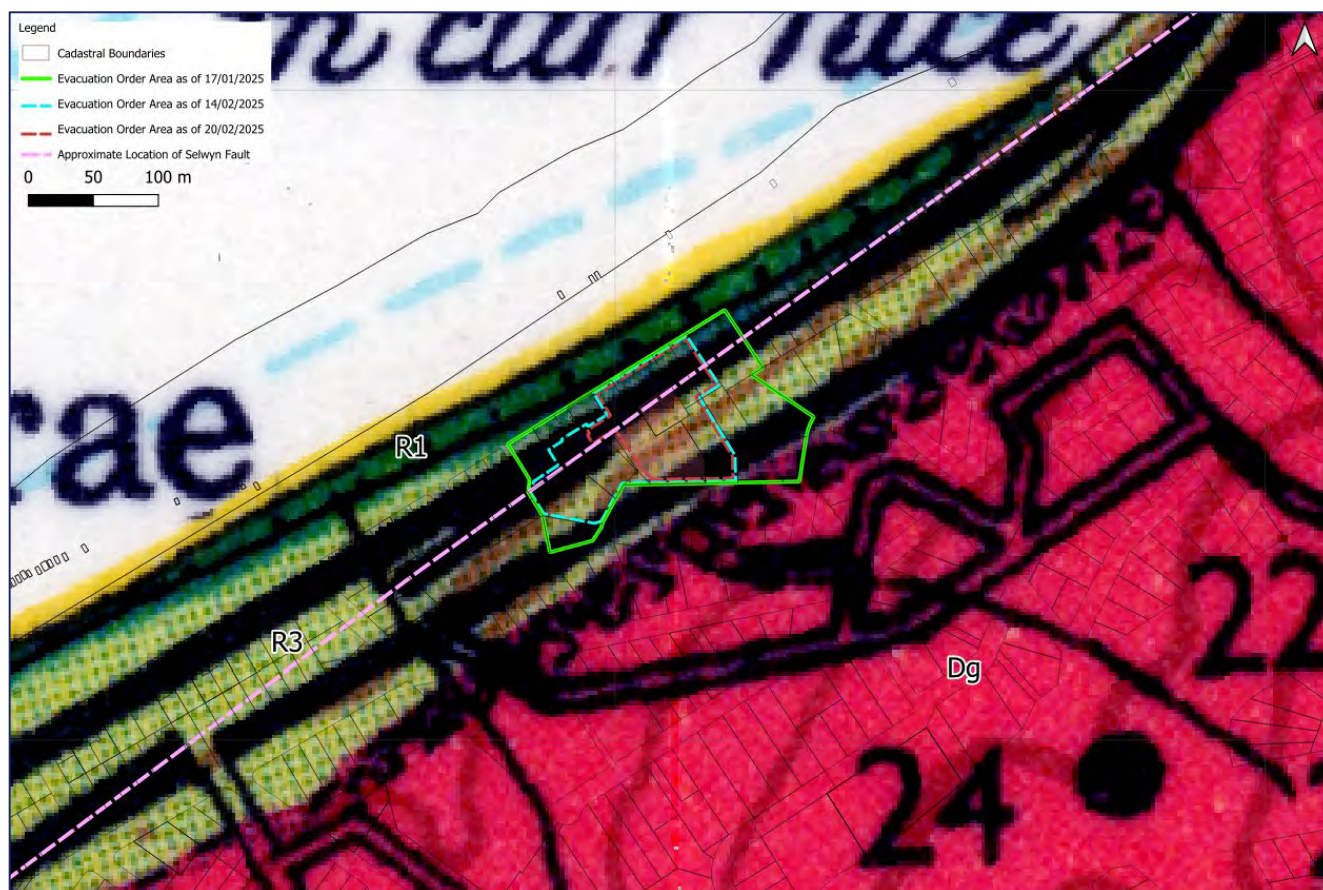
**Inset 2:** Mapped geology from the published Sorrento 1:63,360 geological map.

- Quaternary raised coastal deposits comprising siliceous and calcareous sand, shell beds, guano (Mud Islands) at the base of the escarpment (shown as R3 in Inset 2)
- Palaeozoic granodiorite and granite comprising the elevated terrain of and behind the escarpment (shown as Dg in Inset 2).

A major regional thrust fault, the Selwyn Fault is mapped at a scale of 1:250,000 to strike WSW-ENE and crossing immediately north of the Site (ref Inset 2).

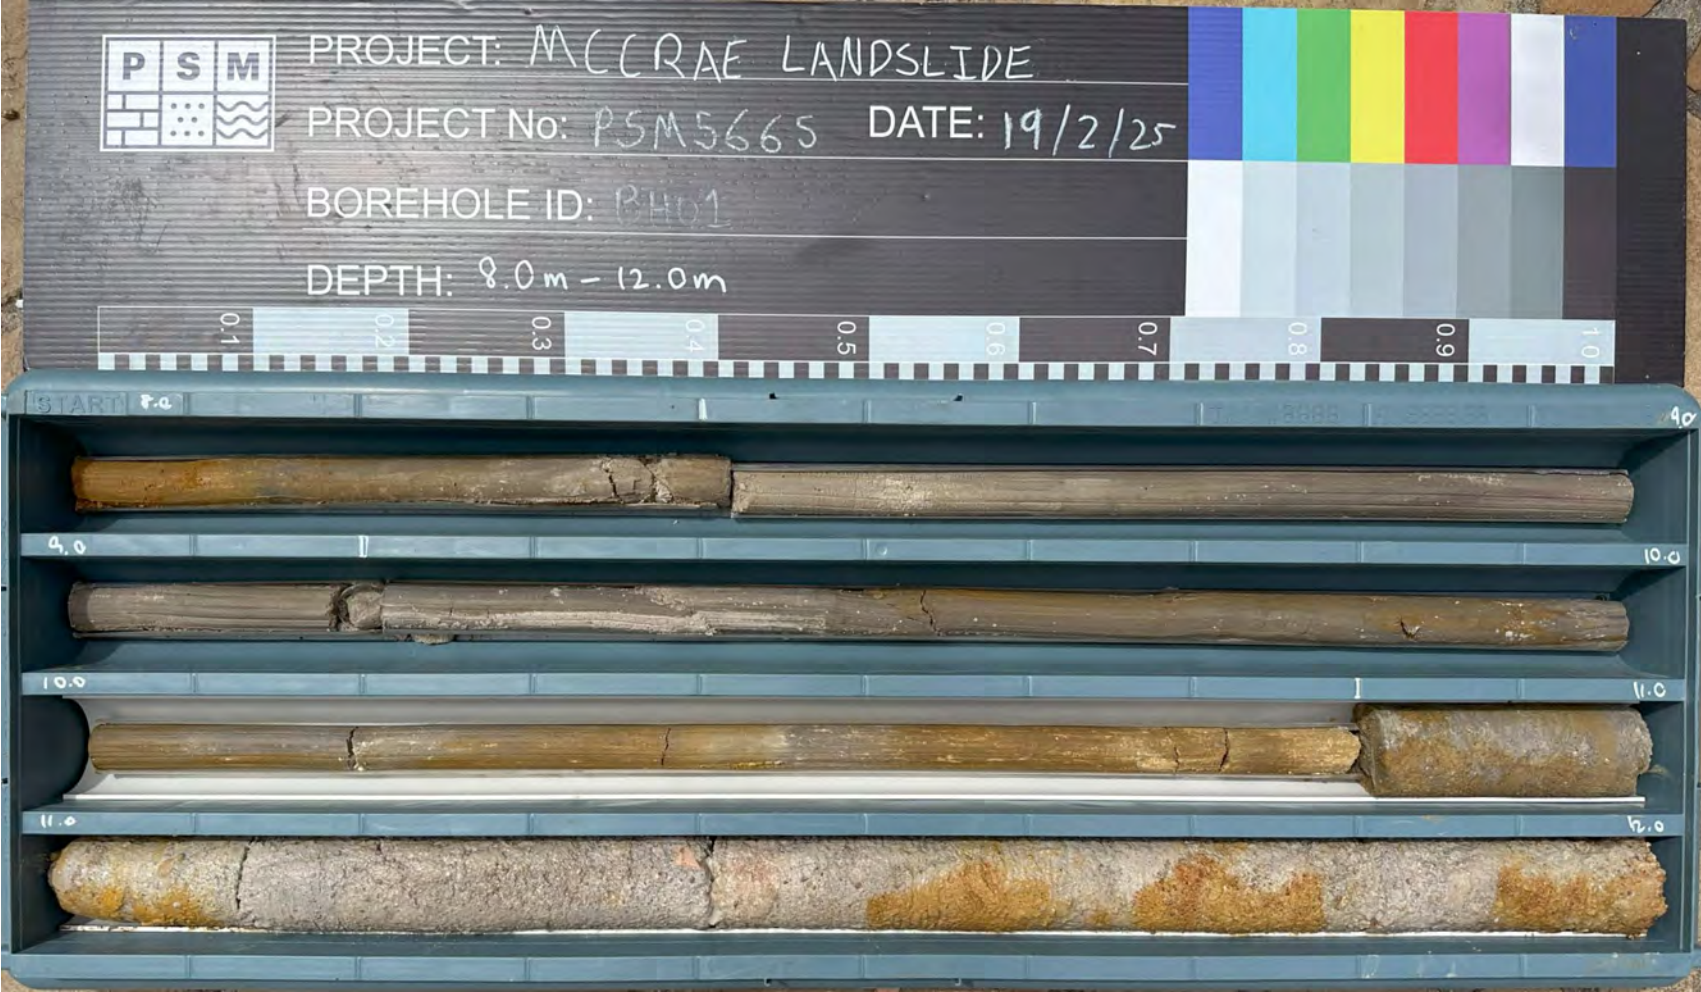
PointID : BH01 Depth Range: 8.00 - 12.00 m

| | TITLE<br><br>Mornington Peninsula Shire Council<br>McCrae Landslide Geotechnical Investigation<br>Core Photo - BH01: 8.00 m - 12.00 m | DRAWN<br>BTA | DATE<br>6/03/2025 |

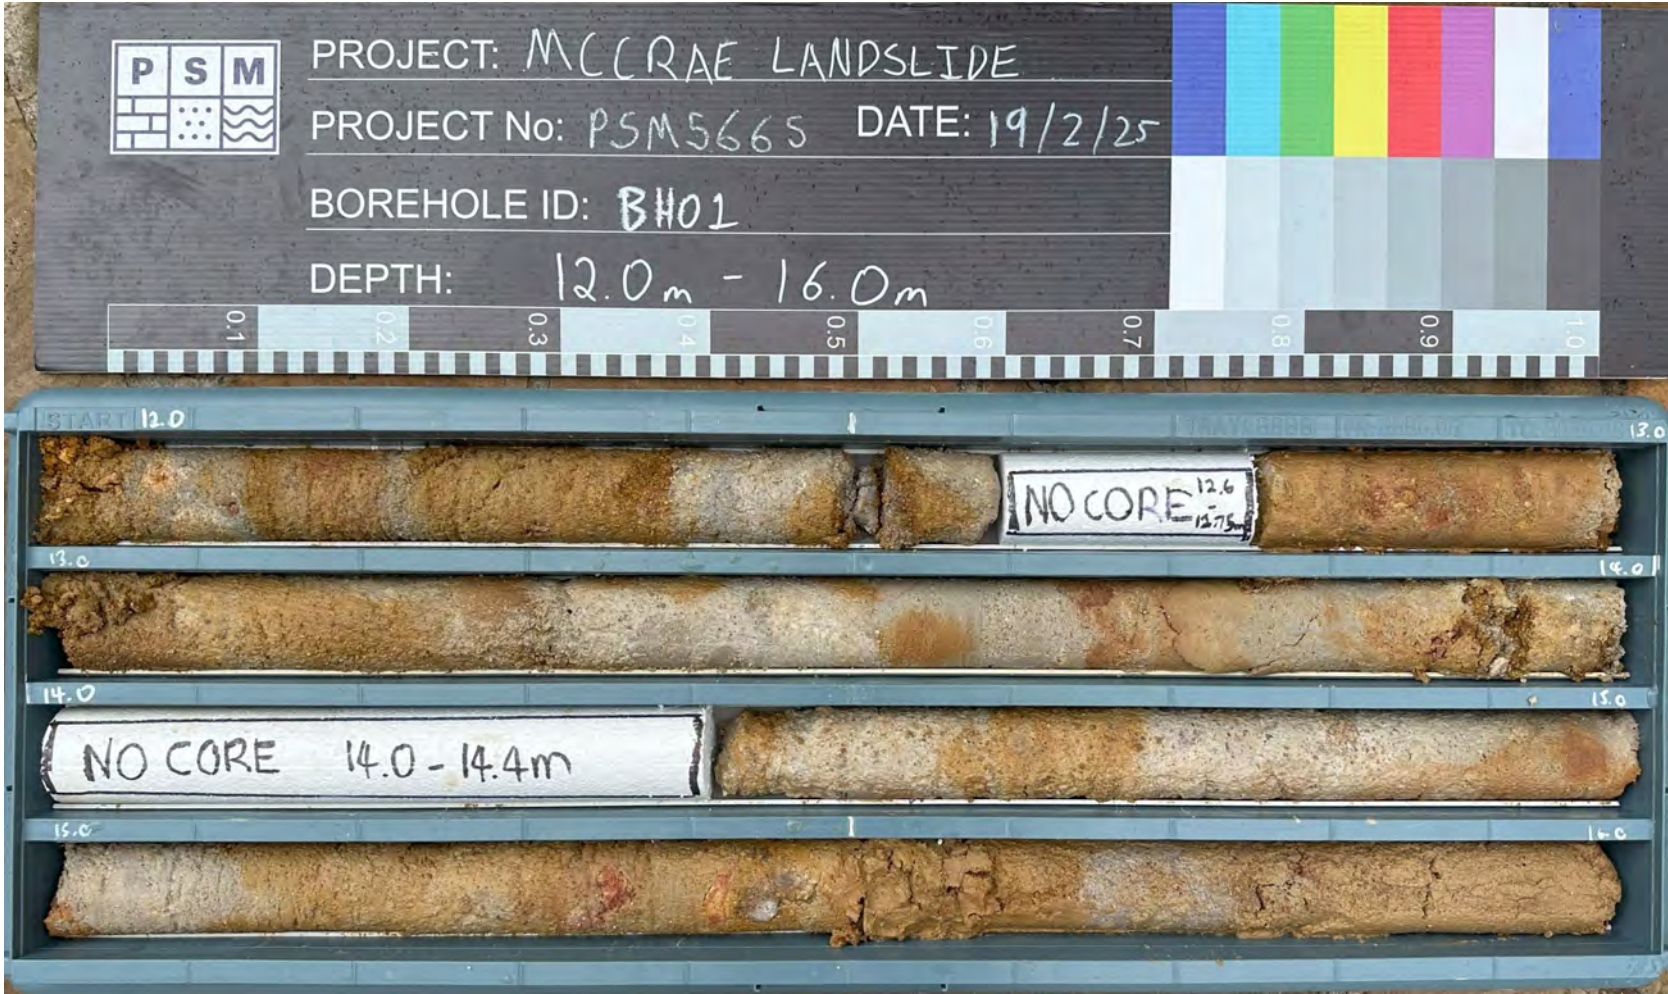
PointID : BH01 Depth Range: 12.00 - 16.00 m

| | TITLE<br><br>Mornington Peninsula Shire Council<br>McCrae Landslide Geotechnical Investigation<br>Core Photo - BH01: 12.00 m - 16.00 m | DRAWN<br>BTA | DATE<br>6/03/2025 |

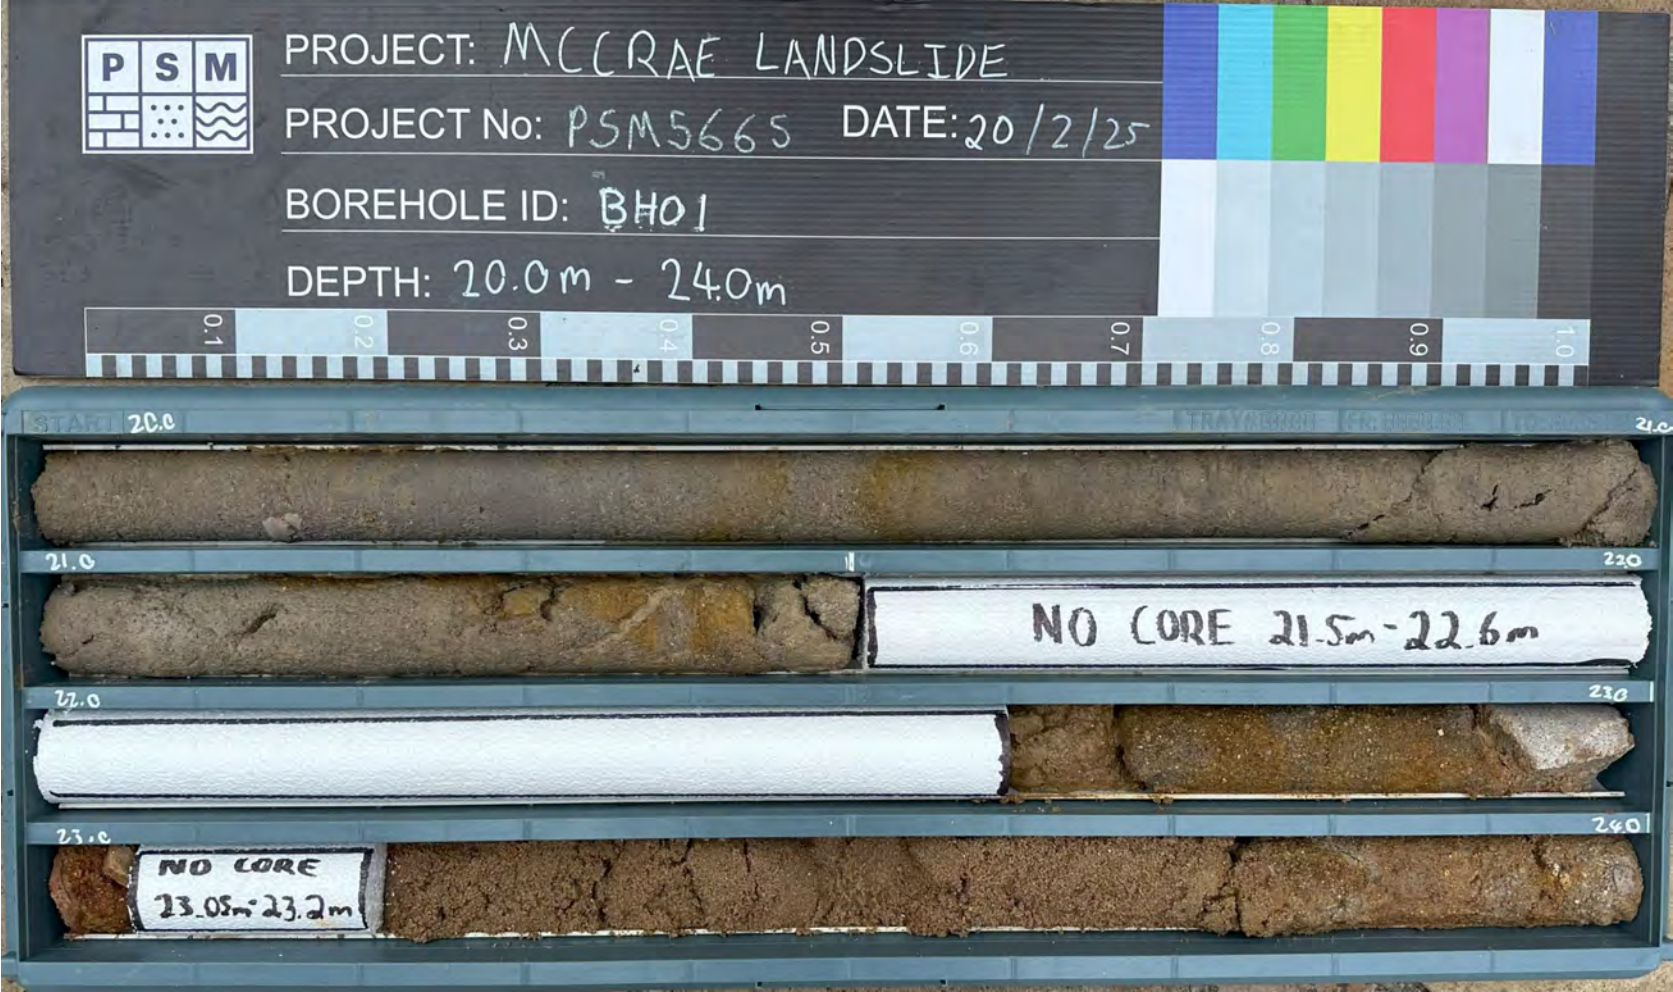
PointID : BH01 Depth Range: 20.00 - 24.00 m

| | TITLE<br><br>Mornington Peninsula Shire Council<br>McCrae Landslide Geotechnical Investigation<br>Core Photo - BH01: 20.00 m - 24.00 m | | DRAWN<br>BTA | DATE<br>6/03/2025 |

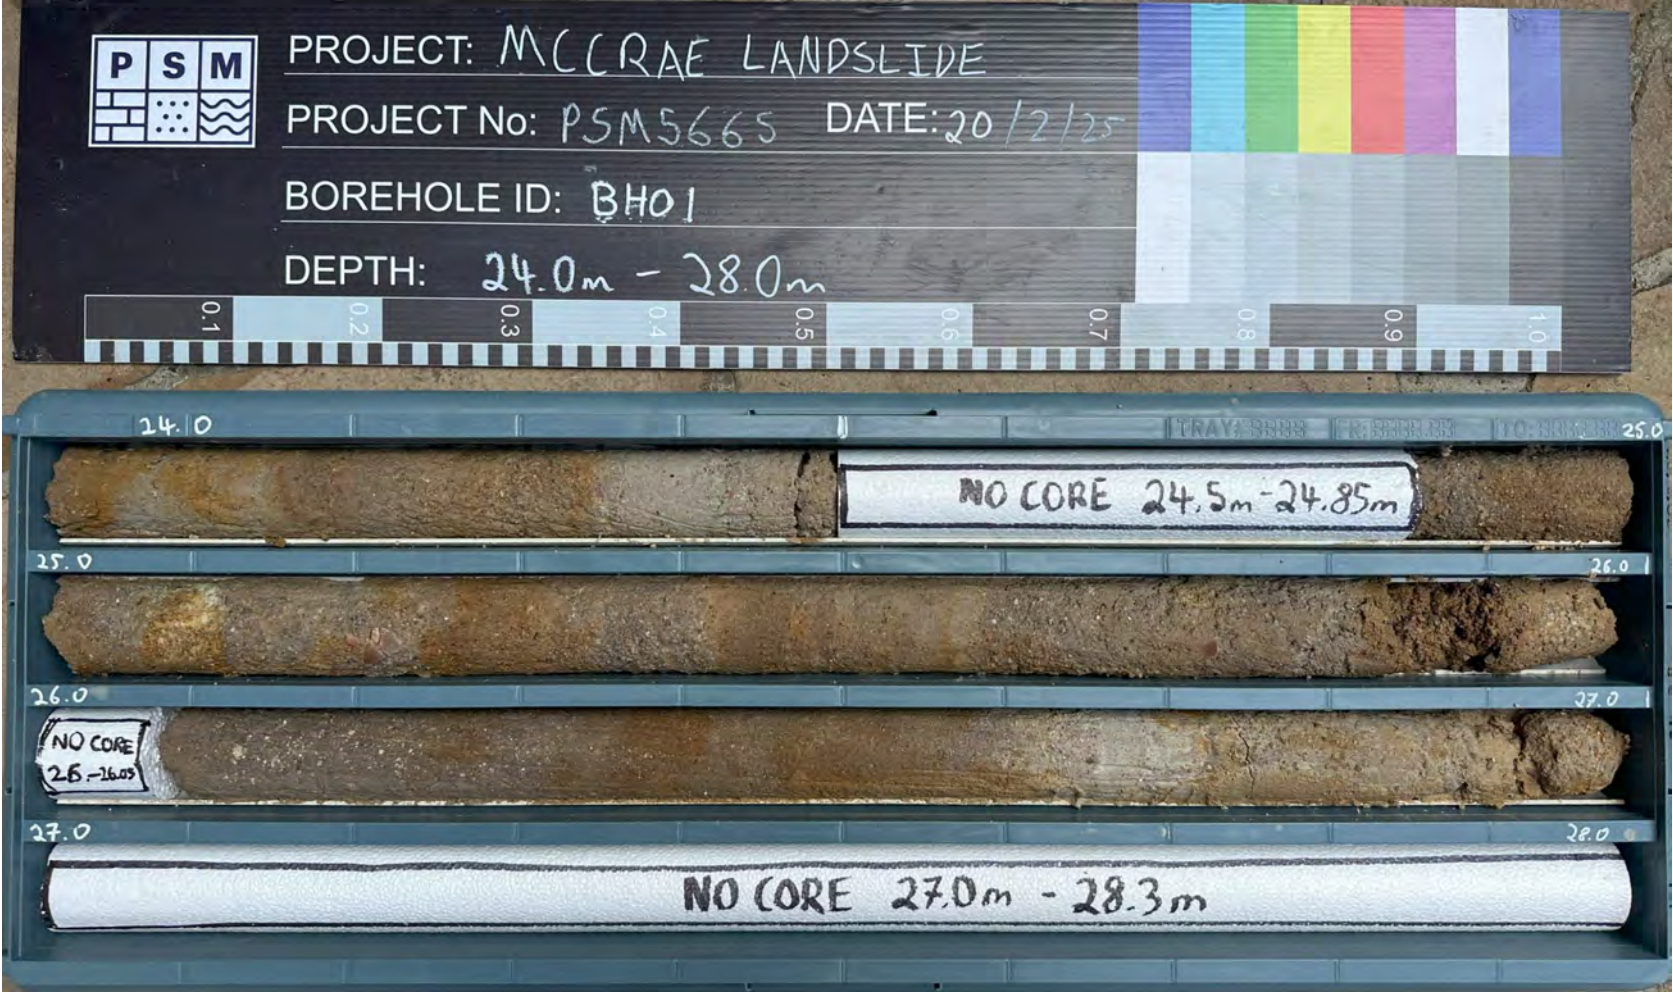
PointID : BH01 Depth Range: 24.00 - 28.00 m

| | TITLE<br><br>Mornington Peninsula Shire Council<br>McCrae Landslide Geotechnical Investigation<br>Core Photo - BH01: 24.00 m - 28.00 m | | DRAWN<br>BTA | DATE<br>6/03/2025 |

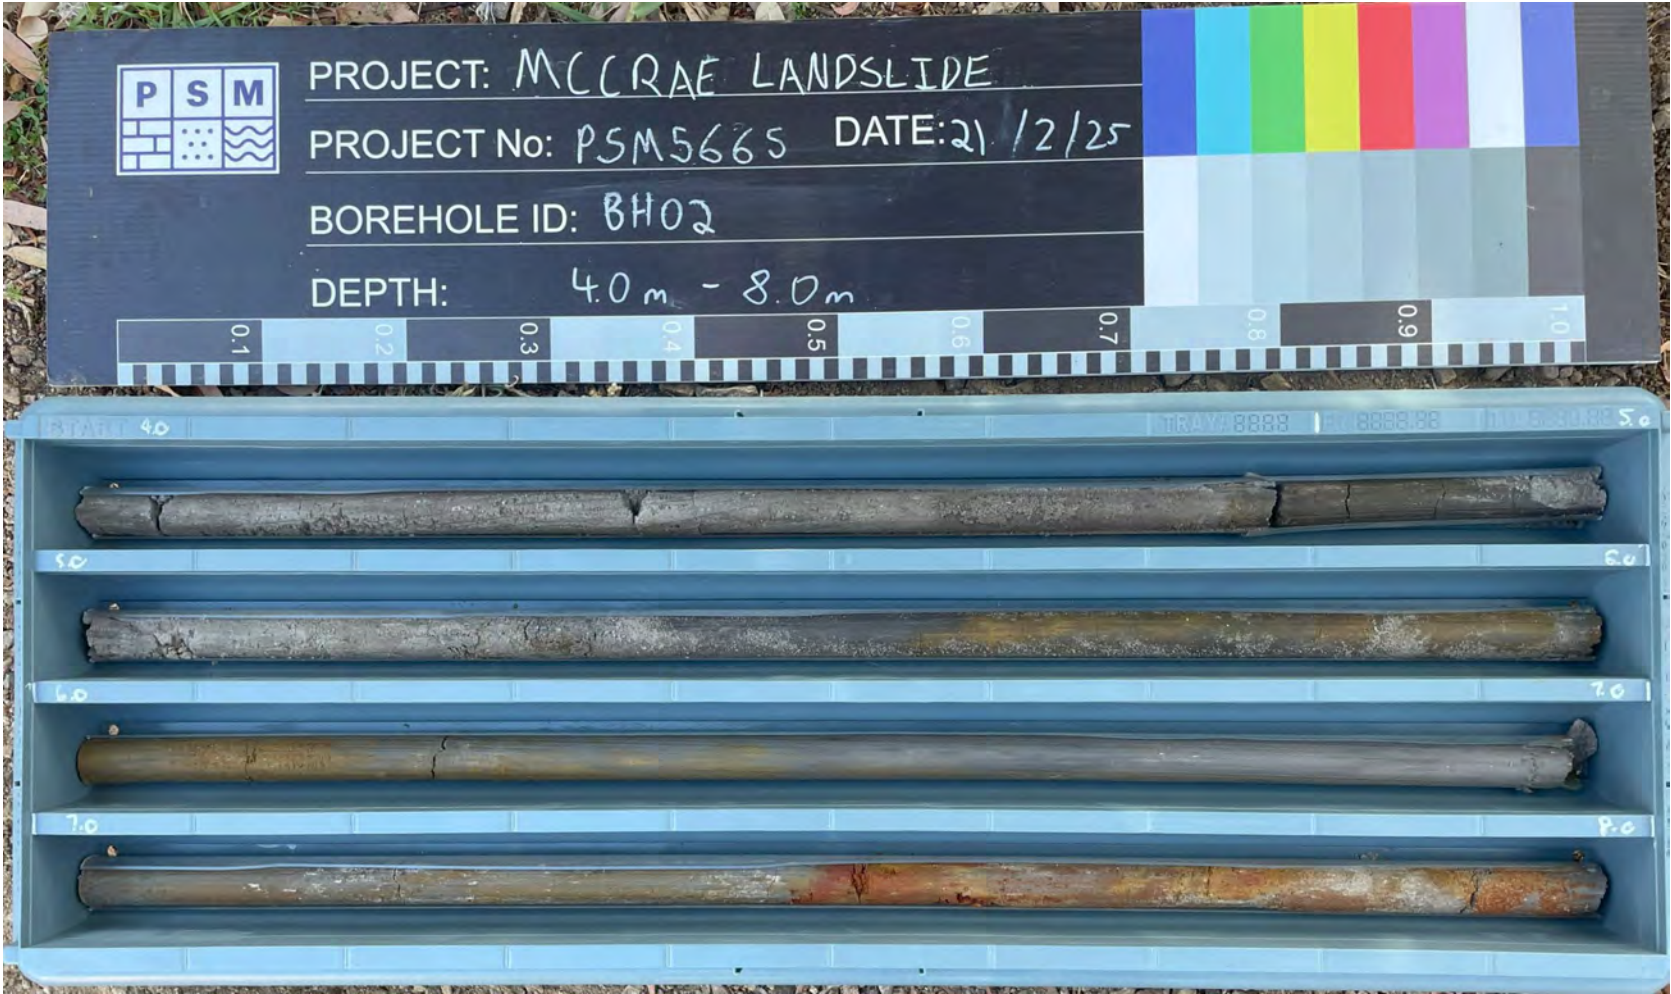
PointID : BH02 Depth Range: 4.00 - 8.00 m

| | TITLE<br><br>Mornington Peninsula Shire Council<br>McCrae Landslide Geotechnical Investigation<br>Core Photo - BH02: 4.00 m - 8.00 m | DRAWN<br>BTA | DATE<br>6/03/2025 |

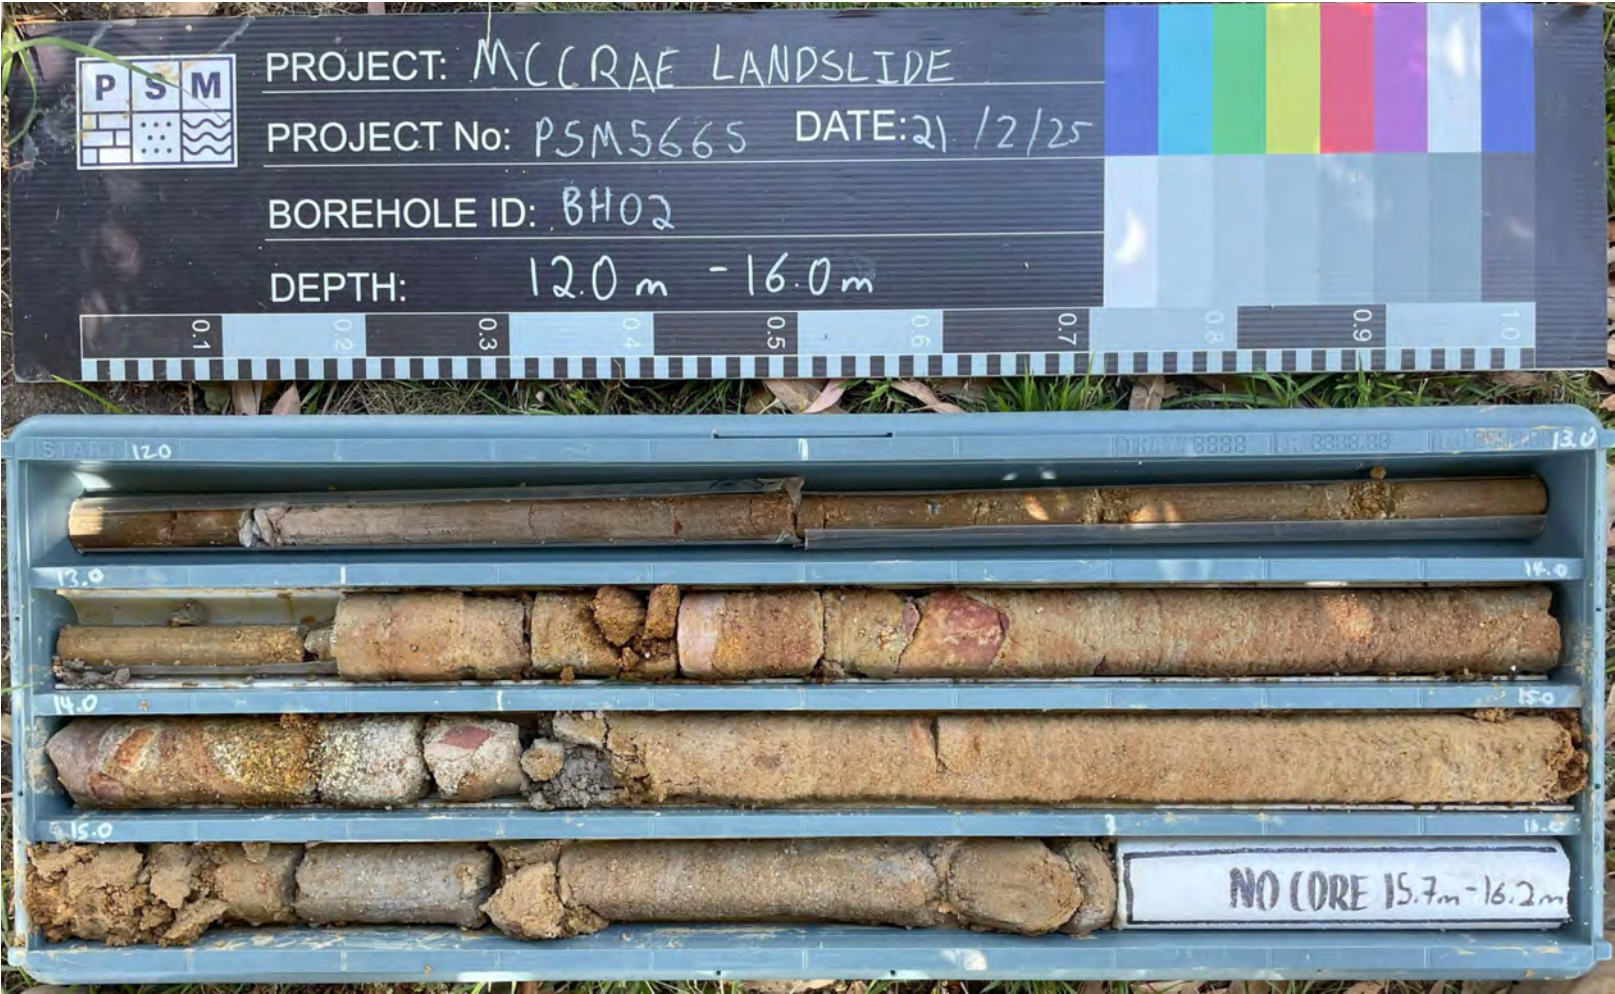
PointID : BH02 Depth Range: 12.00 - 16.00 m

| | TITLE<br><br>Mornington Peninsula Shire Council<br>McCrae Landslide Geotechnical Investigation<br>Core Photo - BH02: 12.00 m - 16.00 m | DRAWN<br>BTA | DATE<br>6/03/2025 |

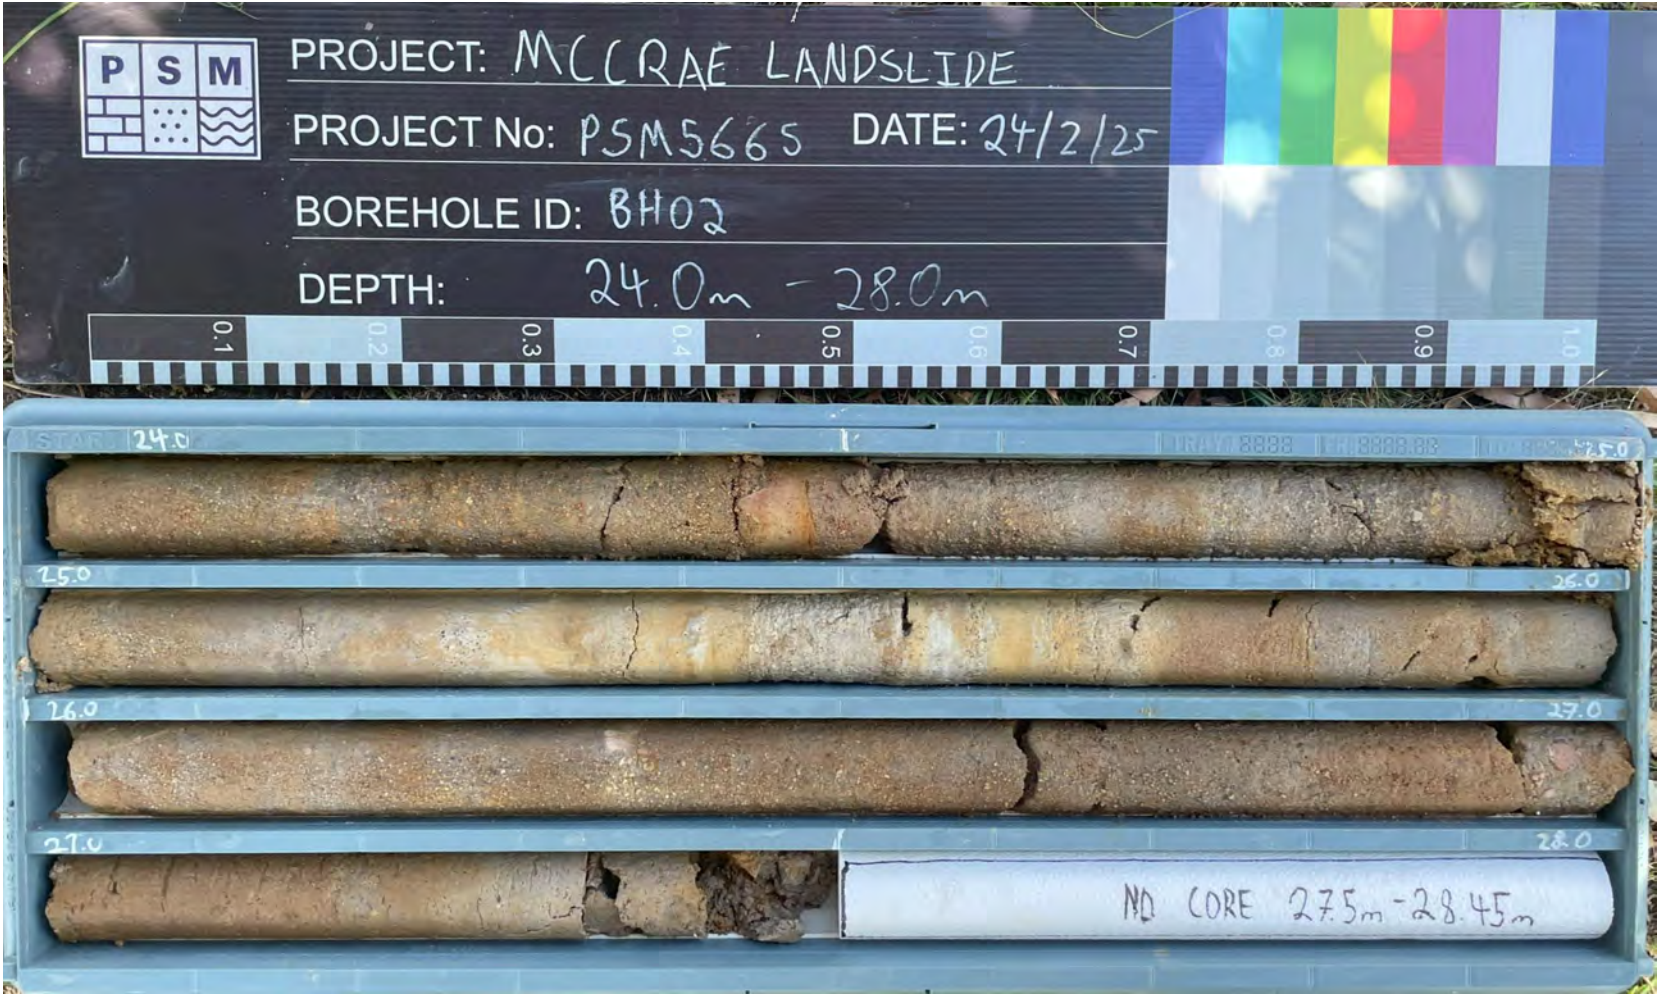
PointID : BH02 Depth Range: 24.00 - 28.00 m

| | TITLE<br><br>Mornington Peninsula Shire Council<br>McCrae Landslide Geotechnical Investigation<br>Core Photo - BH02: 24.00 m - 28.00 m | DRAWN<br>BTA | DATE<br>6/03/2025 |

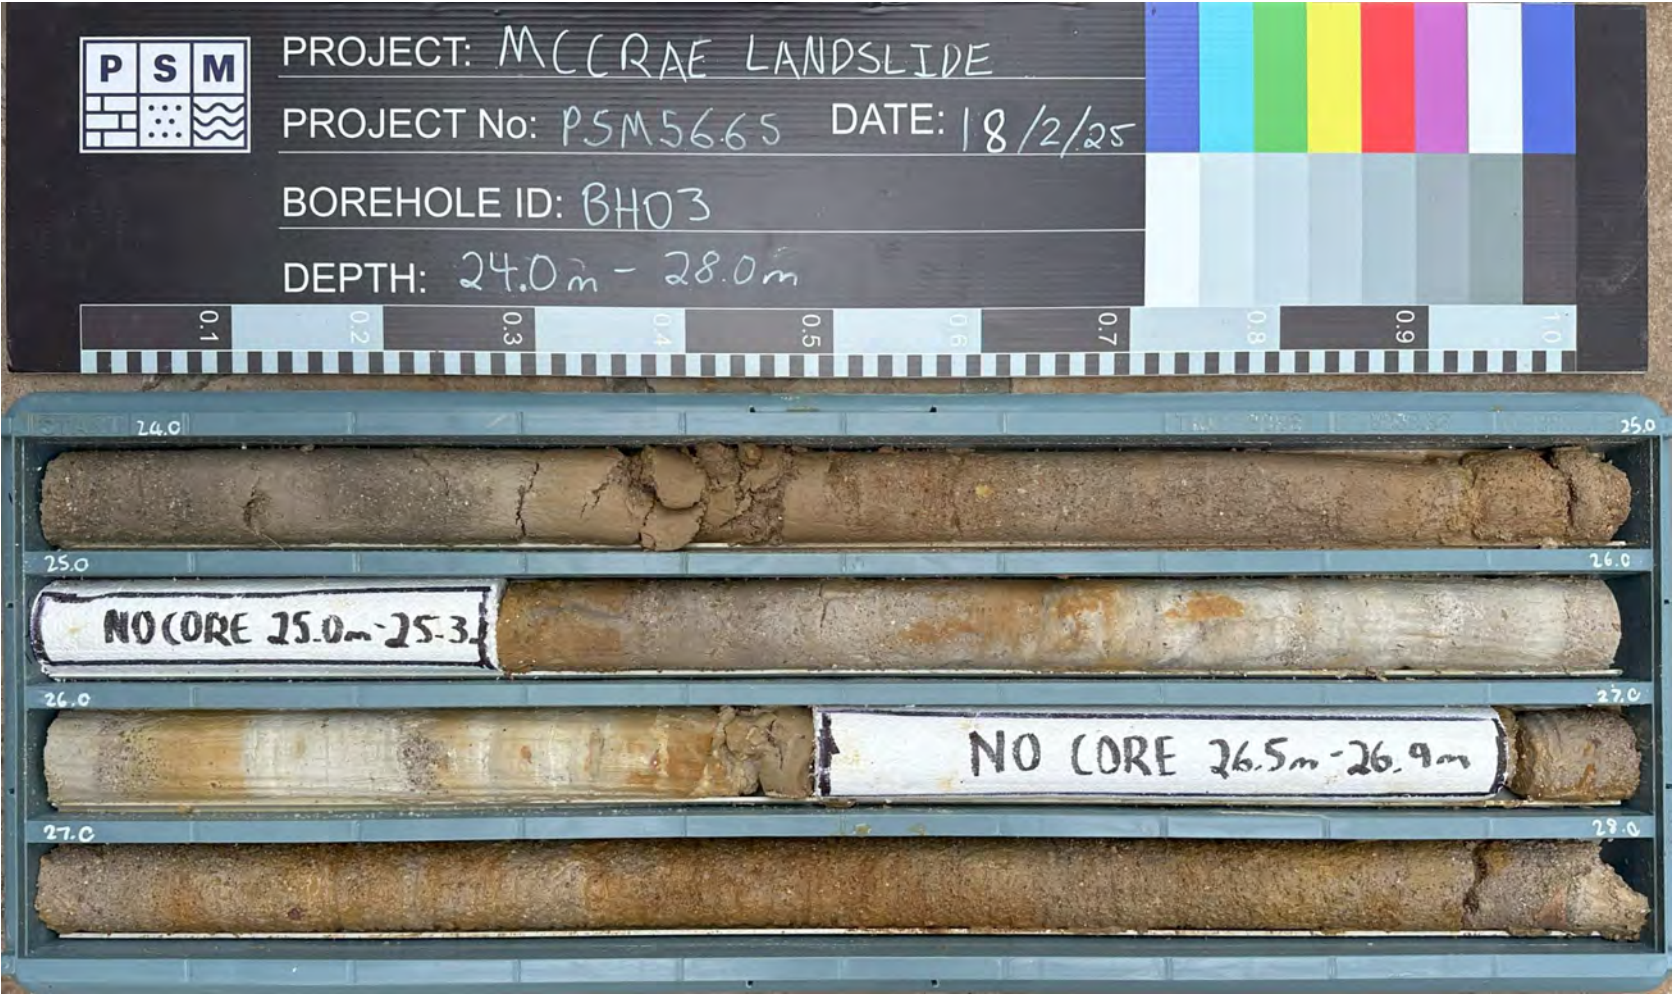
PointID : BH03 Depth Range: 24.00 - 28.00 m

| | TITLE<br><br>Mornington Peninsula Shire Council<br>McCrae Landslide Geotechnical Investigation<br>Core Photo - BH03: 24.00 m - 28.00 m | DRAWN<br>BTA | DATE<br>6/03/2025 |
