# McCrae Landslide - Evacuation Order Area

## Geotechnical Factual Report

PSM5665-GFR REV0      9 April 2025

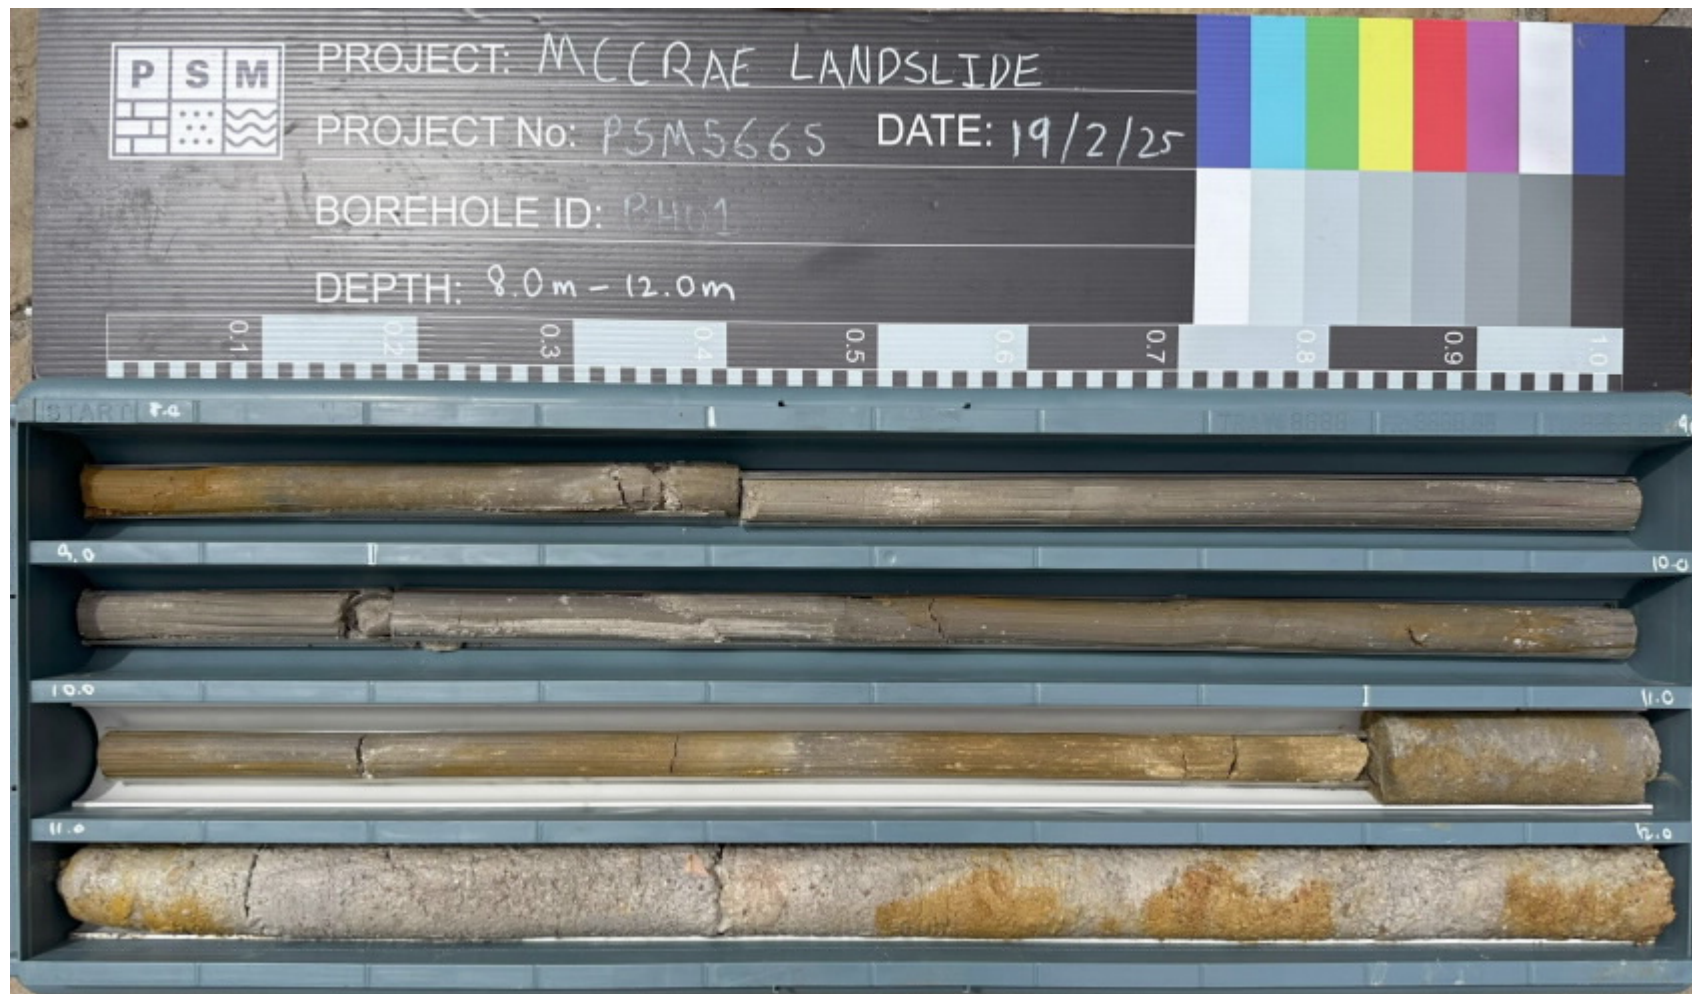
3/8

PointID : BH01 Depth Range: 8.00 - 12.00 m

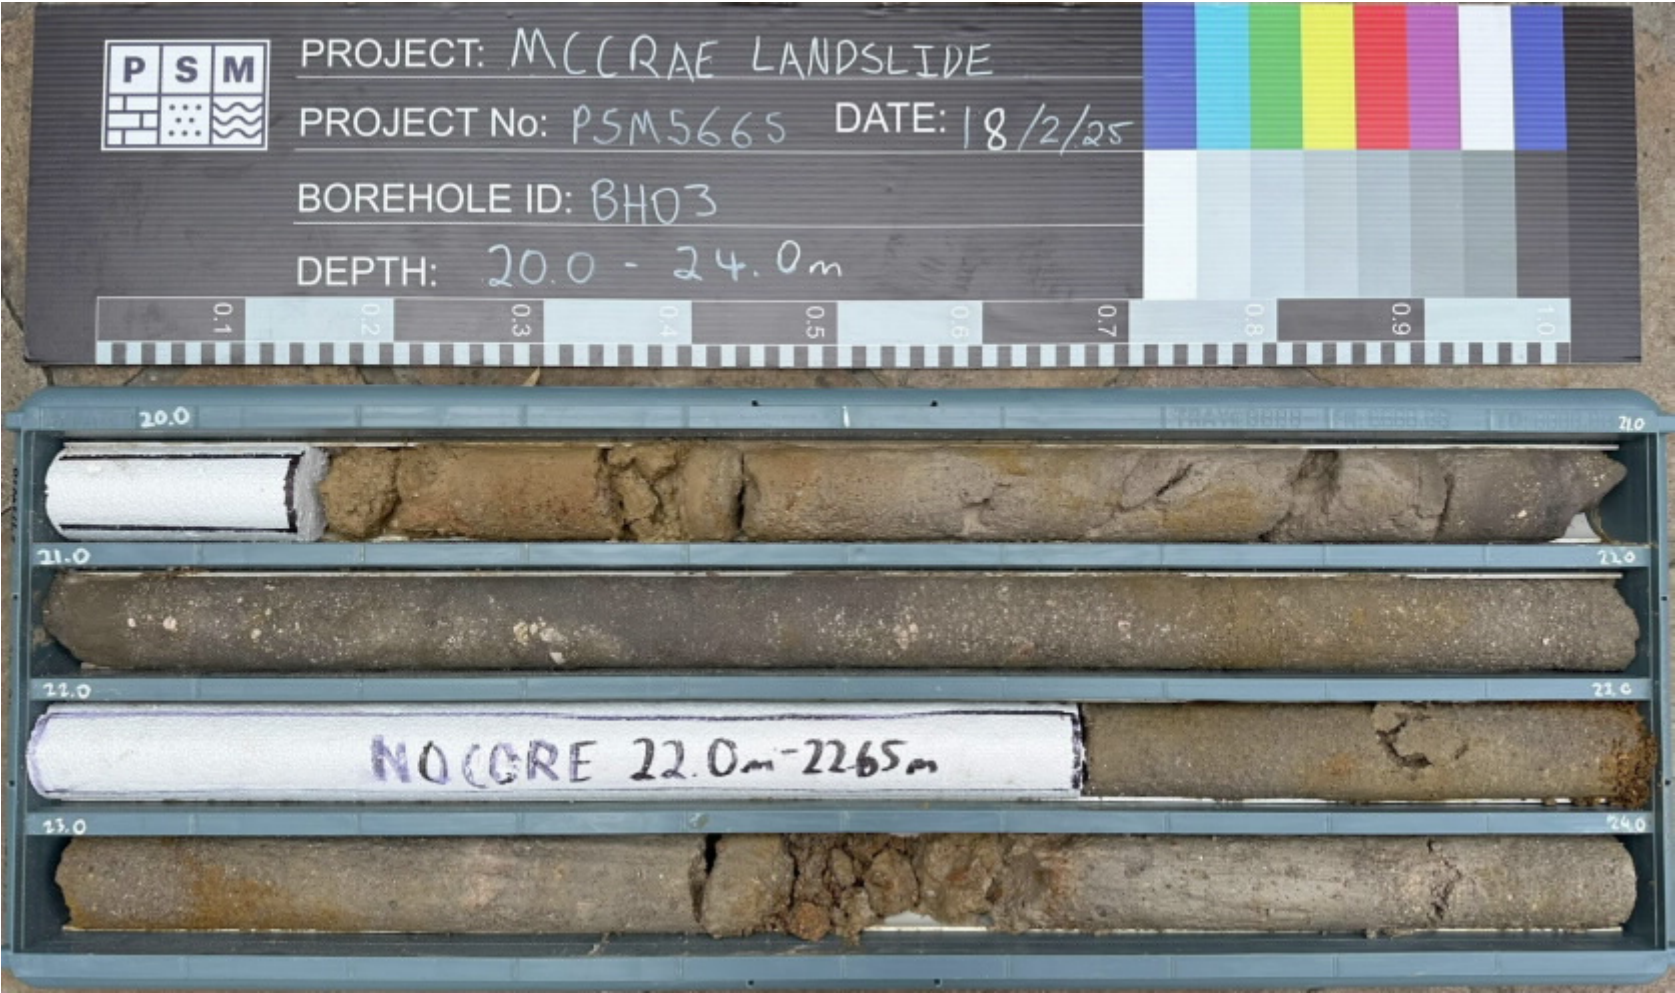
PointID : BH03 Depth Range: 20.00 - 24.00 m

| | TITLE<br><br>Mornington Peninsula Shire Council<br>McCrae Landslide Geotechnical Investigation<br>Core Photo - BH03: 20.00 m - 24.00 m | DRAWN | BTA | DATE | 6/03/2025 |

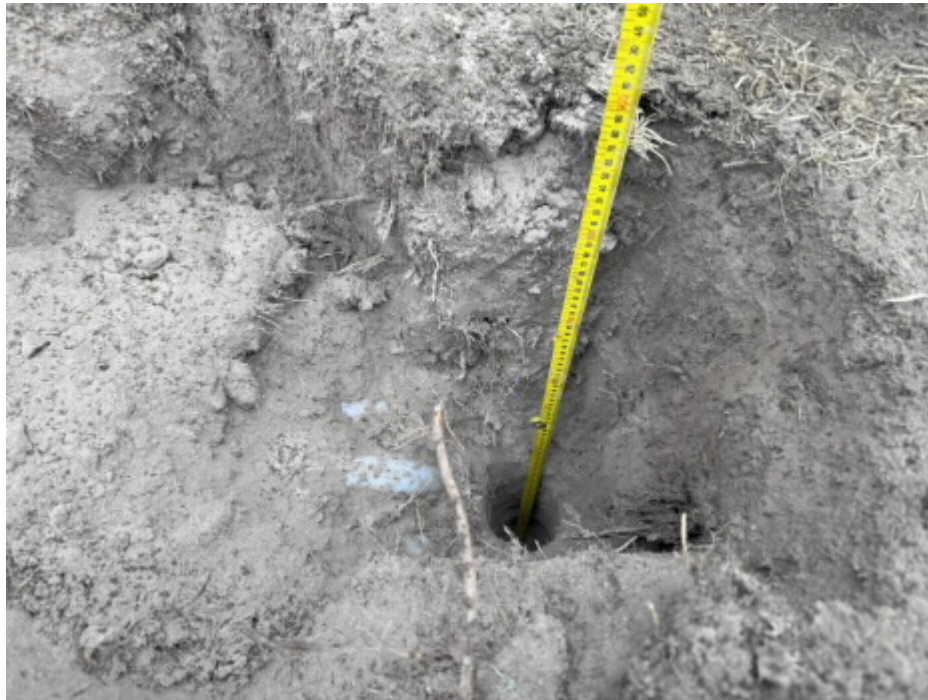
RD1 - 1 Depth Range: 0.00 m - 0.90 m

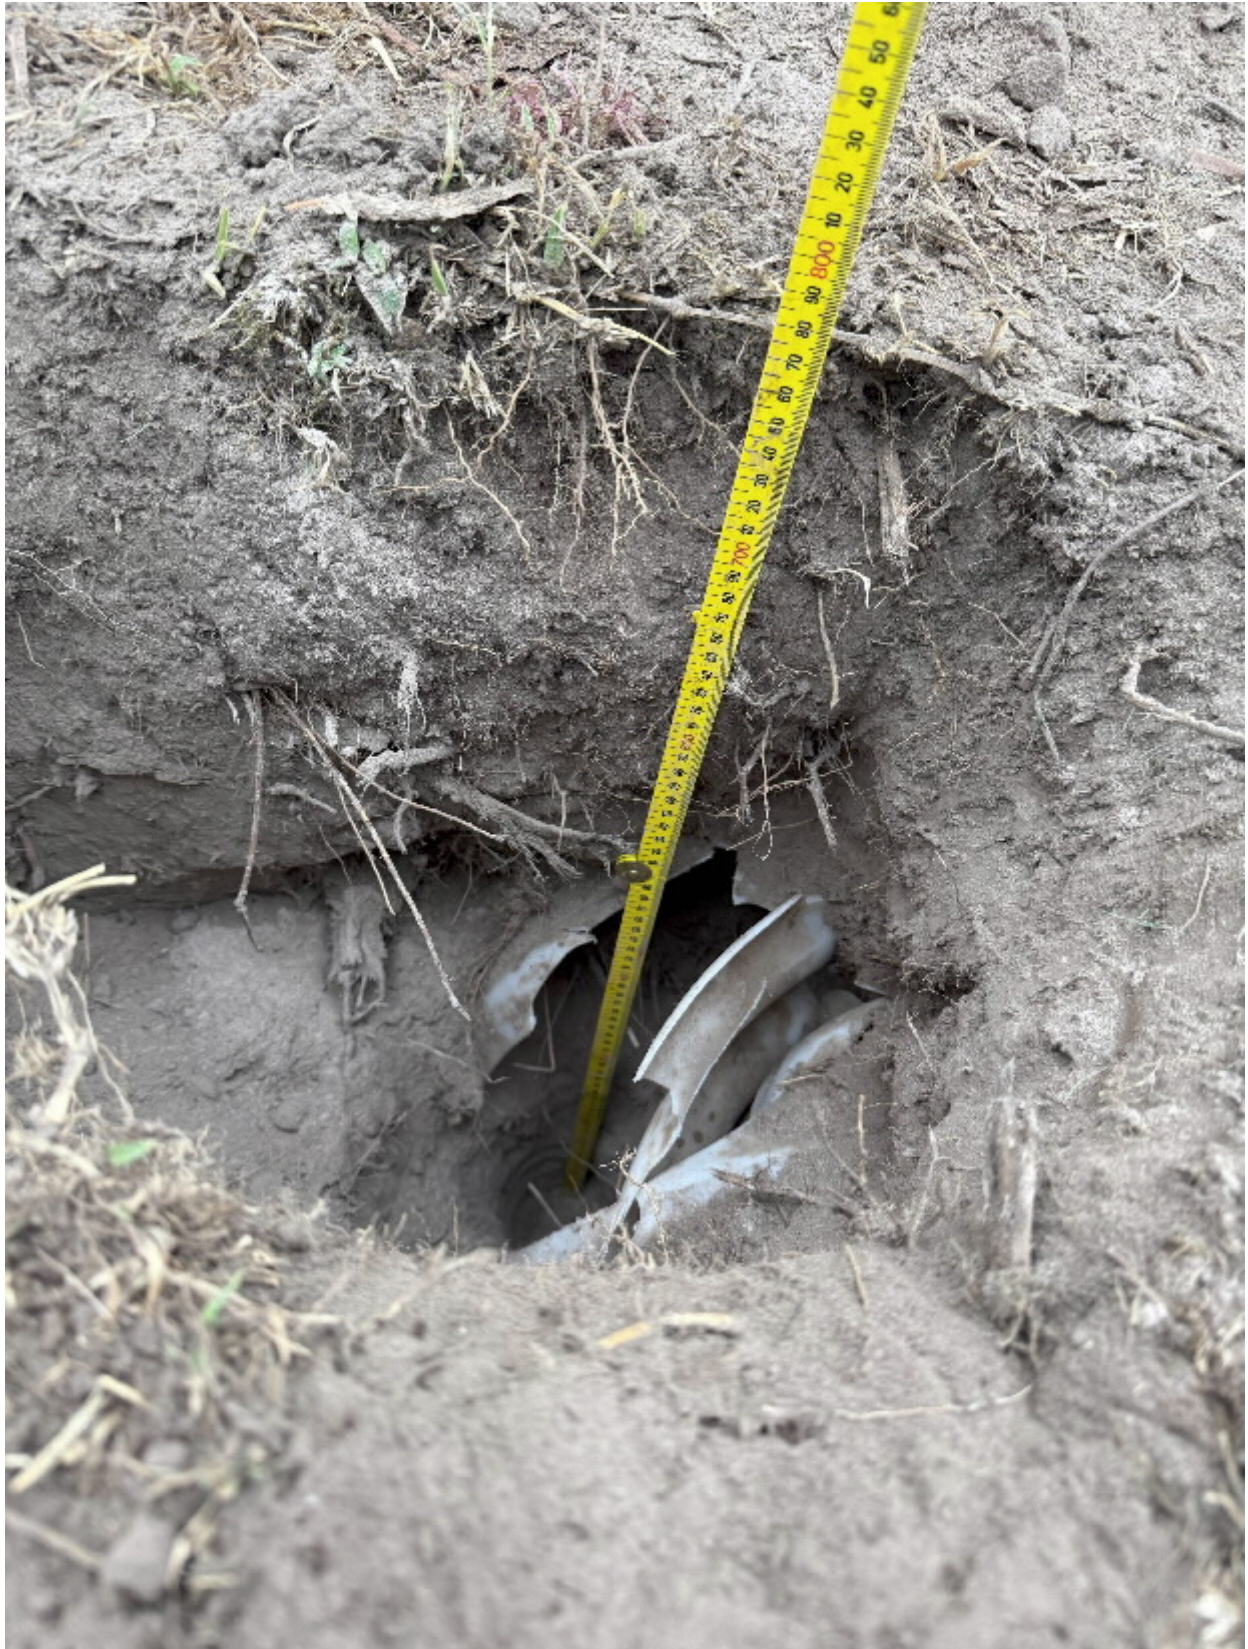
RD2 - 1 Depth Range: 0.00 m - 0.70 m
