**Draft for Comment** Landslide  
Susceptibility Assessment,  
Stage 2  
Mornington Peninsula Shire, Victoria

Doc Ref 207166Report02.1

Prepared for Mornington Peninsula Shire Council

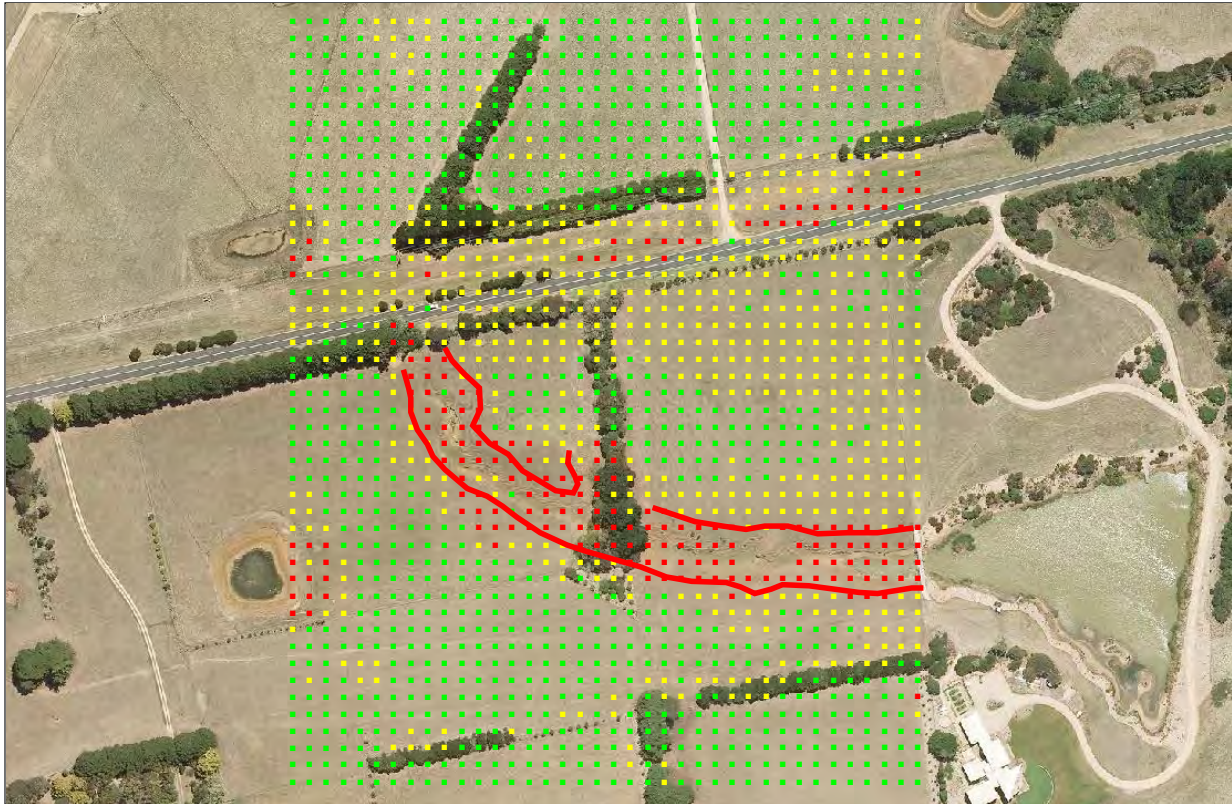
**Figure 10-6: Rosebud Flinders Rd - PA (1993)**

The results of the verification are shown in Figure 9-6 and are discussed below. The landslides in the vicinity of the creek are visible on aerial photography. The approximate limit of where these are visible on the aerial photography is marked with red lines on the figure. The results of the predictive model are shown as a grid of coloured squares with the red squares representing the predicted locations of high susceptibility and yellow squares representing the predicted locations of medium susceptibility.

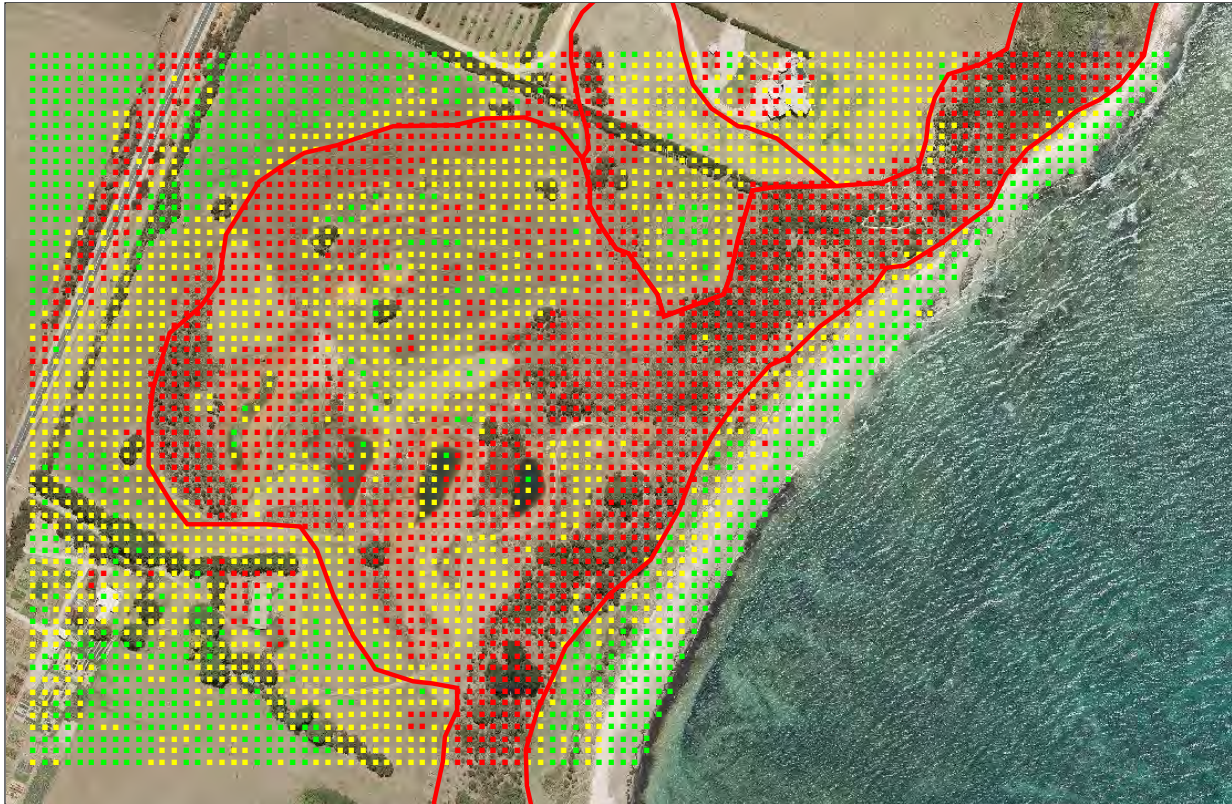
**Figure 10-7: Shoreham - DP(2000)**

The results of the verification are shown in Figure 9-7 and are discussed below. The extent of the landslide as identified in aerial photography is shown with a red line. The results of the predictive model are shown as a grid of coloured squares with the red squares representing the predicted locations of high susceptibility.

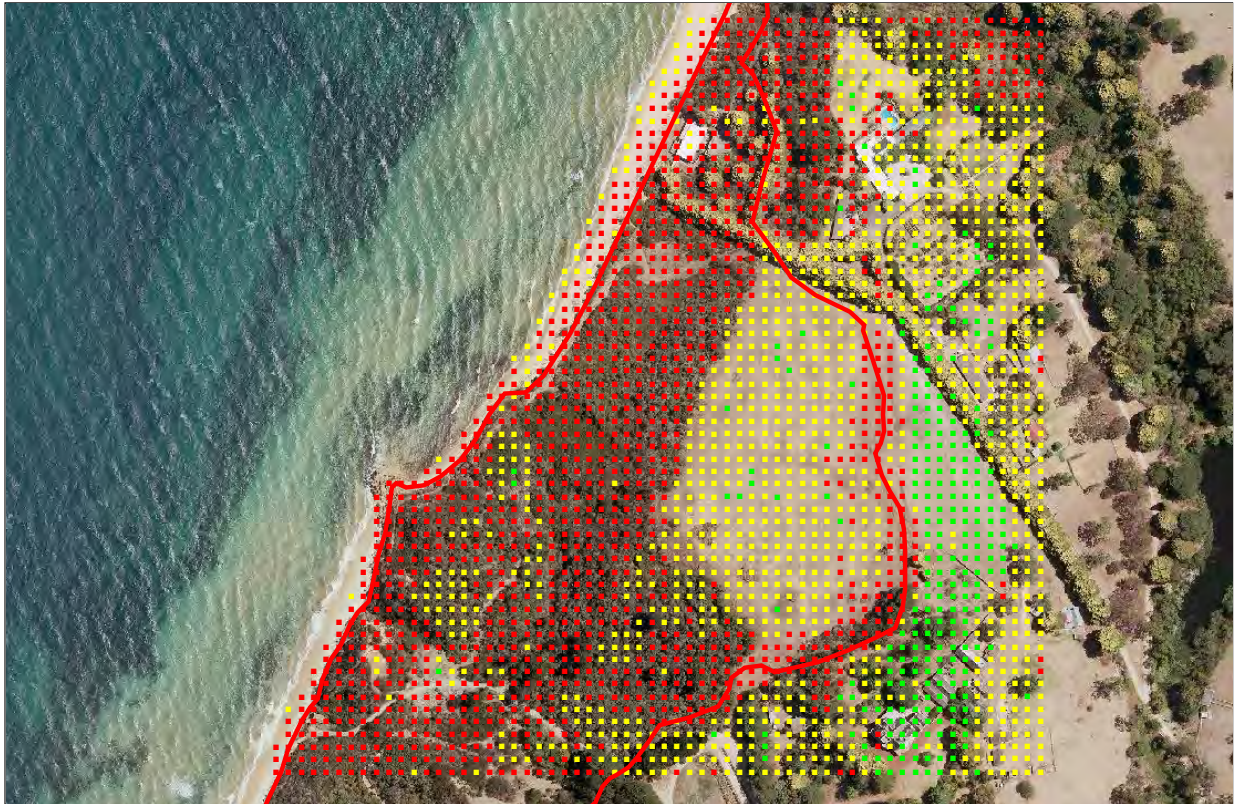
**Figure 10-14: Norman Myer Lodge LP(2007A)**

The results of the verification are shown in Figure 9-14 and are discussed below. The boundary of the high susceptibility zone determined from aerial photographs and visual inspections is shown as a solid red line while the results of the predictive model are shown as a grid of coloured squares with the red squares representing the predicted locations of high susceptibility.

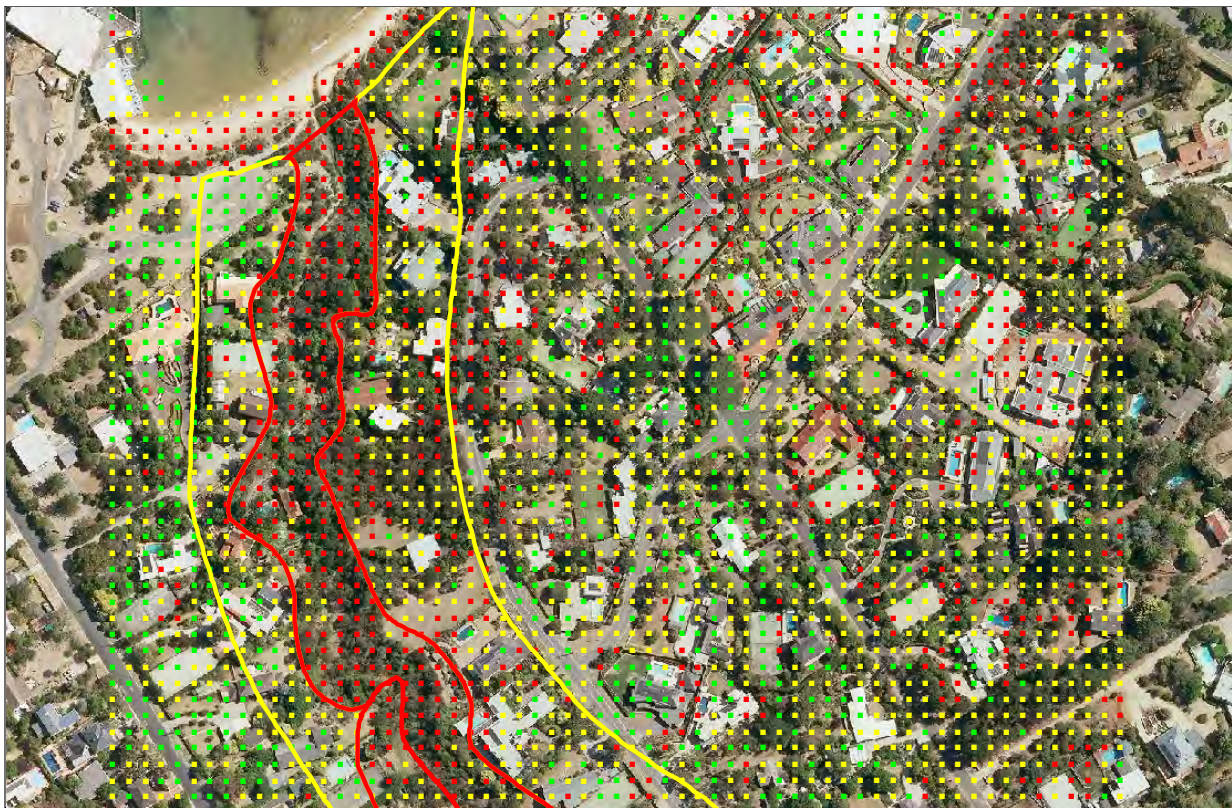
**Figure 10-15: Ballar Creek - CG(1999)**

The results of the verification are shown in Figure 9-15 and are discussed below. The boundaries of the high susceptibility zone and medium susceptibility zone determined from CG(1999) report are shown as a solid red and yellow lines while the results of the predictive model are shown as a grid of coloured squares.

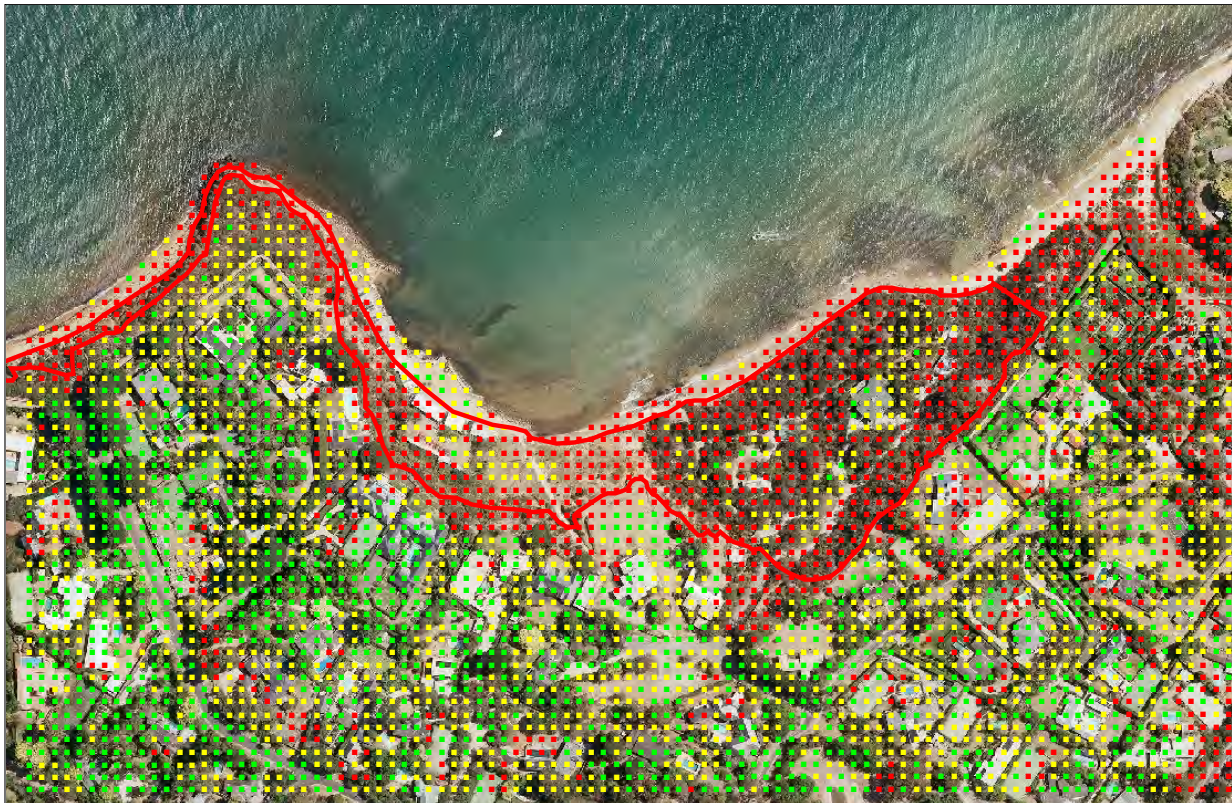
**Figure 10-16: Davey's Bay - PA(2006A) & CF(1993)**

The results of the verification are shown in Figure 9-16 and are discussed below. The boundary of the high susceptibility zone determined from aerial photographs and visual inspections is shown as a solid red line while the results of the predictive model are shown as a grid of coloured squares with the red squares representing the predicted locations of high susceptibility.

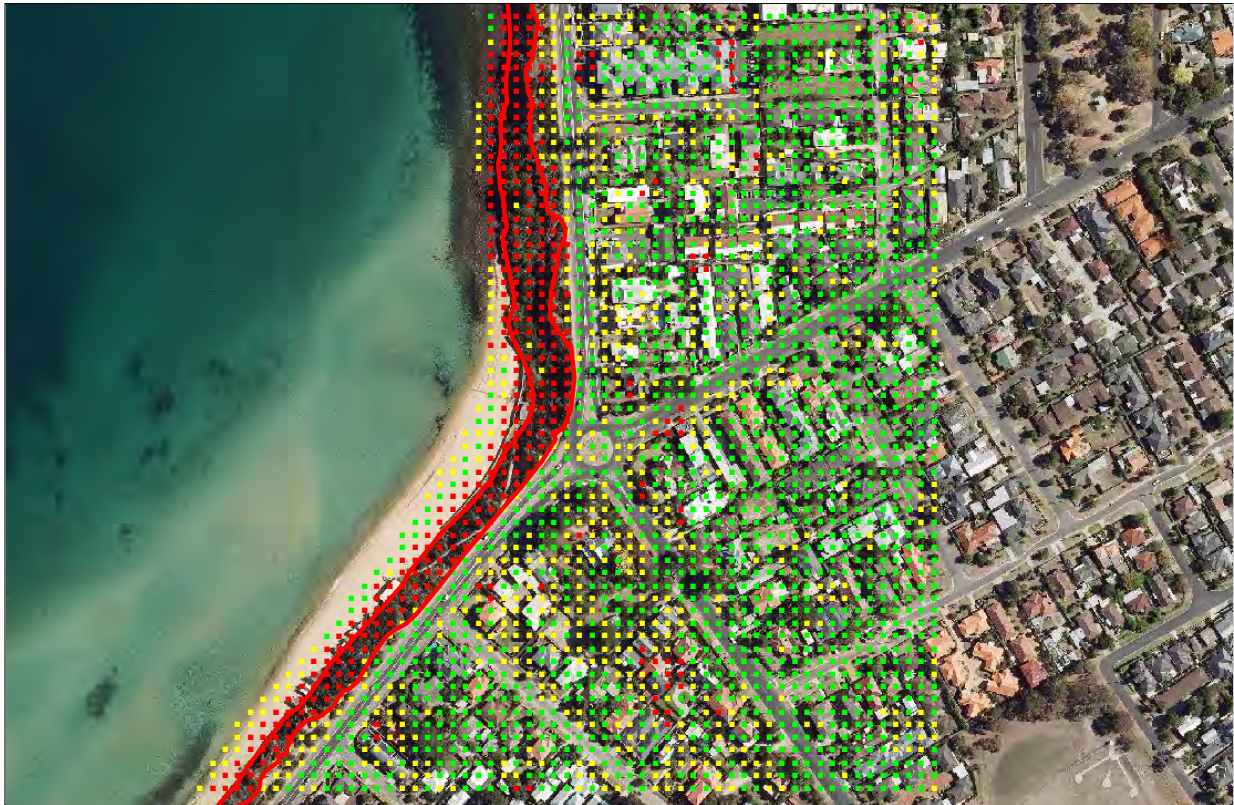
**Figure 10-17: Fishermans Beach - PA(2003)**

The results of the verification are shown in Figure 9-17 and are discussed below. The boundary of the high susceptibility zone determined from aerial photographs and visual inspections is shown as a solid red line while the results of the predictive model are shown as a grid of coloured squares with the red squares representing the predicted locations of high susceptibility.

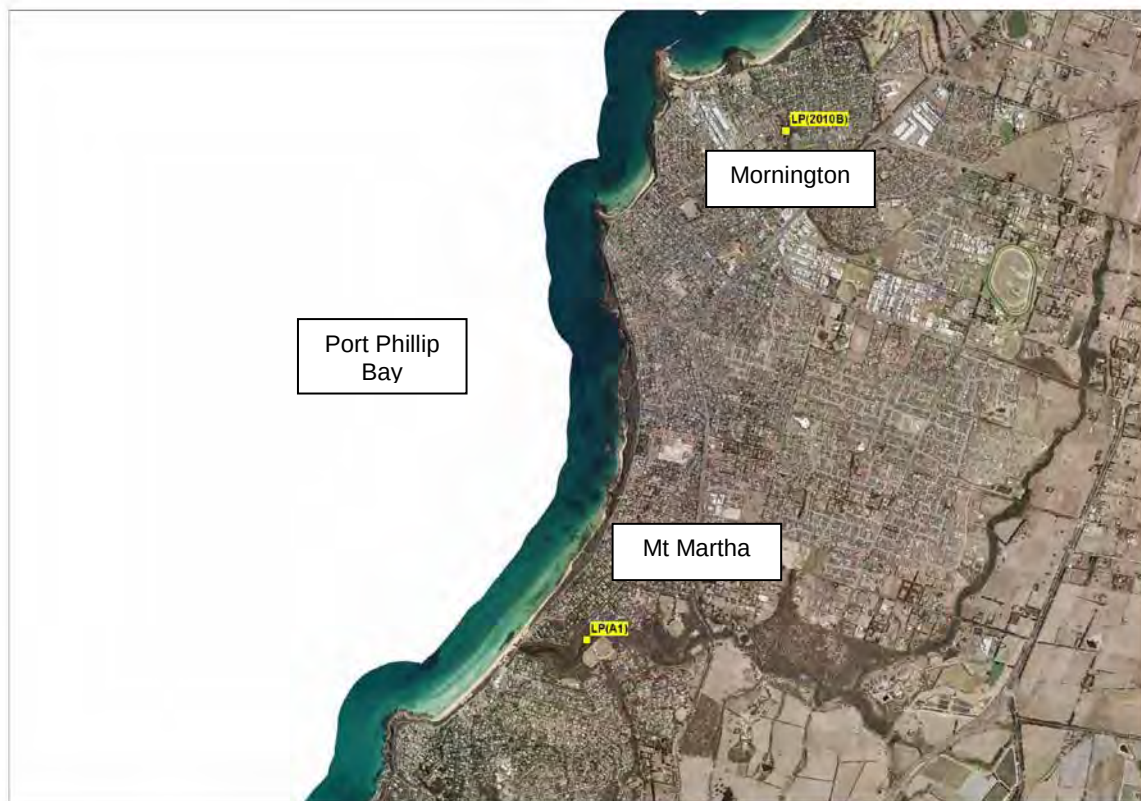
**Figure 10-20: Sites used for Baxter Sandstone Verification**

The locations of these areas of instability are shown on the aerial photograph in the following figure.

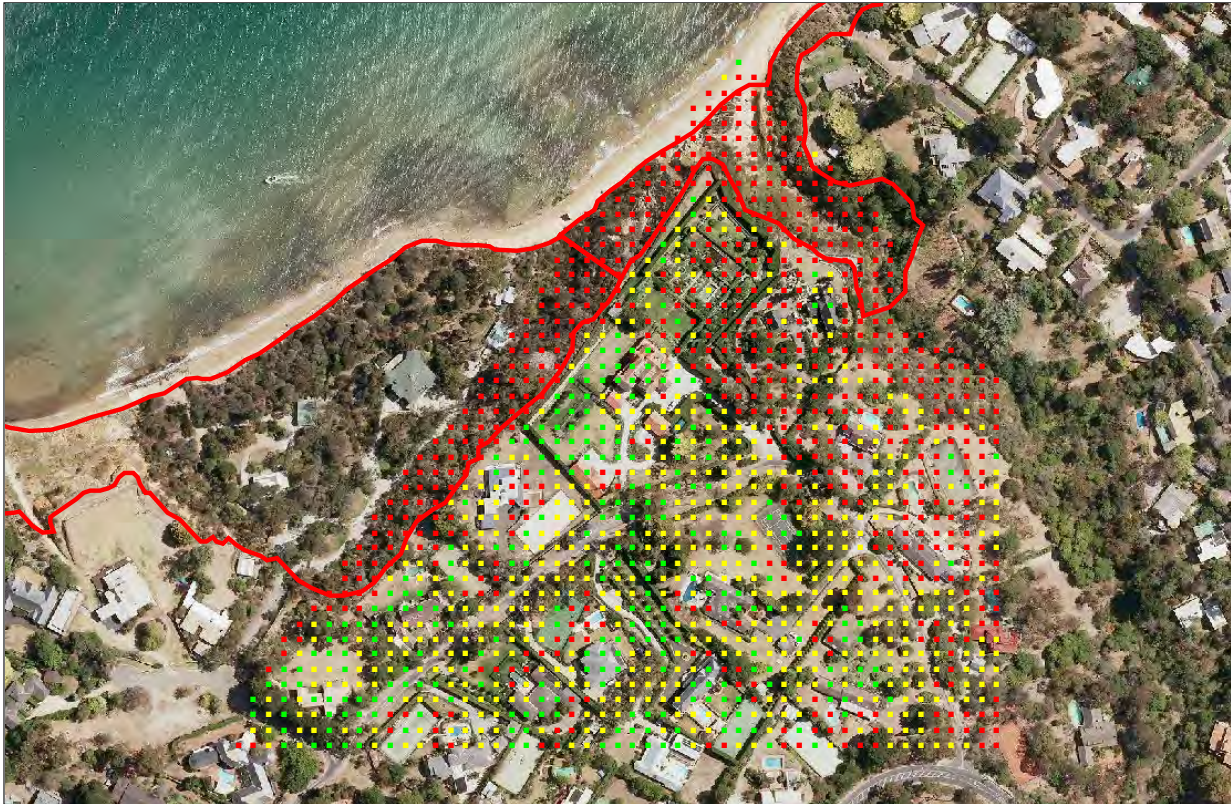
**Figure 10-29: Davey's Bay - CF(1993)**

The results of the verification are shown in Figure 9-29 and are discussed below. Only the part of the model that corresponds to the landslide scarp and upslope of the landslide is shown.

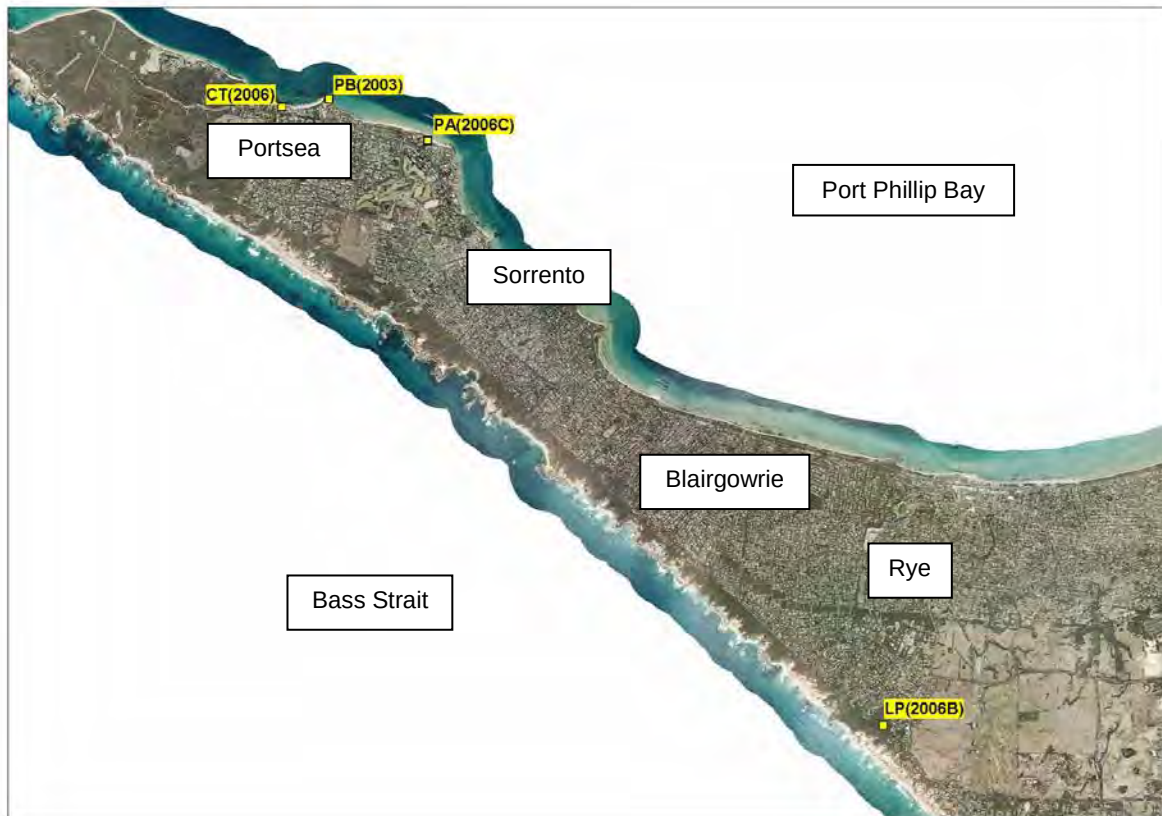
**Figure 10-35: Sites used for Quaternary Sand Verification**

The location of the areas used to develop the model are shown below.

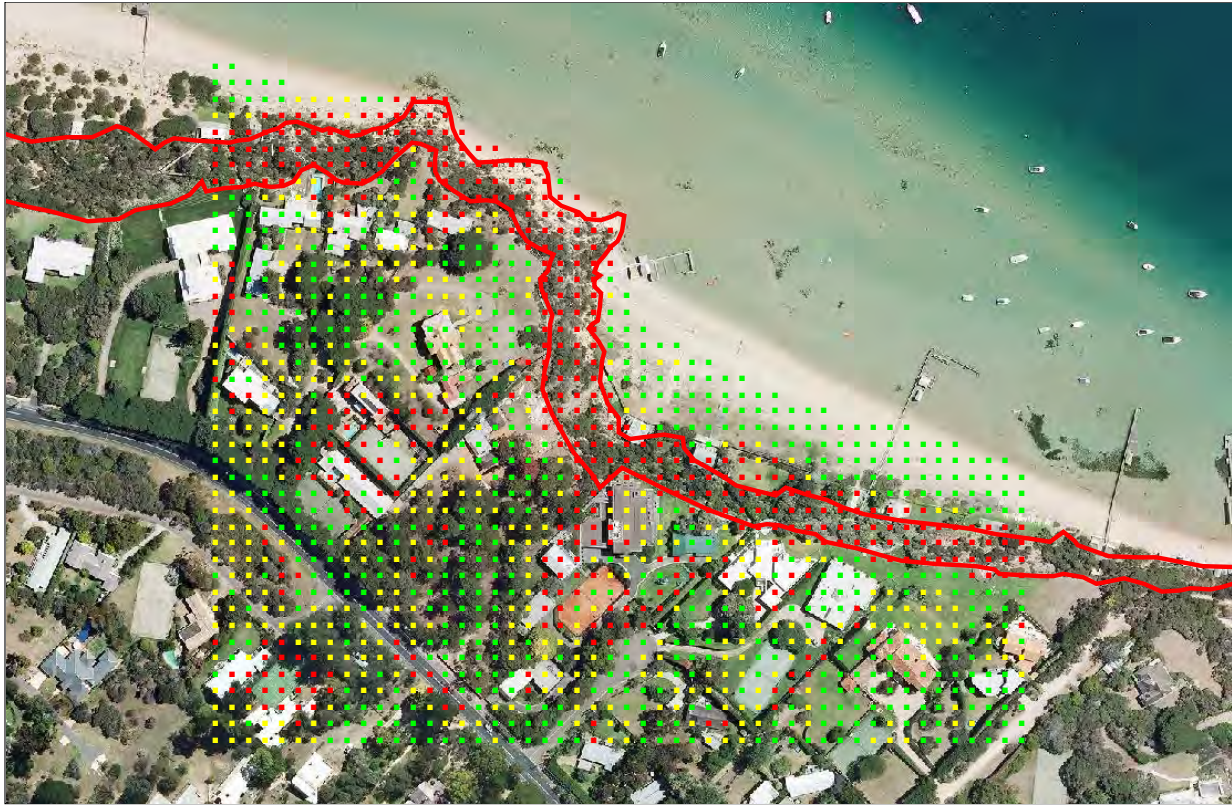
**Figure 10-39: 3550 Pt. Nepean Road - PA(2006C)**

This site is another typical example of the steep coastal cliffs in the area. The results of the verification are shown in Figure 9-38 and are discussed below.

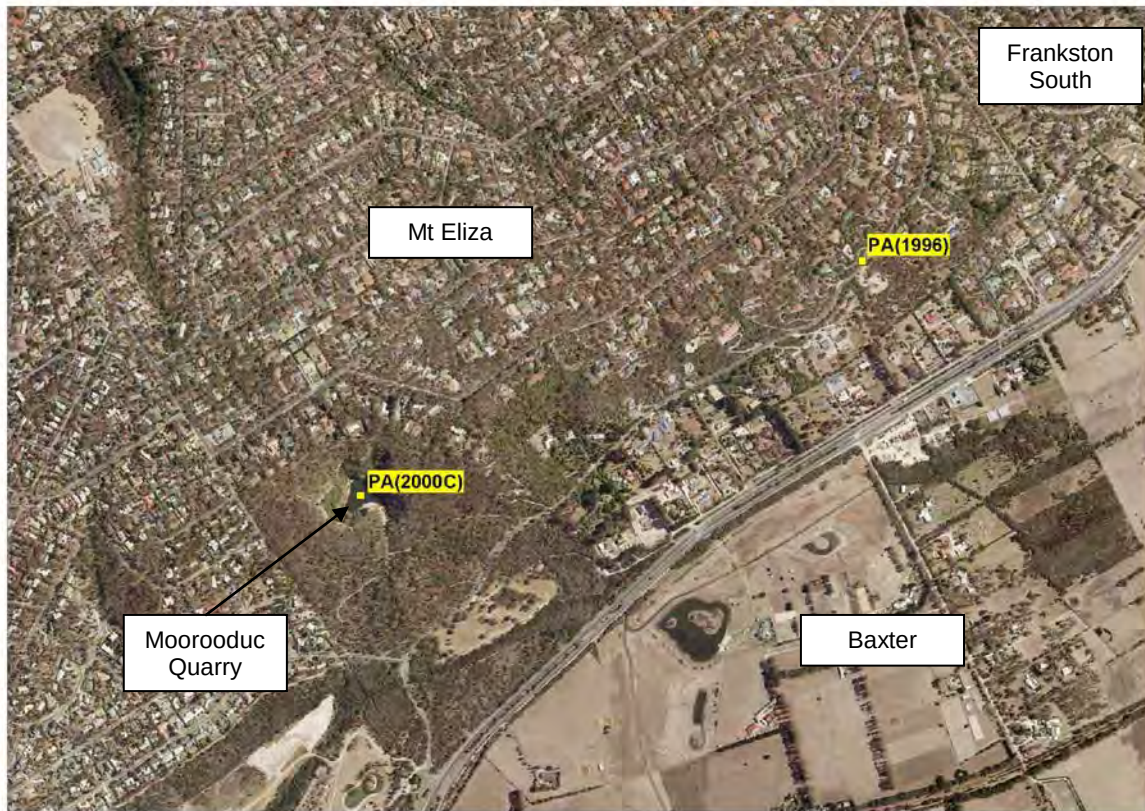
**Figure 10-42: Sites used for Siltstone Verification**

Both of these landslides are a result of slope steepening from mankind activities. The locations of the areas of instability are shown on the following figure.
