**1.14 BN2025 - Erosion Management Overlays and Future Options**

**Draft for Comment** Landslide  
Susceptibility Assessment,  
Stage 2  
Mornington Peninsula Shire, Victoria

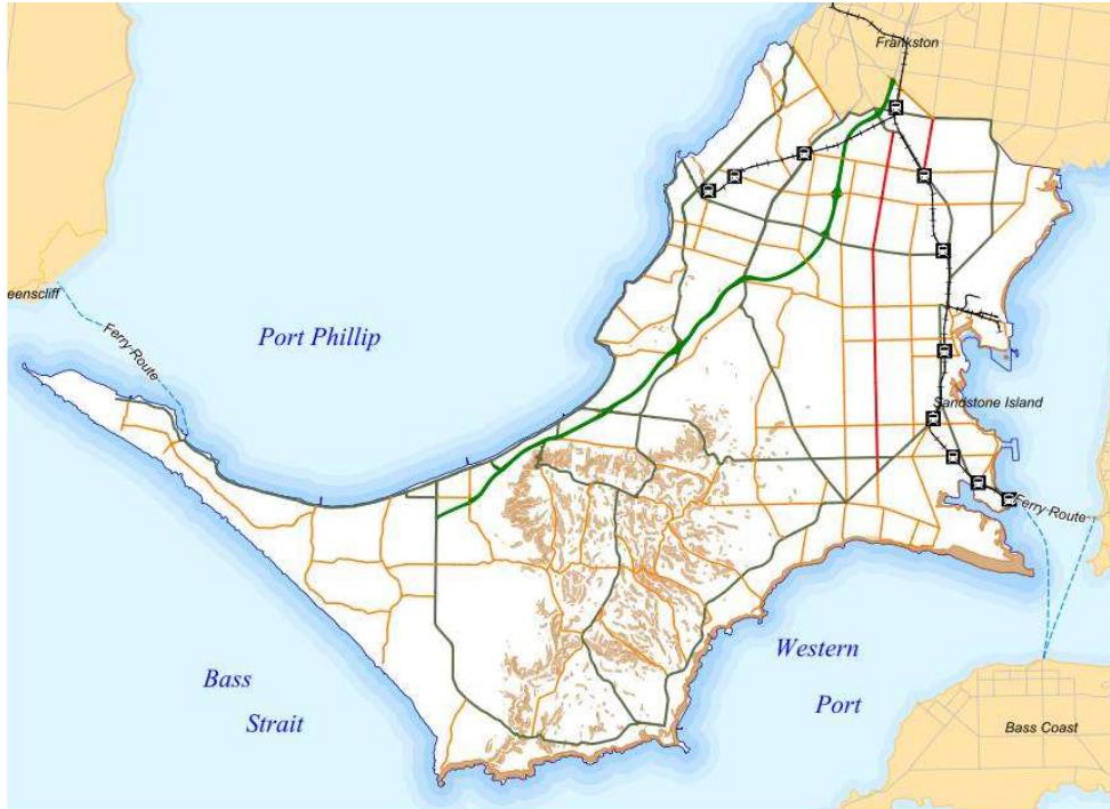
Existing coverage of Erosion Management Overlays on the Mornington Peninsula Shire

There are currently six Erosion Management Overlays (EMO) in the Mornington Peninsula Planning Scheme. The areas they cover are outlined in Attachment 1.

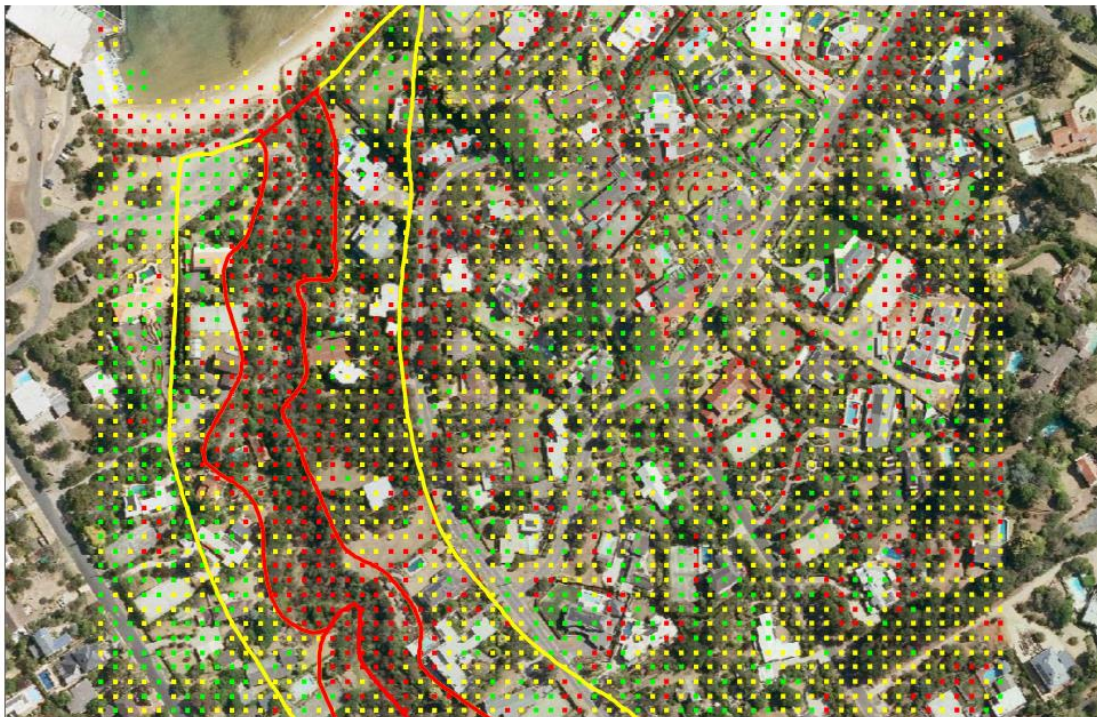
**Figure 10-15: Ballar Creek - CG(1999)**

The results of the verification are shown in Figure 9-15 and are discussed below. The boundaries of the high susceptibility zone and medium susceptibility zone determined from CG(1999) report are shown as a solid red and yellow lines while the results of the predictive model are shown as a grid of coloured squares.

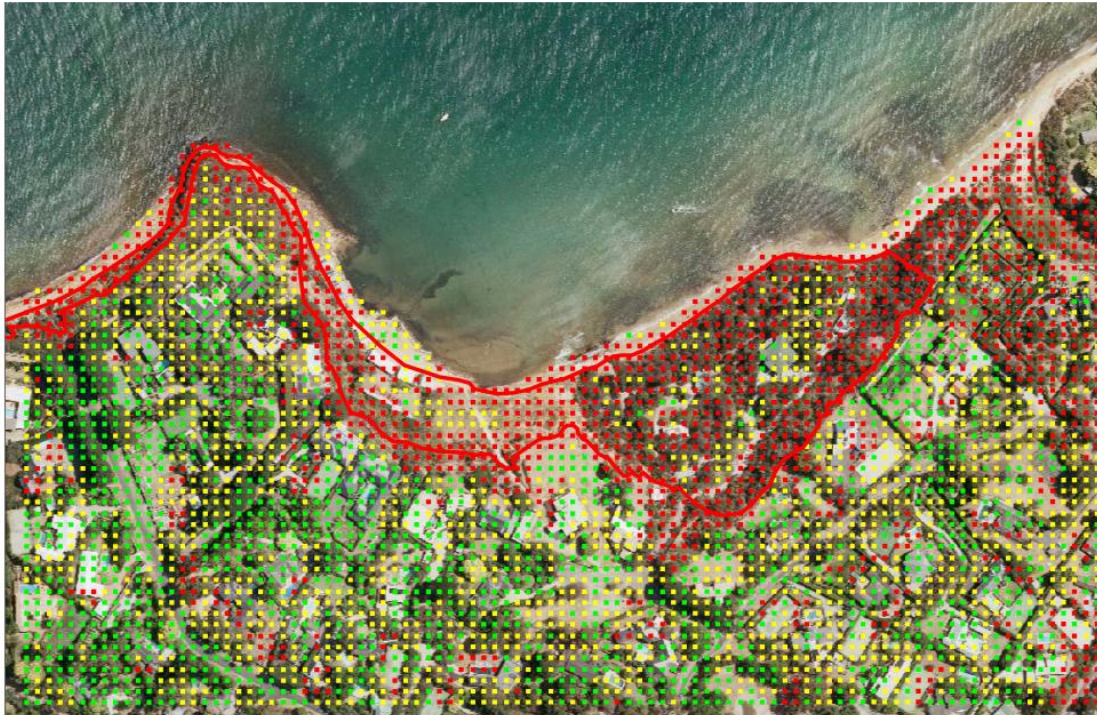
**Figure 10-16: Davey's Bay - PA(2006A) & CF(1993)**

The results of the verification are shown in Figure 9-16 and are discussed below. The boundary of the high susceptibility zone determined from aerial photographs and visual inspections is shown as a solid red line while the results of the predictive model are shown as a grid of coloured squares with the red squares representing the predicted locations of high susceptibility.

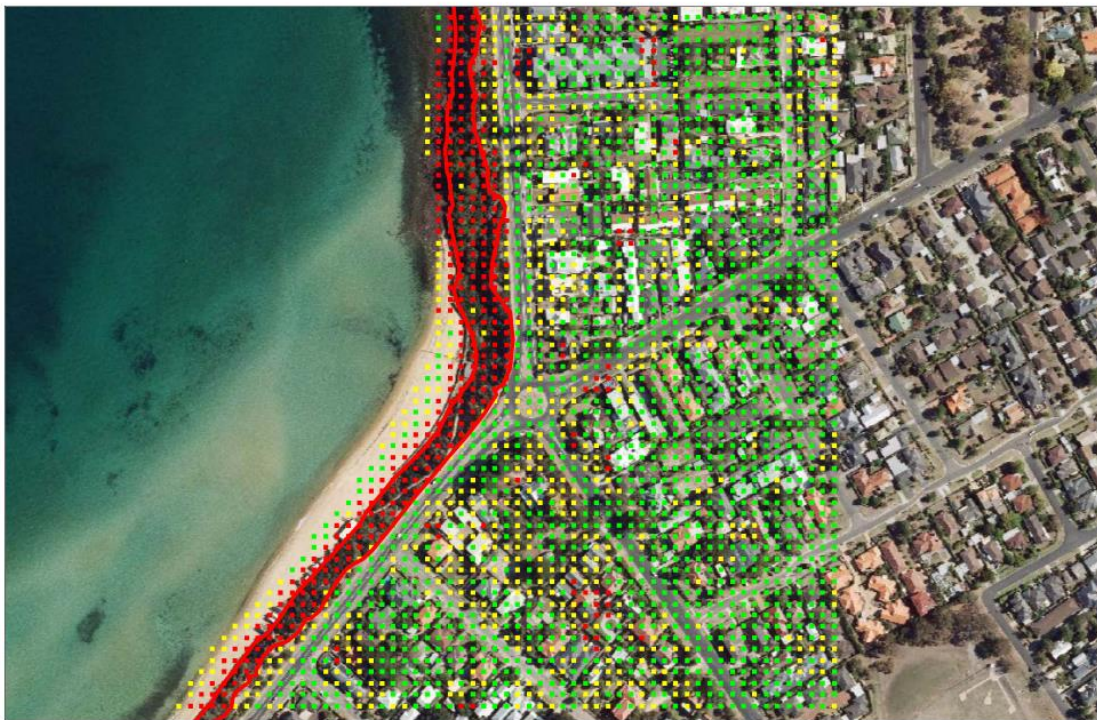
**Figure 10-17: Fishermans Beach - PA(2003)**

The results of the verification are shown in Figure 9-17 and are discussed below. The boundary of the high susceptibility zone determined from aerial photographs and visual inspections is shown as a solid red line while the results of the predictive model are shown as a grid of coloured squares with the red squares representing the predicted locations of high susceptibility.

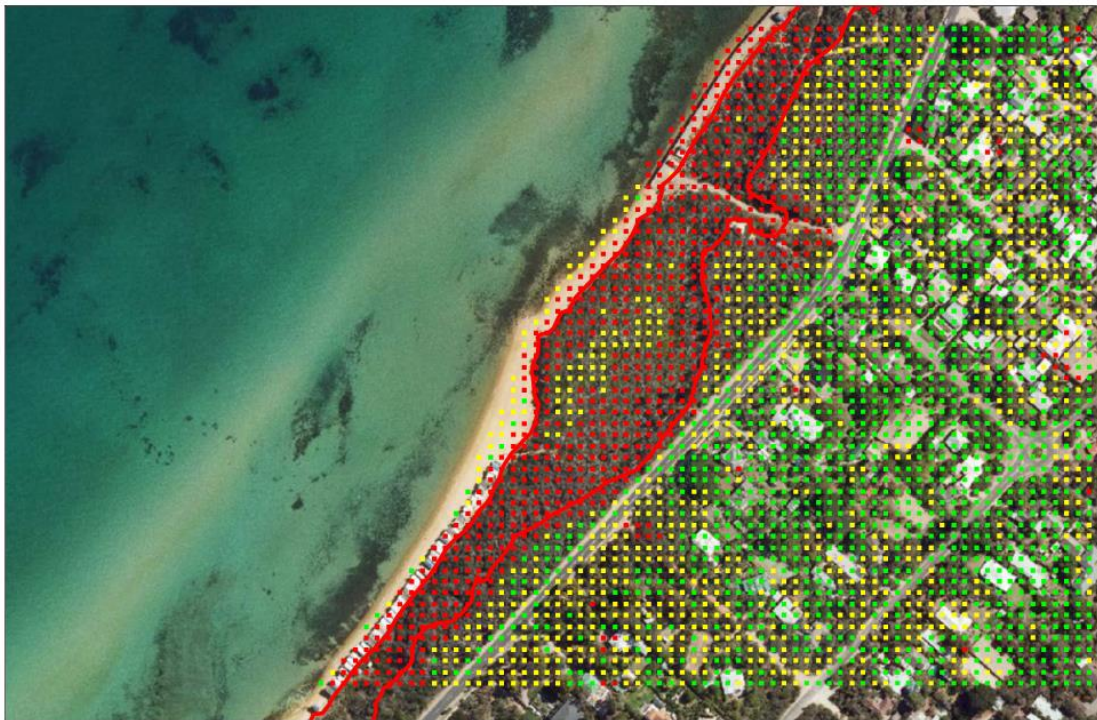
**Figure 10-18: Mount Martha North - LP(2009B)**

This landslide was also used to confirm the model for the Balcombe Clays. The results of the verification are shown in Figure 9-18 and are discussed below.

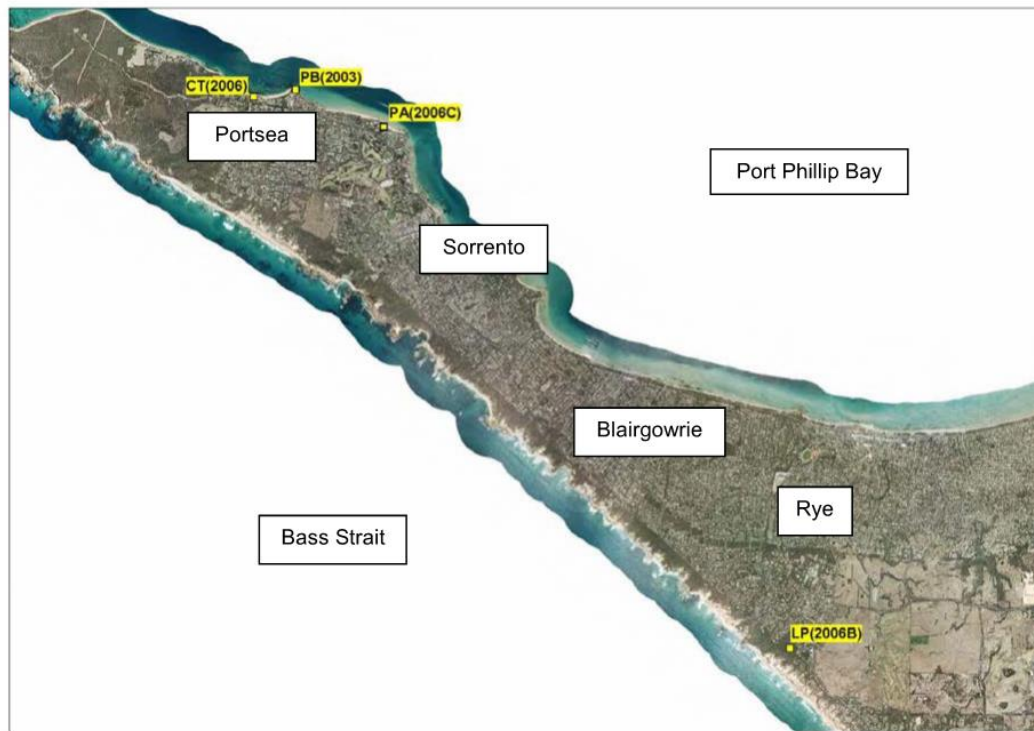
**Figure 10-35: Sites used for Quaternary Sand Verification**

The location of the areas used to develop the model are shown below.

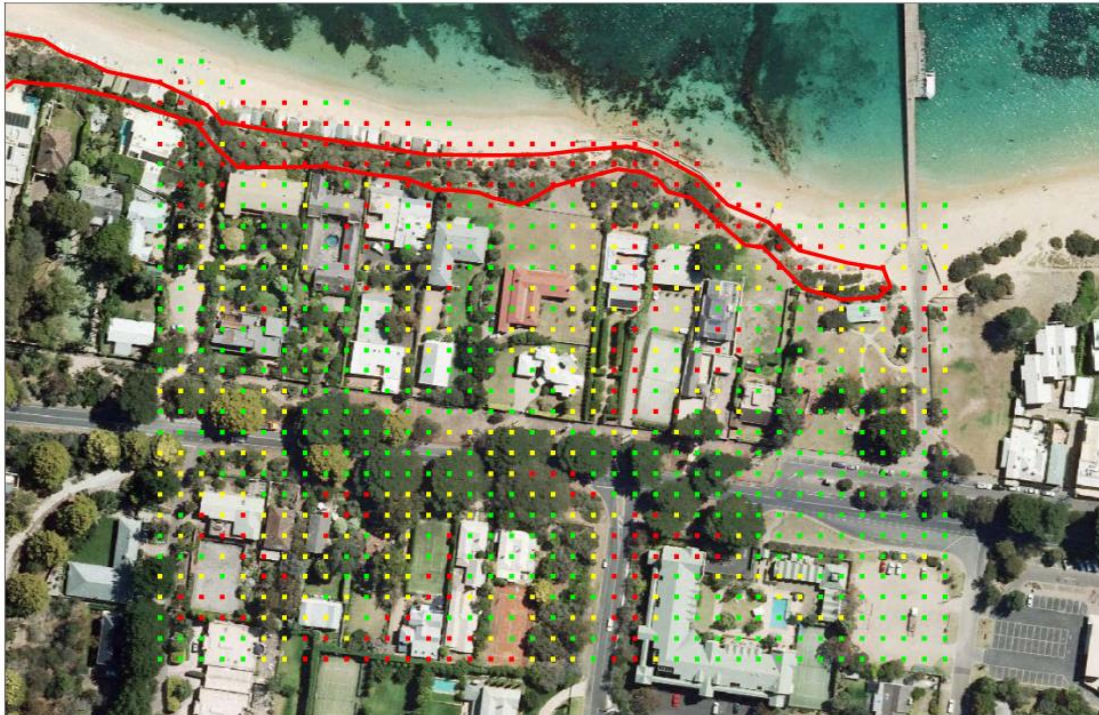
**Figure 10-37: 3804 Pt. Nepean Road - CT(2006)**

The results of the verification are shown in Figure 9-37 and are discussed below.

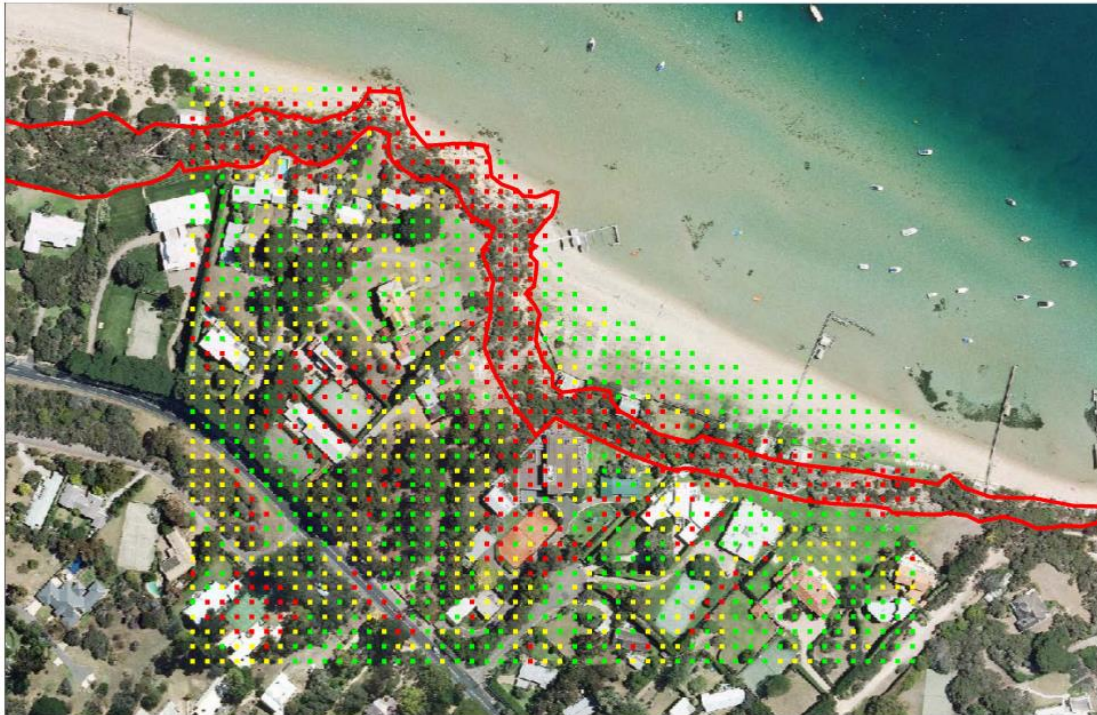
**Figure 10-39: 3550 Pt. Nepean Road - PA(2006C)**

This site is another typical example of the steep coastal cliffs in the area. The results of the verification are shown in Figure 9-38 and are discussed below.
