## Monitoring – GPS Sensor System

## Monitoring – Tilt Sensor System

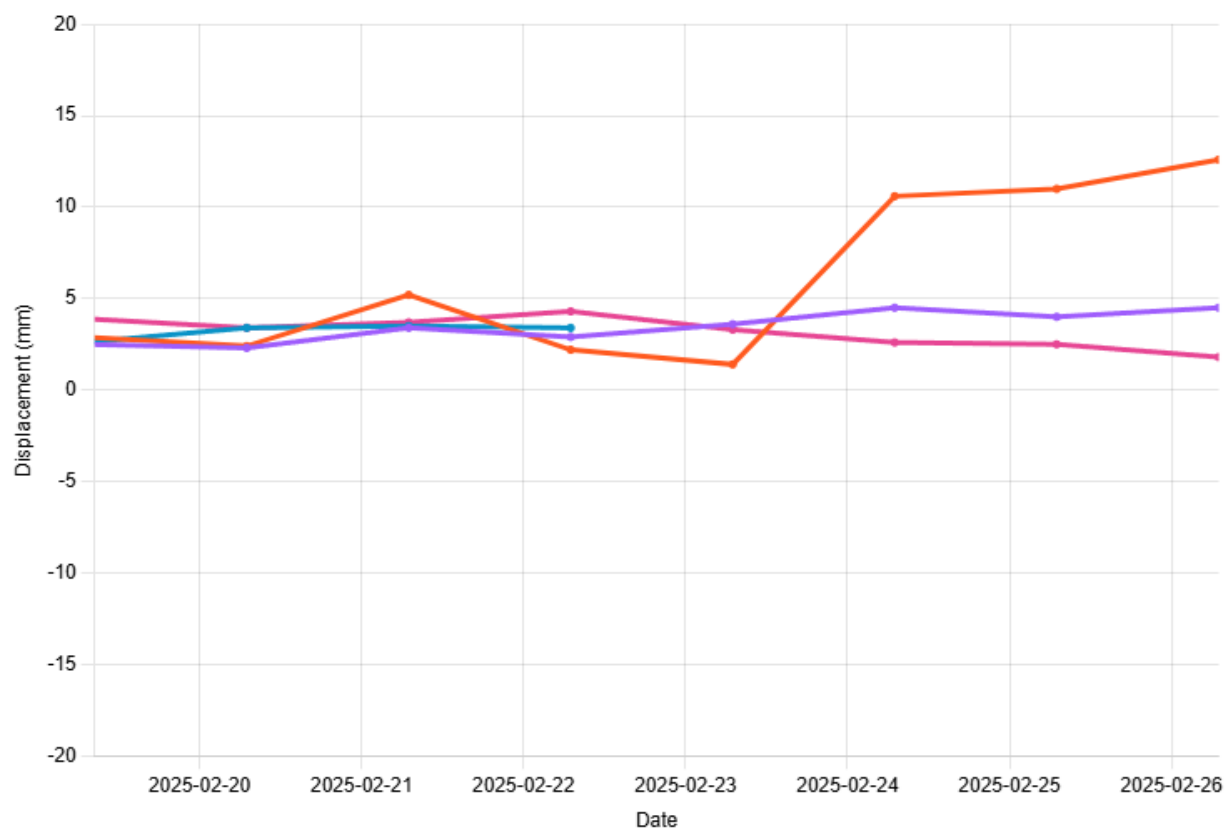
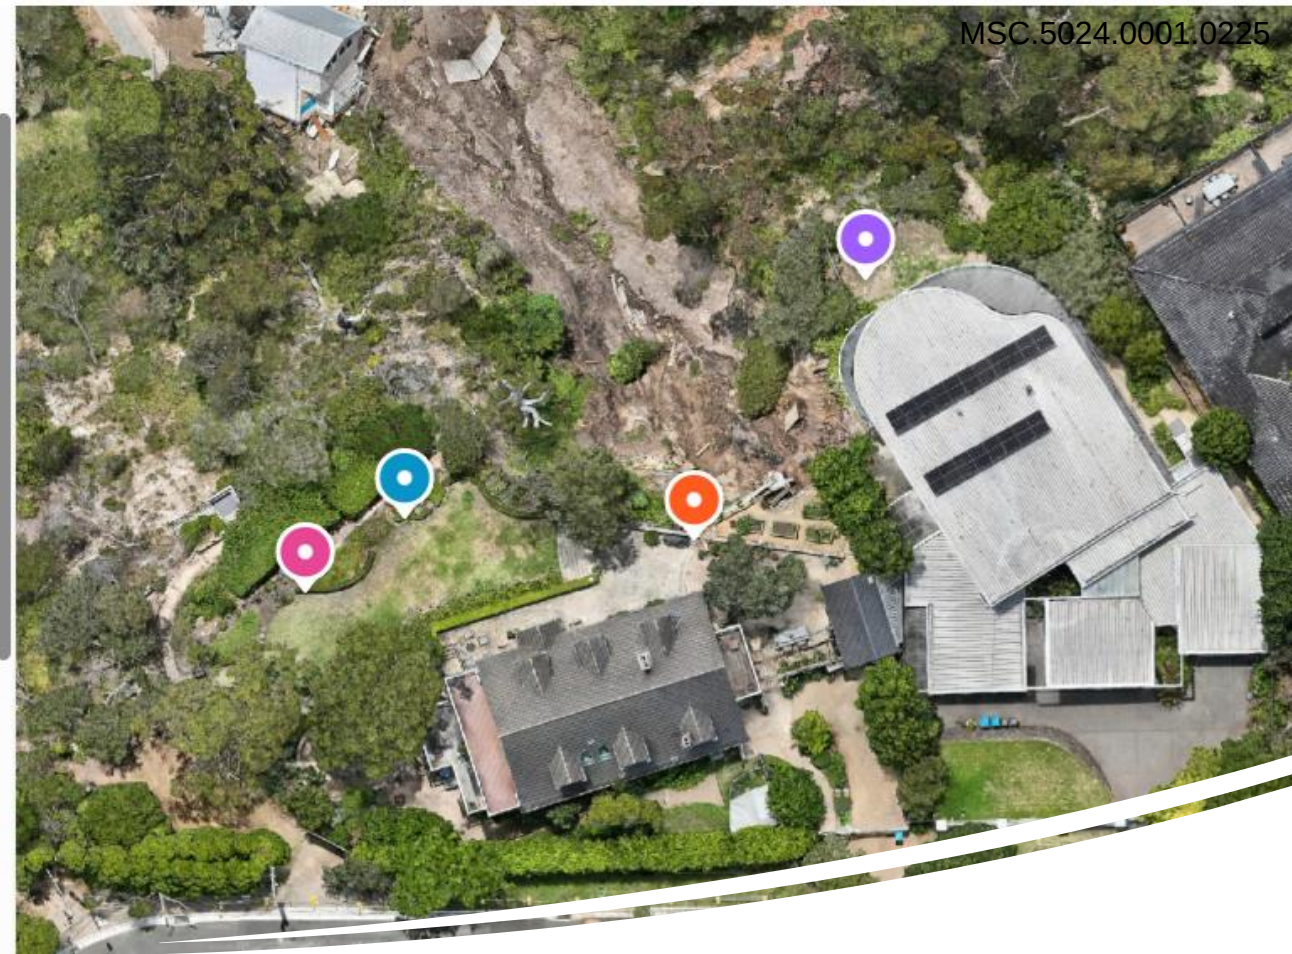
- Creep of the landslide head scarp is ongoing, indicating the landslide is active.
- The GPS sensor on the top of the escarpment indicating movements within the soil.
- Radar, tilt and GPS sensors all support that the immediate vicinity of the landslide headscarp is subject to creep.

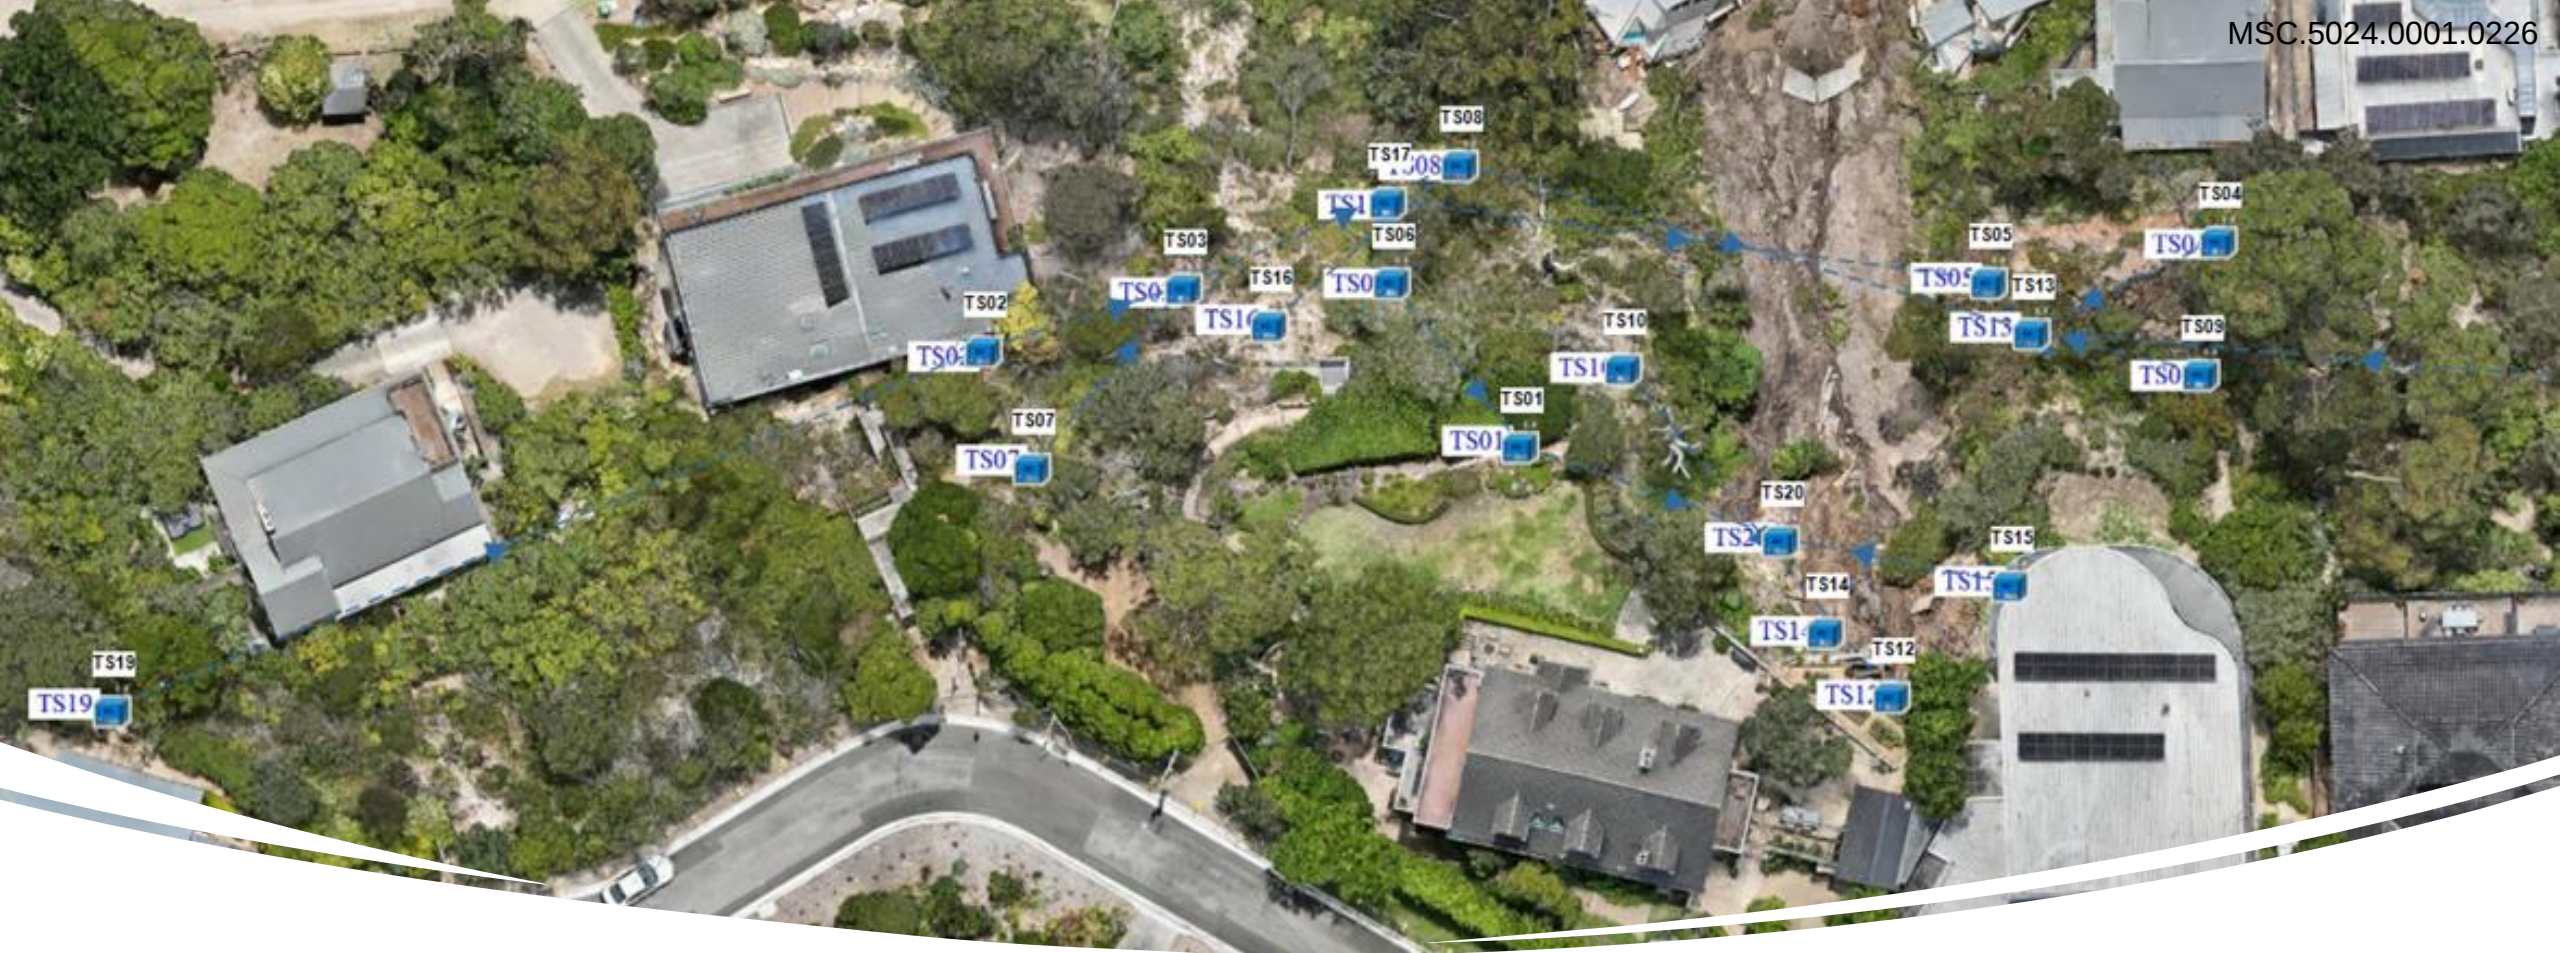
- Visual inspections indicate that localised erosion of the sand/gravel immediately around the retaining wall and headscarp is ongoing and expected to continue given the sandy nature of the surficial soils.
