**Chronology of customer requests received from the Shire between November 2024 and late January 2025 that could be related to Water Main Burst.**

## JK//SEW Interactions

**From:** KIRK, Jenna <[jenna.kirk@fultonhogan.com.au](mailto:jenna.kirk@fultonhogan.com.au)>  
**Sent:** Thursday, January 2, 2025 11:29 AM  
**To:** Customer Support Leadership Group <[Csladershipgroup@mornpen.vic.gov.au](mailto:Csladershipgroup@mornpen.vic.gov.au)>  
**Cc:** Tony Medina <[Tony.Medina@mornpen.vic.gov.au](mailto:Tony.Medina@mornpen.vic.gov.au)>; David Norton <[David.Norton@mornpen.vic.gov.au](mailto:David.Norton@mornpen.vic.gov.au)>; John Richardson <[John.Richardson@fultonhogan.com.au](mailto:John.Richardson@fultonhogan.com.au)>; FERO, Steven <[Steven.Fero@fultonhogan.com.au](mailto:Steven.Fero@fultonhogan.com.au)>  
**Subject:** Current concerns with water overflow - Charlesworth Street & Waller Place McCrae

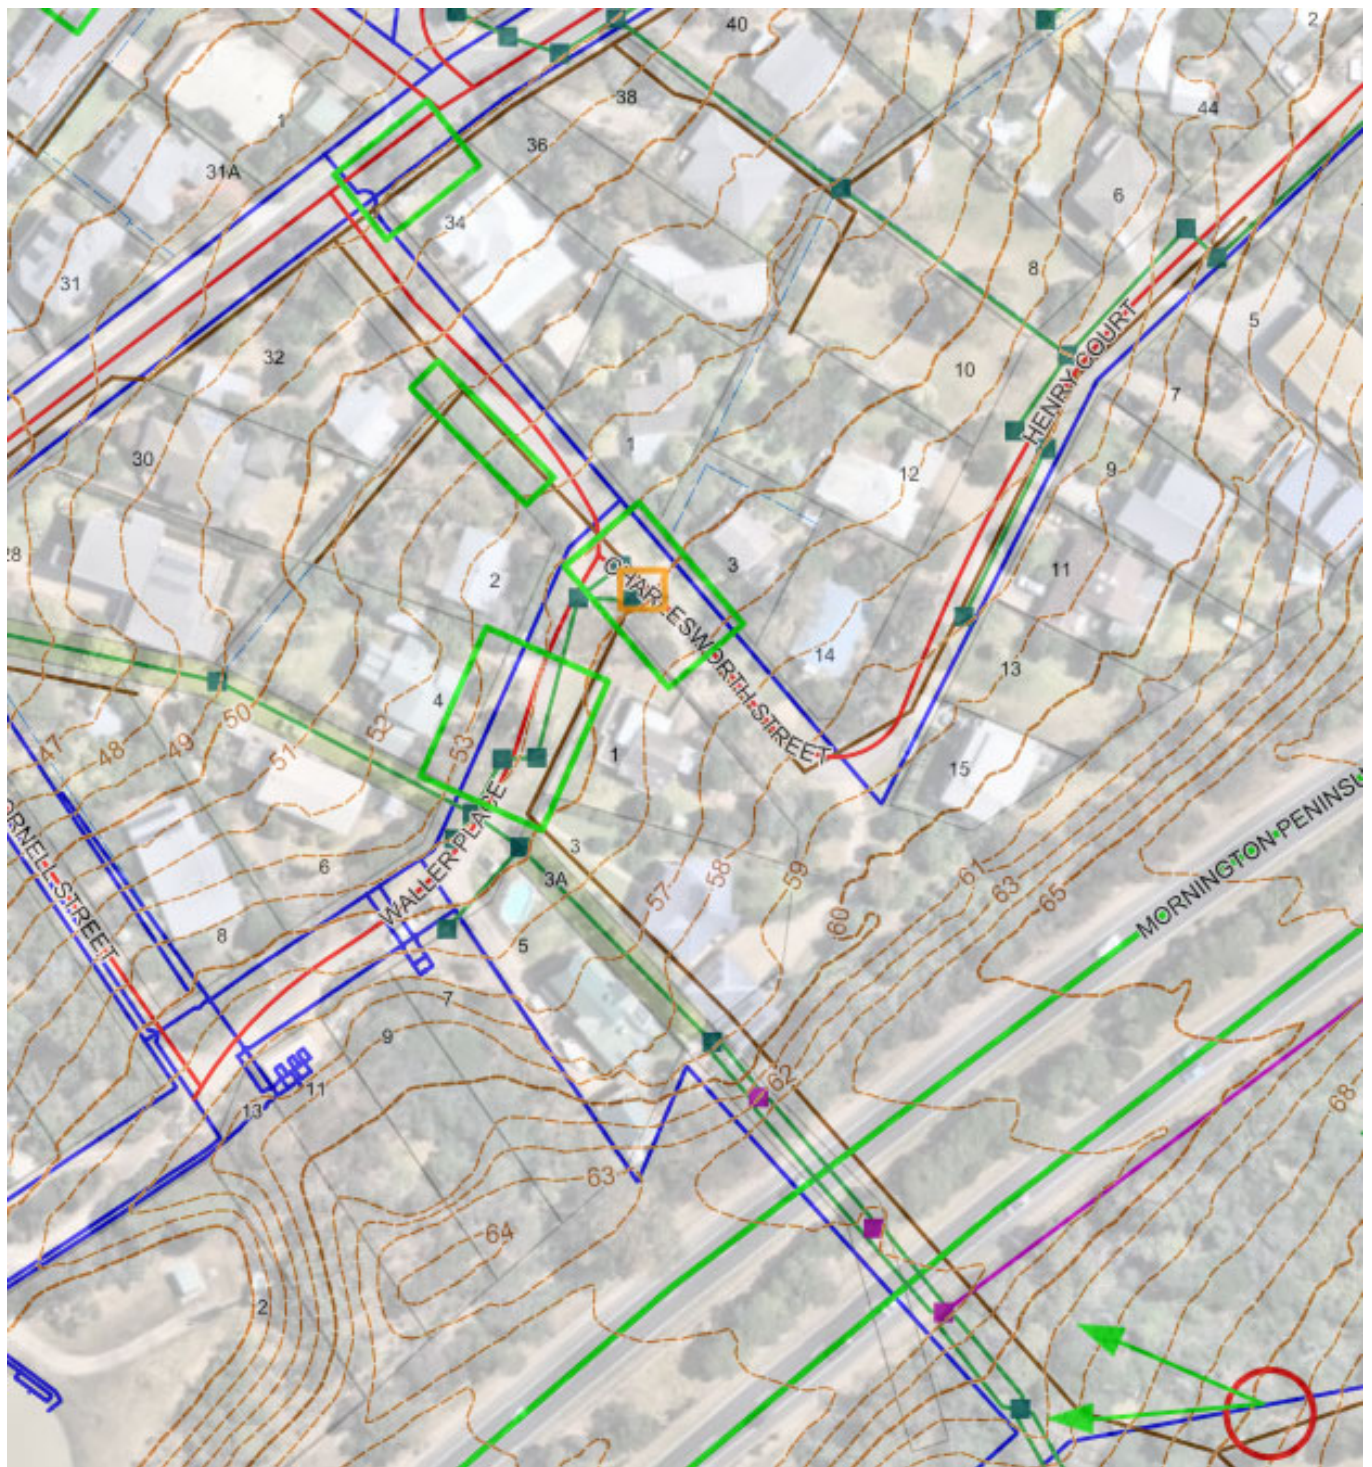
## Q4.3(iii)-B

- Light green boxes – current or recent saturated areas
- Orange box – agi-pipe installed to divert water at surface into adjacent drain
- Red circle with green arrows – South East Water main burst and visible flow path
- Brown lines – sewer managed by South East Water
- Blue lines – South East Water mains
- Dark green lines and squares – Mornington Peninsula Shire drains
- Pink lines and squares – VicRoads drains
- Red lines – Mornington Peninsula Shire roads

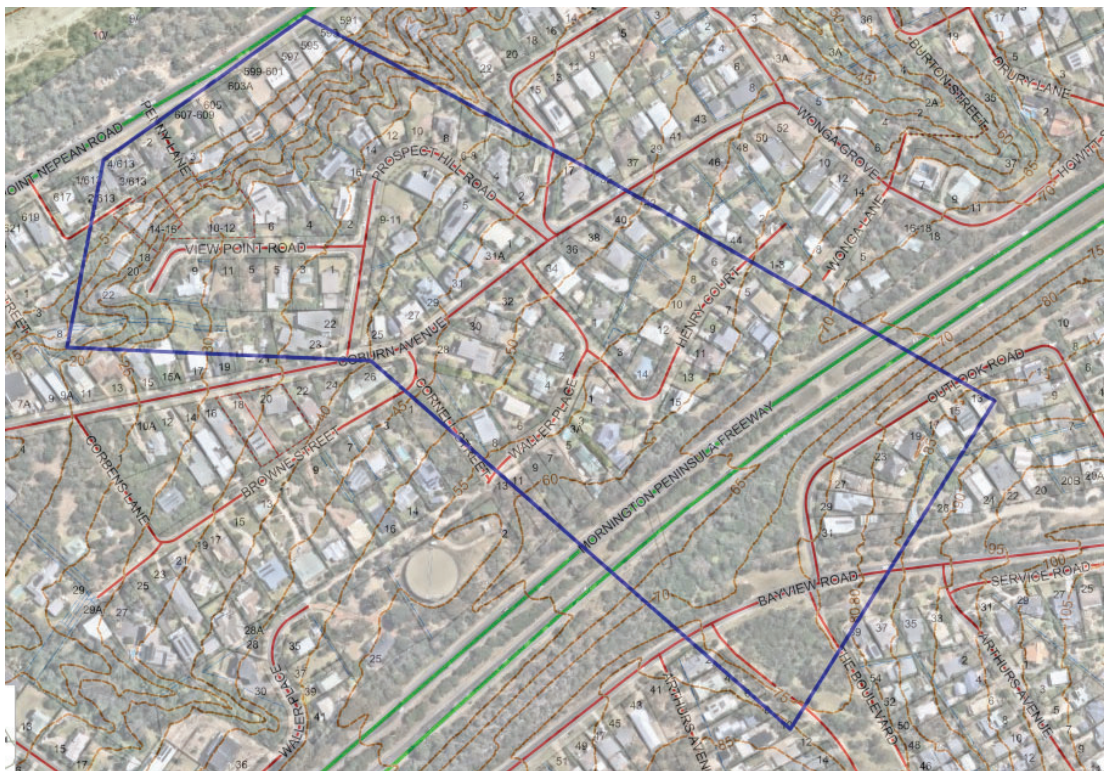
- In relation to camera footage, I presume this is CCTV on the sewer?
  - Yes
- What is the extent of the catchment area “above the landslide”? Can you outline this on the plan shown?
  - Area of interest is shown on the map below. If you have testing or CCTV results from outside of this area but related to investigating the slip we would be interested in those as well.

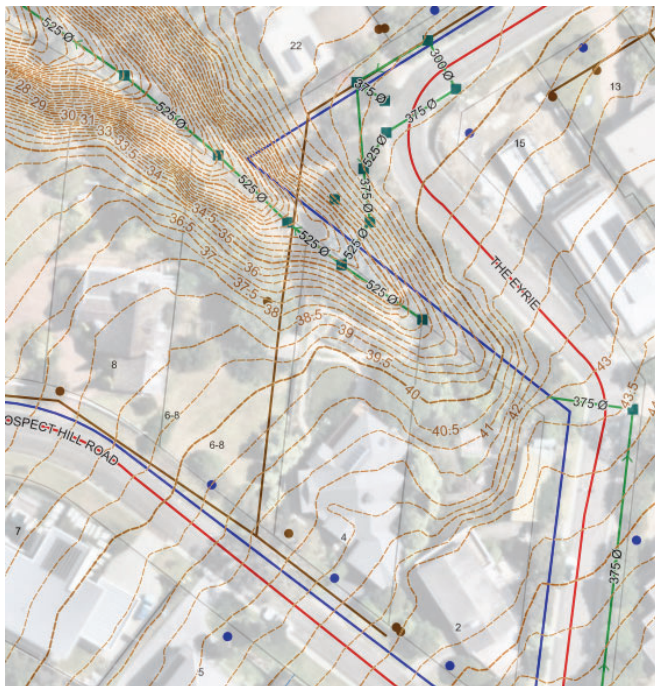
Could you please also advise whether the sewer running between Prospect Hill Rd and The Eyrie (map below) runs north through gravity or is pumped south?

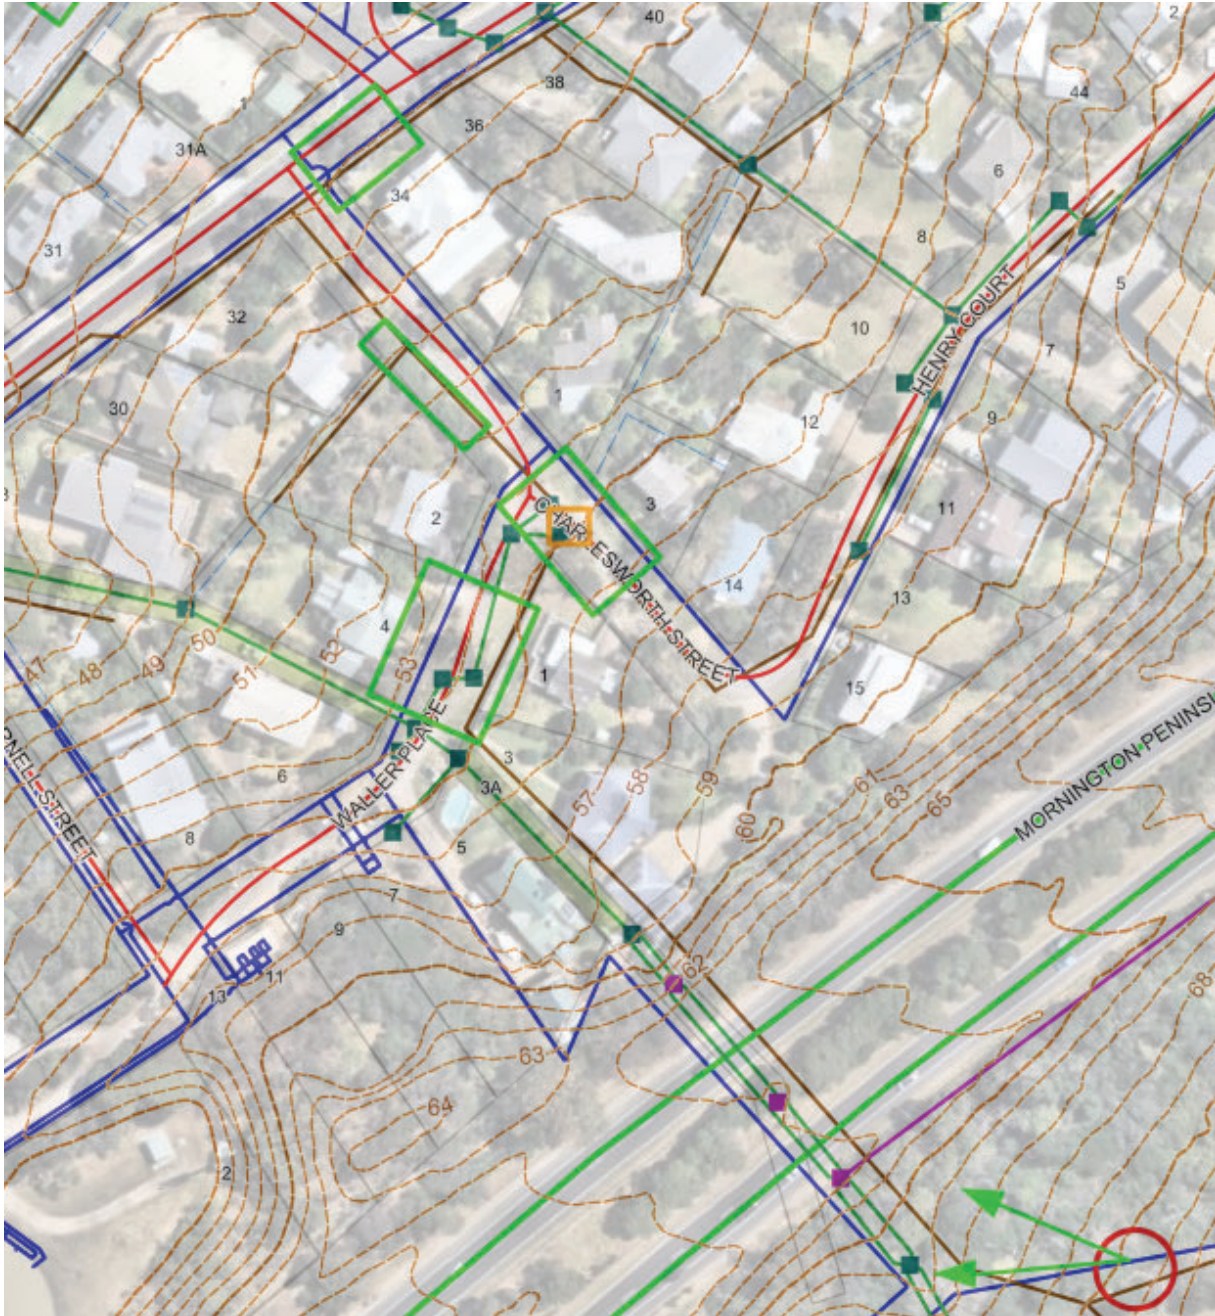
Thanks for your time last Thursday and your prompt action to investigate these issues. Please find the map of site observations that we talked through below.

- Green boxes – current or recent saturated areas
- Orange box – agis installed to divert water at surface into adjacent drain
- Red circle with green arrows – SEW main burst and visible flow path
- Brown lines – sewer
- Blue lines – SEW mains
- Dark green lines and squares – MPS drains
- Pink lines and squares – DTP drains
- Red lines – MPS roads

Thanks for this. My team also walked the area to take a look at the direction of travel of the late December burst, which I believe your arrows suggest predominately seemed to flow in the direction of the capture basin and the storm drains in that area. We have some footage from the patrol we undertook and the sand pathway left by the water is still very clear. The burst main was also of short in duration.

I still await the latest information from my team but early reports suggested that the volume of water entering under & around the sewer track at a depth of around 2.5m at Charlesworth and Waller is very small, "less than a running tap", and there was even less water higher up in the excavation. I am not a Hydrologist but this suggests to me that the water flow in the area is a range of issues, and certainly not from that track alone.
