**IN THE MATTER OF THE BOARD OF INQUIRY
INTO THE MCCRAE LANDSLIDES**

**ANNEXURES TO
WITNESS STATEMENT OF GERRARD RAYMOND BORGHESI**

CivilTest Pty Ltd Technical Memorandum dated 21 December 2023

RE: 10-12 View Point Road MCCRAE - Technical Memorandum

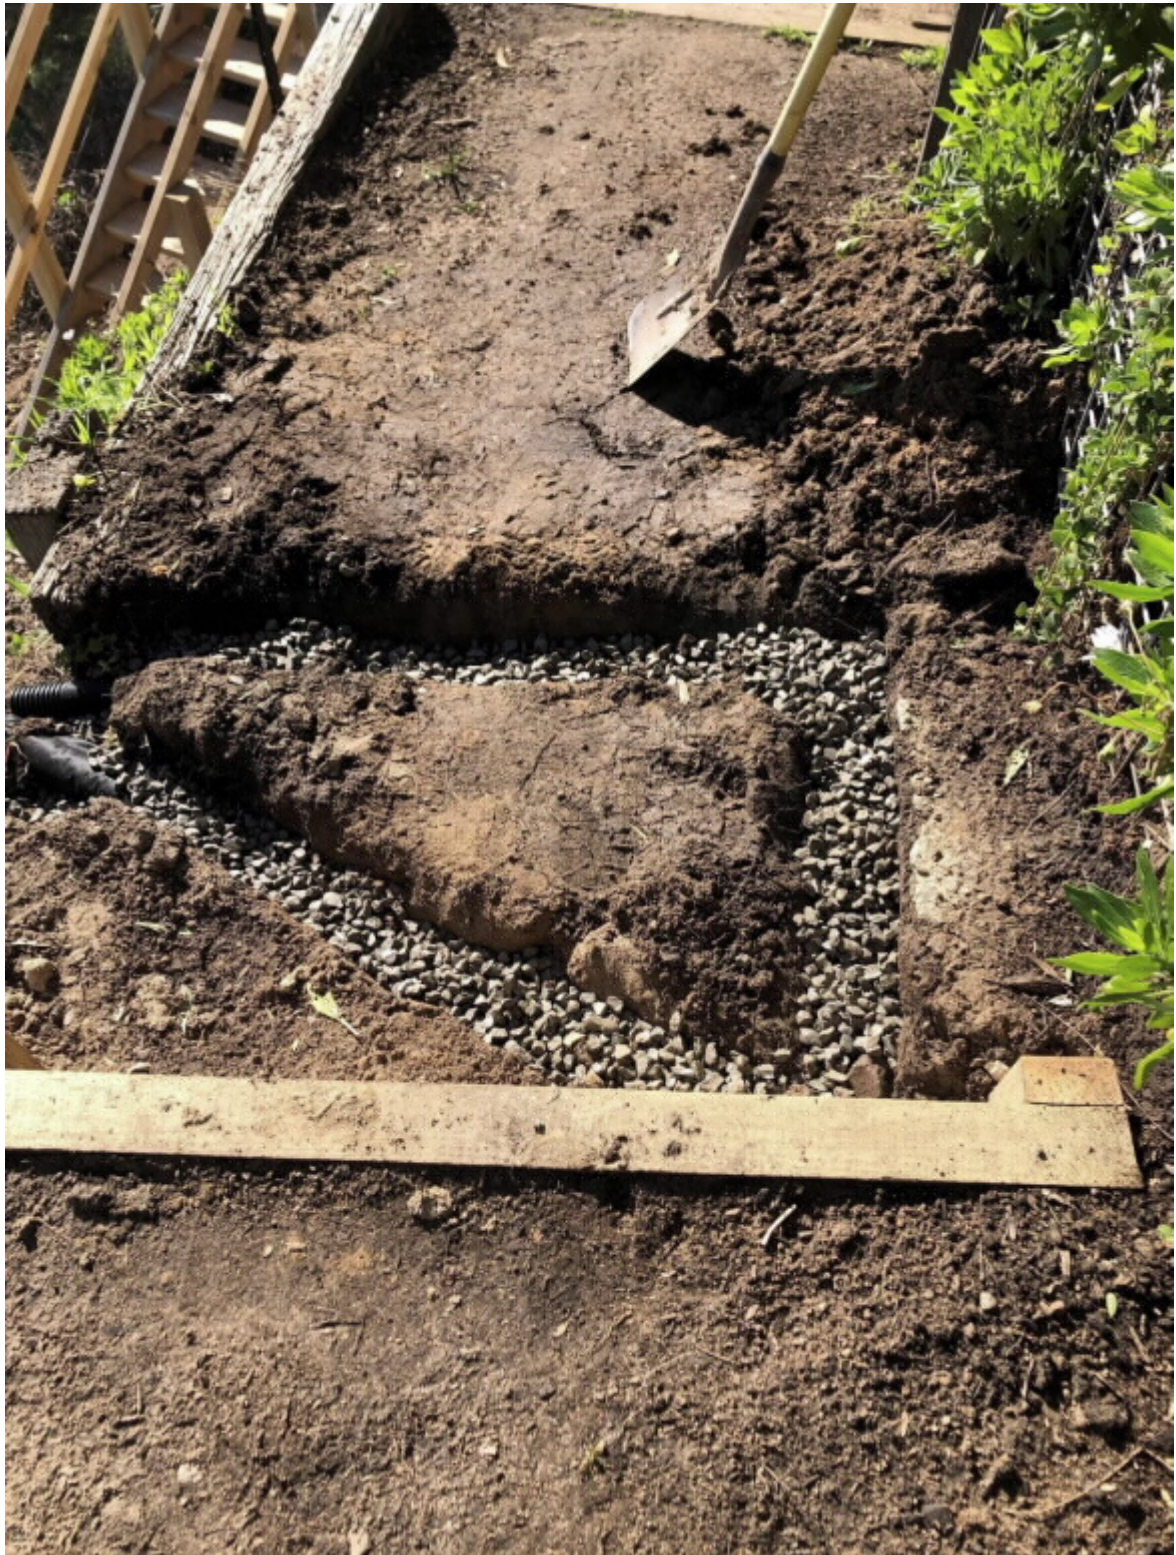
GB-8

“Aggie drains”

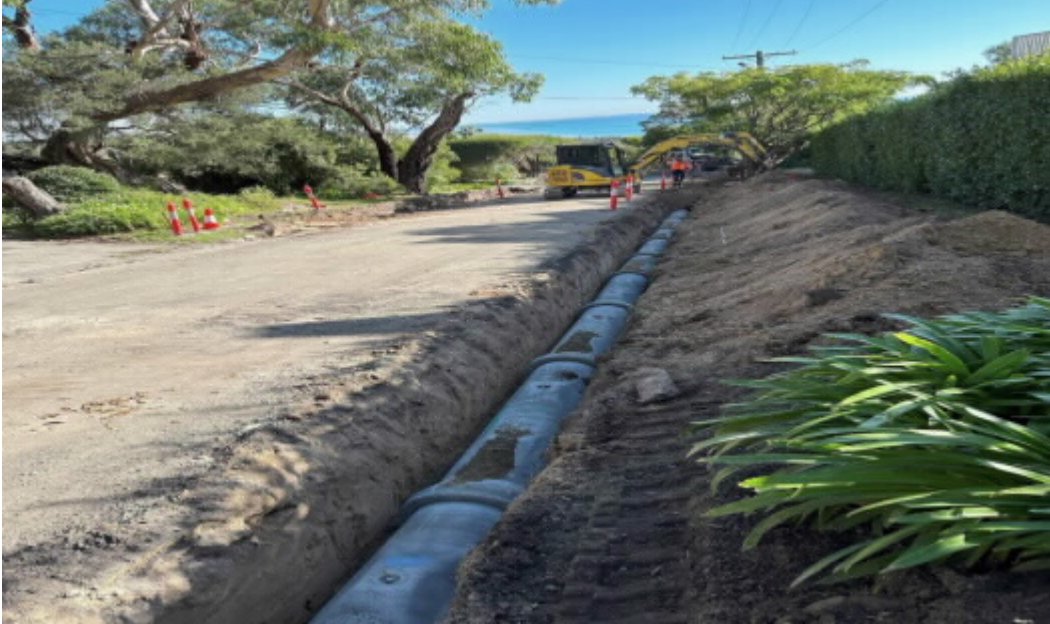
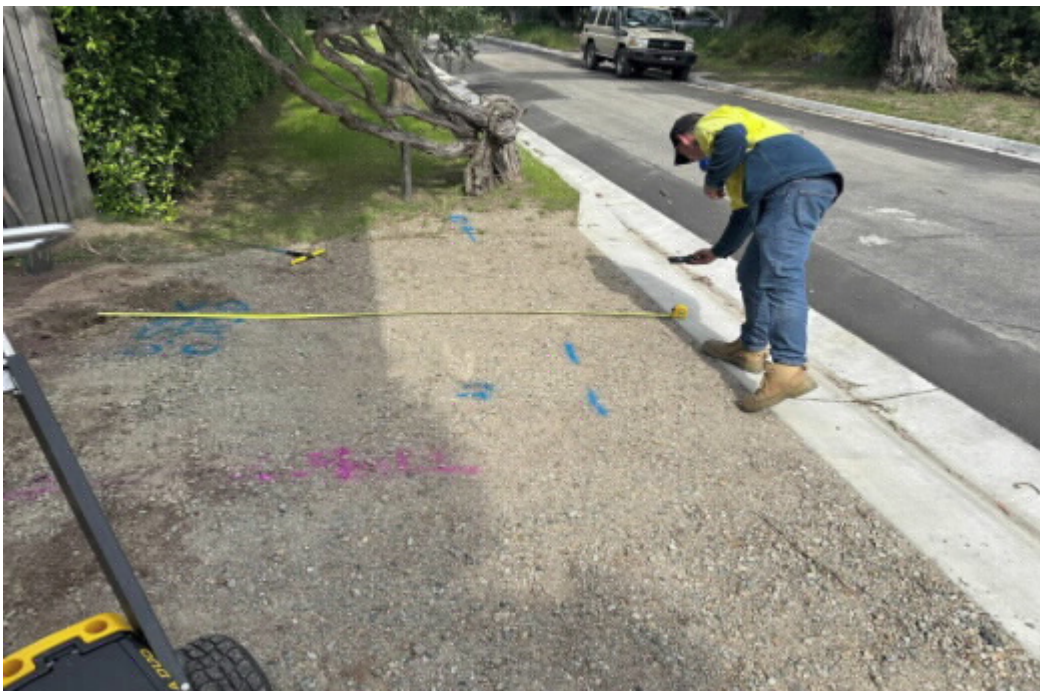
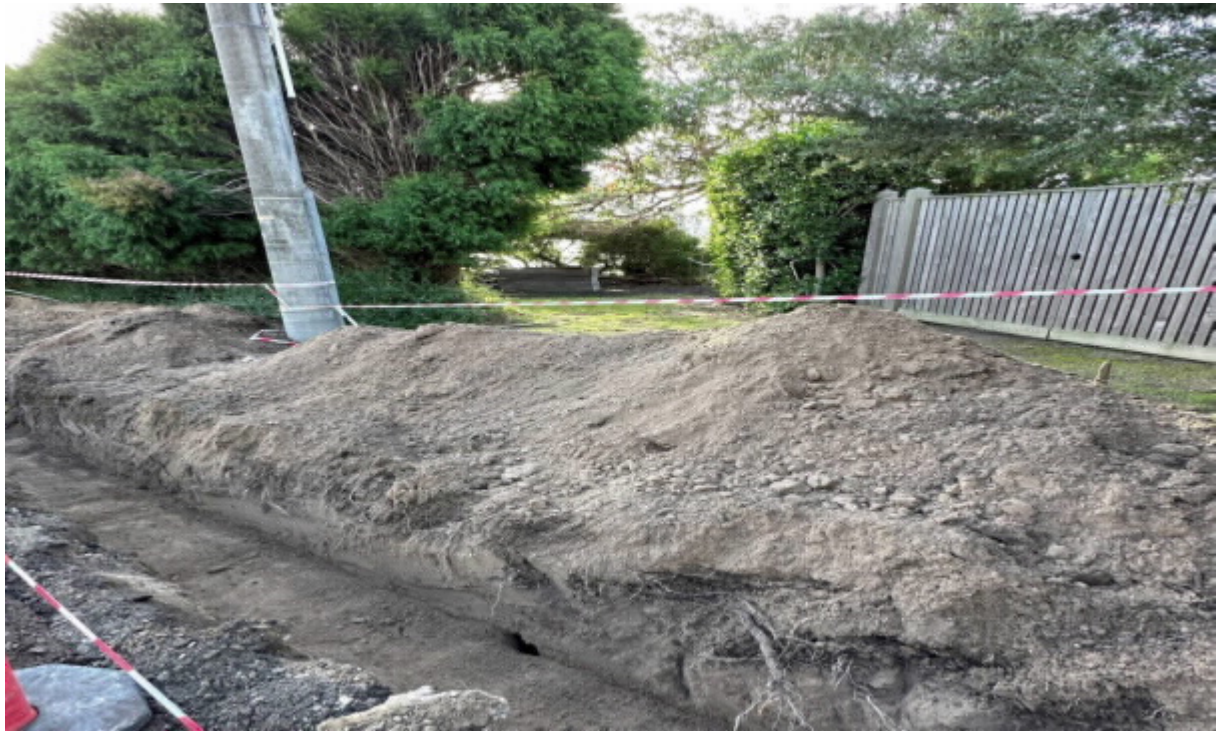
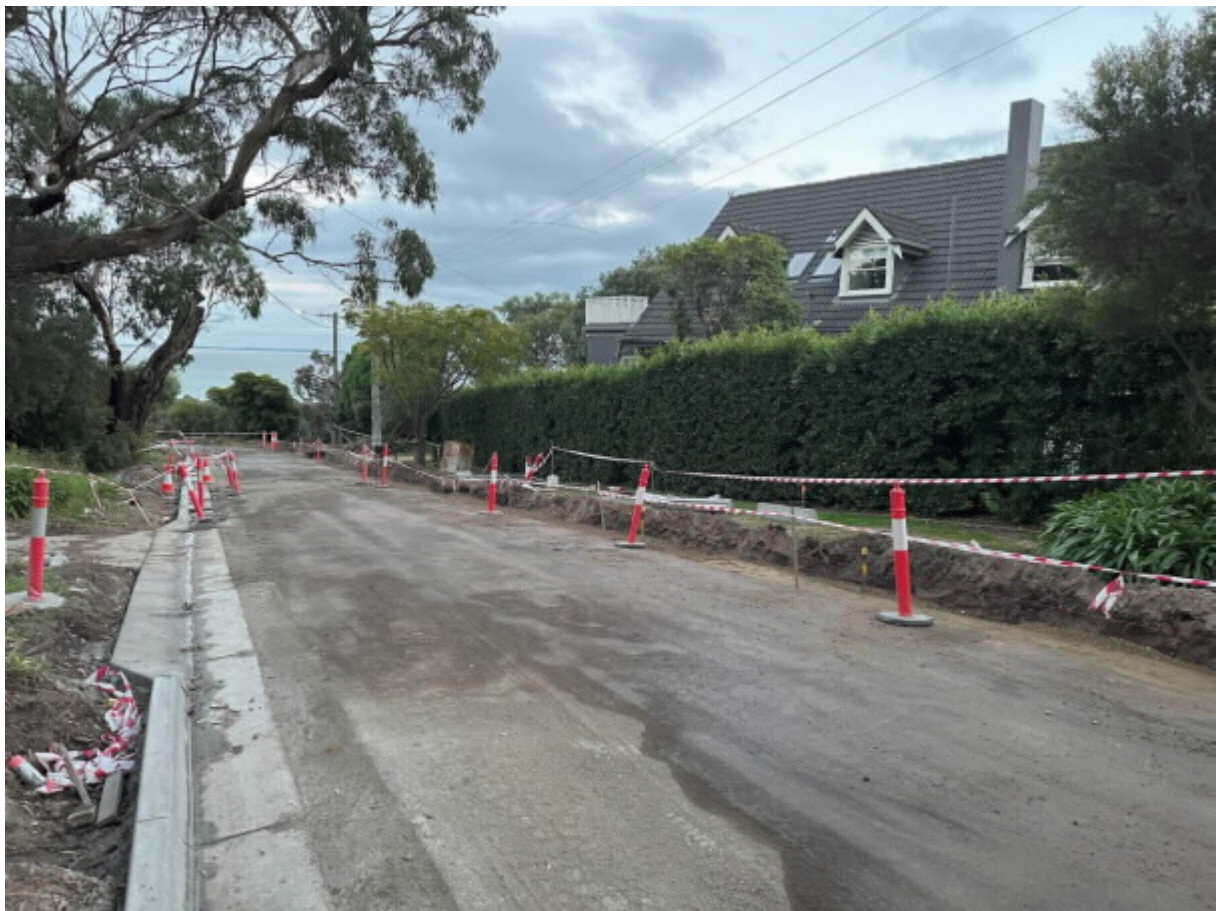
GB-9

Photos of Council Works on View Point Road

In May of 2023, the Mornington Peninsula Shire Council initiated a major stormwater drainage improvement project along View Point Road, which spanned a duration of 14 weeks and encompassed the installation of a 300mm stormwater conduit buried 1.5 metres beneath the road. Multiple culverts were integrated into the system, and the cracked kerbs along both sides of View Point Road were replaced. During the excavation process for the installation of the stormwater drain on View Point Road, a substantial void was unexpectedly revealed directly above the location where the landslide had previously occurred, as reported by the property owner of 10-12 View Point Road. Eight pictures/figures/images with notations are attached showing the abovementioned seepage (seeps), continuous water running along the old kerb, and the void discovered during the excavation of new road drainage installations.

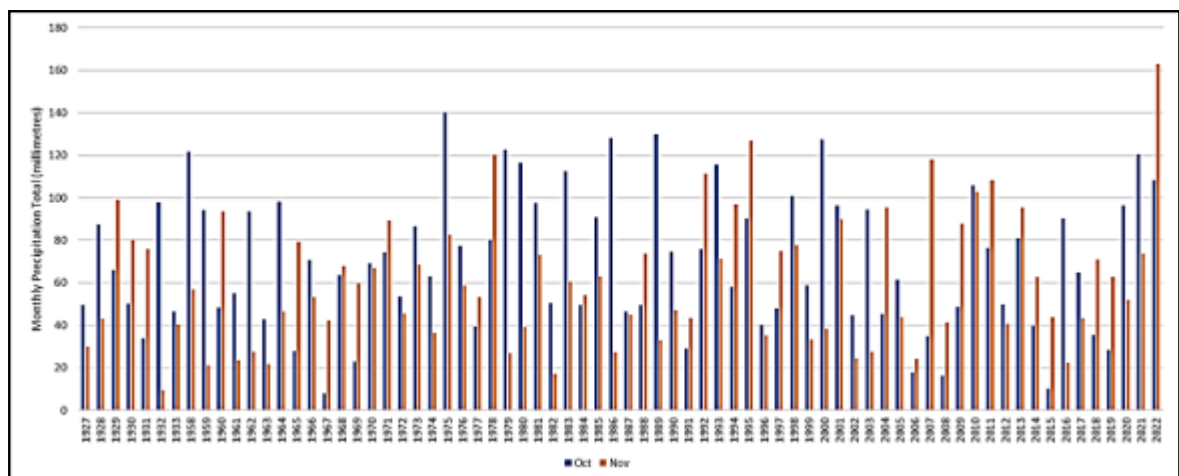
Figure 1: Historical October & November Precipitation Data

Based on the rainfall data obtained from The Australian Bureau of Meteorology (from the nearest Meteorology station at Rosebud), the October and November 2022 monthly precipitation data has been compared with all available data since 1927.

The monthly precipitation in October and November 2022 was much higher than the average monthly precipitation in these months since 1927, with the monthly precipitation in November 2022 being almost triple the historical average.

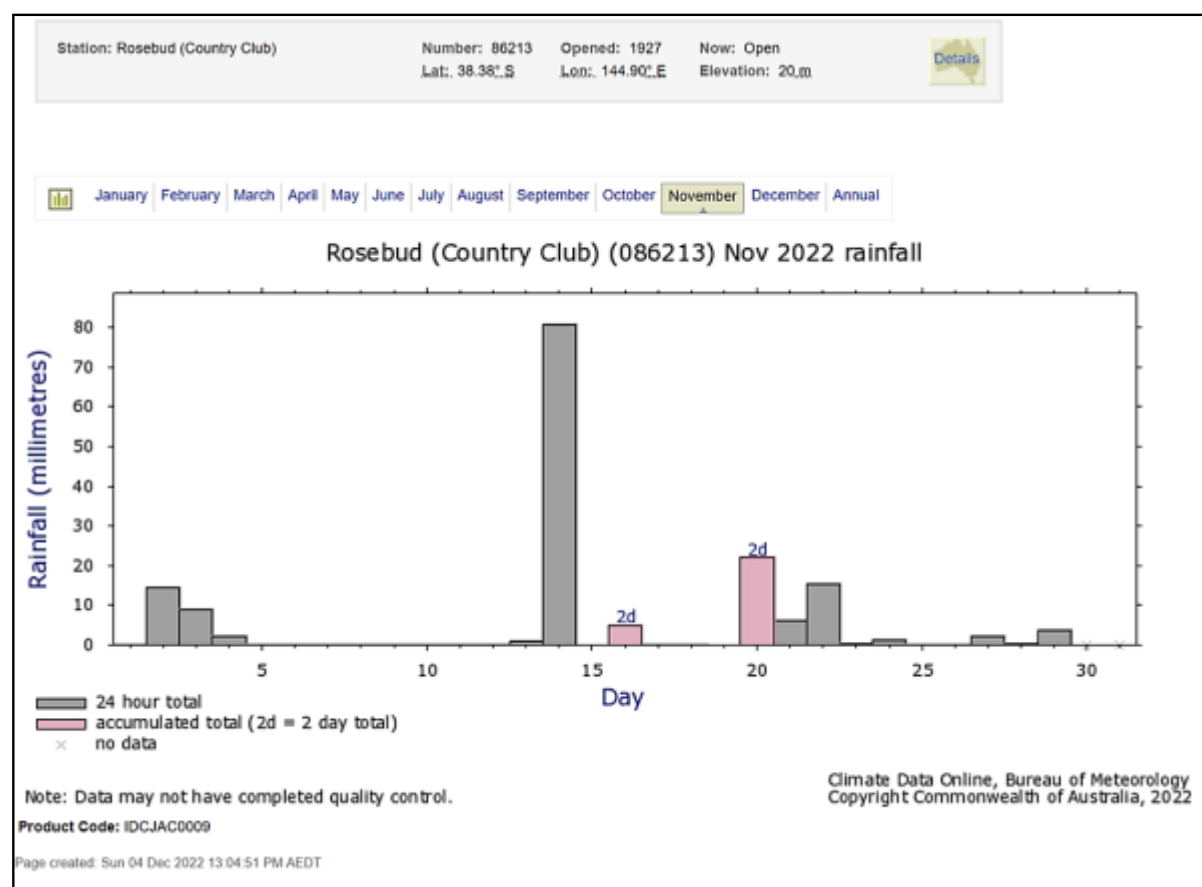
Figure 2: Daily Precipitation November 2022- Rosebud Station

The daily precipitation data for November 2022 revealed that on 14 November 2022, the precipitation for this single day exceeded 80mm, which was more than the historical November monthly average (since 1927) of 60.5mm. The property owner reported that the landslide took place around 6am on 15 November 2022. The size of the landslide reported by the owner was approximately 8m wide by 5m long. Further investigation including a drone survey was conducted to assess the extent of the landslide.

The initial assessment has concluded that the main cause of the landslide, based on the author's view, is the excessive amount of precipitation on 14 November 2022 as shown in Figure 2, and the inadequate management of the drainage on View Point Road. The precipitation on that single day exceeded the historical November monthly average. Perched water had built up at the material interface due to the upper sandy profile overlying the less permeable clayey soils, which led to a lack of friction and cohesion at the interface of materials. Also, excessive precipitation on the day before the landslide, and in November 2022 in general, added weight to the soil, which leads to higher driving and lower resisting forces.

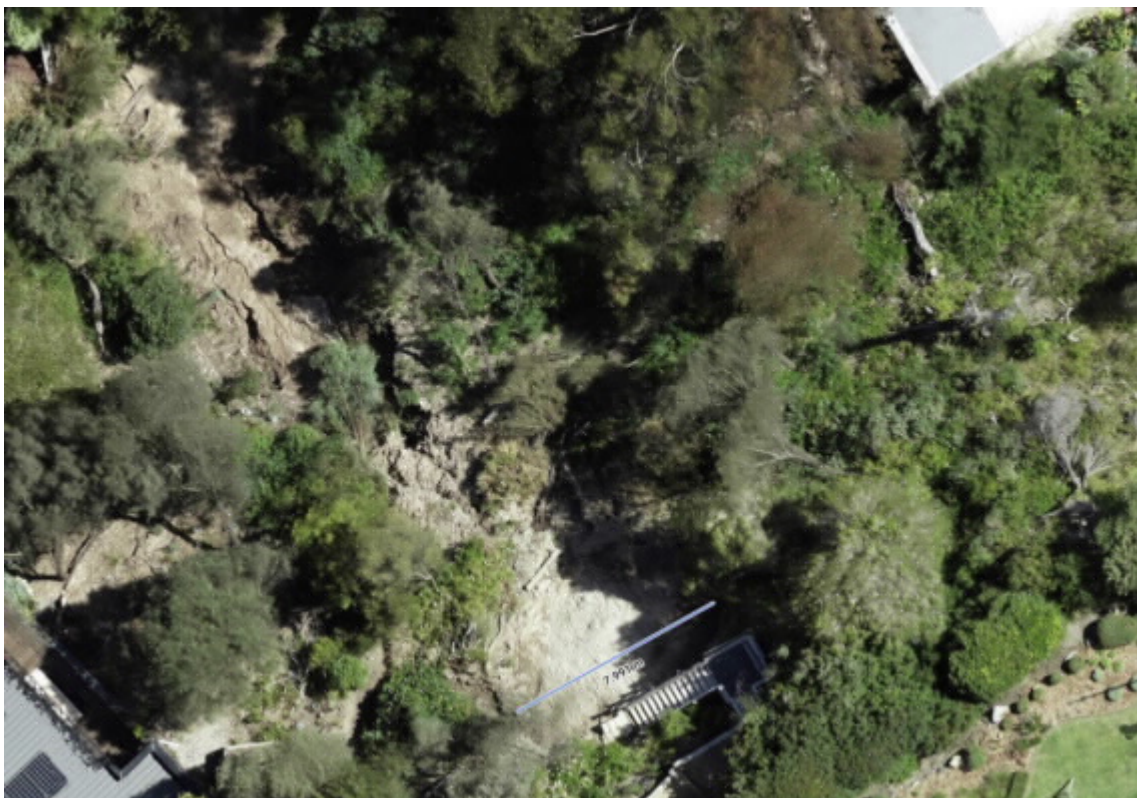
Figure 6: Drone Aerial View of the Landslide Area

A drone topographical survey was conducted by Civiltest on 2 December 2022.

The two surveys have been overlaid and a section (A-A) cutting through the location of the landslide has been obtained from both surveys to estimate the extent of the Earth FLOW. The section overlay is shown on **Figure 5** above. The blue dotted line represents the ground levels before the landslide. The background image showing trees represents the surface levels after the landslide event. The red line represents the estimated extent of the Translational Earth FLOW. The width of the section is approximately 8m from the top and the width varies with distance from the top. The material between the red line and blue dotted line is the residual disturbed earth that stopped moving at the middle to lower section of the slope, which did not flow down to the base of the slope. It should be noted that the contours provided in the abovementioned feature survey are at 1m intervals. The owner suggested the original slope was uniform, which is reflected in the feature survey. The original slope was approximately 35 degrees with the horizontal. It is possible that the feature survey has produced higher than actual ground levels due to the previous vegetation cover in the area and the steepness of the site, causing access issues for the Surveyor to survey the slope. Also, 1m contour intervals on the feature survey drawing would indicate the levels in between the contour lines are estimated. The estimated undisturbed part of the slope after the landslide has similar steepness, except the levels are 1m to 2m lower than the original levels, and the head scarp on the top is now much steeper, approximately 45 degrees.

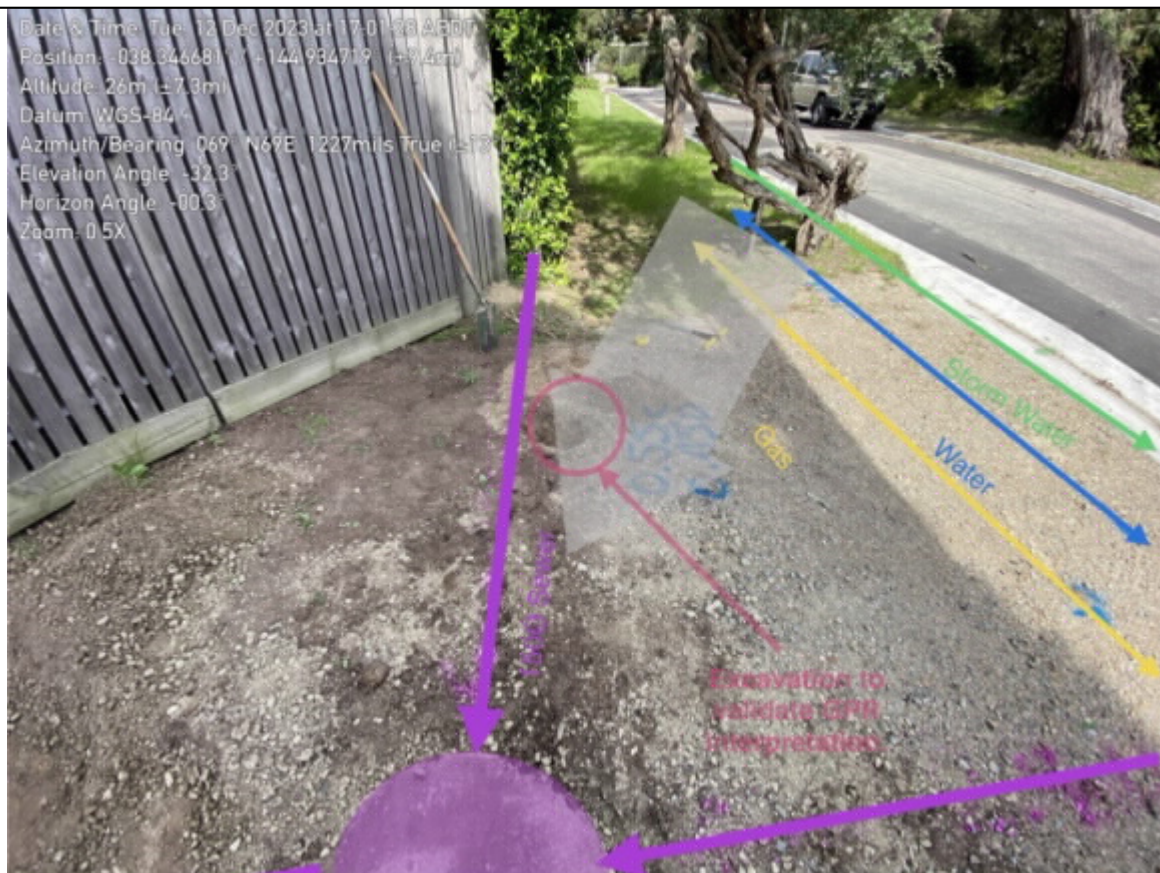
Fig 3: Scan validation location, positioned to avoid underground utilities. Void was proven with 0.55m cover.
