Landslip McCrae Jan 25

3 Penny Lane and 10-12 View Point

Owners – Actions Items

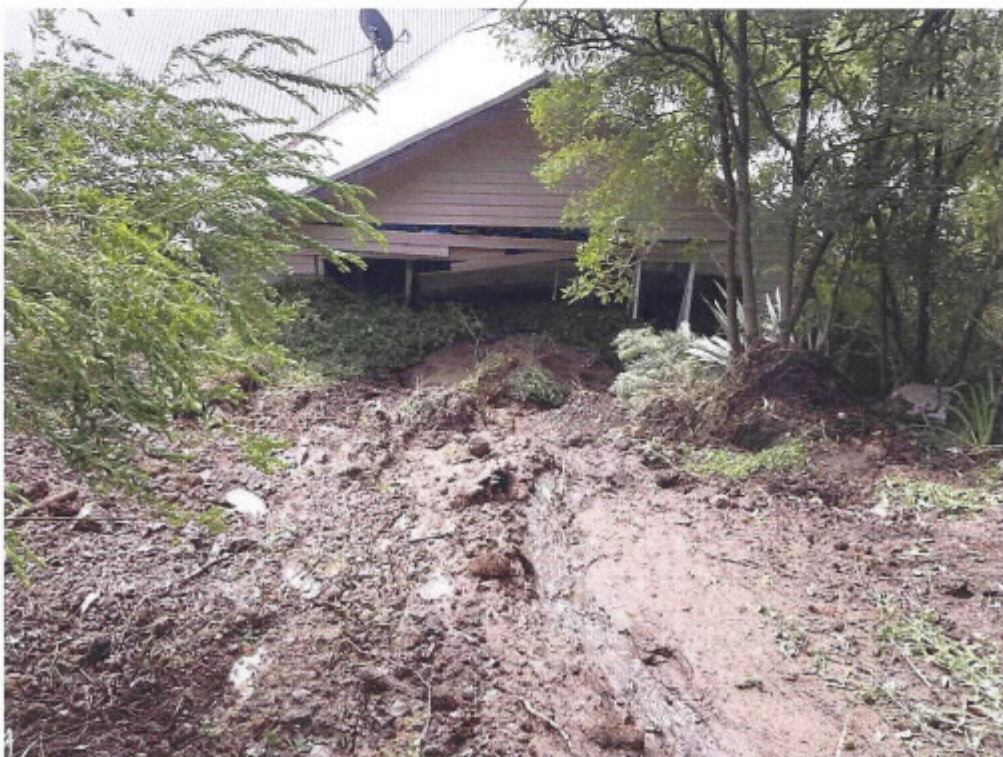
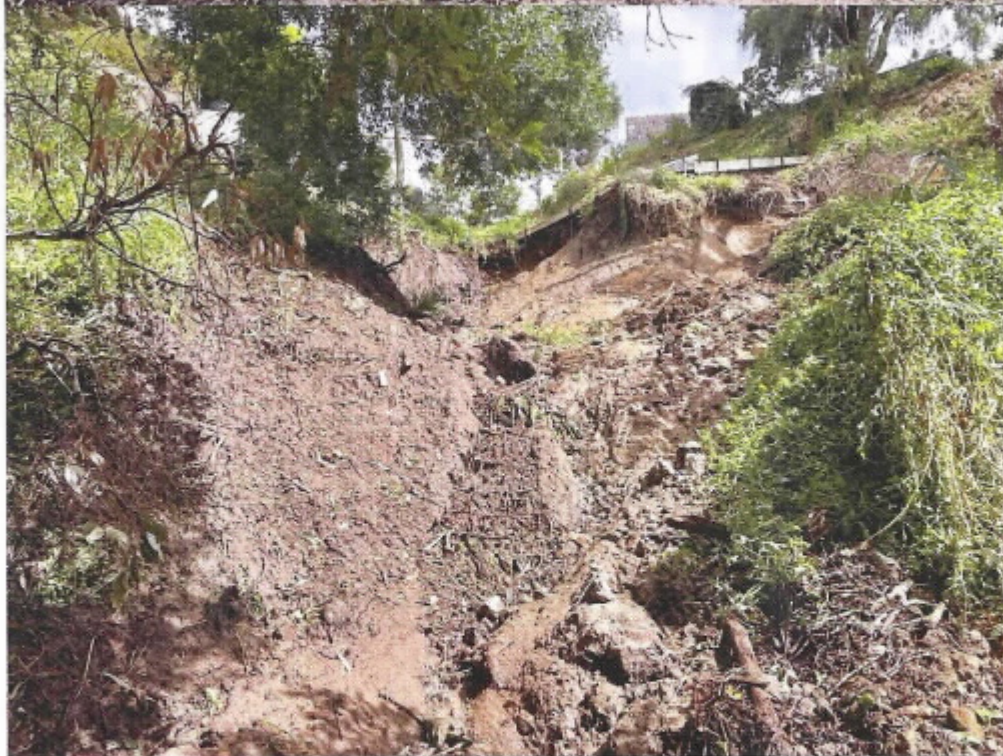
- Initiated from in front of a recently constructed retaining wall on P1 and has impacted the rear of P2, Photo 1.
- The Landslide was initiated on the night of Sunday, 5th January 2025, following two days of dry, hot weather. Rainfall **followed** the event.
- Translational slide which has evacuated materials down to the natural granitic soils at the base of the Landslide.
- A sub-vertical head scarp up to 1.5 m high, Photo 2.
- A significant portion of the headscarp was saturated and with measurable flow of water (0.15-0.2 L/s) flowing along the base and down the hill. The seepage was observed at the contact with surficial soils (fills/ancient landslide debris) and the underlying natural soils.
- Volume in the range of 15 to 20 m³.

Property	Actions
P1	<ul style="list-style-type: none"> • Monitor slopes immediately behind the failure for signs of change and or deterioration. • Cease all garden watering in the vicinity of the Landslide. • Surficial cut off bund with Coir logs or sandbags behind the retaining wall to direct surface water away from the head scarp. • Seek advice from their engaged Geotechnical engineer to make safe as best as is practical.

P2	<ul style="list-style-type: none"> • Monitor slopes immediately behind the house for signs of change and or deterioration. • Remove mud from between the house and the rear retaining wall. Do not disturb mud upslope of the retaining wall unless cutting temporary cut off drains. If the retaining wall has collapsed, seek further advice. Caution in areas of potentially unstable walls of the dwelling. This may require a spotter to monitor uphill slope behaviour. • Divert surface water around the dwelling (use hand cut off drains, Coir logs/sand bags). • Install a secondary cut off drain under the deck (hand dig, divert to east, Figure 1 • Install weep holes in northern most retaining wall as required (following installation and assessment of hand dug cut off drains/Coir logs) • Install one to two x ballasted shipping containers (2 x 20 ft or 1 x40 ft containers), 2.44 m wide) in the northern most section of lawn, Figure 1. These should be offset from the P3 retaining wall by at least the height of that retaining wall (~1.2m) and be aligned to protect P3. Ballast may be soil, F type barriers or plastic crash barriers filled with water. Temporary tie downs may be required (screw piles or equivalent). The containers should be back tilted into the slope without undercutting the existing retaining walls. This may require local cut/fill to achieve a 5 to 10% back tilt. Where bulk earthworks or retaining wall loading constraints apply, the containers may need to sit on screw piles or equivalent. Further advice should be sought to detail the design.
