Legally Privileged Multidisciplinary Expert Report

# McCrae Landslip Project

Prepared for: Thomson Geer

5 May 2025

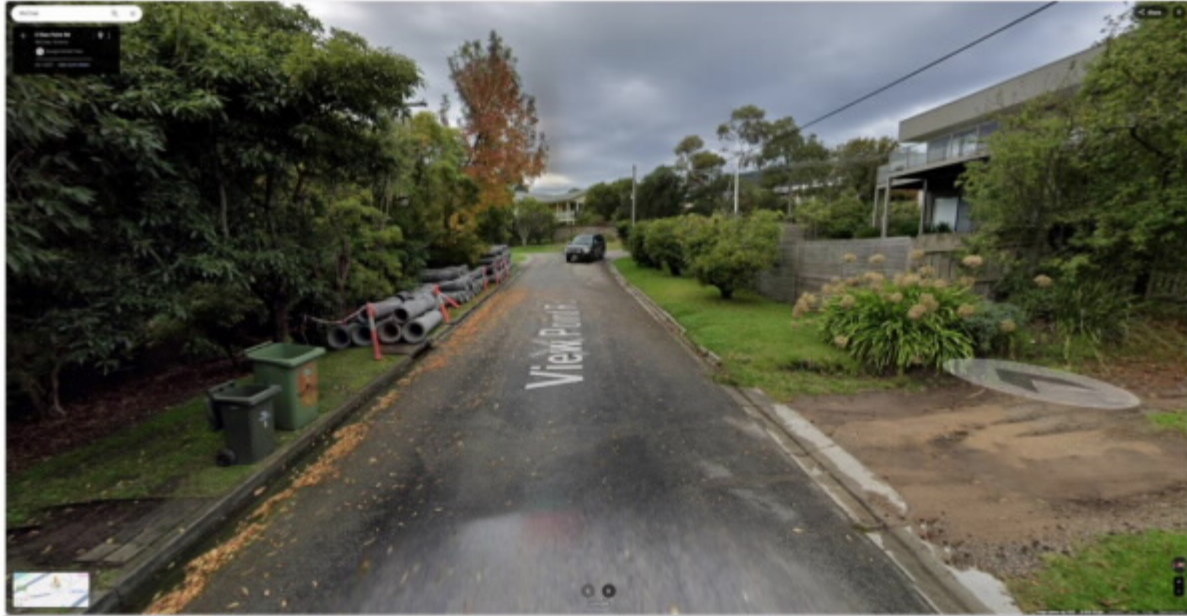
Publicly available photographs suggest stormwater upgrade works took place during Autumn 2023 (that is, after the November 2022 landslide) (see Figure 4).

Figure 4: Google Streetview image from April 2023 looking east from outside No. 3 View Point Road. Note the stored pipes on the verge.

*[The property owner] said the area [of the November 2022 landslide] was previously very wet but is now dry. And he suspected it has something to do with the construction of the stormwater drain on the north side of the View Point Rd [Refer to Figure 4].*

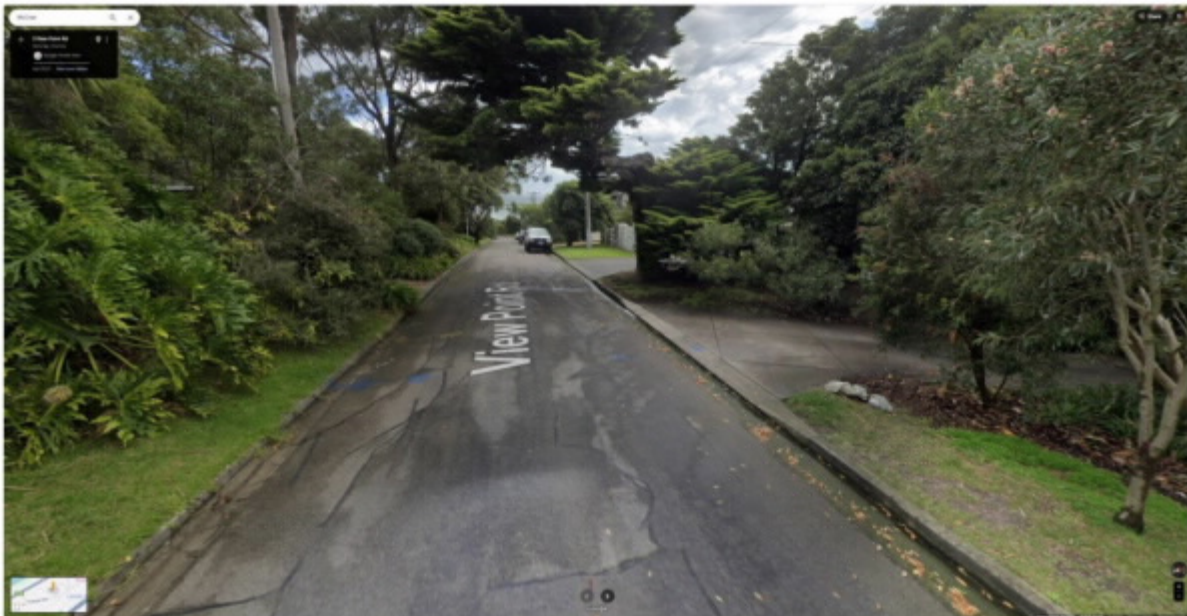
Figure 5, Figure 6 and Figure 7 provide an indication of the condition of View Point Road. The condition of the pavement is characterised by numerous longitudinal cracks (Figure 5) and areas of crocodile cracking and spalling. Such evidence can indicate pavement fatigue or aging, or weak subgrade. Water is noted to be flowing down the eastbound kerb within the photographs. The precise date of the photographs is not known. But we note the greenish tinge of the kerb and channel, compared to the south side, which could indicate vegetation build up due to high levels of moisture content.

Figure 5: Google Streetview image from April 2023 looking west from outside No. 3 View Point Road.

Note that Figure 5, Figure 6 and Figure 7 indicate that continuous flow along the kerb, which may confirm this statement.

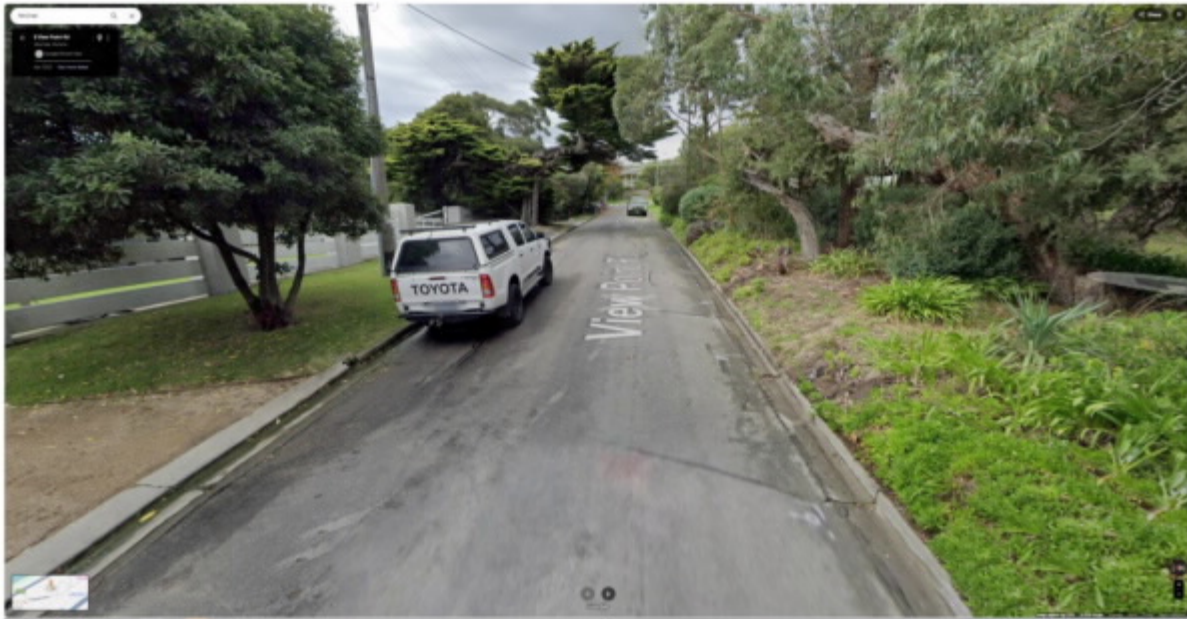
Figure 7: Google Streetview image from April 2023 looking east from outside No. 10-12 View Point Road.

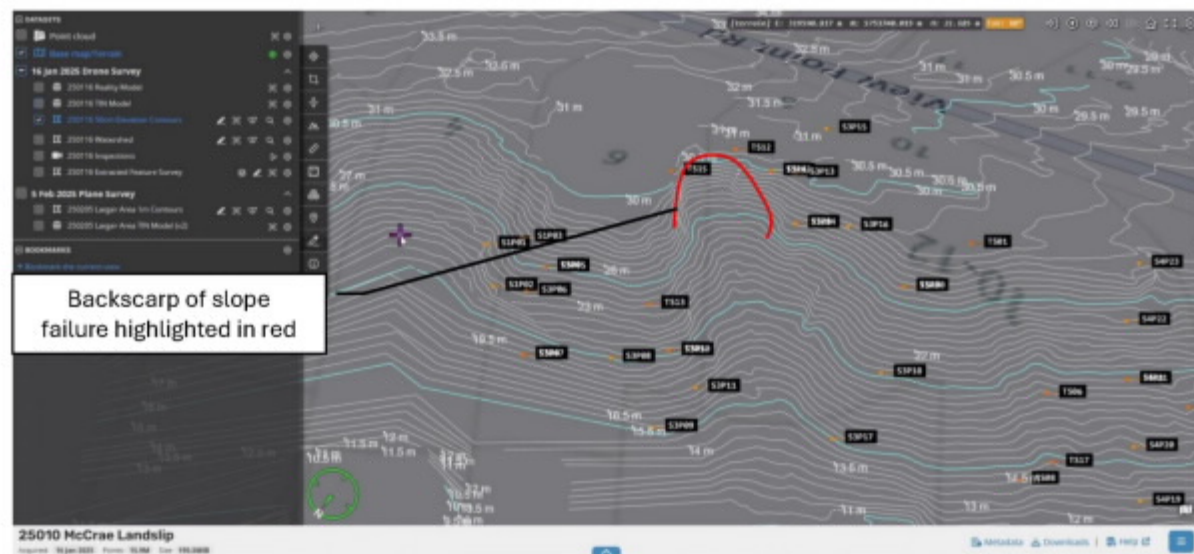
Figure 9: Oblique image showing approximate contours of the site.

Figure 9 provides imagery showing the height of the slope around the subject site. From this image, SMEC has been able to estimate the elevation of springs noted during drone footage.

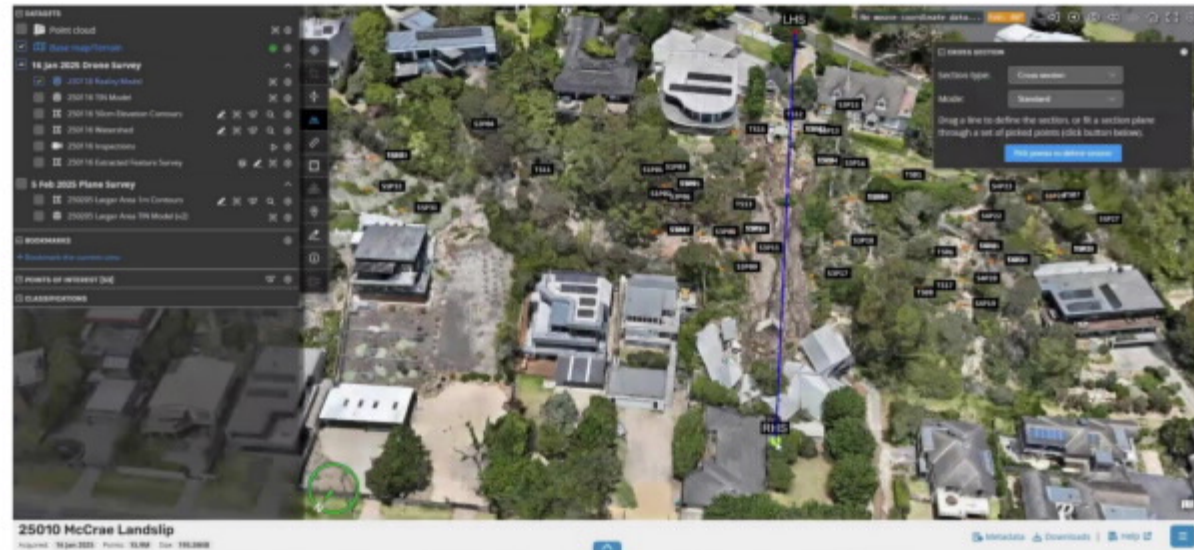
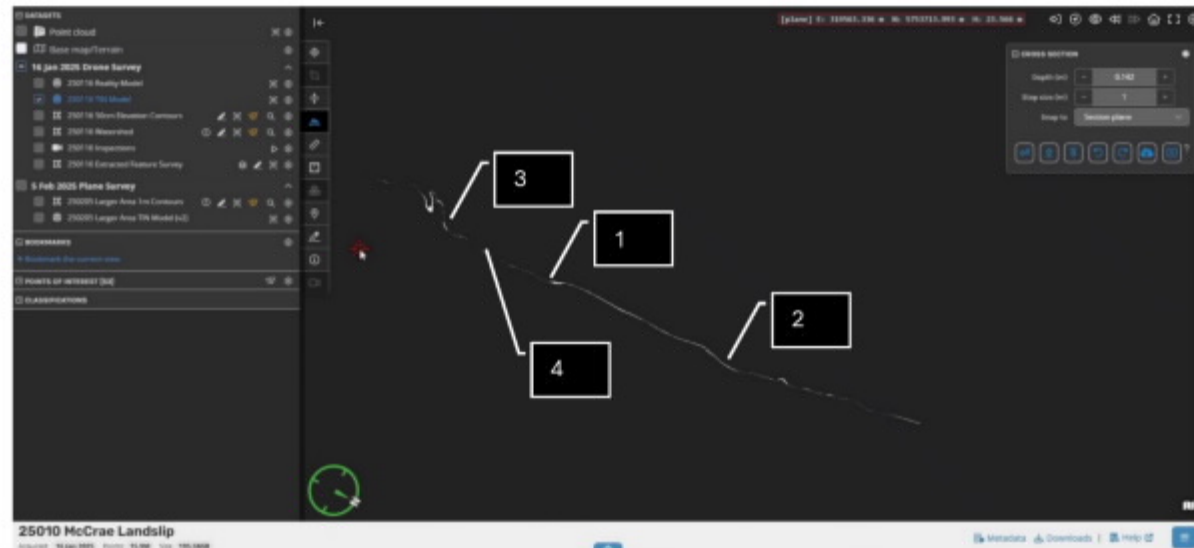
Although Figure 13 is not scaled, the variation of the slope gradient is clear. Note that between points 1 and 2, the cross-section cuts through undisturbed slope. Point 3 shows the location of the backscarp of the failure, with point 4 the slip surface. The geometry of the topography shown in Figure 8, Figure 10 and Figure 11, suggest that the slip surface of the failure daylighted at an elevation similar to point 1. The toe debris has funnelled down a narrow gully throat before spilling out as illustrated in Figure 8 and Figure 11.

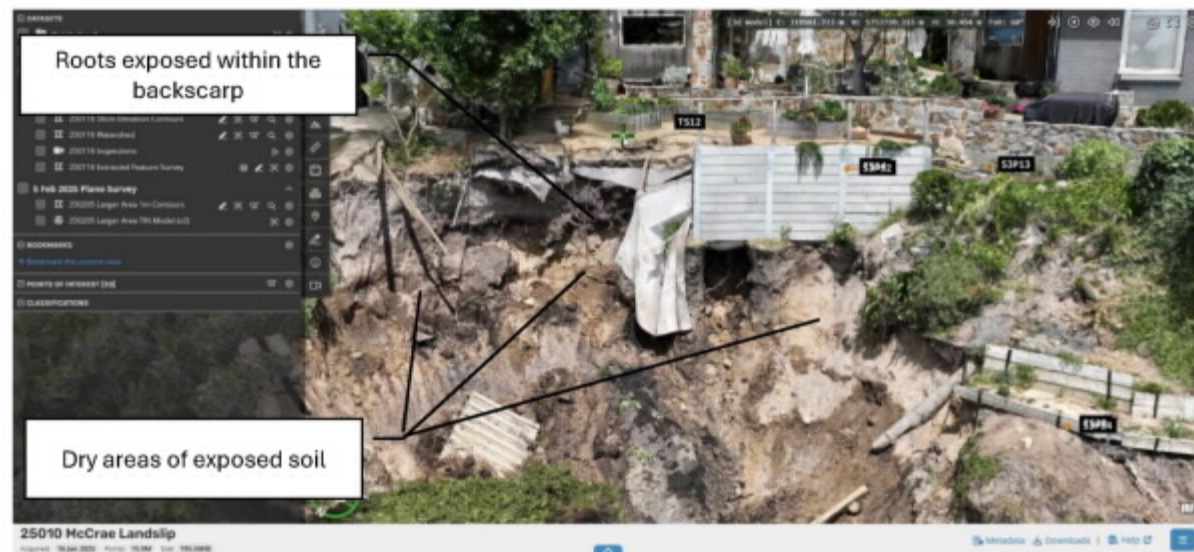
Figure 17: Drone footage looking directly at retaining wall

Figure 17 shows the condition of the retaining wall. The remaining posts have soil still surrounding them, with 'unretained' soil having slipped through the gaps. The dry nature of the remaining backscarp material is of interest. Considering the 30 m distance between SEW asset and the backscarp, the highly localised nature of the inferred wetter material does not indicate that the source of water is the SEW assets.

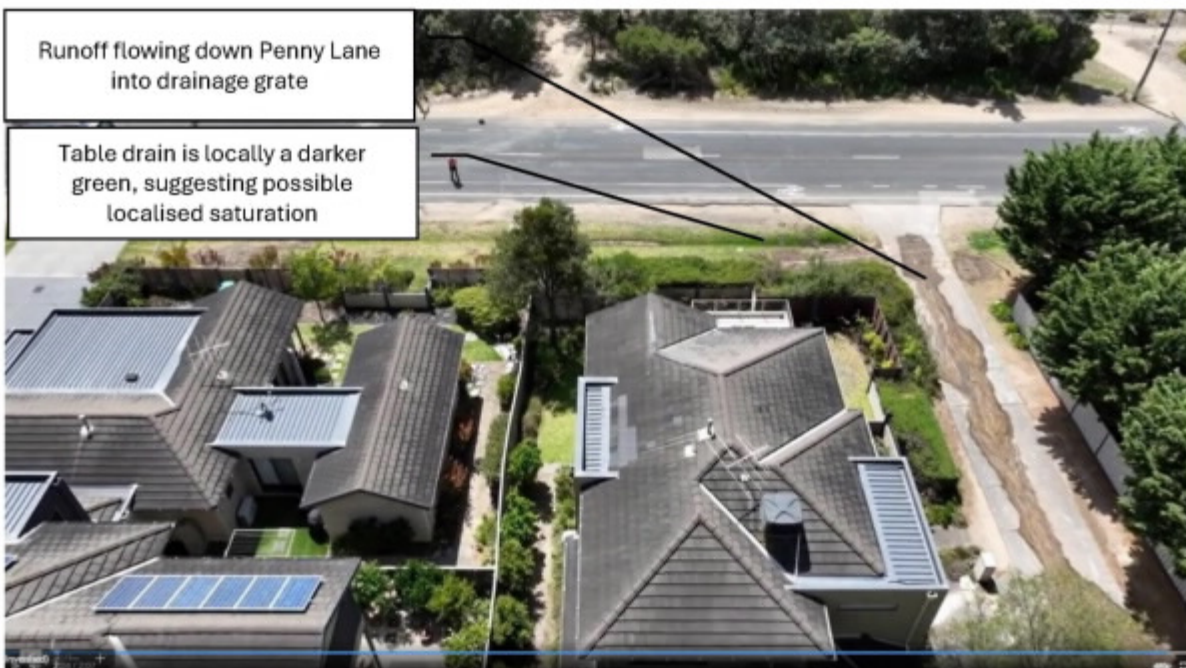
Figure 19: Drone footage from near the toe of the failure, looking towards Point Nepean Road.

Figure 19 shows water flowing down Penny Lane, and into a drainage grate, then flowing into a table drain. The surface area near the grate, is greener than the remaining length of drain.

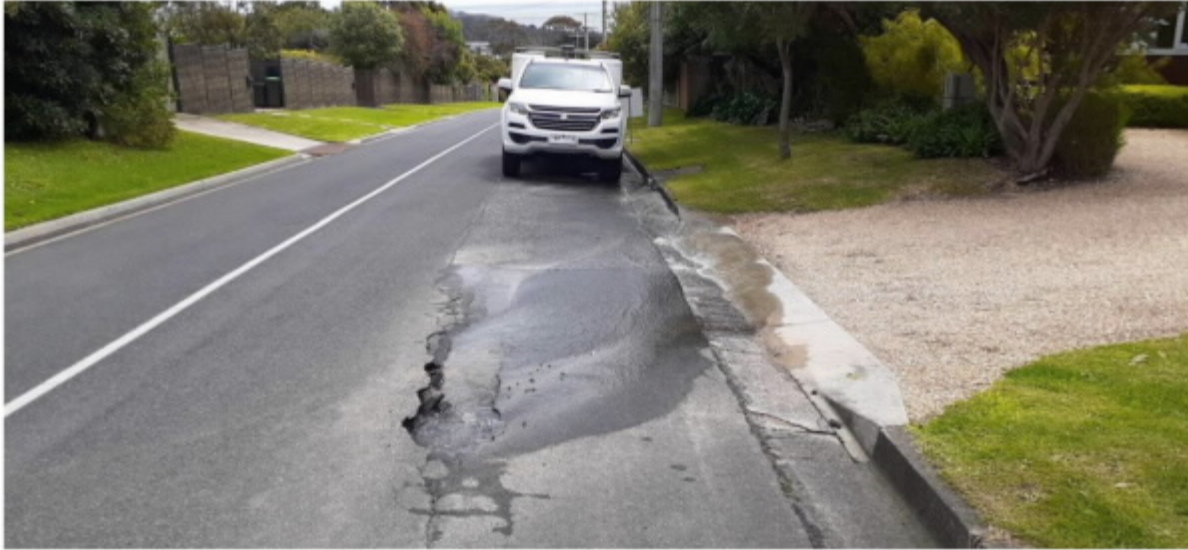
Figure 21: Photograph from SEW taken on 14 November 2022, looking west along Coburn Avenue from junction with Prospect Hill Road showing site conditions.

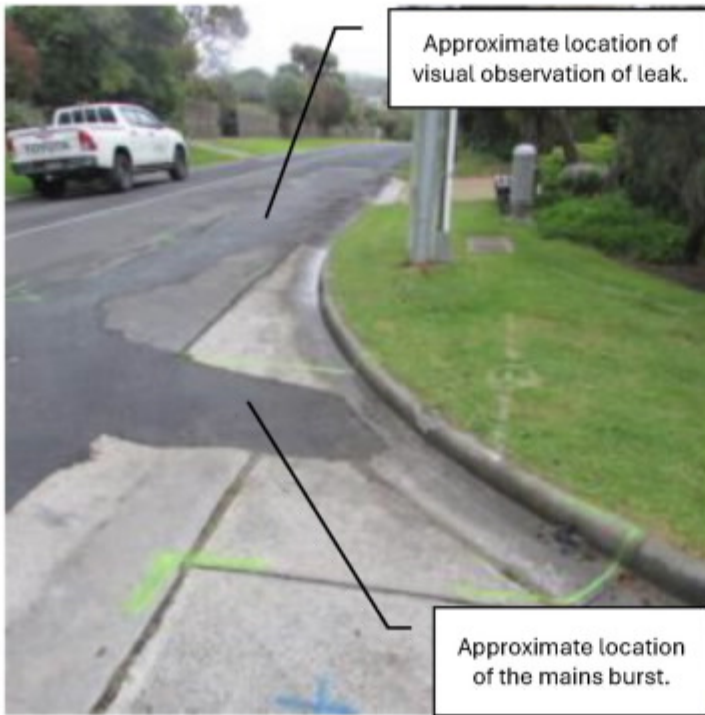
Figure 23: Photograph from SEW taken on 15 November 2022 (approximately), looking west along Coburn Avenue from junction with Prospect Hill Road showing completed mains repair works

Repair works were carried out on 15 November 2022.

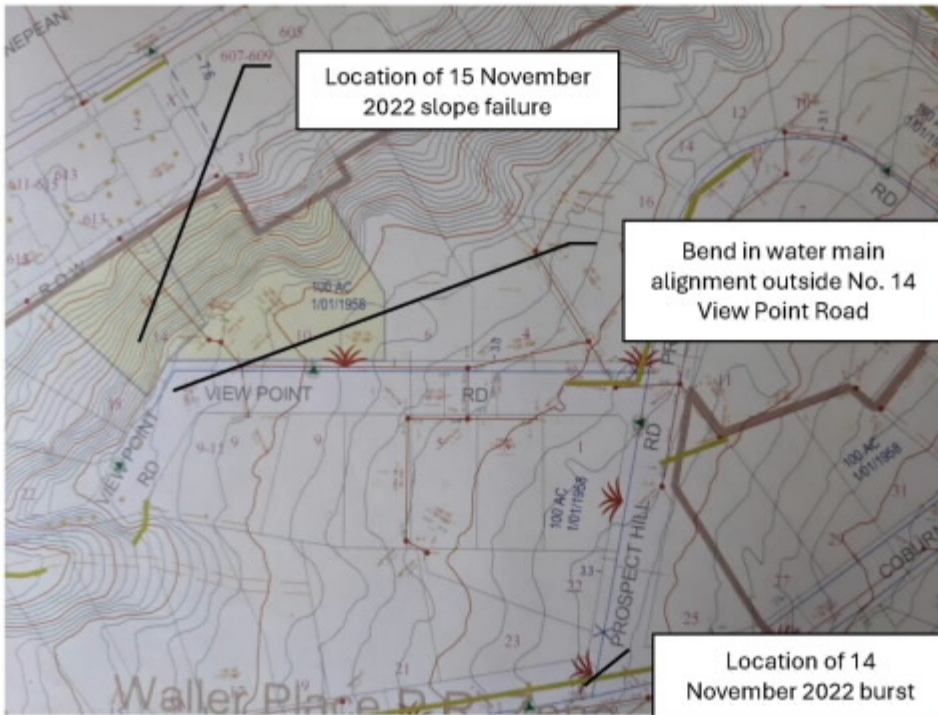
We understand that the 15 November 2022 slope failure is under current proceedings. It is not within the scope of the report to consider causes of this failure. However, Figure 31 illustrates that:

- the mains water for View Point Road, is linked to the mains water outside 23 Coburn Avenue. Leaked water could feasibly flow within the embedment material of the mains water.
- there is a bend in the mains water alignment at 14 View Point Road. This may have allowed water within the embedment material to seep out at that location and into 14 View Point Road. However, SMEC notes that there is no record of surface deformation between the mains trench and the slope failure.
- That the mains water system also links the site of the mains burst with a mains alignment down Coburn Avenue.
- Records suggest that the burst was repaired on the same date as it was observed, the volume of water lost is likely to be considerably less than the volume of water estimated for the Bayview Road leak located on 30 December 2024 and repaired on 1 January 2025.

Figure 31: Excerpt of SEW map showing location of 23 Coburn Avenue, and the location of the 15 November 2022 slope failure, with annotations.

In conclusion, the evidence of 15 November 2022 suggests that pipe burst can cause defects which are most likely to occur within the proximity of the burst. It is considered not feasible that water can transport down buried service trenches and leave the trench without resulting in defects being observed close to (i.e. within 5m) of the burst.

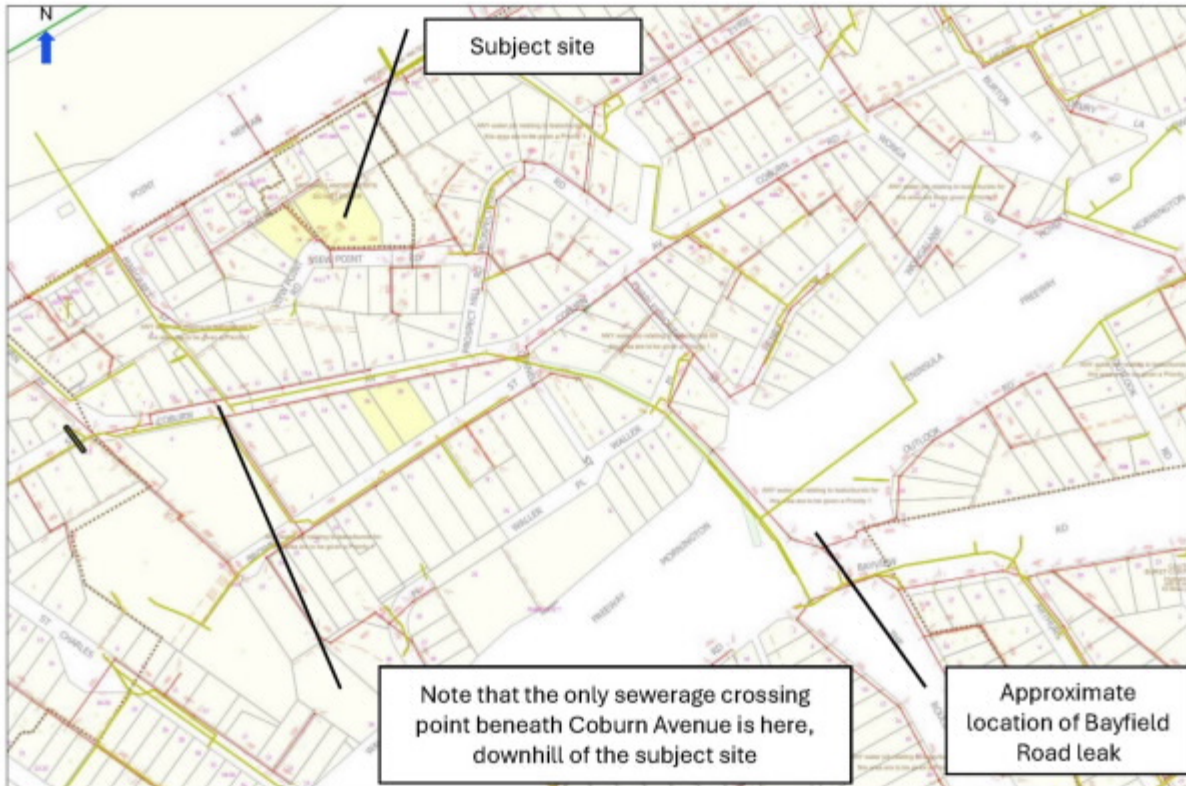
Figure 35: Plan showing sewerage network around locality of View Point Road. Note that the leak near Bayview Road is the south side of Mornington Freeway.

Figure 35 shows the location of buried sewer assets in the locality of View Point Road. It should be noted that the ground level tends to dip towards the northwest. There is no link between the sewer network of Prospect Hill Road and View Point Road, and the network south, or uphill from Coburn Avenue, as illustrated in Figure 58.

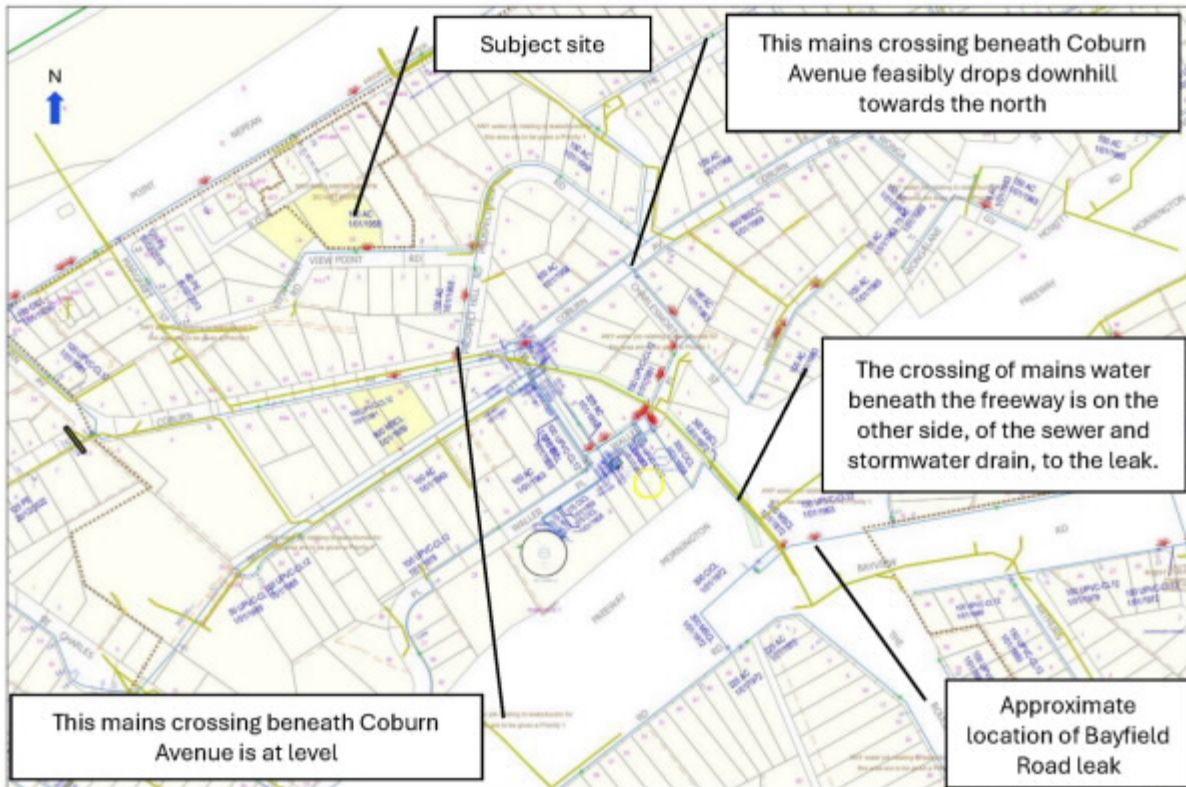
Figure 36: Plan showing water mains network around the locality of View Point Road.

Figure 36 illustrates that the link within the mains network at the T-junction of Prospect Hill and Coburn Avenue is level. This is not a concern for pumped water flow, but it indicates that the embedment material surrounding the mains, grades upwards towards Prospect Hill Road.

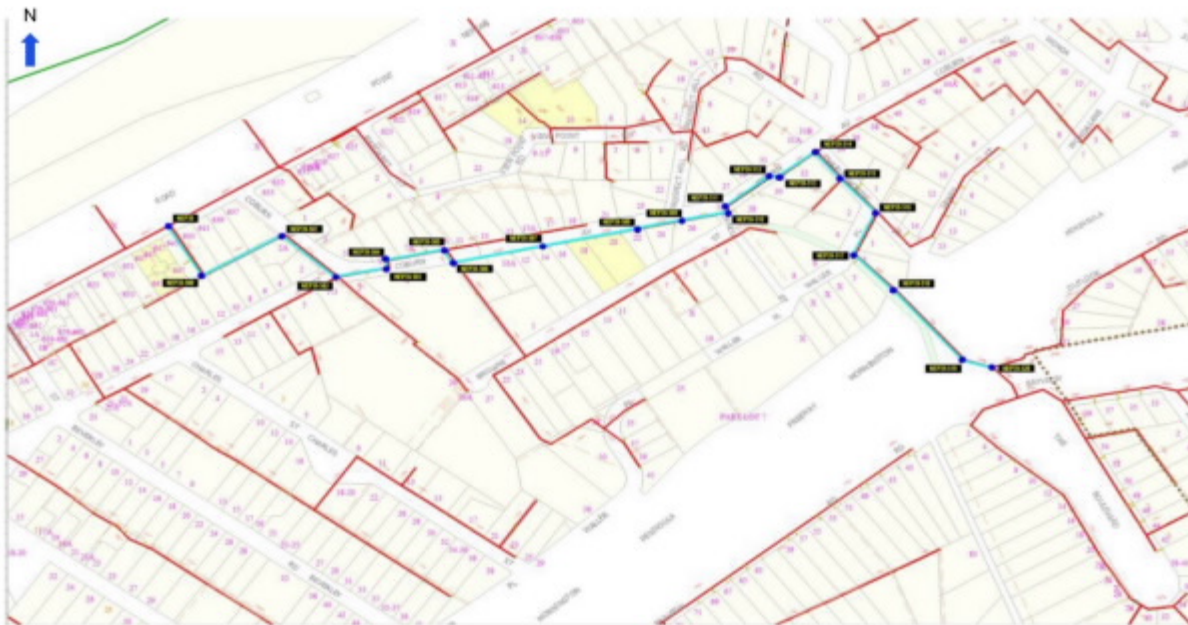
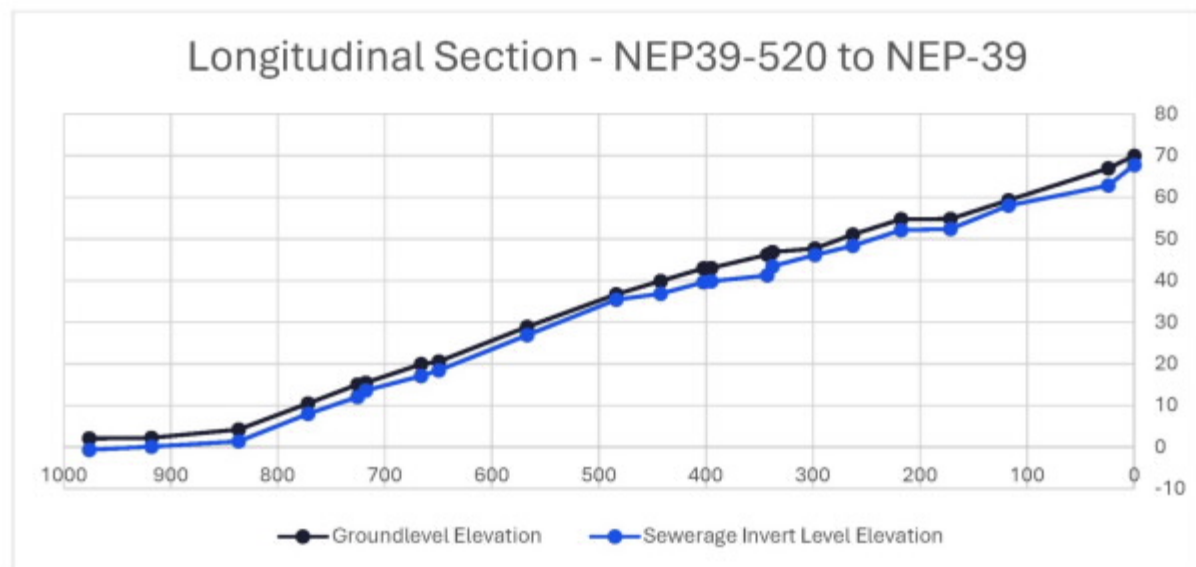
Figure 37: Map showing sewer network from Bayview Road and Point Nepean Road.

Figure 38: Graphical long section showing the ground level and invert levels of the sewer network between Bayview Road and Point Nepean Road

Figure 37 and Figure 38 illustrate the gradient through Bayview Hill Road into Point Nepean Road. Chainages 217.75 m to 298.25 m are located along Charlesworth Street, where upwelling was noted (Section 7.6.3.2). The depth to invert along Charlesworth Street varies from 2.69 m to 1.56 m. It is noted that the invert depths along Charlesworth Street are not the shallowest inverts along the alignment. It is therefore not certain that the depth to invert is solely related to the likelihood of upwelling.

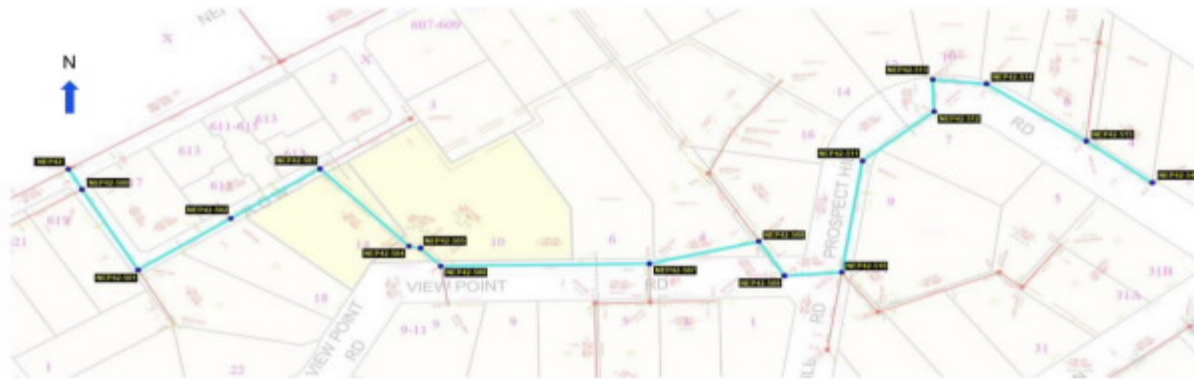
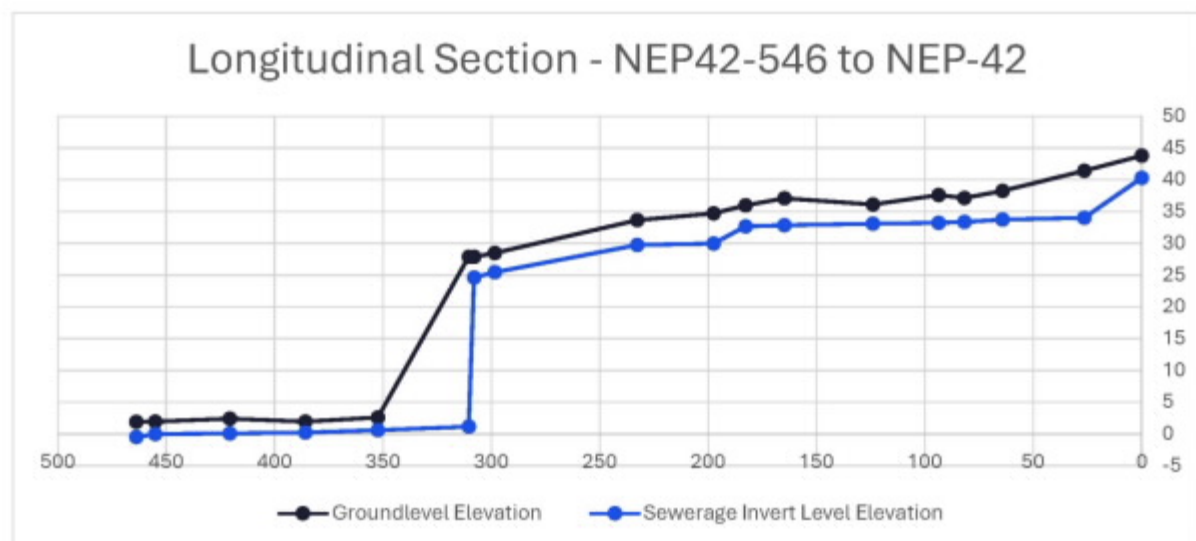
Figure 39: Map showing sewer network from Prospect Hill Road and Point Nepean Road.

Figure 40: Graphical long section showing the ground level (CL) and invert levels (IL) of the sewer network between Prospect Hill Road and Point Nepean Road.

Figure 39 and Figure 40 illustrate the gradient through Prospect Hill Road into View Point Road. Note that the scales differ from Figure 37 and Figure 38. Note that 10 View Point Road is at chainage 298.4 m. The figures show a fall in invert level along the chainage, irrespective of the ground level. Note that Chainage 83.9m to 93.7m, is outside 10 Prospect Hill Place.

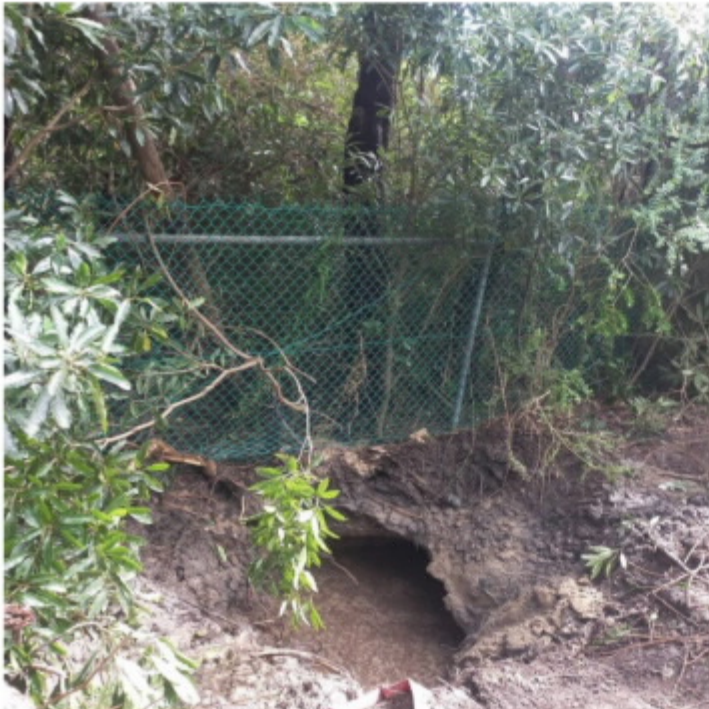
Figure 46: Provided by SEW, understood to have been taken on 31 December 2024, showing the Bayview Road leak site during pumping and excavation works.

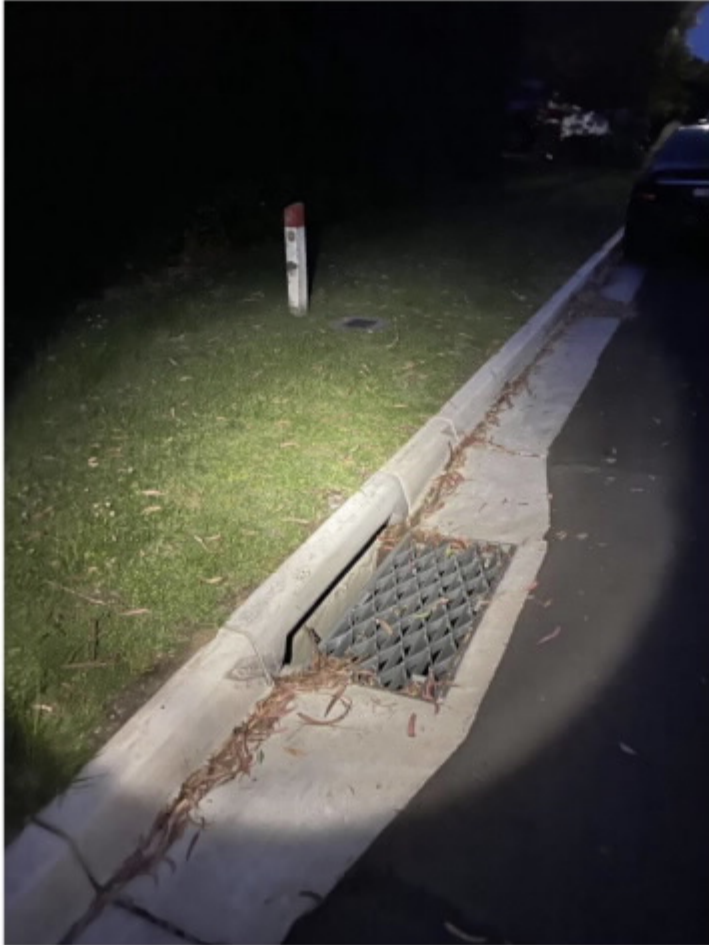
Figure 49: Photograph taken on the night of 5-6 January 2025, of a stormwater drainage pit outside what is thought to be No. 10 View Point Road

Figure 49 shows a storm water pit with a grate. The accompanying records from SEW personnel do not explicitly say where this pit is. However, based on locations of fire hydrants and recognisable fences, SMEC believe it is outside No. 10 (see Figure 6).

SEW has advised SMEC that in January 2025, SEW advised the owner of 5 Prospect Hill Road that they had identified a leak in the property from leak detection activities. In April 2025, the owner found the leak and repaired it. The flow of water within the stormwater drain (Figure 49) is considered to be at least in part due to the pumping of groundwater from the basement.

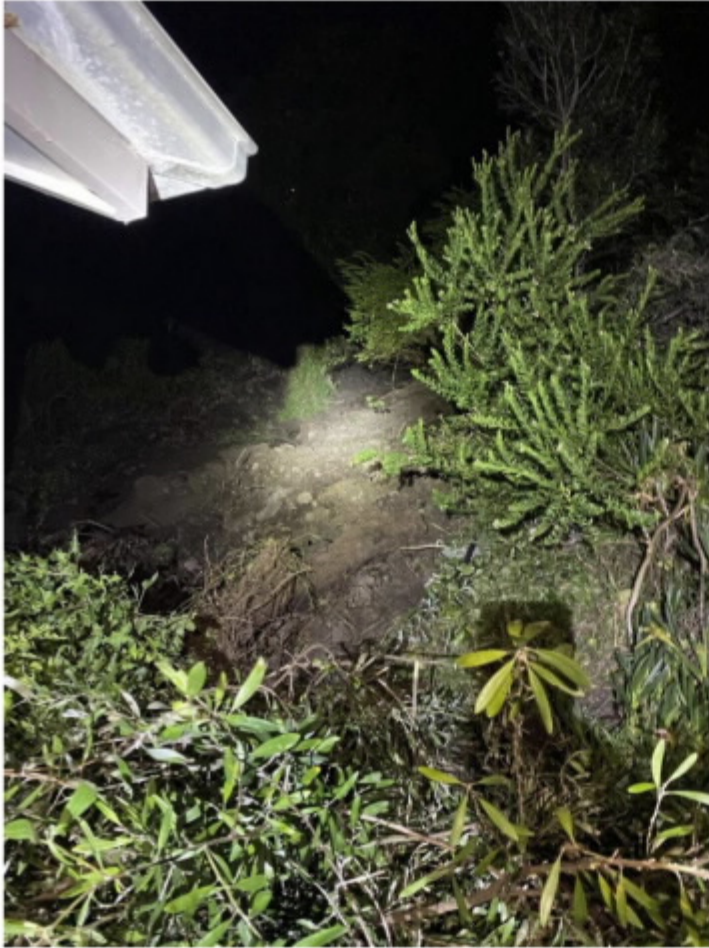
Figure 51: Photograph taken on the night of 5-6 January 2025, looking south from behind 3 Penny Lane

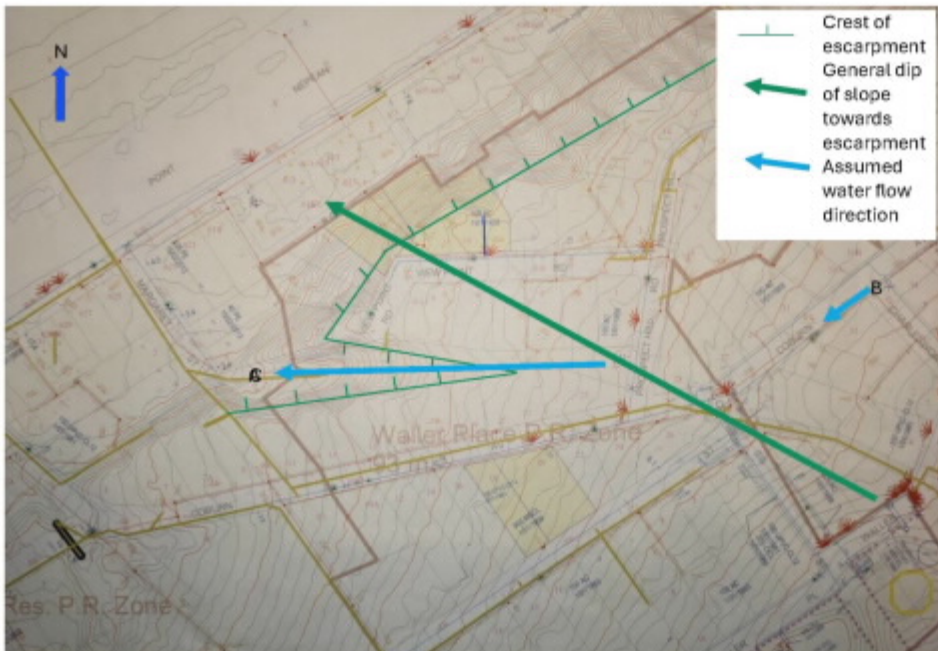
It is considered **not** possible that a leak close to the site could create such conditions without other evidence of deterioration being observed at the surface.

Figure 57: Map illustrating the evidence needed to confirm the hypothesis that the McCrea Landslide was impacted by a leak within SEW assets in the vicinity of the subject site

Figure 16 and Figure 32 illustrate the distance between the landslide and the location of the water main (located within the verge of View Point Road) is approximately 30 m. The ground level tends to drop across the alignment of View Point Road (see the green arrow, Figure 57).

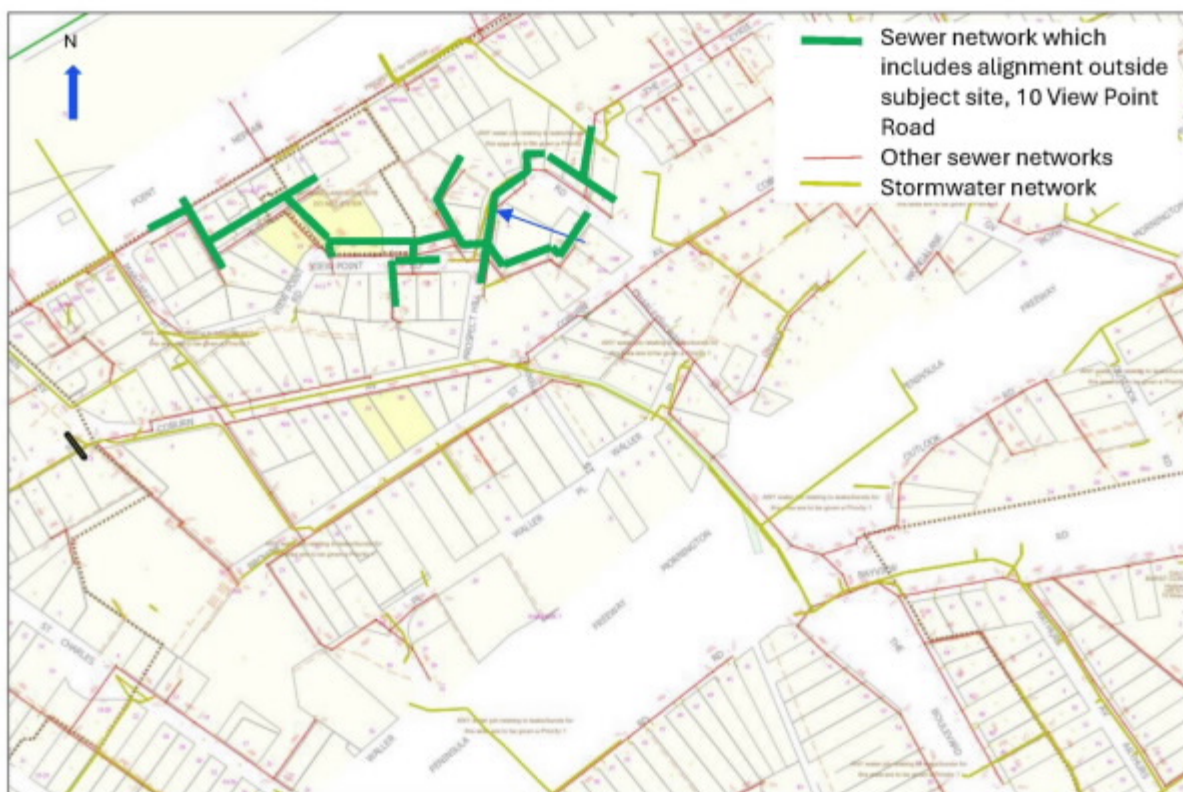
Figure 58: Map illustrating the evidence needed to confirm the hypothesis that the McCrea Landslide was impacted by a leak within SEW assets in the vicinity of the subject site

This means that there is no contiguous trenched network associated with the sewerage that could allow water from significantly uphill of the subject site to reach the site.

The network that connects View Point Road, taking account of gravity, is limited to the green annotated network in Figure 58.

A water source remote from the site, for example the Bayview Road leak, does not have a direct flowpath to View Point Road. A route is possible which uses a range of buried service trenches as indicated in Drawing No. 003, transferring between trenches at the T-junction of Charlesworth Street and Coburn Avenue, is feasible, but requires all water to be transferred via upwelling, and therefore it is reasonable to conclude that the majority of the water would continue within the sewer trench down Coburn Avenue.

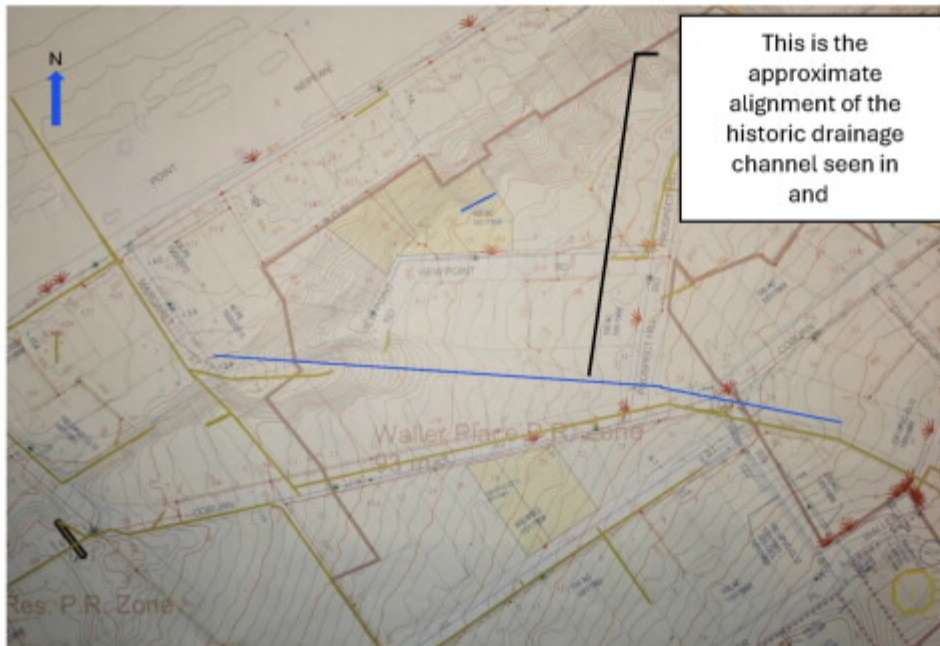
Figure 59: Map illustrating the historical drainage channel in the locality of the subject site, in the context of current development

- A single leak 465 m uphill from the landslide,
  - Creating water flow across a historic surface water channel that outfalled at Margaret Road (Figure 59),
  - but also, across a modern cut that takes the Mornington Peninsula Freeway past McCrae (Drawing 003), and

- raised the groundwater locally to a site some 20 m wide.
- Seepage, distortion, settlement or failure or other ground movement has not been observed at any location in between the leak and the site. There are observations of welling of water at locations which anecdotally appear to have occurred since May 2024, but with more frequency between 24 November 2024 and 13 January 2025 (Waller Place and Charlesworth Road, Drawing 003).

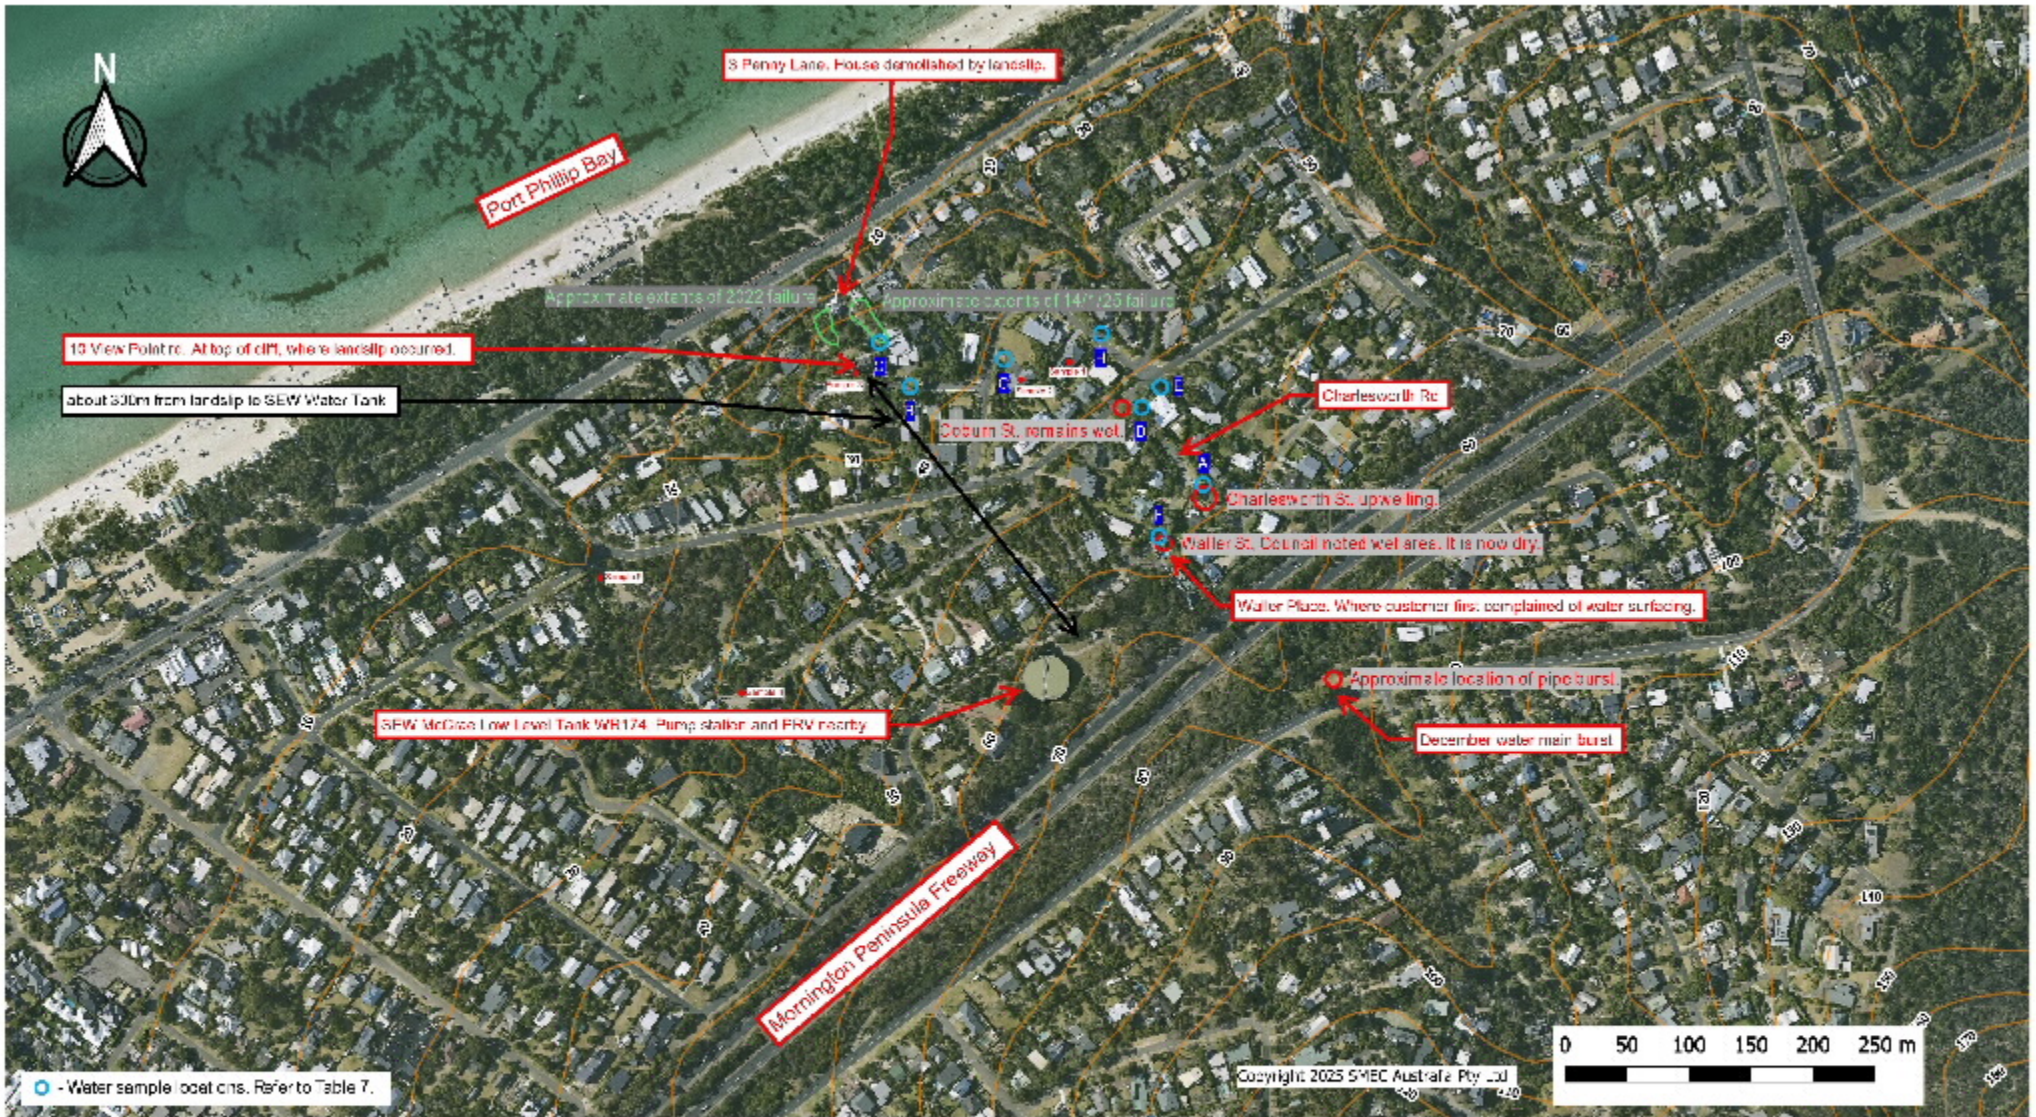
**FIGURE TITLE** Drawing 002 - Aerial photograph of the locality of the subject site, showing locations of note

Records of known storage facilities, or buried pipelines show that (see Drawing 002, Figure 35 and Figure 36):
