# Expert Opinion Report - Landslide Assessment

10-12 View Point Road, McCrae

PSM5226-006R Rev0      11 June 2024

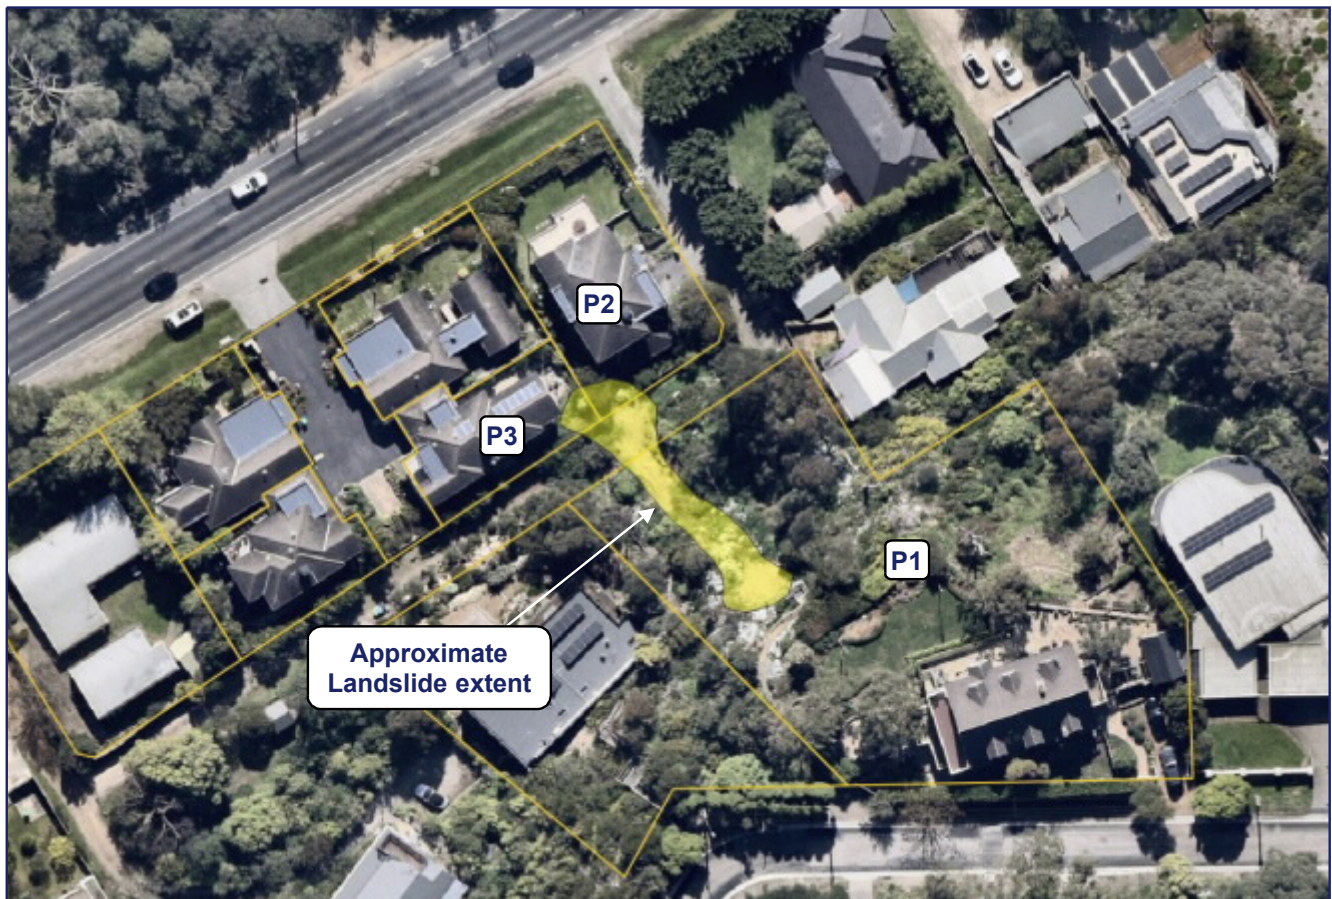
**Inset 1: Plan of properties affected by the Landslide (Aerial Image from Nearmap dated 25 August 2023).**

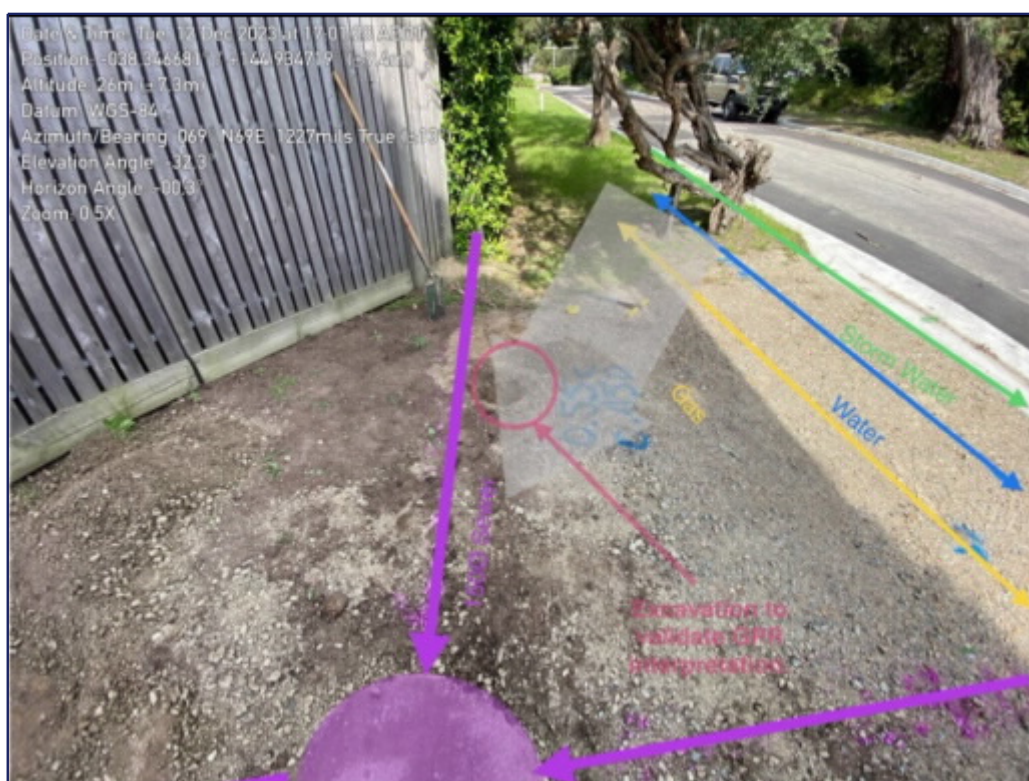
- Sewer, gas, water, and stormwater sub-surface utilities were identified in the nature strip, Inset 5.
13. I note that I have not observed any direct evidence of connectivity between this "void" and the Landslide.

**Inset 5:** Figure 2 of Safety Scan scanning report showing location of sub-surface utilities

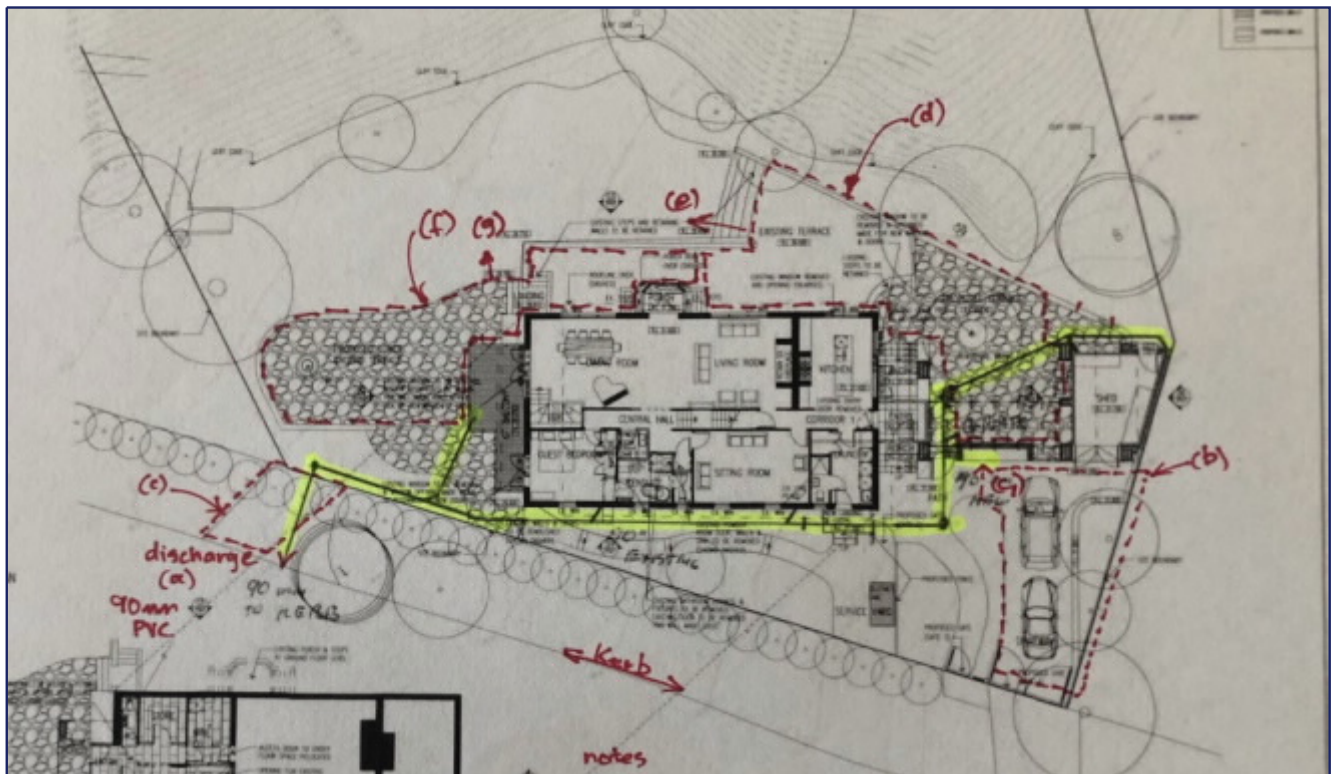
22. I have assumed that the P1 stormwater system drawing is an as constructed representation.
23. Document 6 of the Brief includes a letter from Ian Chudleigh Plumbers detailing the results of a pressure test that was performed on the water lines within P1 (pdf page 96 of the Brief). It indicates to me that:

- (a) There are no leaks within the tested water lines.
  - (b) An automatic irrigation system is present on Site.

**Inset 9: Plan of P1 stormwater system (pdf page 95 of the Brief).**

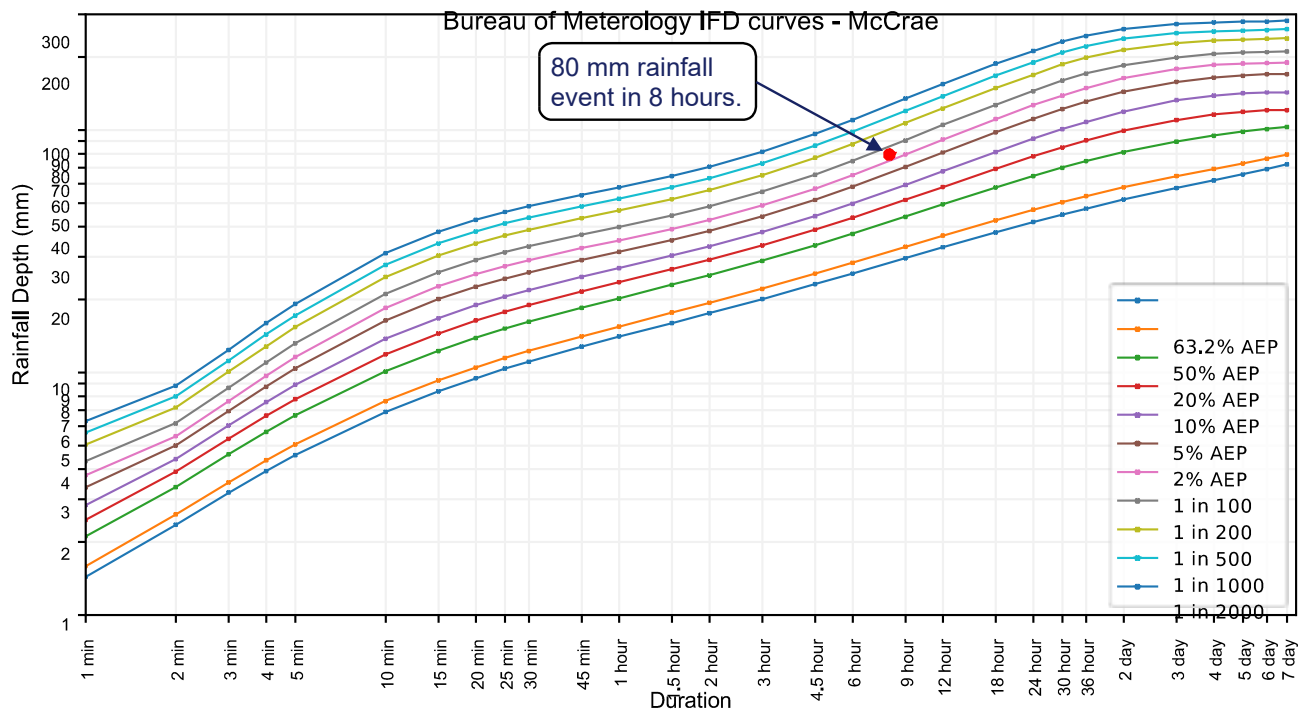
29. I have considered the Australian Rainfall and Runoff Intensity Frequency Duration (IFD) curves, published by BOM (<http://www.bom.gov.au/water/designRainfalls/revised-ifd/>, accessed 4 December 2023). These are presented in Inset 10.
30. These records indicate to me that:
- (a) The Rain Event intensity over the 8-hour period had 1 in 100 years to 1 in 200 years probability of occurring.
  - (b) 80 mm of rainfall in a 24-hour period has a 1 in 20 probability of occurring in any given year.
  - (c) The Rain Event was an infrequent and intense event.

**Inset 10: BOM IFD curves for McCrae, with Rain Event marked.**

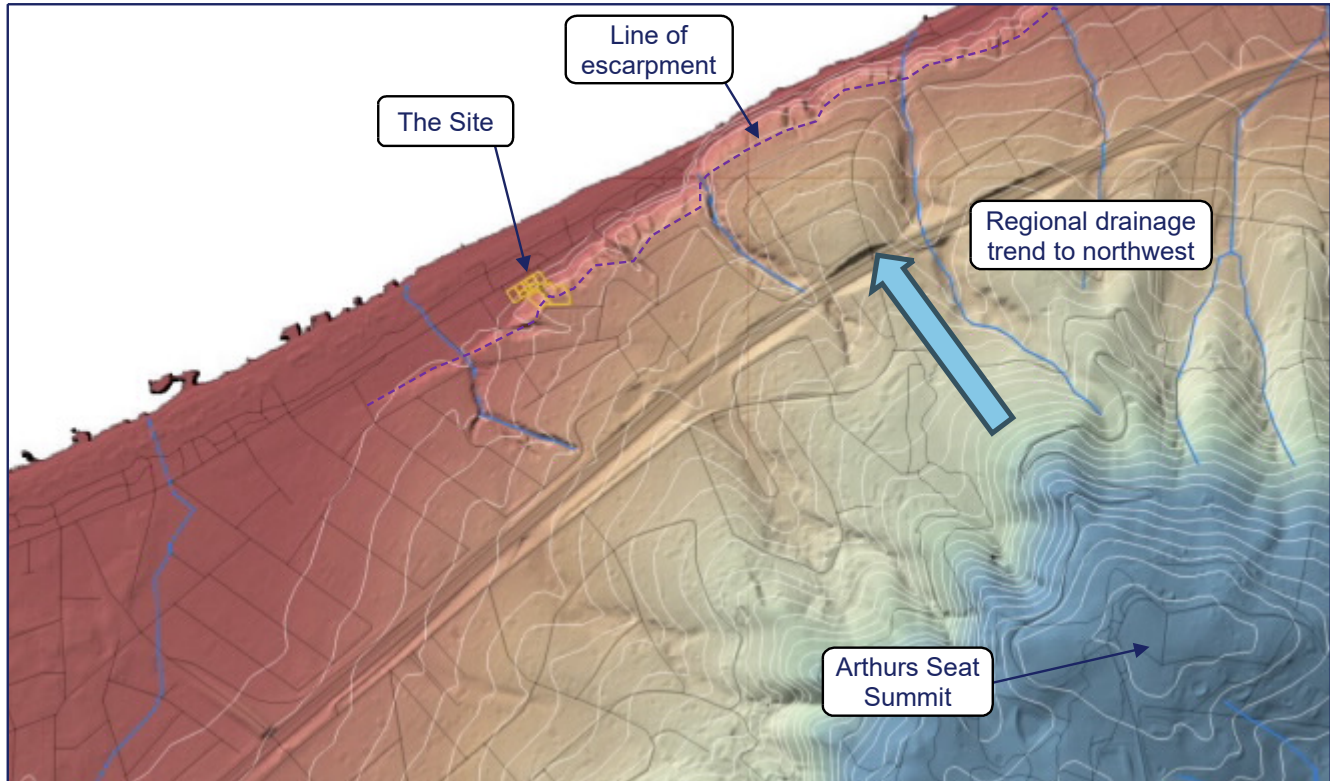
48. The Coastal LiDAR indicates that the Site is located at the lower escarpment of Arthurs Seat, Inset 12. There is approximately 270 metres of relief measured in a northwest direction from the summit of Arthurs Seat to the escarpment at the Site. I note that drainage paths typically strike in a north to northwest direction and that the Mornington Peninsula Freeway provides significant disruption to surface and sub-surface water flows in the region.

### Inset 12: Topography and drainage paths of Arthurs Seat.

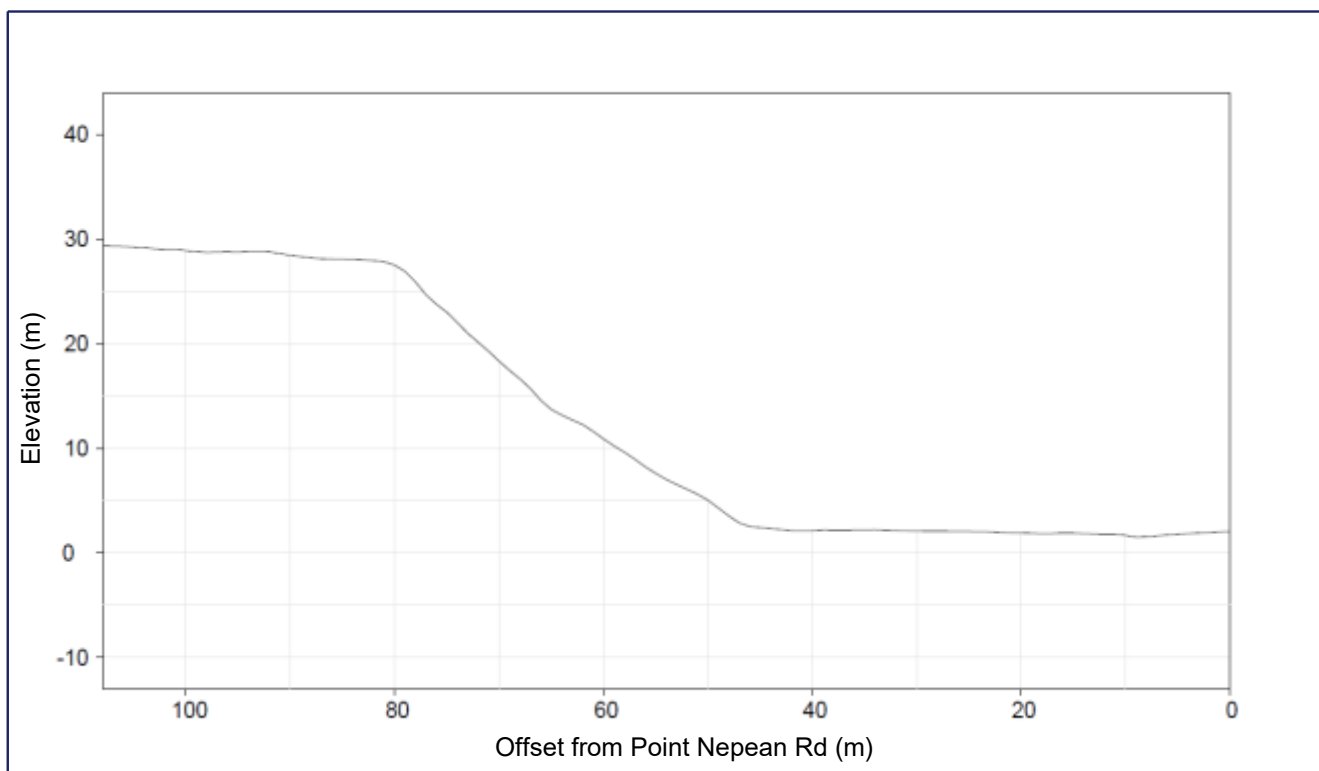
- (e) Pre-failure slope geometry of the Landslide is shown in Inset 13.
  - (f) A lack of large-scale features other than gullies, that may indicate the presence of a large, full height slope failure mechanism.

**Inset 13: Prefailure slope geometry through the centre of the Landslide from Coastal LiDAR 1 DEM.**

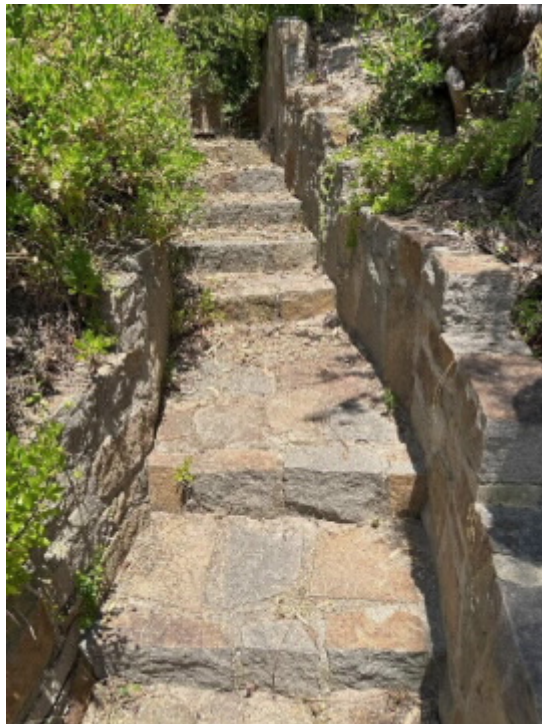
- (e) A series of paths had been constructed across the slope to provide access from the top to the bottom of the escarpment, Photo 8 & 9 Appendix E. The paths are constructed from varying materials. Other infrastructure associated with the paths include minor RWs, board walks and stairs.

Photo 9 - Granite stairs leading from garden area to path at top of landslide

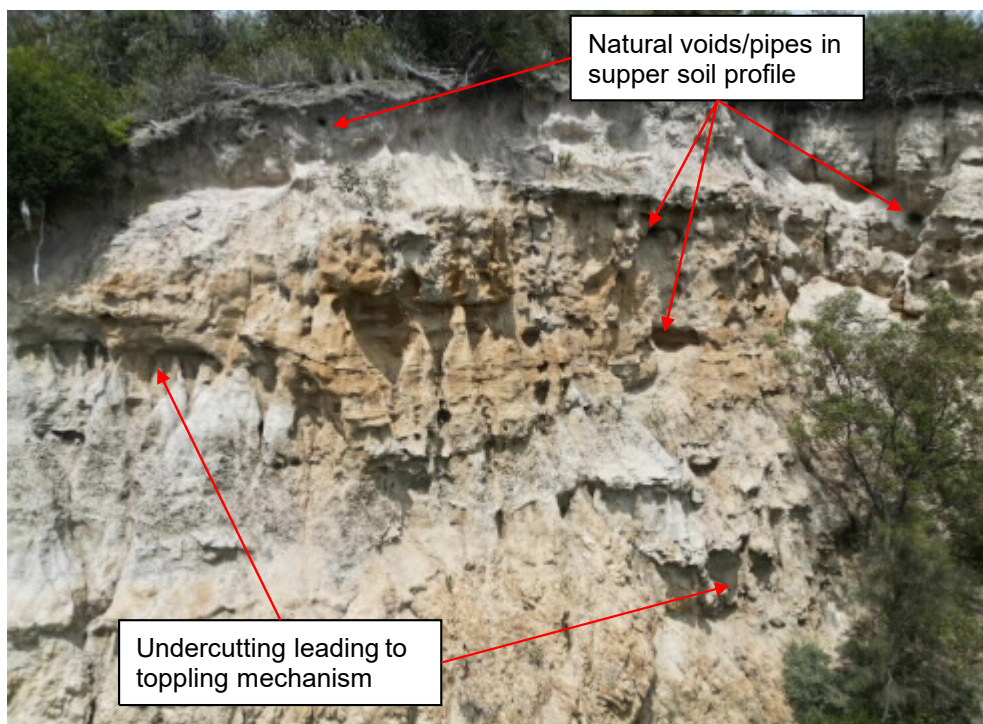
- i. Natural voids and internal erosion (i.e., piping) is common in upper soil profile, Photo 13 Appendix E.
  - ii. A sub vertical cliff profile in extremely weathered and highly weathered granite, Photo 14 Appendix E. I note this sub-vertical may be the result of road construction activities in the 1920's and 1930's.

Photo 13 - Natural cliff profile near Anthony's Nose

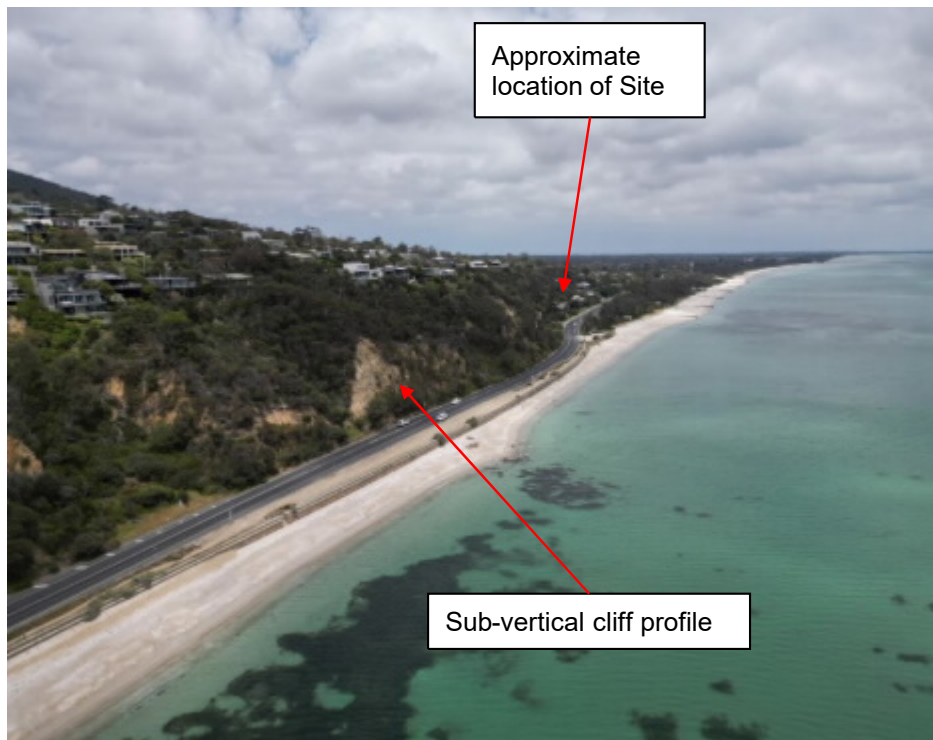
- (c) The Site is located on the lower slopes of Arthurs Seat where those slopes meet Port Phillip Bay and have formed an escarpment, Photo 14 Appendix E. In proximity to the Site the general topography of the areas slopes to the northwest. There is extensive residential development above the Site on the lower slopes of Arthurs Seat.

Photo 14 - Anthony's Nose

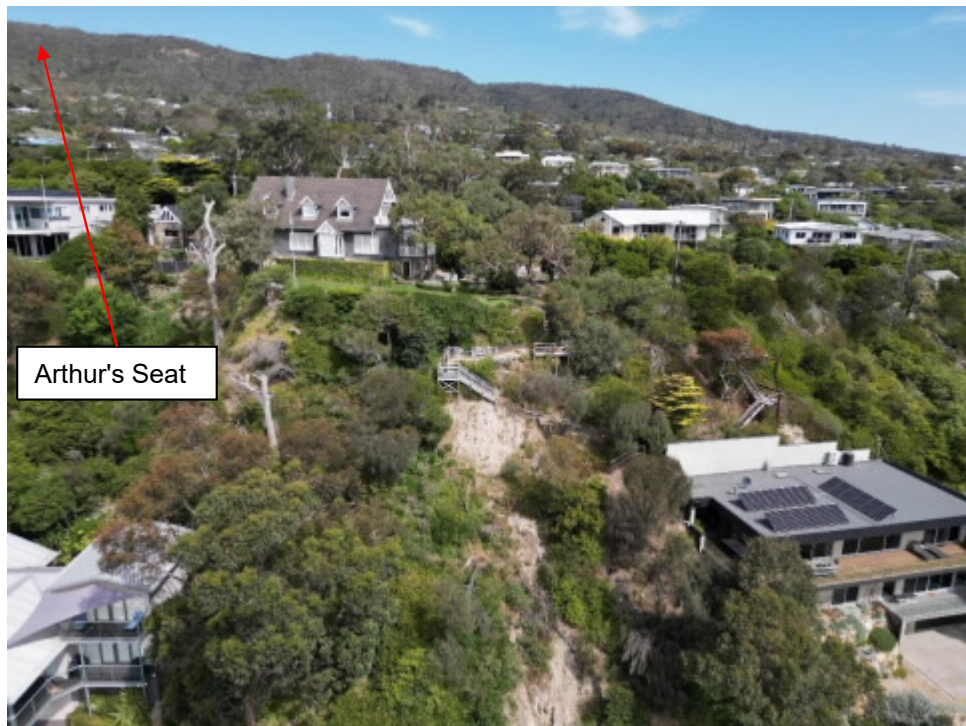
- iii. Granite rock is exposed in shore platform below the road.
  - iv. Steep to sub-vertical upper slopes is inferred to fail by undercutting and erosion of the lower slope leading to toppling/wedge style failures, Photo 15 Appendix E.

Photo 15 - Arthur's Seat in background
