9th Jan 2024

CHARLESWORTH ST & WALLER PL

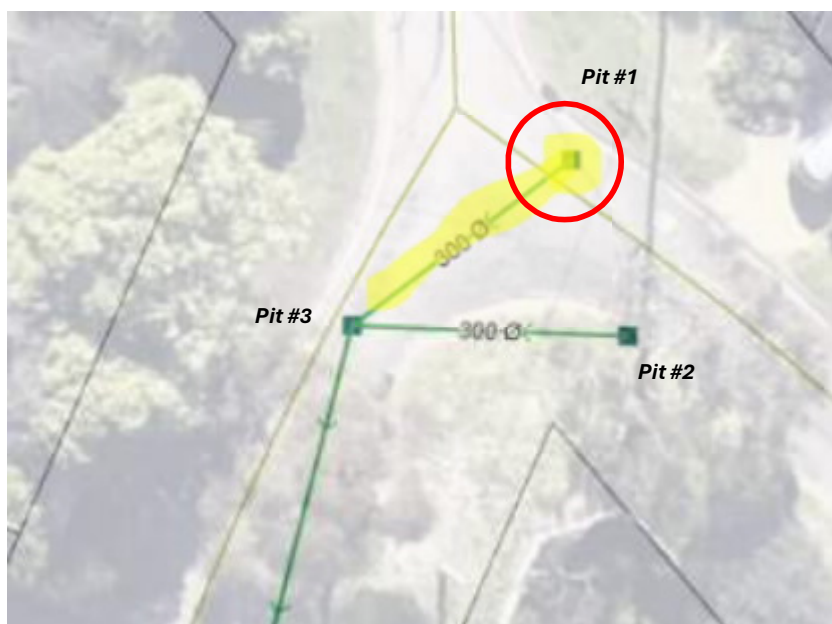
**Pit #1**

Pit #1 was cleared by hand (even though not at intervention levels and the pipe outlet wasn't obstructed).

The line from Pit #1 to #3 was proved to be unobstructed and functional.

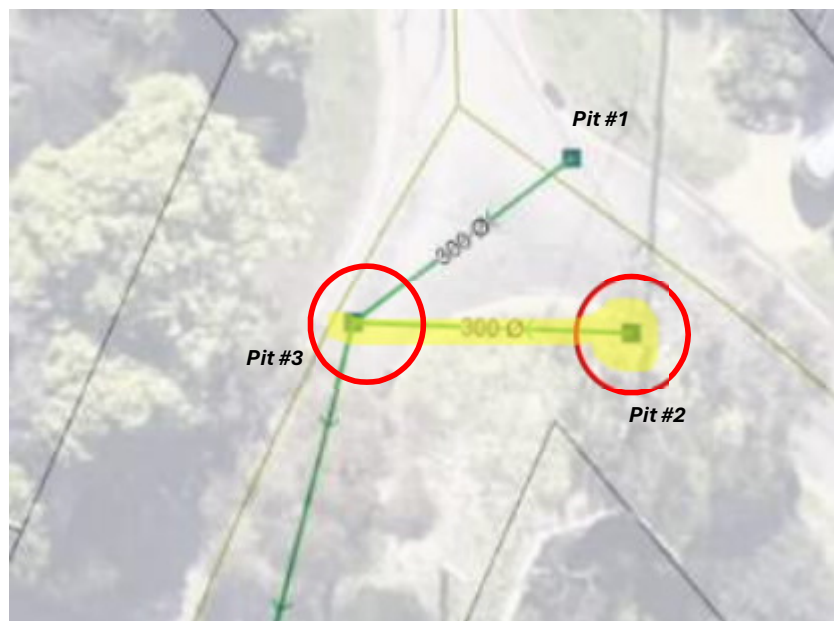
Pit #3 – Has approx 100mm slurry on bottom – but not within maintenance intervention & not obstructing inlet / outlets
