Date of inspection 15/01/2025	Time of inspection 9:00 AM	Land ownership Public land	Pipe Asset ID A TOO B	Nr. 1
Project name FULTONHOGAN - AE407 10-12 VIEW POINT ROAD MCCRAE	Contractor's Job Number	Coding Standard WSA 2020	Name of operator Alex Elliott	Job ID 10-12 VIEW POINT ROAD MCCRAE

Section Inspection - 15/01/2025 - A TOO B

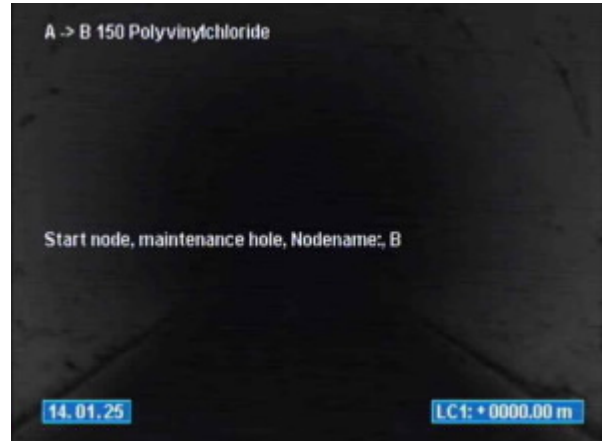
10-12 VIEW POINT ROAD MCCRAE_15.01.2025_090054_A
 TOO B _006.jpg, 00:00:00, 0.00
 Start node, maintenance hole, Nodename:, B

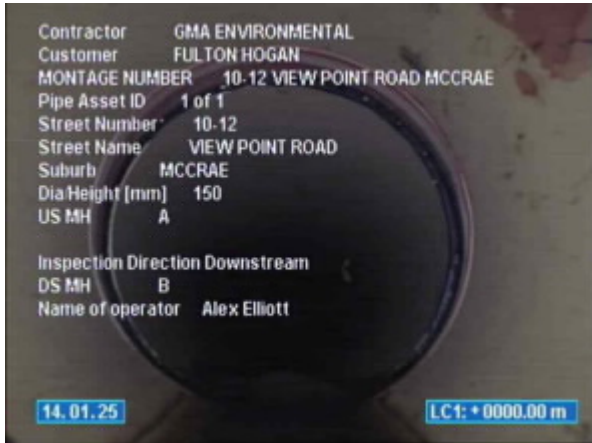
10-12 VIEW POINT ROAD MCCRAE_15.01.2025_083859_A
 TOO B _001.jpg, 00:00:00, 0.00
 Start node, maintenance hole, Nodename:, A

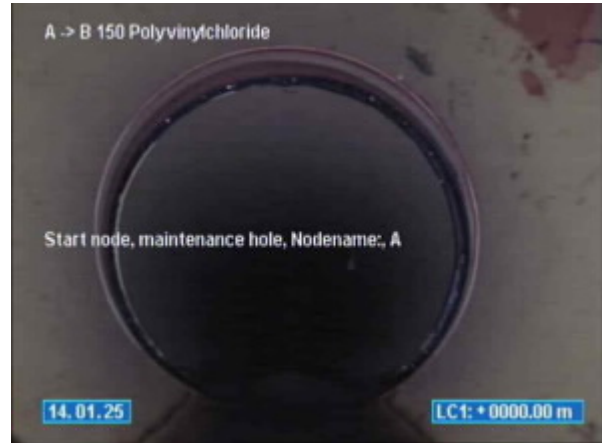
10-12 VIEW POINT ROAD MCCRAE_15.01.2025_083859_A
 TOO B _002.jpg, 00:00:00, 0.00
 Start node, maintenance hole, Nodename:, A

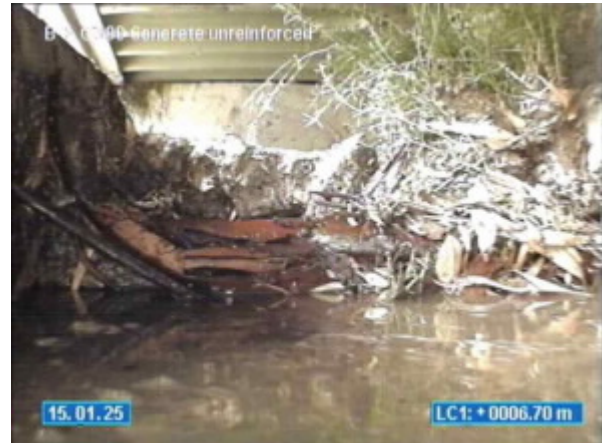
10-12 VIEW POINT ROAD MCCRAE_15.01.2025_102122_B
 TOO C _013.jpg, 00:04:19, 6.70
 Finish node, maintenance hole, Nodename:, C

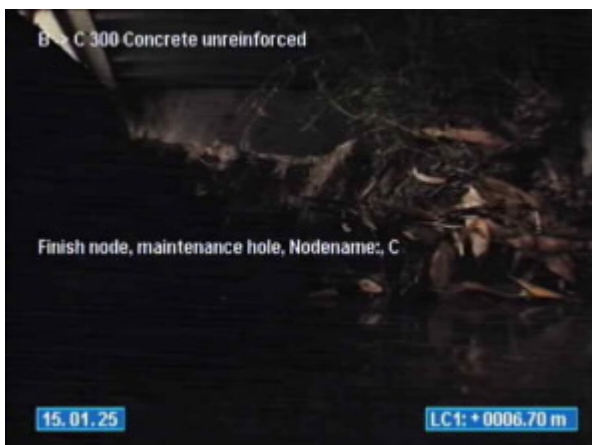
10-12 VIEW POINT ROAD MCCRAE_15.01.2025_102122_B
 TOO C _014.jpg, 00:04:19, 6.70
 Finish node, maintenance hole, Nodename:, C

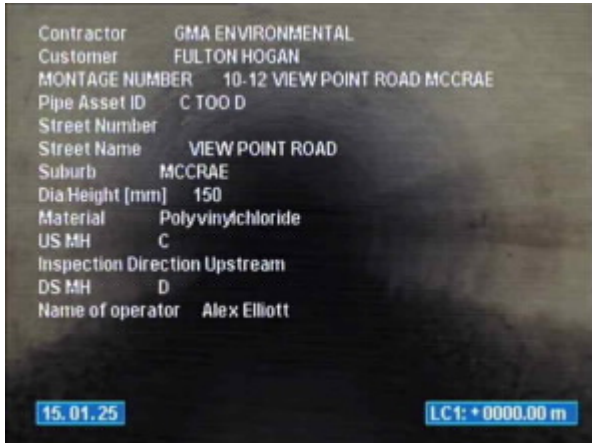
10-12 VIEW POINT ROAD MCCRAE_15.01.2025_114611_C
 TOO D_021.jpg, 00:04:25, 0.00
 Start node, maintenance hole, Nodename:, D

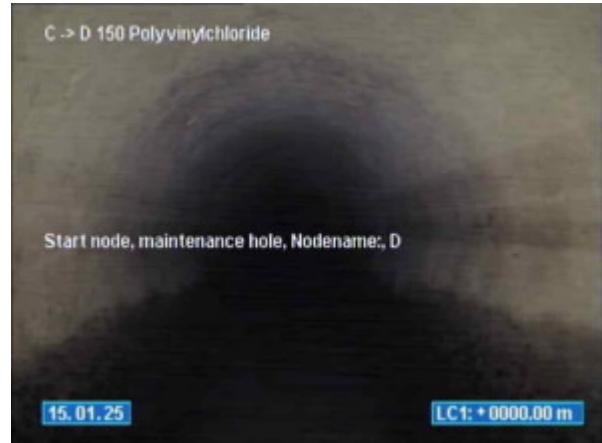
10-12 VIEW POINT ROAD MCCRAE_15.01.2025_114611_C
 TOO D_022.jpg, 00:04:25, 0.00
 Start node, maintenance hole, Nodename:, D

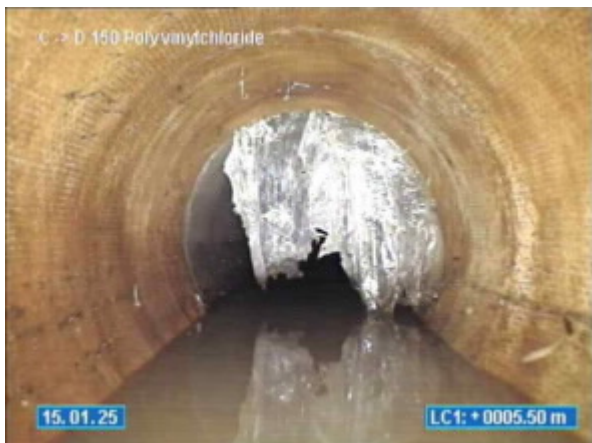
10-12 VIEW POINT ROAD MCCRAE_15.01.2025_114611_C
 TOO D_023.jpg, 00:04:25, 5.50
 Change of conduit material. New material, Fibre reinforced
 cement, at joint

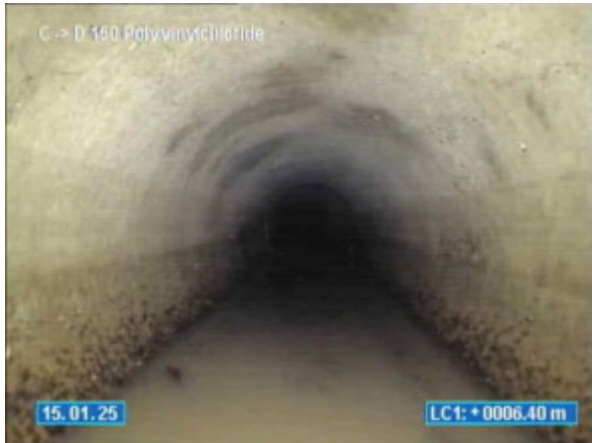
10-12 VIEW POINT ROAD MCCRAE_15.01.2025_114611_C
 TOO D_025.jpg, 00:04:25, 6.40
 Change of conduit material. New material, Concrete segments,
 at joint

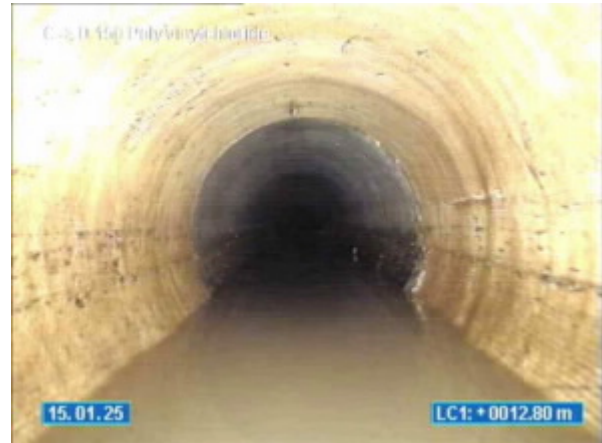
10-12 VIEW POINT ROAD MCCRAE_15.01.2025_114611_C
 TOO D_026.jpg, 00:04:25, 12.80
 Change of conduit material. New material, Fibre reinforced
 plastic

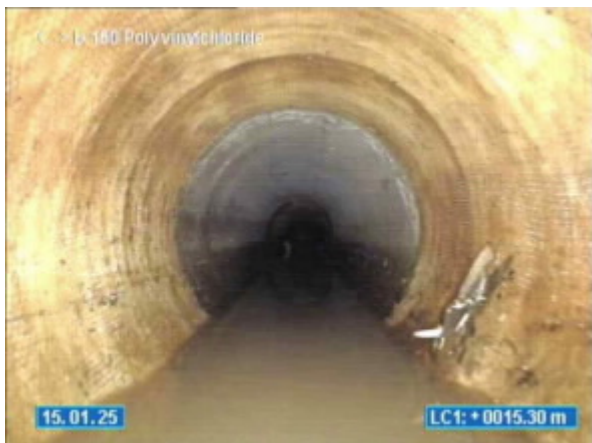
10-12 VIEW POINT ROAD MCCRAE_15.01.2025_114611_C
 TOO D_027.jpg, 00:04:25, 15.30
 Change of conduit material. New material, Fibre reinforced
 plastic, at joint

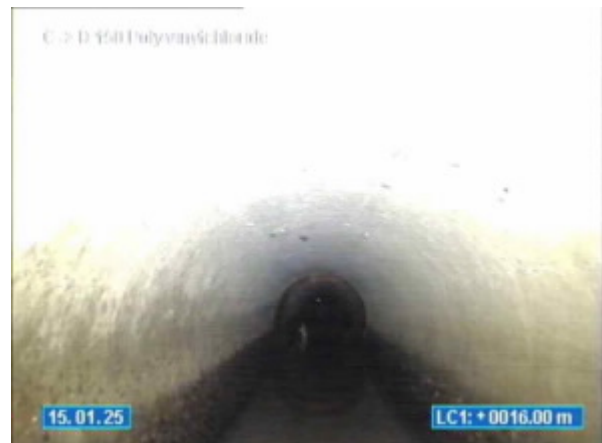
10-12 VIEW POINT ROAD MCCRAE_15.01.2025_114611_C
 TOO D_028.jpg, 00:04:25, 16.00
 Change of conduit material. New material, Concrete segments,
 at joint

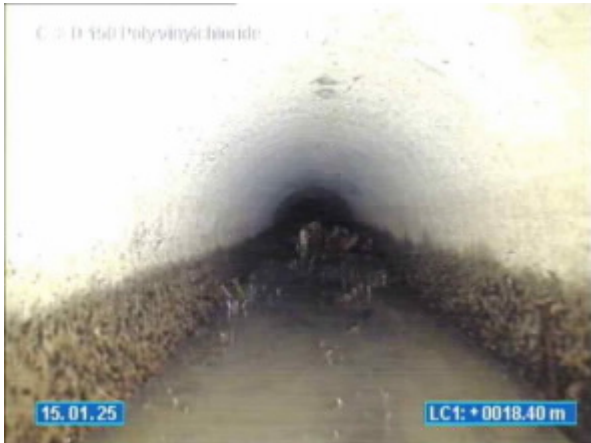
10-12 VIEW POINT ROAD MCCRAE_15.01.2025_114611_C
 TOO D_029.jpg, 00:04:25, 18.40
 Change of conduit material. New material, Fibre reinforced
 plastic, at joint

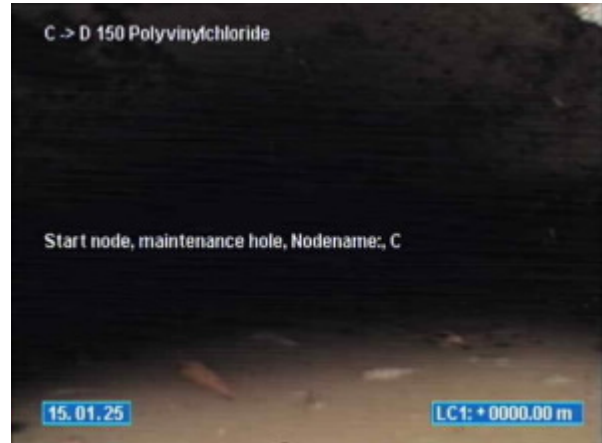
10-12 VIEW POINT ROAD MCCRAE_15.01.2025_104134_C
 TOO D_016.jpg, 00:00:00, 0.00
 Start node, maintenance hole, Nodename:, C

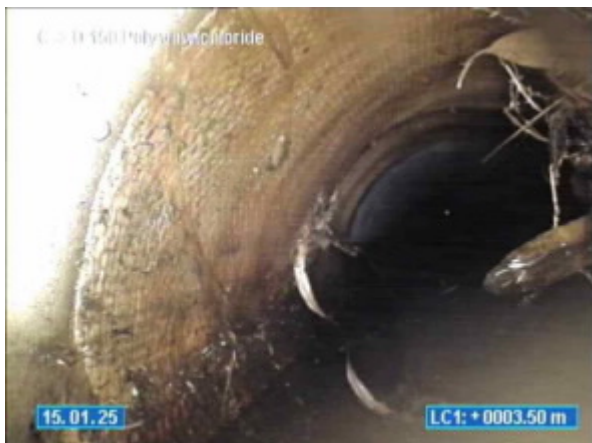
10-12 VIEW POINT ROAD MCCRAE_15.01.2025_104134_C
 TOO D_017.jpg, 00:02:45, 3.50
 Change of conduit material. New material, Fibre reinforced plastic

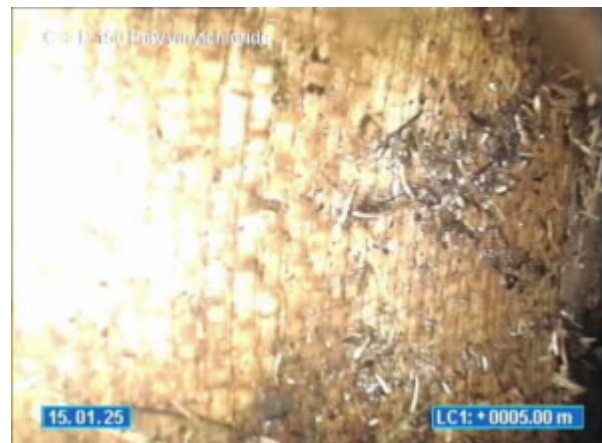
10-12 VIEW POINT ROAD MCCRAE_15.01.2025_104134_C
 TOO D_018.jpg, 00:03:47, 5.00
 Change of conduit material. New material, Fibre reinforced plastic

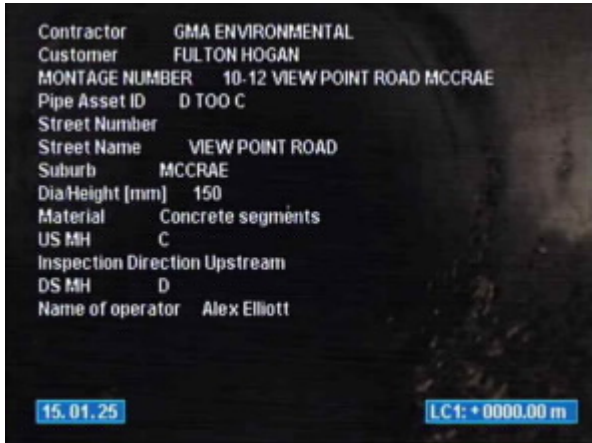
10-12 VIEW POINT ROAD MCCRAE_15.01.2025_132020_D
 TOO C _033.jpg, 00:33:07, 0.00
 Start node, maintenance hole, Nodename:, D / CLEAN LINE
 AND RECCTV

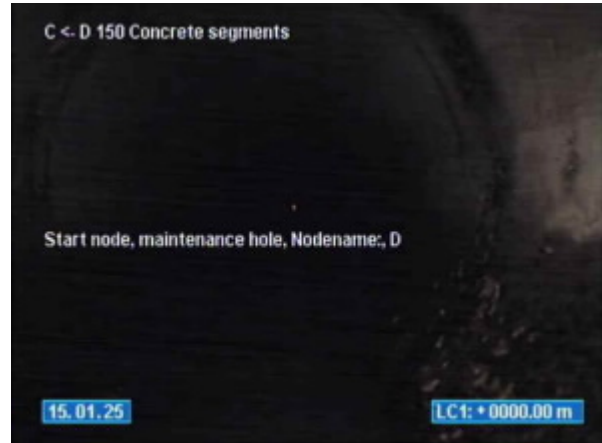
10-12 VIEW POINT ROAD MCCRAE_15.01.2025_132020_D
 TOO C _034.jpg, 00:33:07, 0.00
 Start node, maintenance hole, Nodename:, D / CLEAN LINE
 AND RECCTV

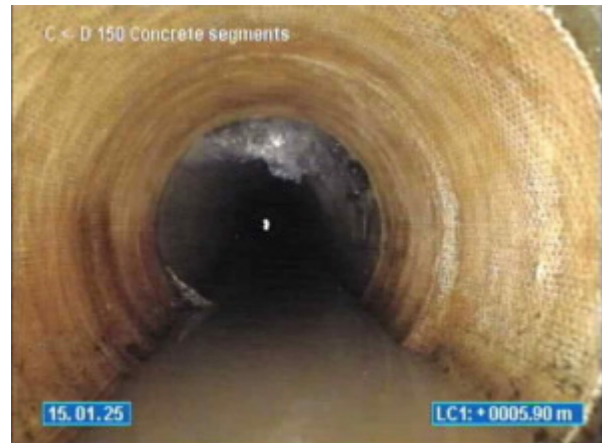
10-12 VIEW POINT ROAD MCCRAE_15.01.2025_132020_D TOO C _038.jpg, 00:33:07, 5.90
 Change of conduit material. New material, Fibre reinforced plastic, at joint

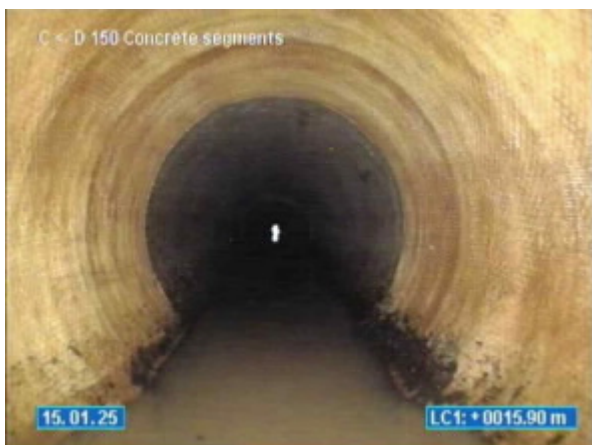
10-12 VIEW POINT ROAD MCCRAE_15.01.2025_132020_D TOO C _039.jpg, 00:33:07, 15.90
 Change of conduit material. New material, Fibre reinforced plastic, at joint

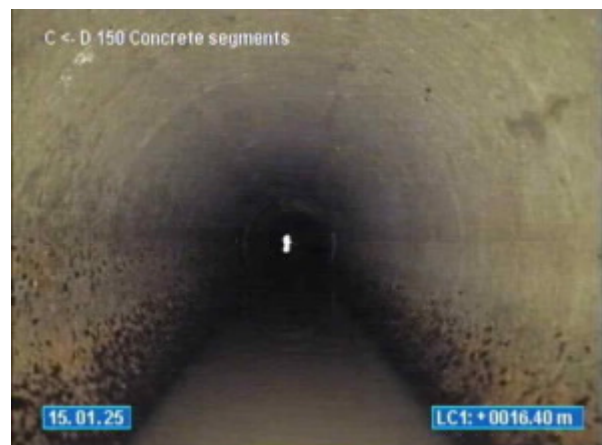
10-12 VIEW POINT ROAD MCCRAE_15.01.2025_132020_D TOO C _040.jpg, 00:33:07, 16.40
 Change of conduit material. New material, Concrete reinforced, at joint

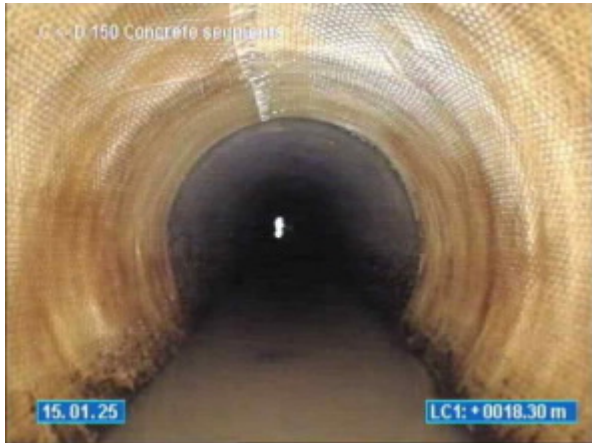
10-12 VIEW POINT ROAD MCCRAE_15.01.2025_132020_D TOO C _041.jpg, 00:33:07, 18.30
 Change of conduit material. New material, Fibre reinforced plastic, at joint

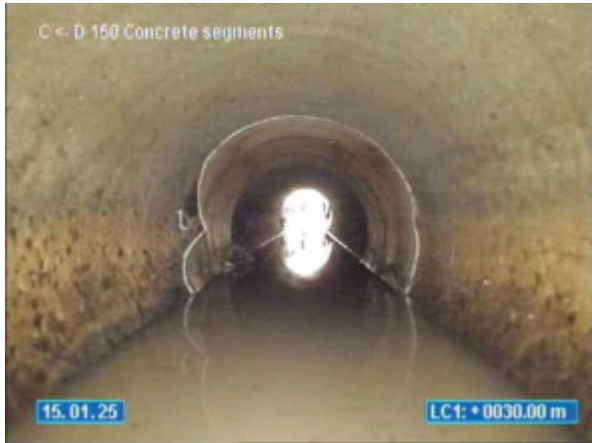
10-12 VIEW POINT ROAD MCCRAE_15.01.2025_132020_D
 TOO C _045.jpg, 00:33:07, 30.00
 Change of conduit material. New material, Concrete
 reinforced, at joint

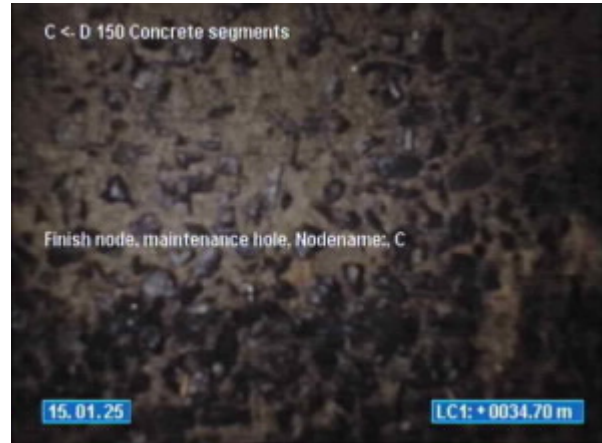
10-12 VIEW POINT ROAD MCCRAE_15.01.2025_132020_D
 TOO C _046.jpg, 00:00:00, 34.70
 Finish node, maintenance hole, Nodename:, C

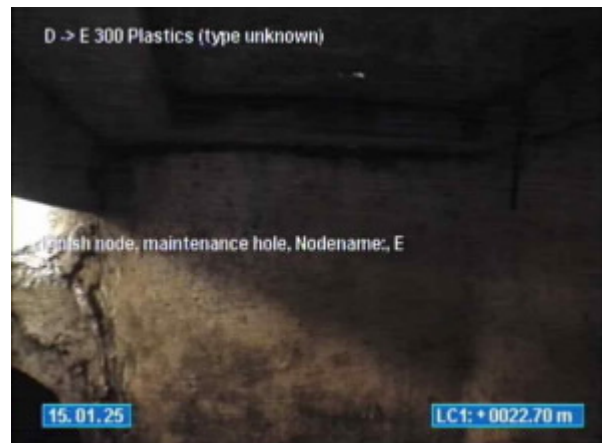
10-12 VIEW POINT ROAD MCCRAE_15.01.2025_135956_D
 TOO E _050.jpg, 00:03:01, 22.70
 Finish node, maintenance hole, Nodename: E

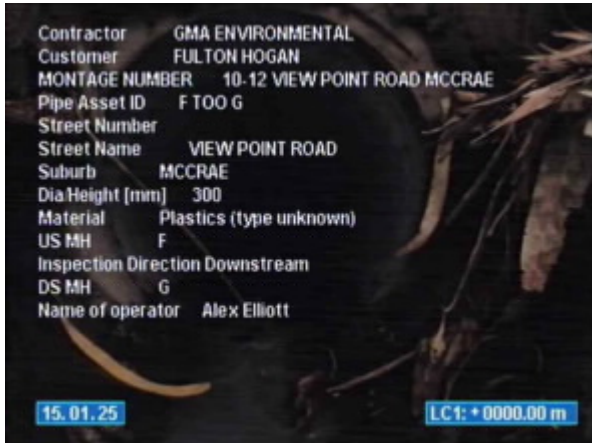
10-12 VIEW POINT ROAD MCCRAE_15.01.2025_142844_F
 TOO G _054.jpg, 00:00:00, 0.00
 Finish node, maintenance hole, Nodename:, G
