Our Ref: PSM5226-002L Rev1

RE: RISK ASSESSMENT. 10-12 VIEW POINT ROAD, MCRAE

PSM were commissioned by Harwood Andrews (**HA**) on behalf of Mornington Peninsula Shire (**MPS**) to carry out a Landslide Risk Assessment (**LRA**) at 10-12 View Point Road, McRae (the "**Site**") in accordance with the Australian Geomechanics Society (**AGS**) Guidelines on Landslide Risk Assessment (AGS, 2007). The scope of the LRA is restricted to the following:

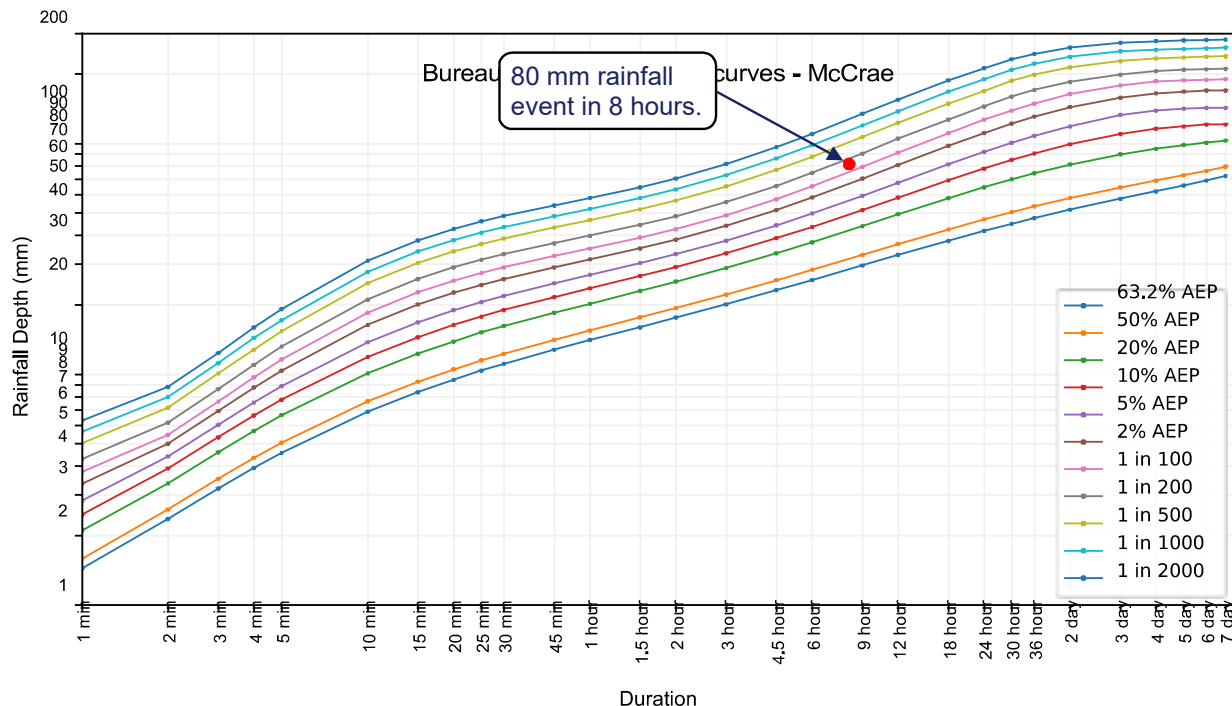
Inset 3: BOM IFD curves for McCrae, with Rain Event marked

- The Rain Event intensity over the 8-hour period had 1 in 100 years to 1 in 200 years probability of occurring
- 80 mm of rainfall in a 24-hour period has a 1 in 20 probability of occurring in any given year
- The Rain Event was an infrequent and intense event.

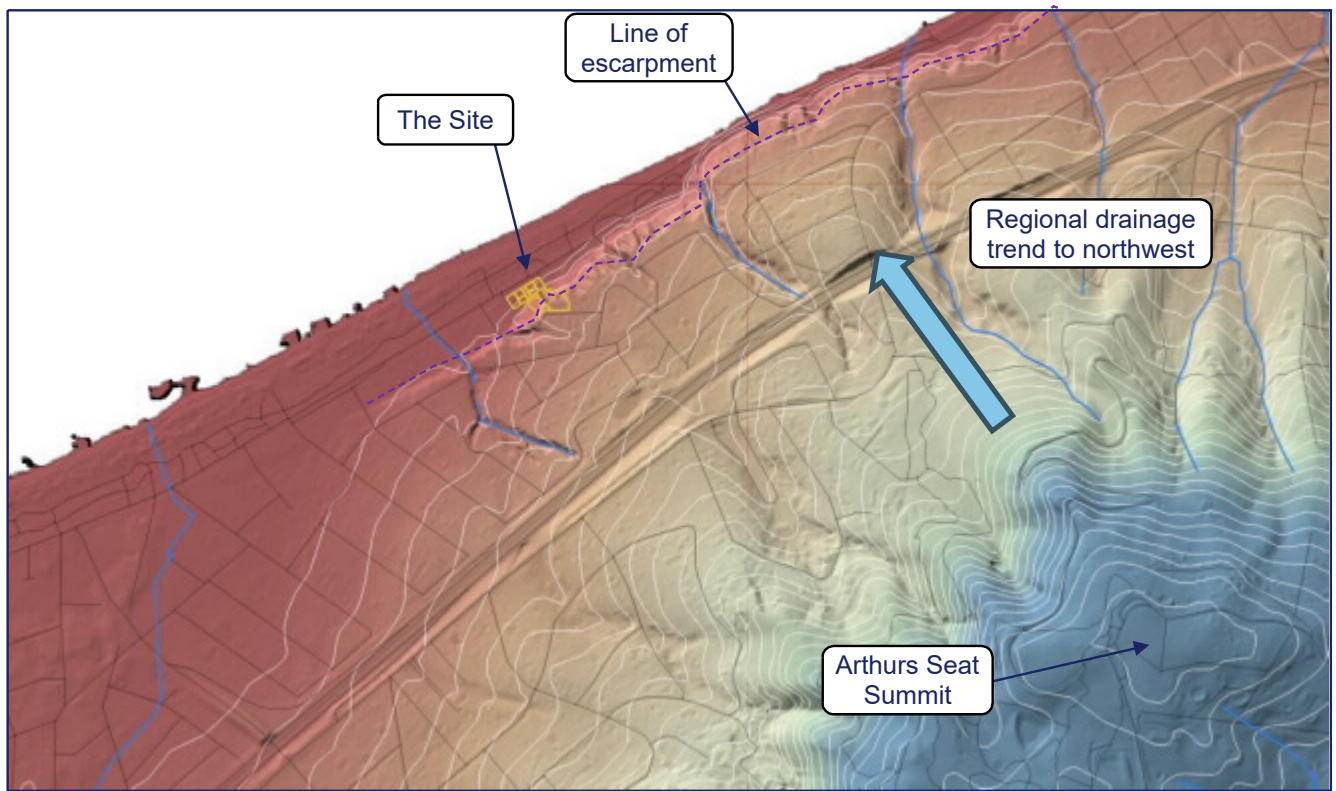
Inset 4: Topography and drainage paths of Arthurs Seat

- A new stormwater drainage system has been constructed in View Point Rd. A constant flow of water was observed to be running in this drainage system.
- The Site is located on the lower slopes of Arthurs Seat where those slopes meet Port Phillip Bay and have formed an escarpment, Photo 14 & 15 Appendix B. In proximity to the Site the general topography of the areas slopes to the northwest. There is extensive residential development above the Site on the lower slopes of Arthurs Seat.

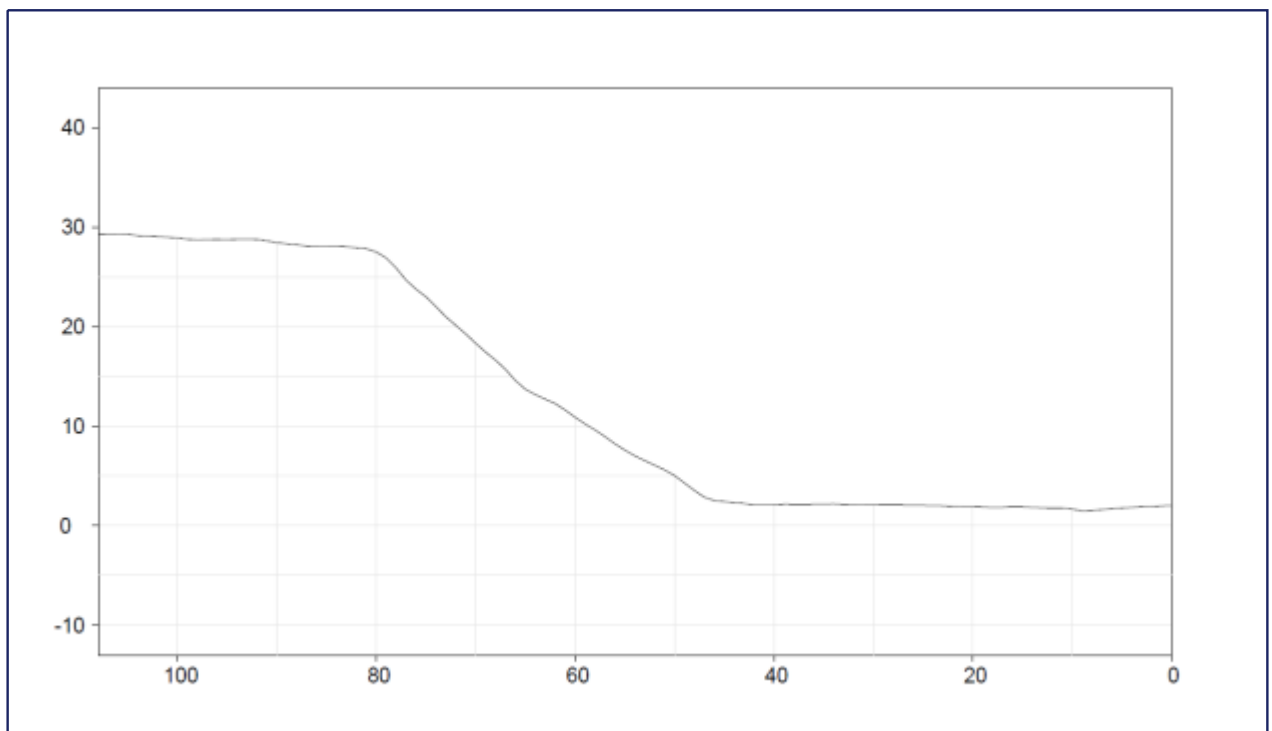
Inset 5: Prefailure slope geometry through the centre of the Landslide from Coastal LiDAR 1 DEM.

- (a) The strike of the escarpment line changes from 030° to 100°. This creates a local convex geometry or "bullnose" slope (in plan) at the location of the Landslide.
- (b) 25 to 30 metres of relief between the toe and crest of the escarpment.
- (c) A typical overall slope angle of 30 to 35°.
- (d) A concave (in section) slope profile with the upper half of the escarpment being steeper (typically 35 to 40°) than the lower half of the escarpment (typically 25 to 30°).

- (e) Pre-failure slope geometry of the Landslide is shown in Inset 5.
- (f) A lack of large-scale features other than gullies, that may indicate the presence of a large, full height slope failure mechanism.

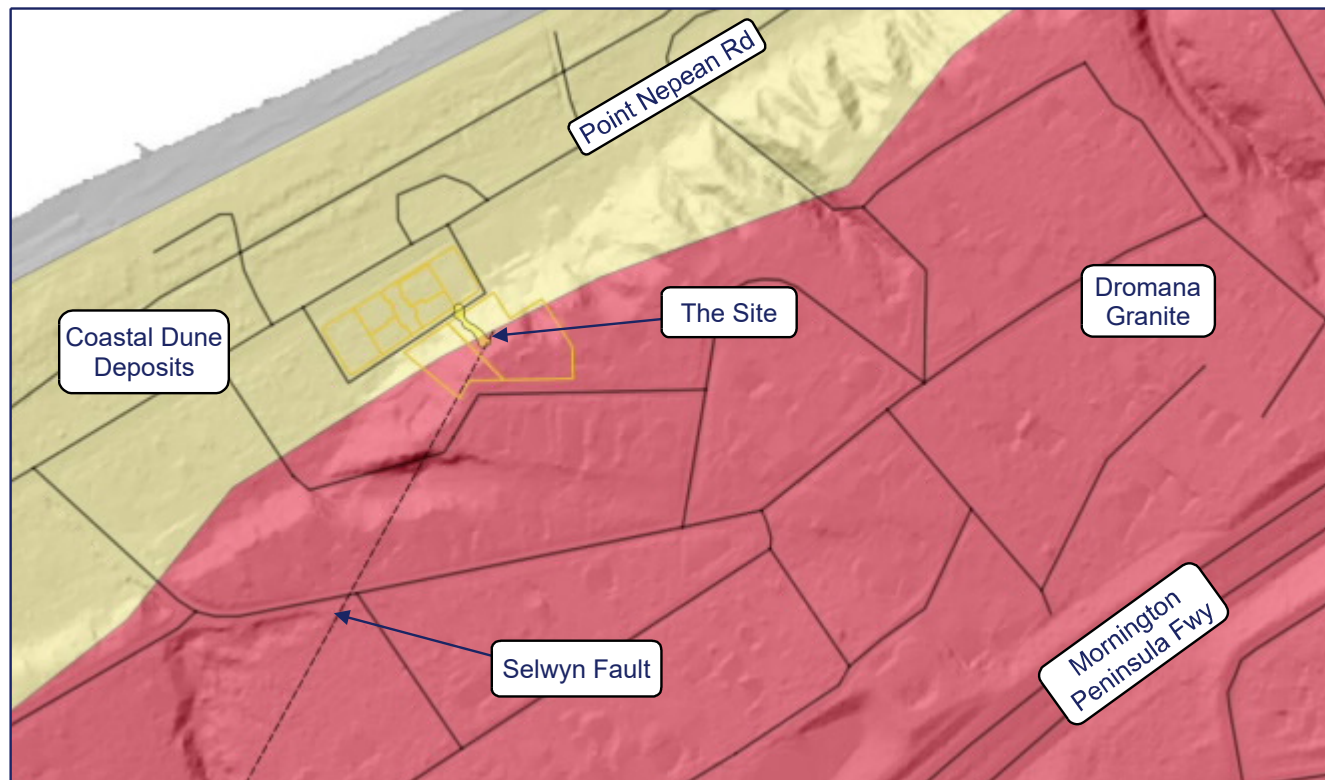
Inset 6: Earth Resources seamless geology map of the area, with Selwyn Fault highlighted.

The Victoria Seamless Geology ([Earth Resources publications \(efirst.com.au\)](http://EarthResourcespublications.efirst.com.au) , (2014)) model indicates that the Site is close to the boundary of Quaternary aged dune deposits (with siliceous and calcareous sands) and Devonian aged Dromana granite. The Earth Resources mapping portal ([GeoVic Anonymous \(gsv.vic.gov.au\)](http://GeoVicAnonymous(gsv.vic.gov.au)), accessed 1 November 2023) indicates that the inferred location of the Selwyn Fault traverses the Site, Inset 6.

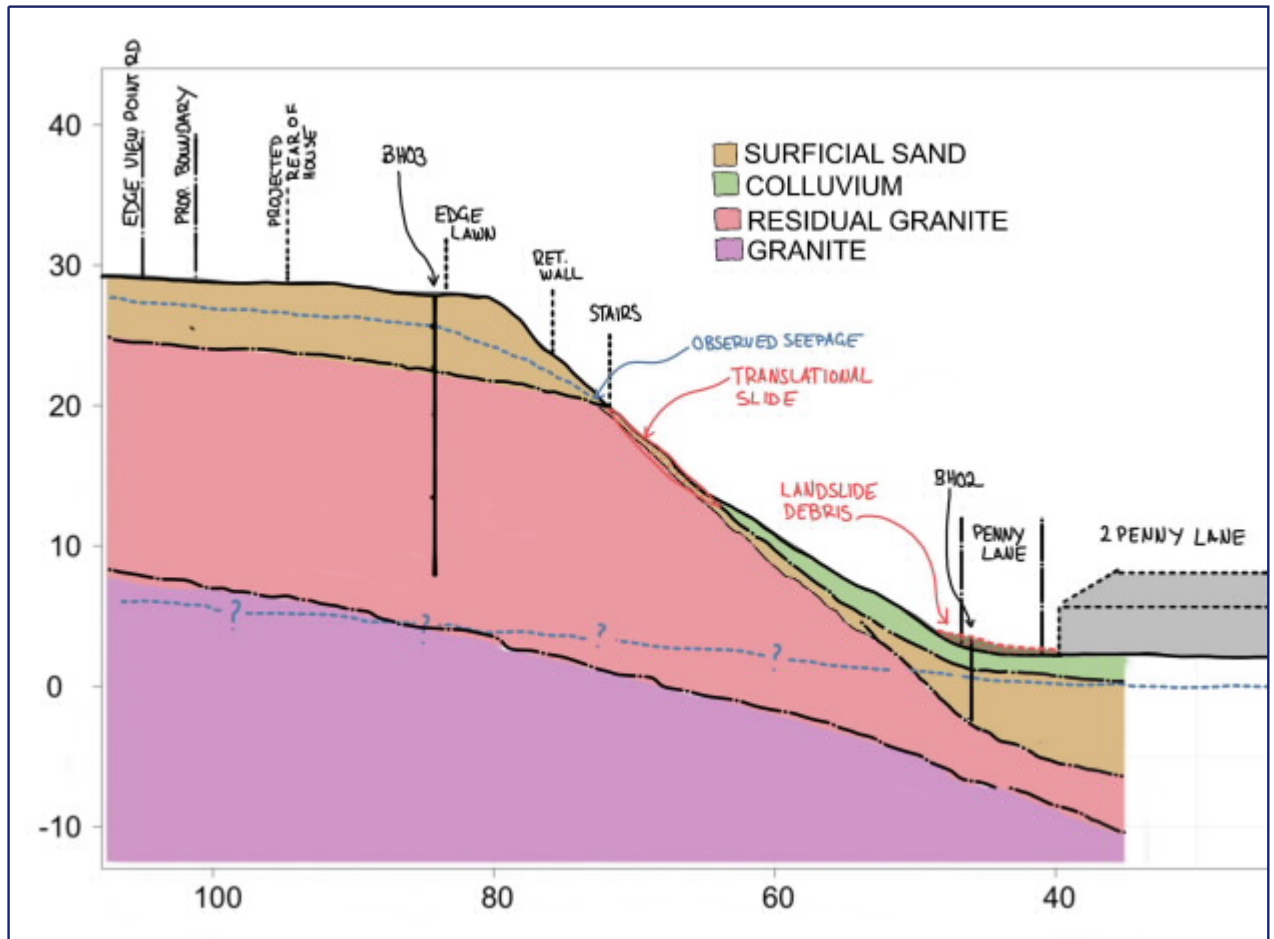
Inset 7: PSM geological model

Our interpretation of the geological conditions is presented in Inset 7. With regards to the geological model PSM notes the following key observations:

- There is uncertainty regarding the contact between the SURFICIAL SAND and the RESIDUAL GRANITE owing to the likelihood of some of the parent material of the SURFICIAL SAND being derived from erosion of the Dromana Granite. PSM has assumed that the wet soils are an indicator of the contact between the two geotechnical units.
- The laboratory testing indicates that all samples between 3 m and 19 m bgl have very similar Particle Size Distributions, Inset 8, and Atterberg limits indicate low plasticity CLAY fines.

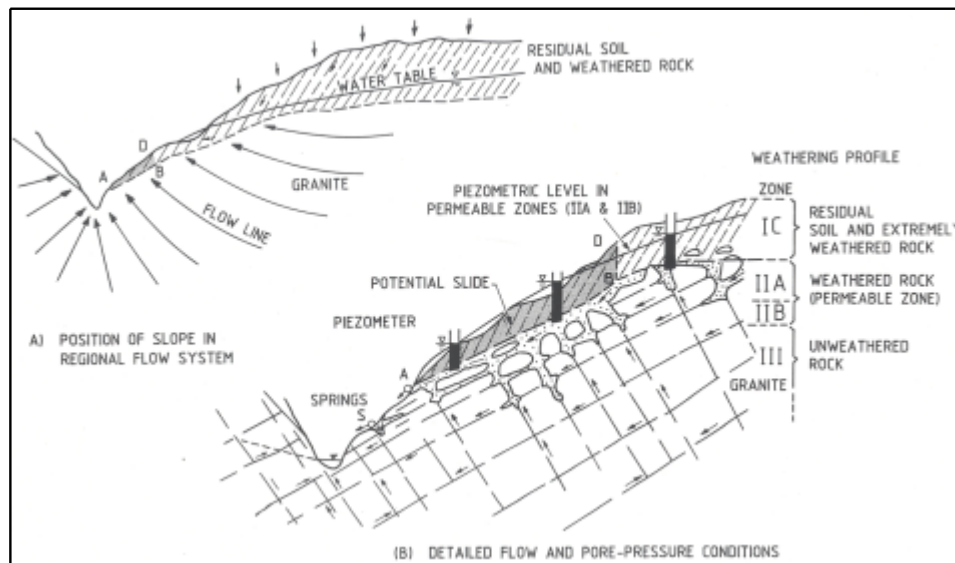
Inset 9: Possible piezometric conditions in weathered granitic soils (Fell et al, 2004)².

- The observation by CivilTest of wet soils encountered in borehole 3 between 1.8 m and 5.2 m bgl in March 2023. I note that this was not during or following a period of high rainfall, Section 2.4.1.
- Furthermore, the CivilTest observation is consistent with published groundwater models in weathered granitic profiles, Inset 9.
- Observations of seepage during the Site visit (refer to Section 3).

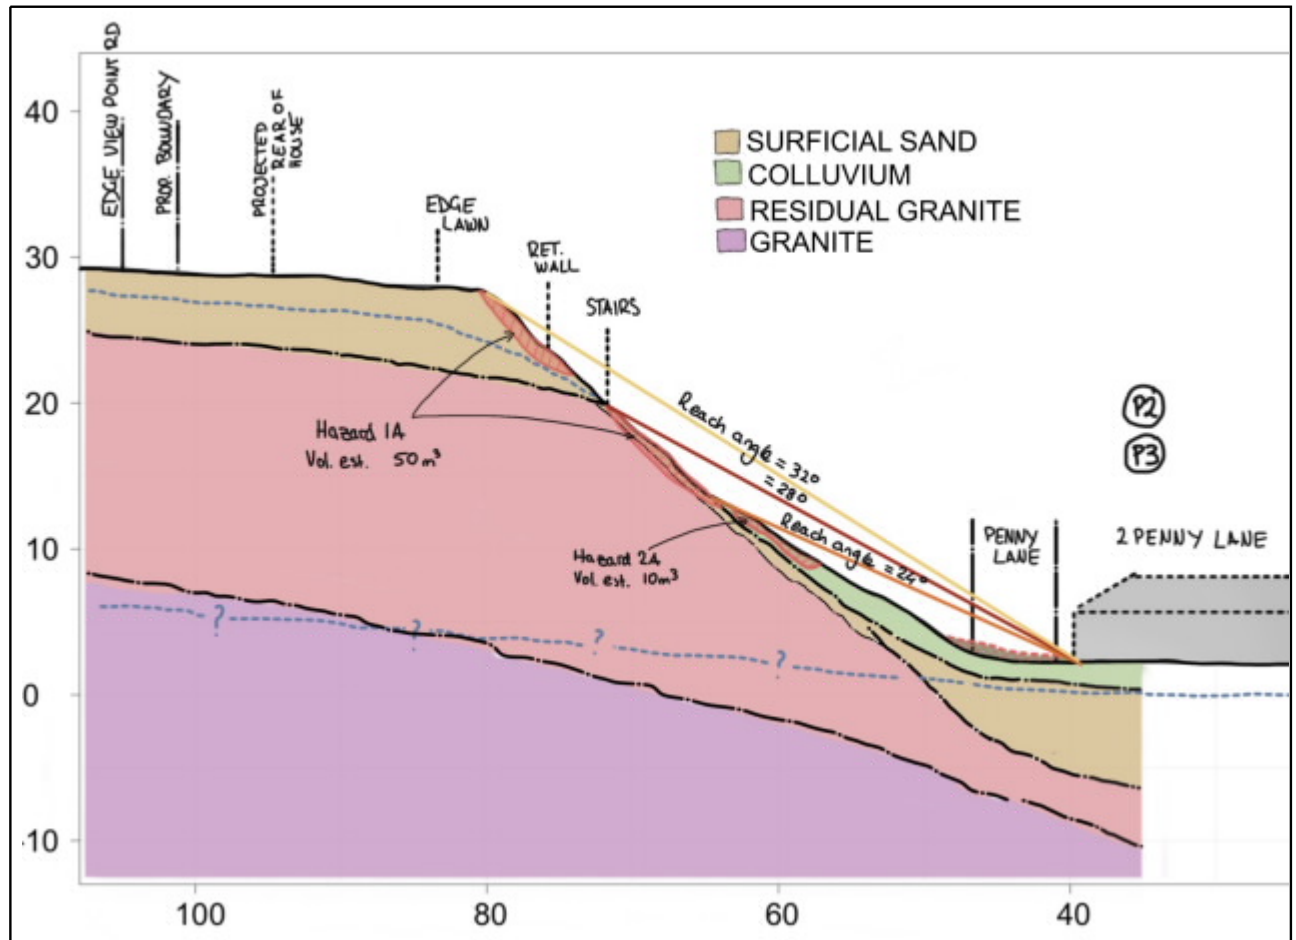
Inset 10: Landslide hazards

- Spatial risks are high (1) when on or below the landslide hazards.

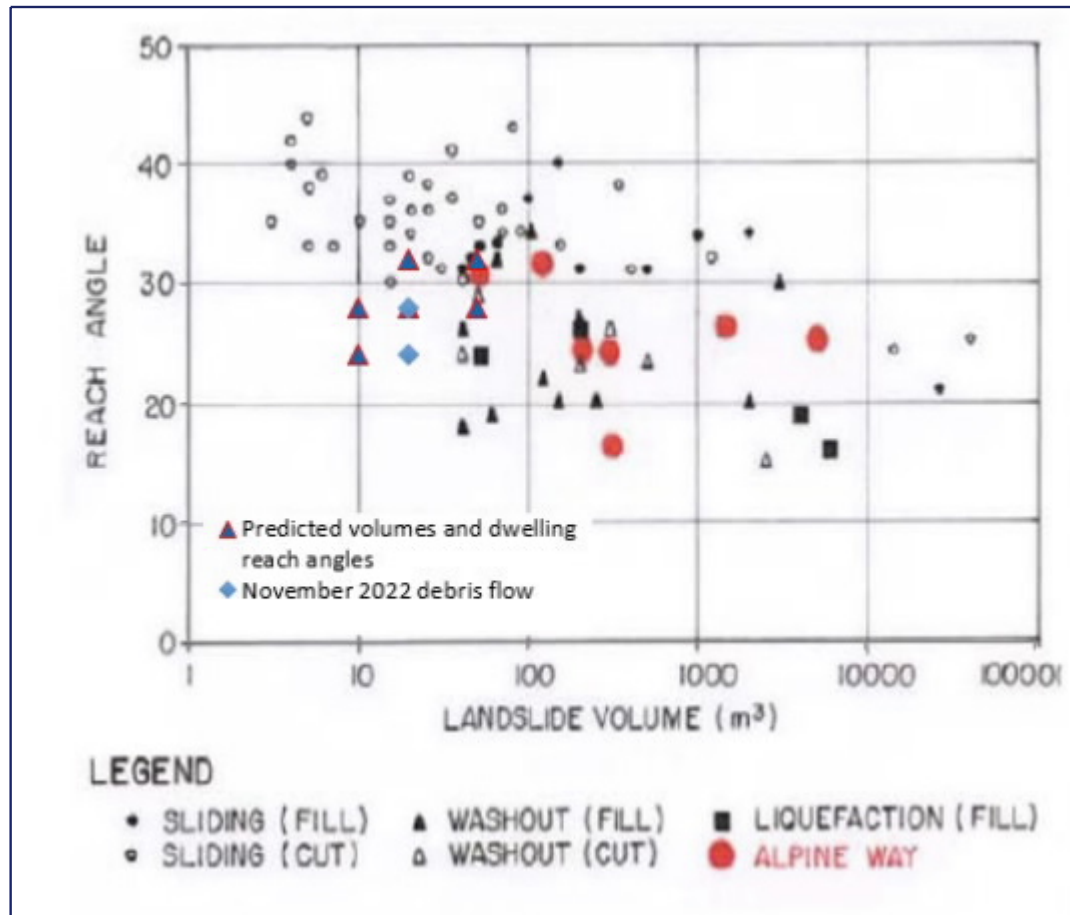
Inset 11: Predicted volumes and measured reach angles to P2 and P3, plotted on Mostyn and Sullivan (2002) landslide data

- For debris flow Hazard 1B, based on the comparison to published data sets and the measured debris flow the adopted $P_{(S:H)}$ is 0.43.
- For debris flow Hazard 2B the previous landslide has created a preferential flow path making impact more likely. The $P_{(S:H)}$ for this scenario is taken as 1.

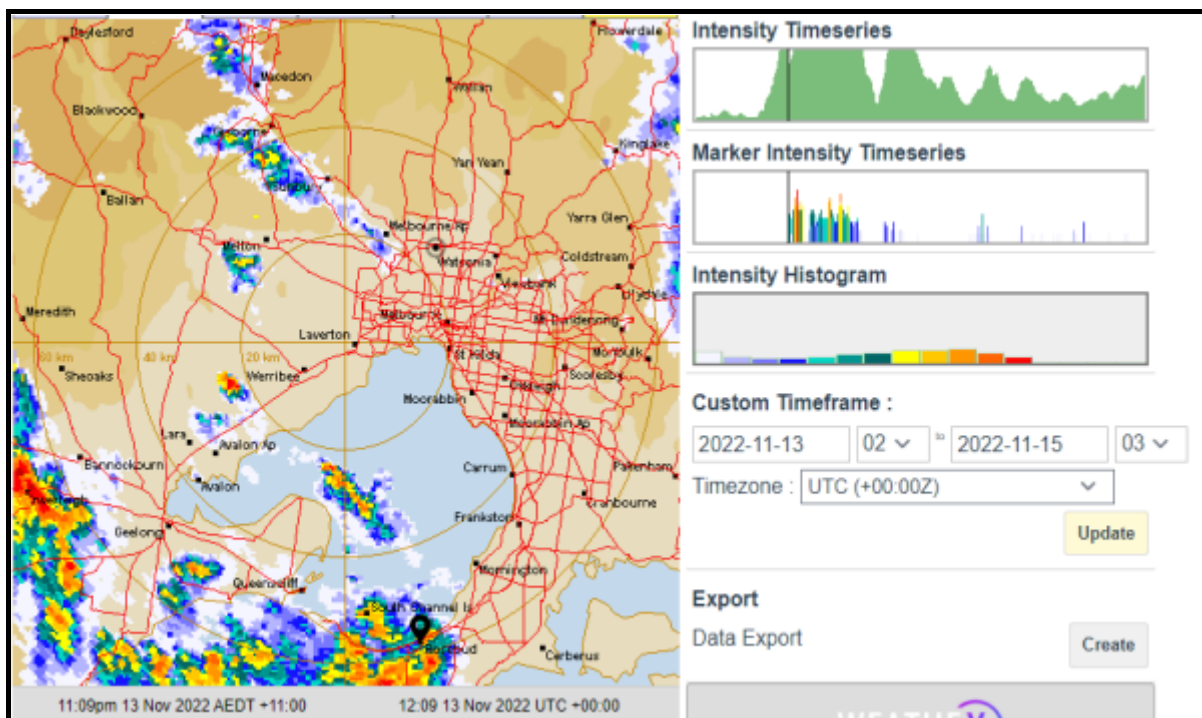
Figure A7: Radar plot 11:09 pm on 13/11/2022

- The majority of moderate to heavy rainfall was observed between 11pm on 13/11/2023 and 7am on 14/11/2023, Figures A7 to A8 of Appendix A
- Some showers were recorded for the remainder of the 14/11/2023, Figure A9 of Appendix A.

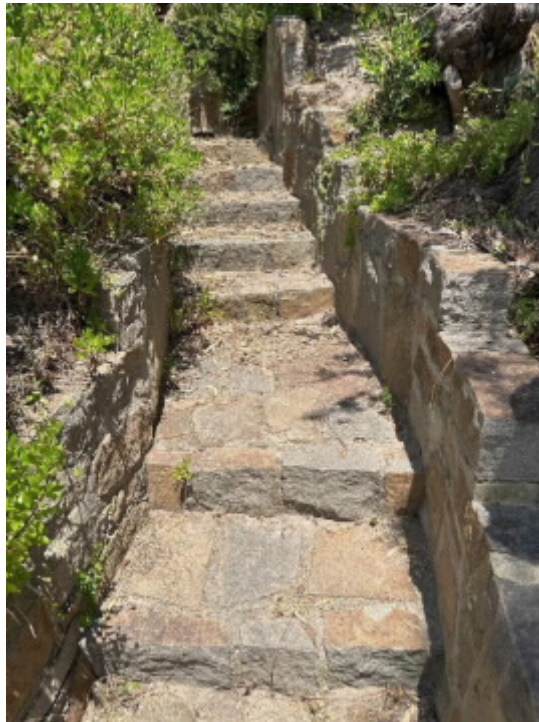
- A series of paths had been constructed across the slope to provide access from the top to the bottom of the escarpment, Photo 8 & 9 Appendix B. The paths are constructed from varying materials. Other infrastructure associated with the paths include minor RWs, board walks and stairs.

Photo 9 - Granite stairs leading from garden area to path at top of landslide

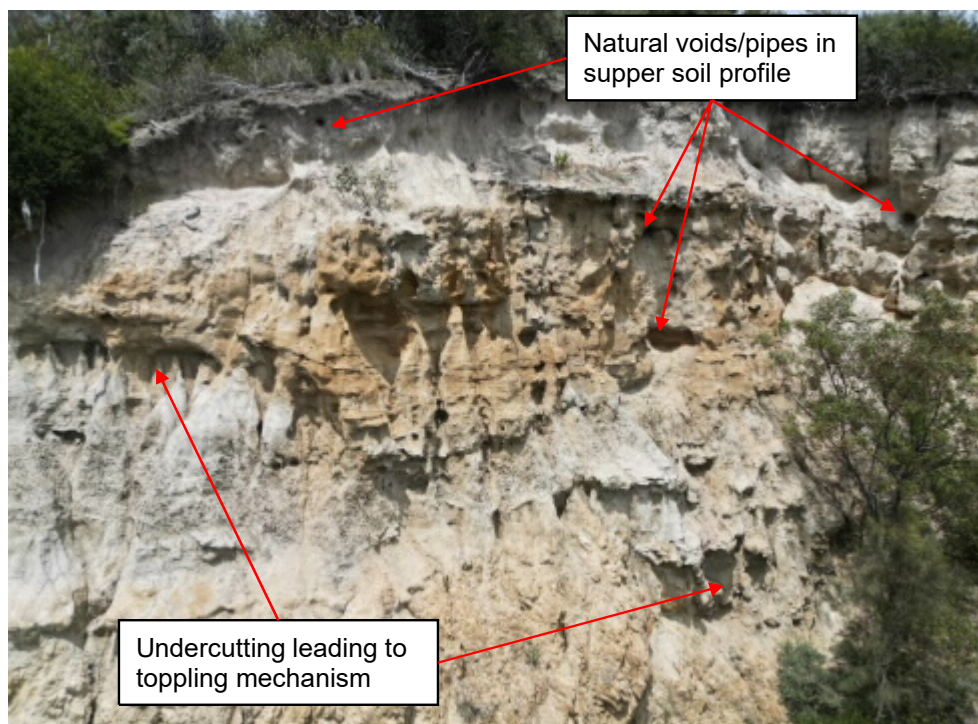
- Natural voids and internal erosion (i.e., piping) is common in the upper soil profile, Photo 13 Appendix B.
 - A sub vertical cliff profile in extremely weathered and highly weathered granite, Photo 14 Appendix B. PSM note the sub-vertical profile may be the result of road construction activities in the 1920's and 1930's.

Photo 13 - Natural cliff profile near Anthony's Nose

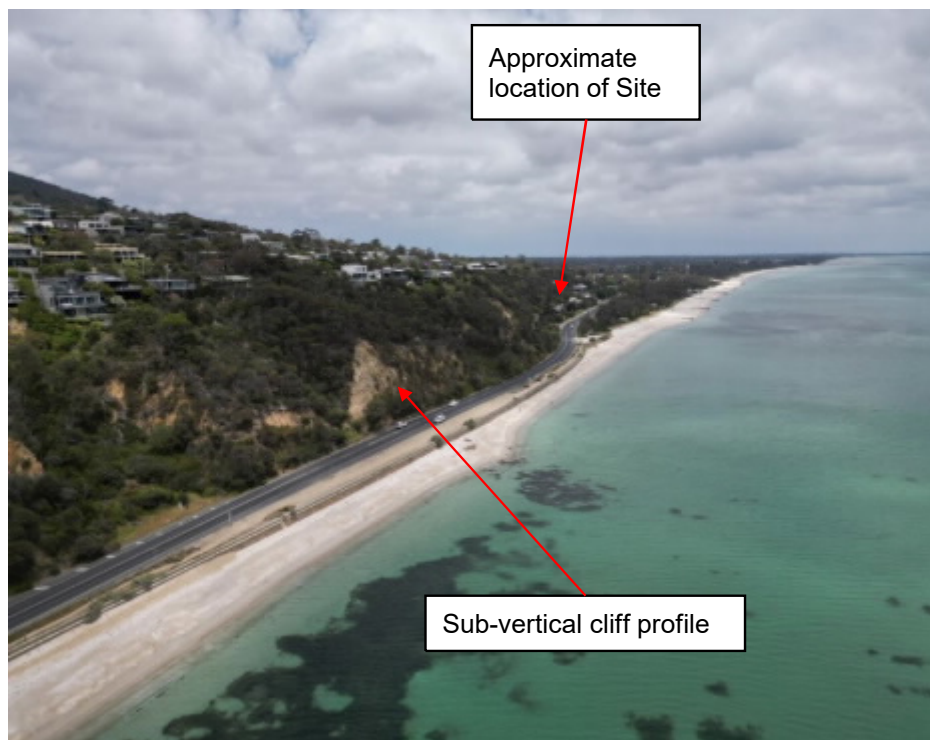
Photo 14 - Anthony's Nose
