# Expert Opinion Report - Landslide Assessment

10-12 View Point Road, McCrae

PSM5226-006R Rev0      11 June 2024

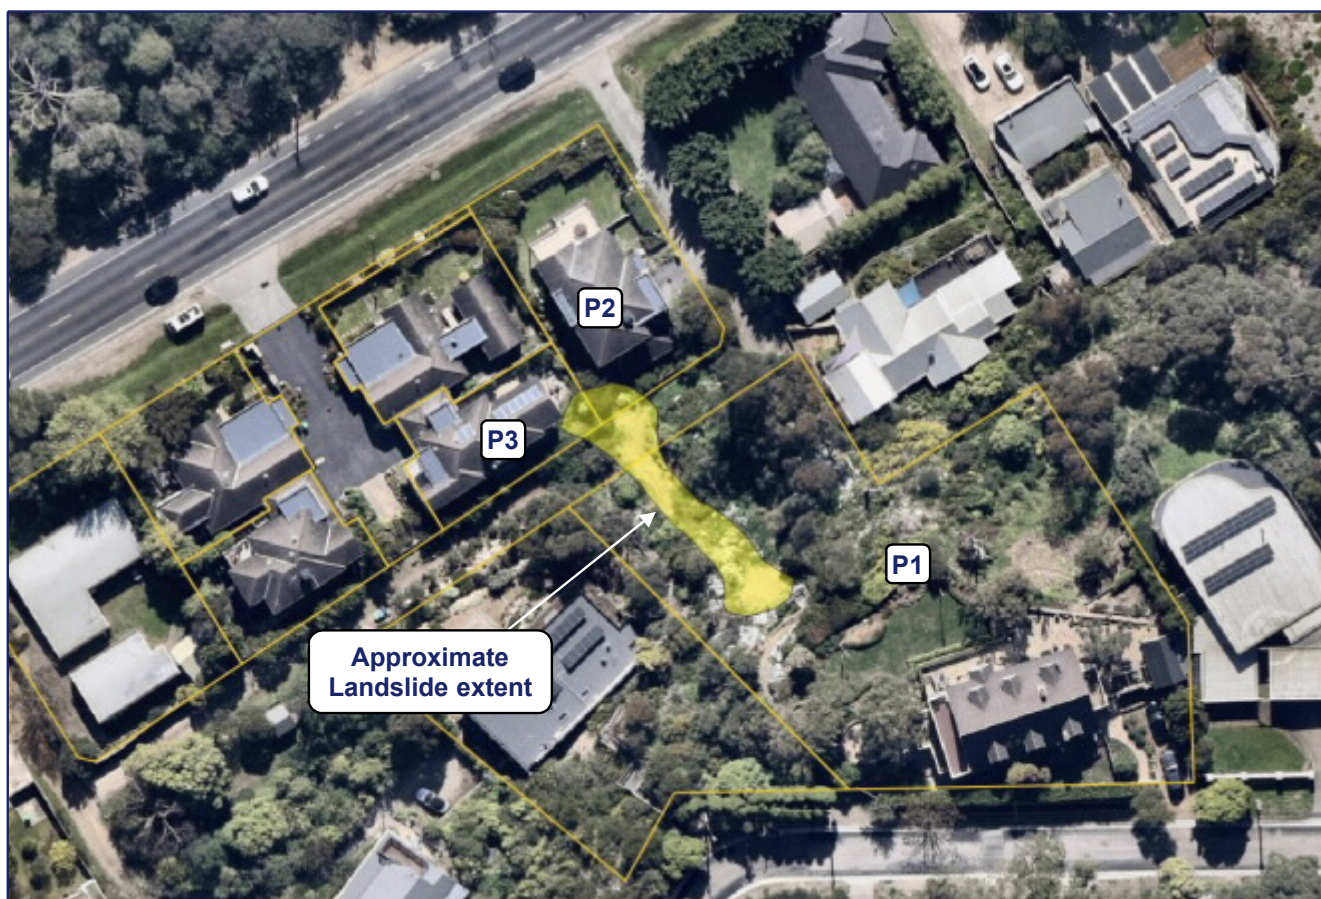
**Inset 1: Plan of properties affected by the Landslide (Aerial Image from Nearmap dated 25 August 2023).**

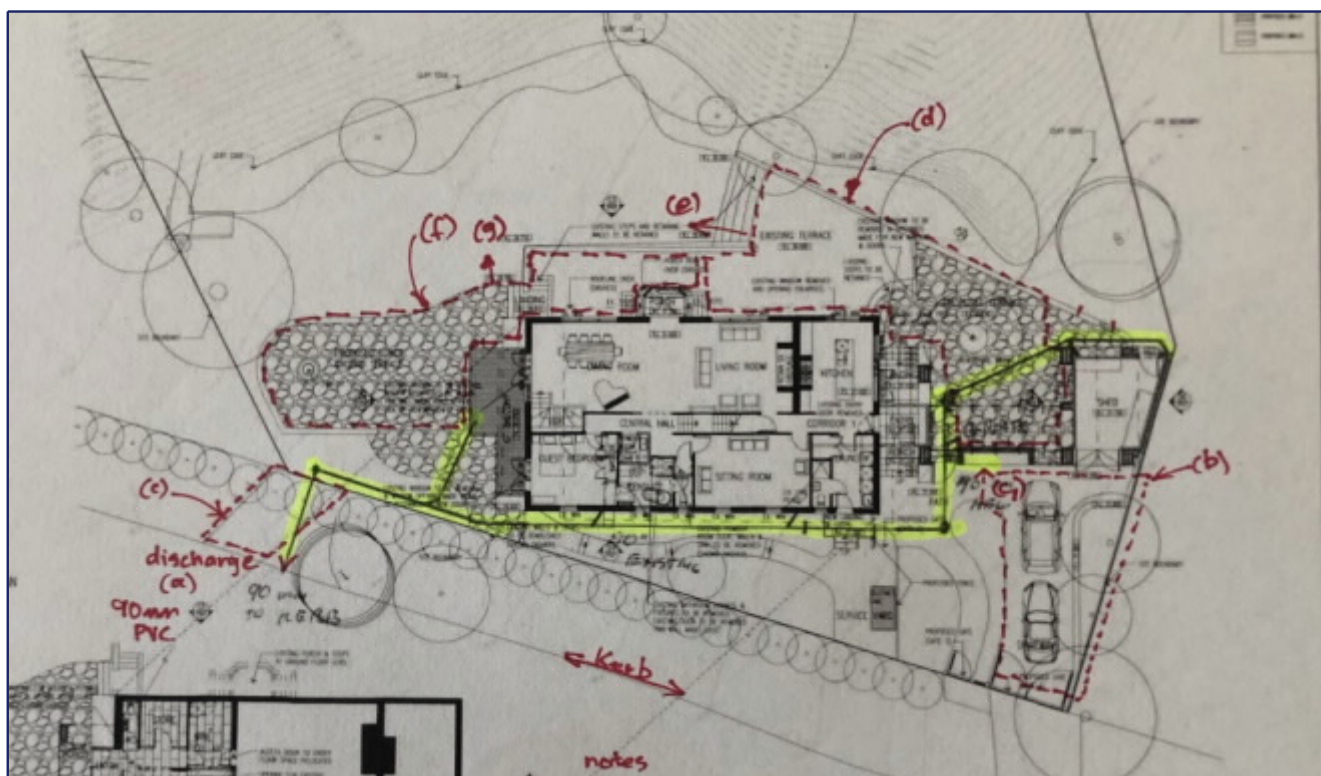
22. I have assumed that the P1 stormwater system drawing is an as constructed representation.
23. Document 6 of the Brief includes a letter from Ian Chudleigh Plumbers detailing the results of a pressure test that was performed on the water lines within P1 (pdf page 96 of the Brief). It indicates to me that:

- (a) There are no leaks within the tested water lines.
  - (b) An automatic irrigation system is present on Site.

**Inset 9: Plan of P1 stormwater system (pdf page 95 of the Brief).**

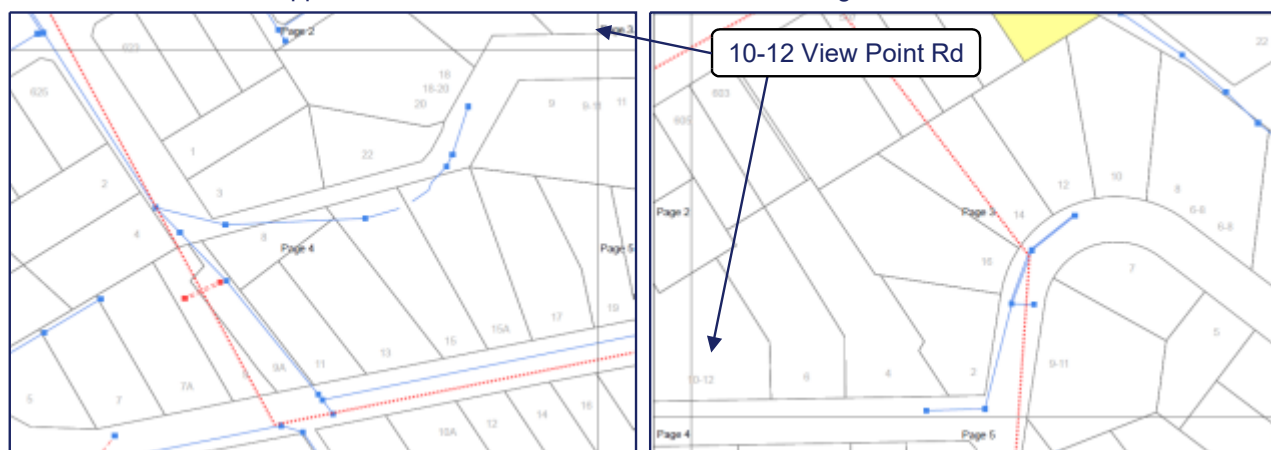
- (b) APA gas line is present in nature strip on the north side of View Point Rd, it is located approximately 3.0 m from the property boundary line.
36. I understand that the stormwater system was reconstructed in mid-2023 and it now includes stormwater pits and pipes for the whole length of View Point Road, refer paragraph [24(b)].

**Inset 11: MPSC drainage network. Drainage pits are shown as blue squares, and drainage pipes as blue lines (([www.byda.com.au](http://www.byda.com.au)) on 16 November 2023).**

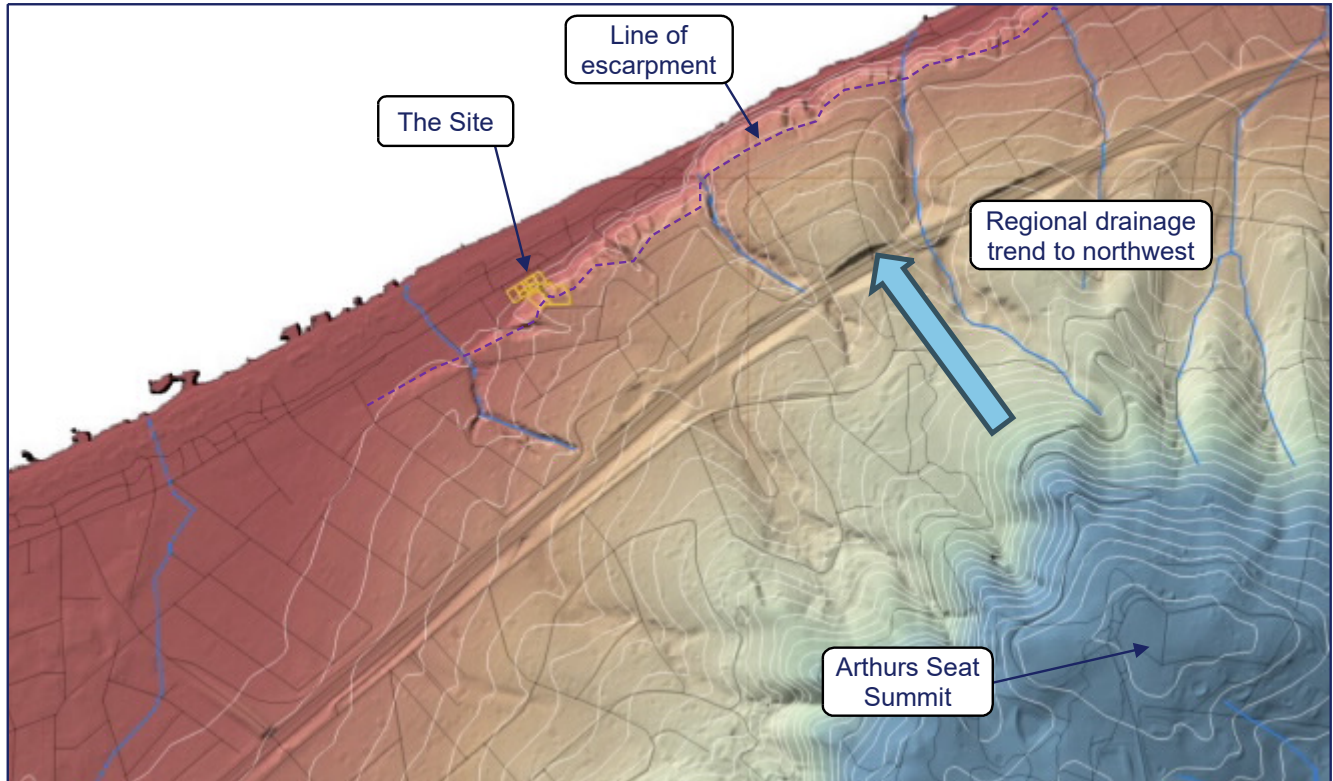
48. The Coastal LiDAR indicates that the Site is located at the lower escarpment of Arthurs Seat, Inset 12. There is approximately 270 metres of relief measured in a northwest direction from the summit of Arthurs Seat to the escarpment at the Site. I note that drainage paths typically strike in a north to northwest direction and that the Mornington Peninsula Freeway provides significant disruption to surface and sub-surface water flows in the region.

**Inset 12: Topography and drainage paths of Arthurs Seat.**

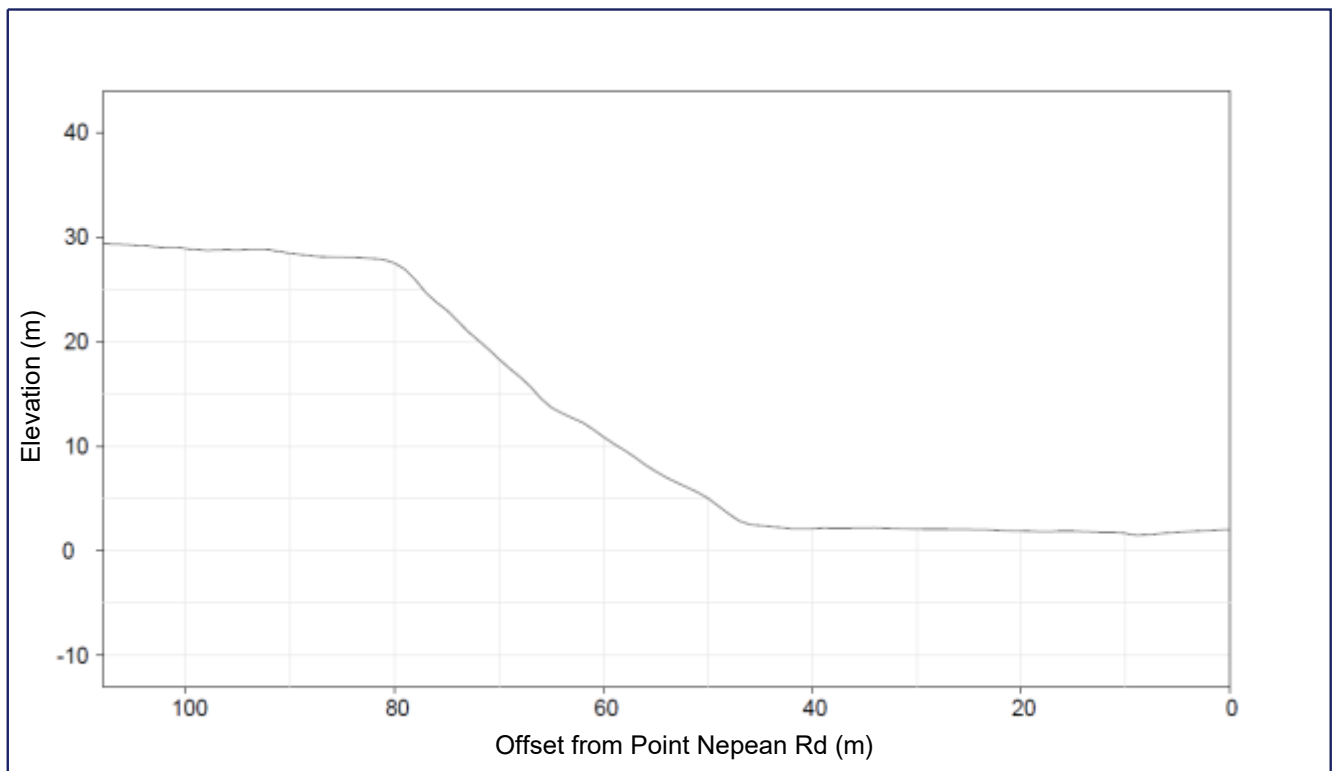
- Pre-failure slope geometry of the Landslide is shown in Inset 13.
  - A lack of large-scale features other than gullies, that may indicate the presence of a large, full height slope failure mechanism.

**Inset 13: Prefailure slope geometry through the centre of the Landslide from Coastal LiDAR 1 DEM.**

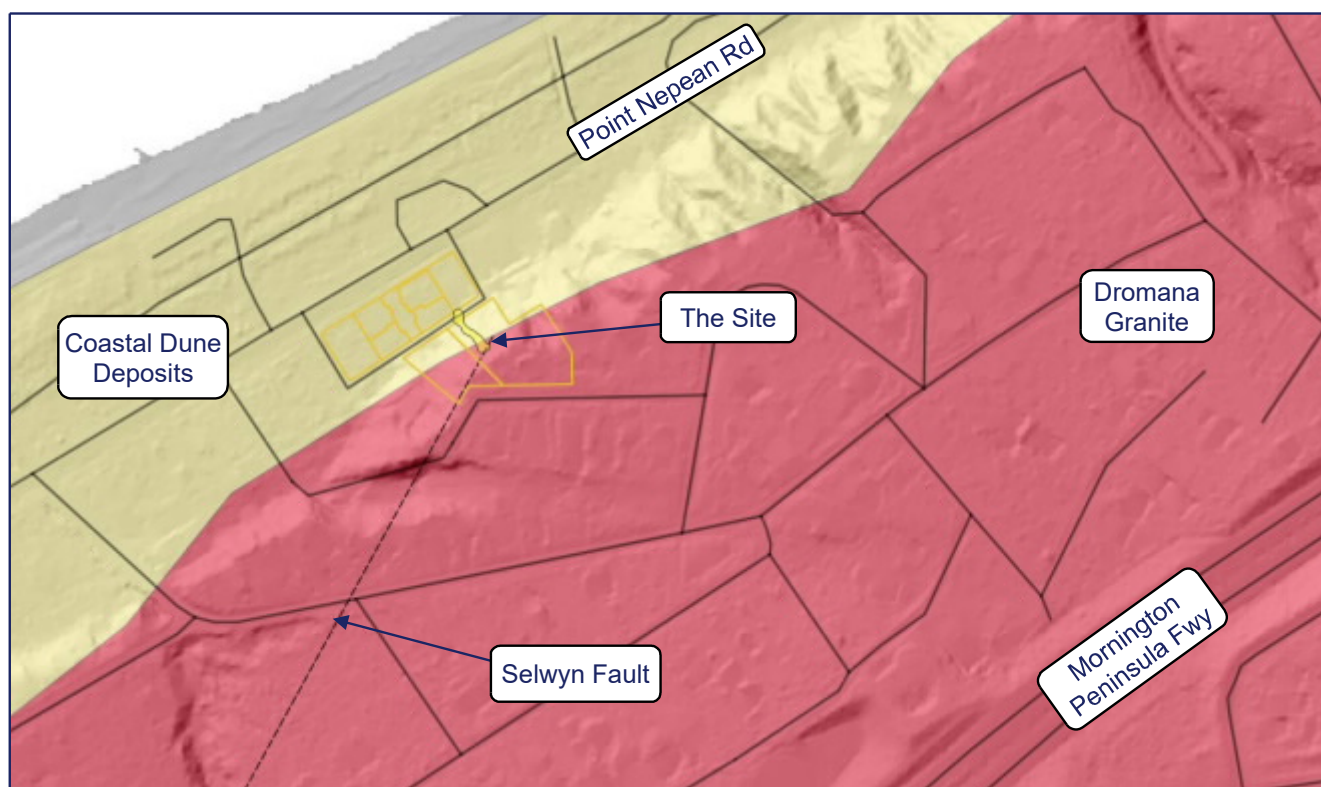
51. The Victoria Seamless Geology (Earth Resources publications (efirst.com.au), (2014)) model indicates that the Site is close to the boundary of Quaternary aged coastal dune deposits (with siliceous and calcareous sands) and Devonian aged Dromana granite. The Earth Resources mapping portal (GeoVic Anonymous (gsv.vic.gov.au), accessed 1 November 2023) indicates that the inferred location of the Selwyn Fault traverses the Site, Inset 14.

**Inset 14: Earth resources seamless geology map of the area, with Selwyn Fault highlighted.**

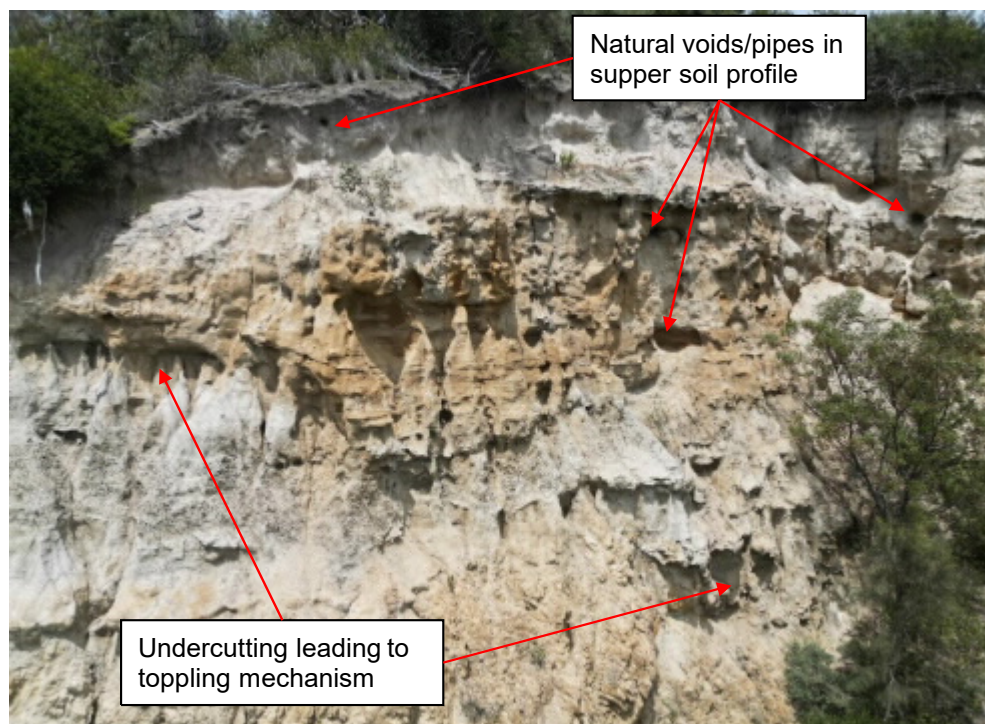
- i. Natural voids and internal erosion (i.e., piping) is common in upper soil profile, Photo 13 Appendix E.
    - ii. A sub vertical cliff profile in extremely weathered and highly weathered granite, Photo 14 Appendix E. I note this sub-vertical may be the result of road construction activities in the 1920's and 1930's.

Photo 13 - Natural cliff profile near Anthony's Nose
