Our Ref: PSM5226-002L

**RE: RISK ASSESSMENT. 10-12 VIEW POINT ROAD, MCRAE**

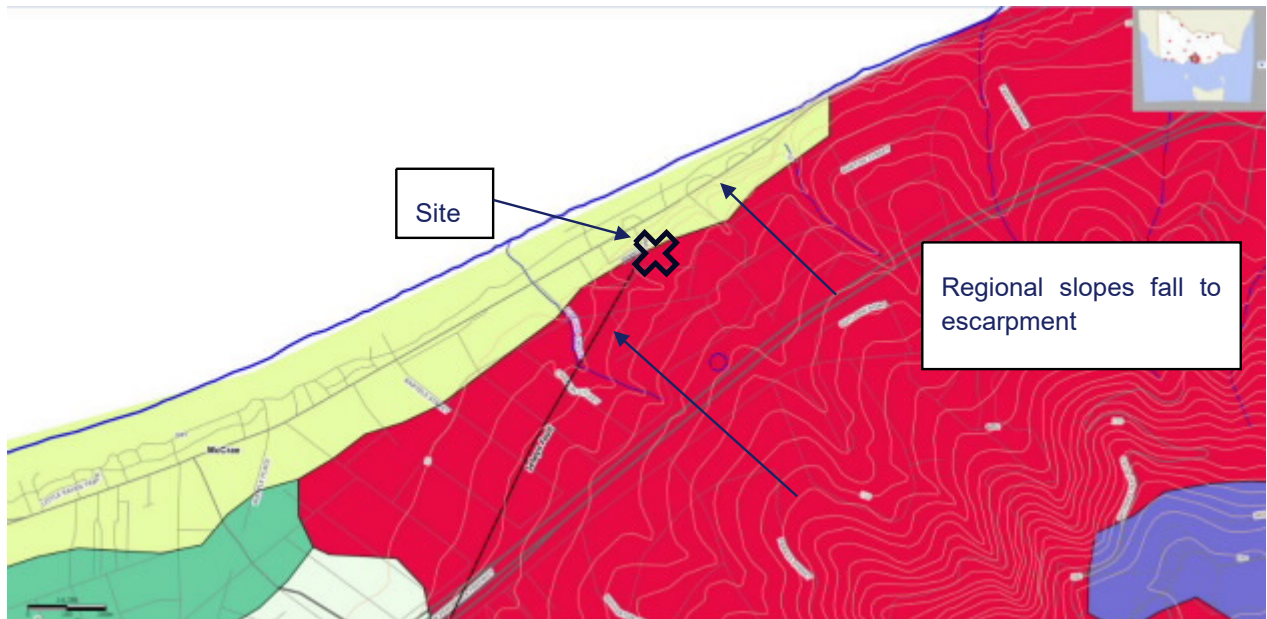
**Inset 6: Topography and drainage paths of Arthurs Seat**

The Site is located at the lower escarpment of Arthurs Seat, Inset 6 ([GeoVic Anonymous \(qsv.vic.gov.au\)](https://qsv.vic.gov.au/), accessed 1 November 2023) with approximately 270 of metres of relief measured in a south west direction from the summit of Arthurs Seat. Several drainage paths strike in a north to northwest direction.

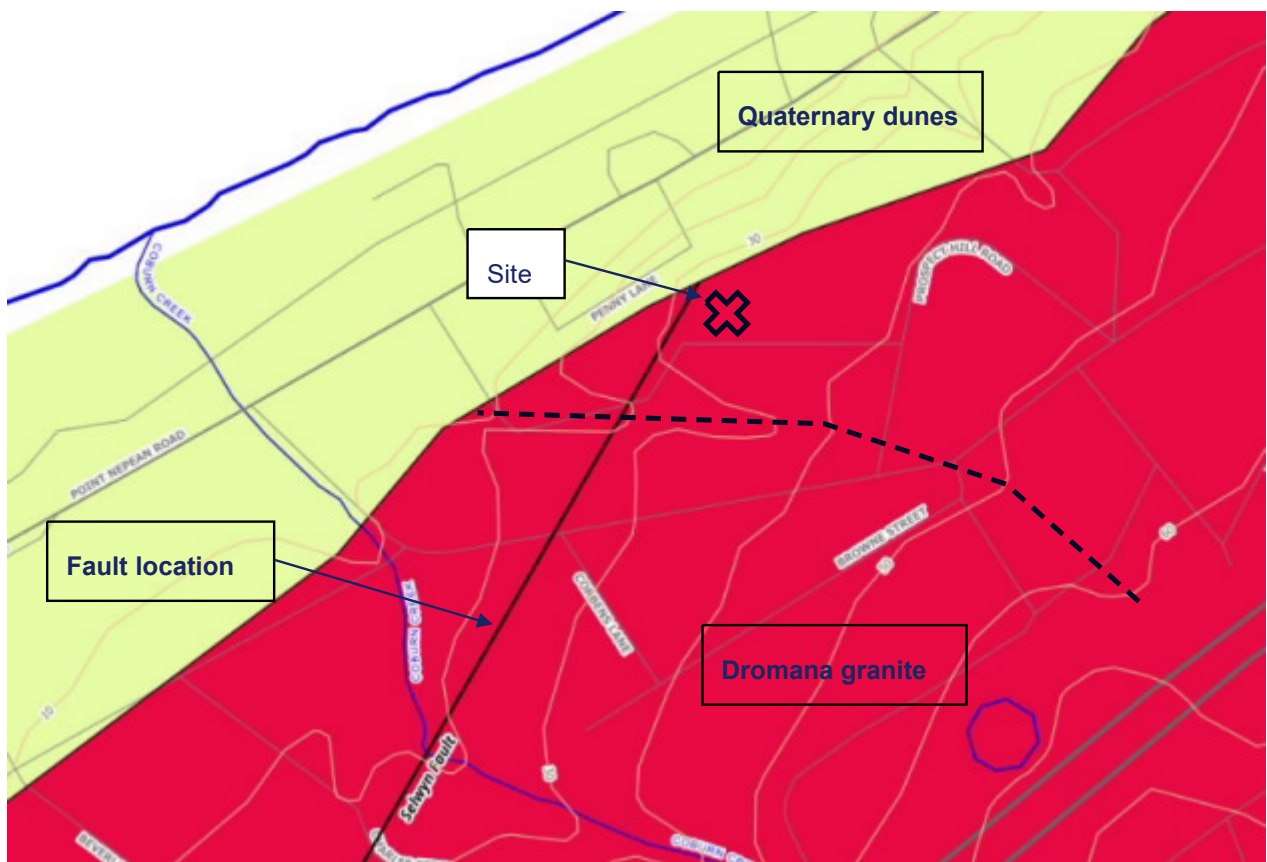
**Inset 7: Earth Resources geological map with Selwyn Fault highlighted.**

The Victoria Seamless Geology ([Earth Resources publications \(efirst.com.au\)](http://EarthResourcespublications.efirst.com.au), (2014)) model indicates that the Site is close to the boundary of Quaternary aged dune deposits (with siliceous and calcareous sands) and Devonian aged Dromana granite. The Earth Resources mapping portal ([GeoVic Anonymous \(gsv.vic.gov.au\)](http://GeoVicAnonymous(gsv.vic.gov.au)), accessed 1 November 2023) indicates that the inferred location of the Selwyn Fault traverses the Site, Inset 7.

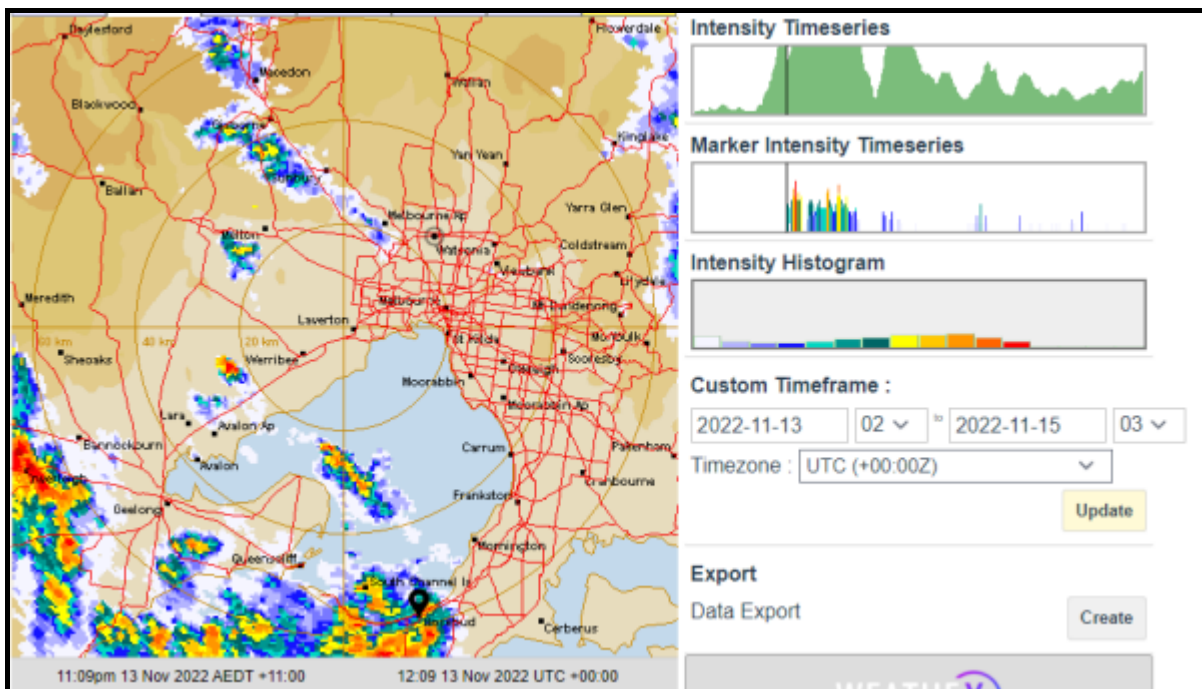
Figure A7: Radar plot 11:09 pm on 13/11/2022

- The majority of moderate to heavy rainfall was observed between 11pm on 13/11/2023 and 7am on 14/11/2023, Figures A7 to A8 of Appendix A.
- Some showers were recorded for the remainder of the 14/11/2023, Figure A9 of Appendix A.
