# Expert Opinion Report - Rectification

10-12 View Point Road, McCrae

PSM5226-005R 11 June 2024

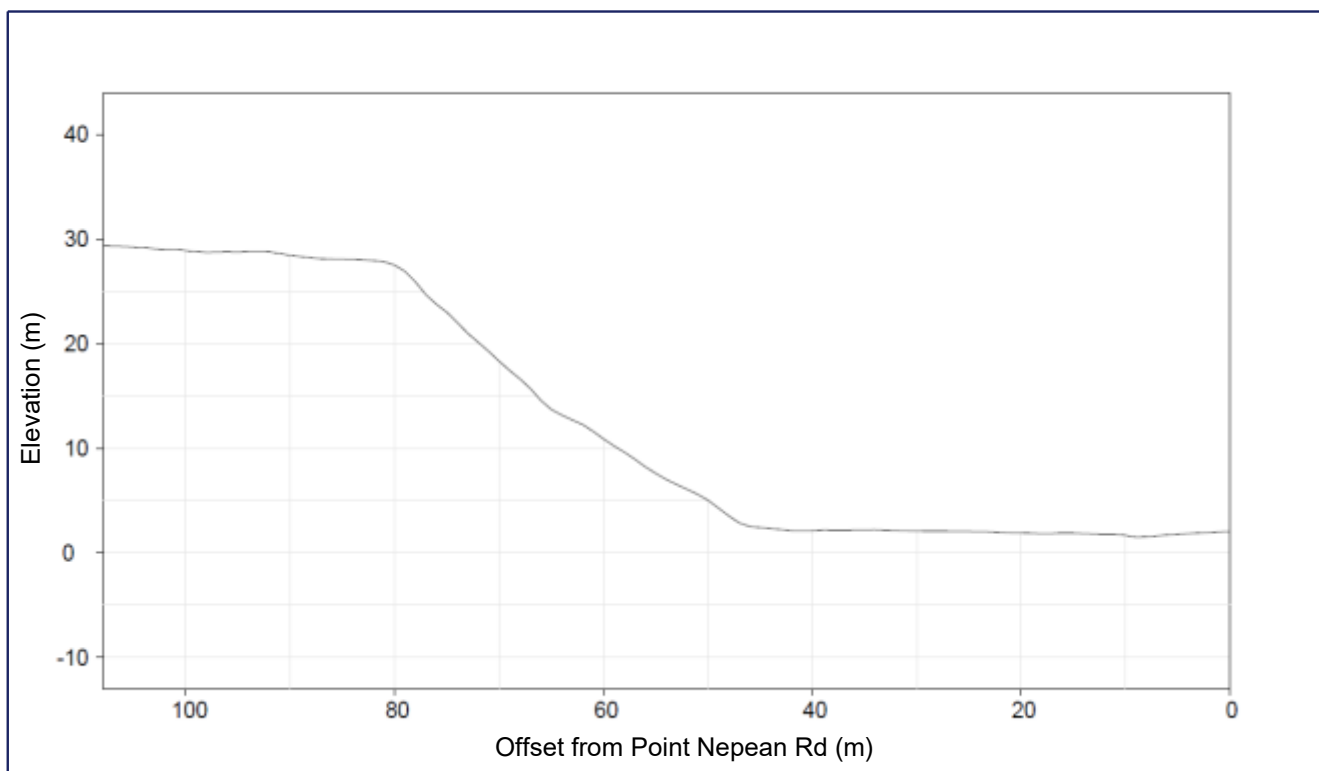
**Inset 7: Prefailure slope geometry through the centre of the Landslide from Coastal LiDAR 1 DEM**

34. In the area of the Landslide the Coastal LiDAR data indicates:

- (a) 25 to 30 metres of relief between the toe of the escarpment and the crest of the escarpment.
- (b) A typical overall slope angle of 30 to 35°.
- (c) A concave slope profile with the upper half of the escarpment being steeper (typically 35 to 40°) than the lower half of the escarpment (typically 25 to 30°).
- (d) Pre-failure slope geometry of the Landslide is shown in Inset 7.
- (e) A lack of large-scale features other than gullies, that may indicate the presence of a large, full height slope failure mechanism.

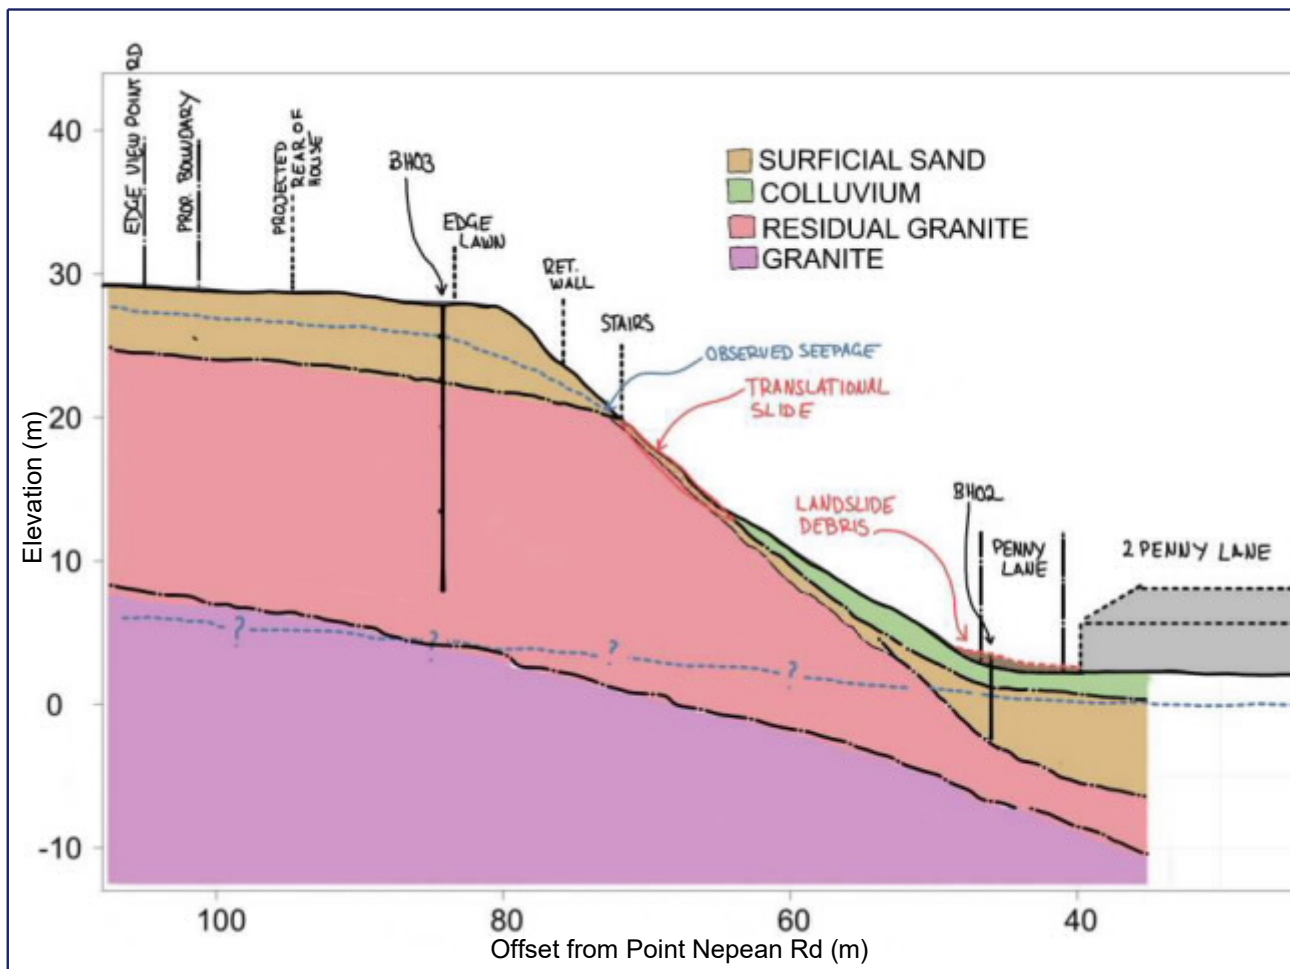
Inset 9: Cross section of my geotechnical model

38. My interpretation of the geological conditions is presented in Inset 9. With regards to the geotechnical model, I note the following key observations:

- (a) There is uncertainty regarding the contact between the SURFICIAL SAND and the RESIDUAL GRANITE owing to the likelihood of some of the parent material of the SURFICIAL SAND being derived from erosion of the Dromana Granite. I have assumed that the wet soils are an indicator of the contact between the two geotechnical units.
- (b) The laboratory testing indicates that all samples between 3 m and 19 m bgl have very similar Particle Size Distributions, Inset 10, and Atterberg limits indicate low plasticity CLAY fines.

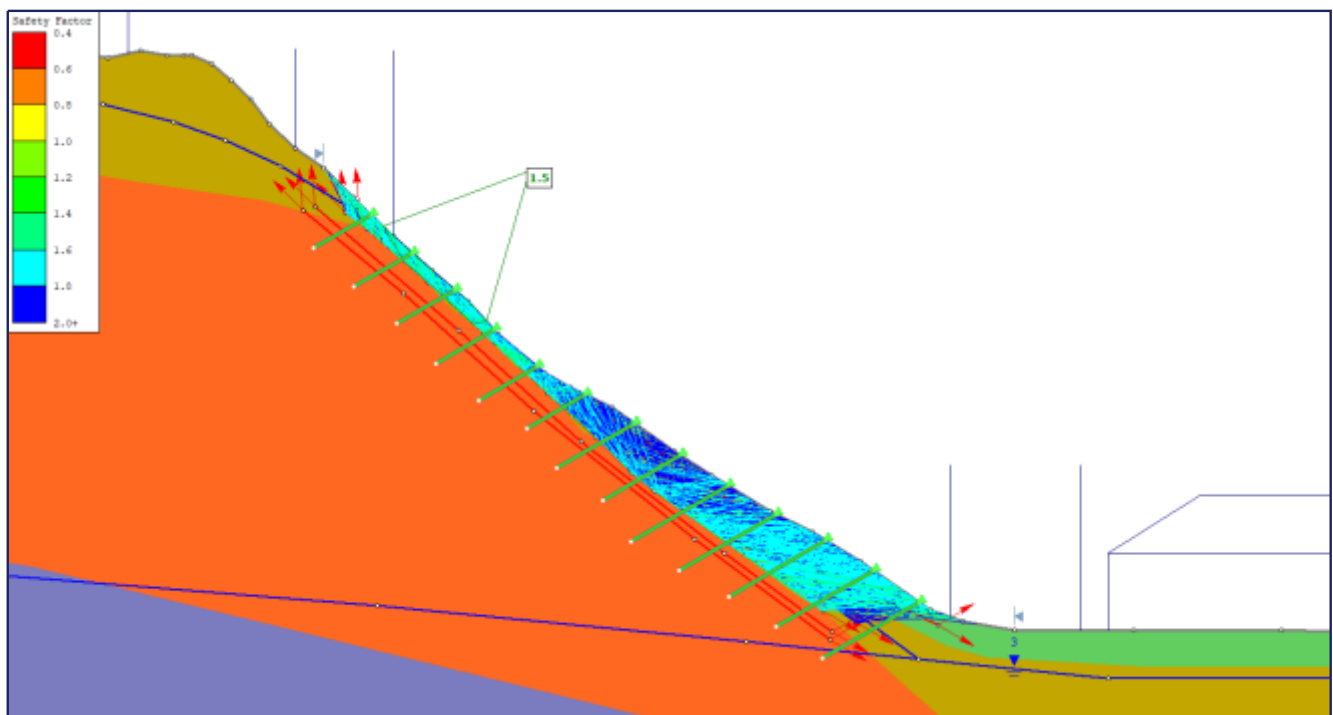
Inset 14: Slide 2 analysis output for static loading conditions

- (f) Shear capacity of the soil nail was conservatively not included in the analysis.
64. The output for static and seismic loading conditions is presented in Inset 14 and Inset 15.

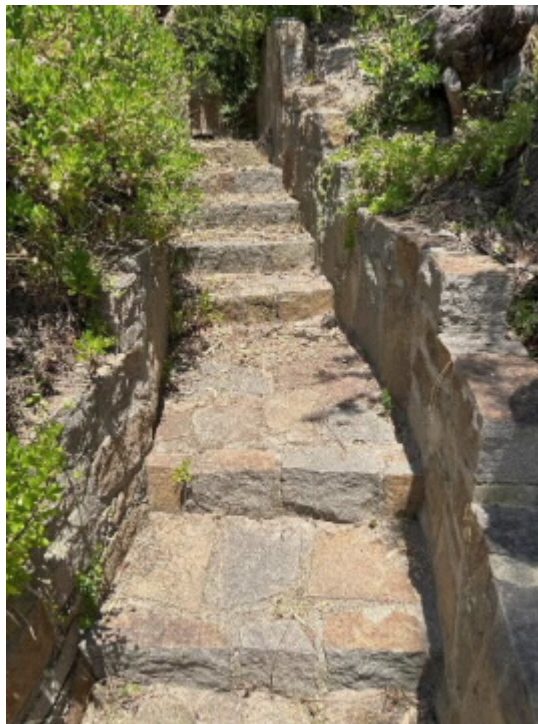
- i. Subsurface 'agi-drains'
    - ii. Water pipes including taps.
  - (e) A series of paths had been constructed across the slope to provide access from the top of the escarpment to the bottom of the escarpment, Photo 8 & 9 Appendix C. The paths are constructed from varying materials. Other infrastructure associated with the paths include minor RWs, board walks and stairs.

Photo 9 - Granite stairs leading from garden area to path at top of landslide

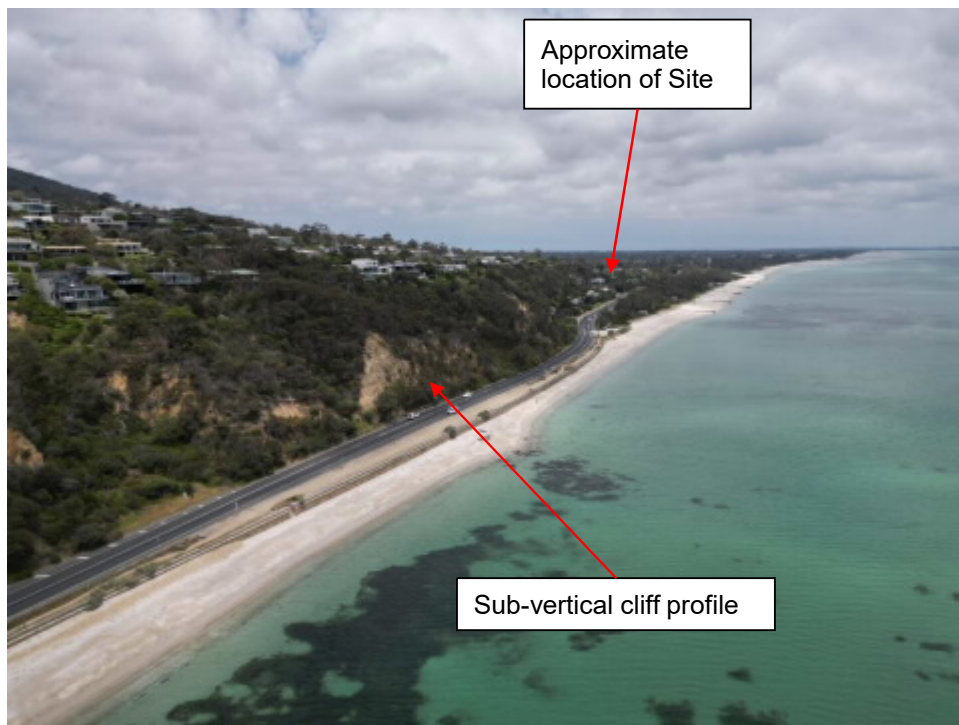
- i. Natural voids and internal erosion (i.e. piping) is common in upper soil profile, Photo 12 Appendix C.
    - ii. A sub vertical cliff profile in extremely weathered and highly weathered granite, Photo 13 Appendix C. I note this sub-vertical may be the result of road construction activities in the 1920's and 1930's.

Photo 13 - Anthony's Nose

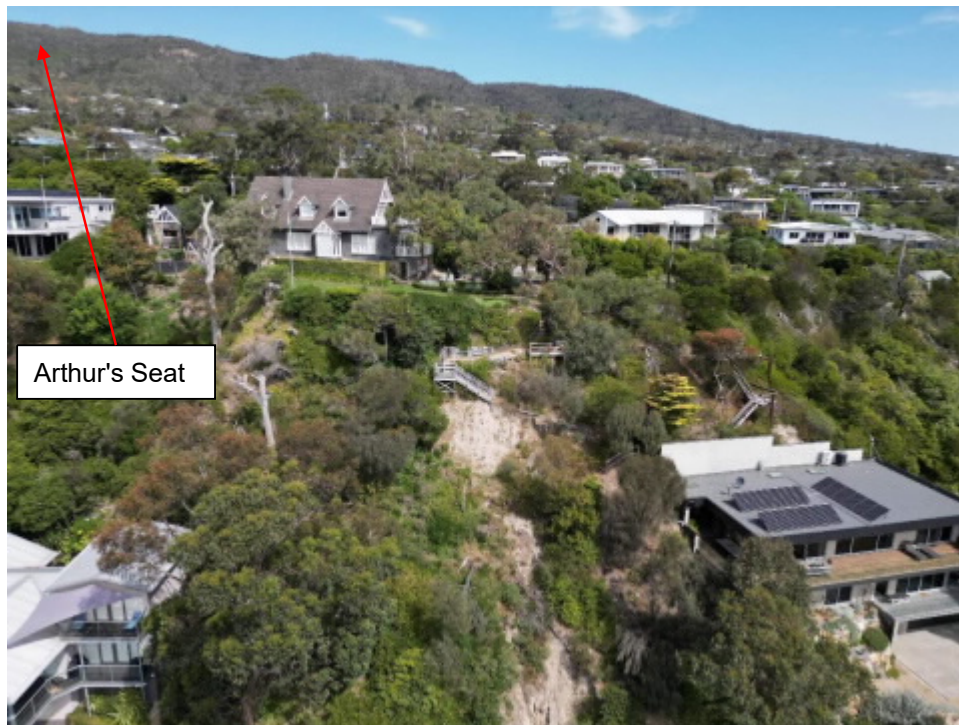
- (c) The Site is located on the lower slopes of Arthurs Seat where those slopes meet Port Phillip Bay and have formed an escarpment, Photo 14 Appendix C. In proximity to the Site the general topography of the areas slopes to the north west. There is extensive residential development above the Site on the lower slopes of Arthurs Seat.

Photo 14 - Arthur's Seat in background
