Expert Opinion Report - Rectification

10-12 View Point Road, McCrae

PSM5226-005R 11 June 2024

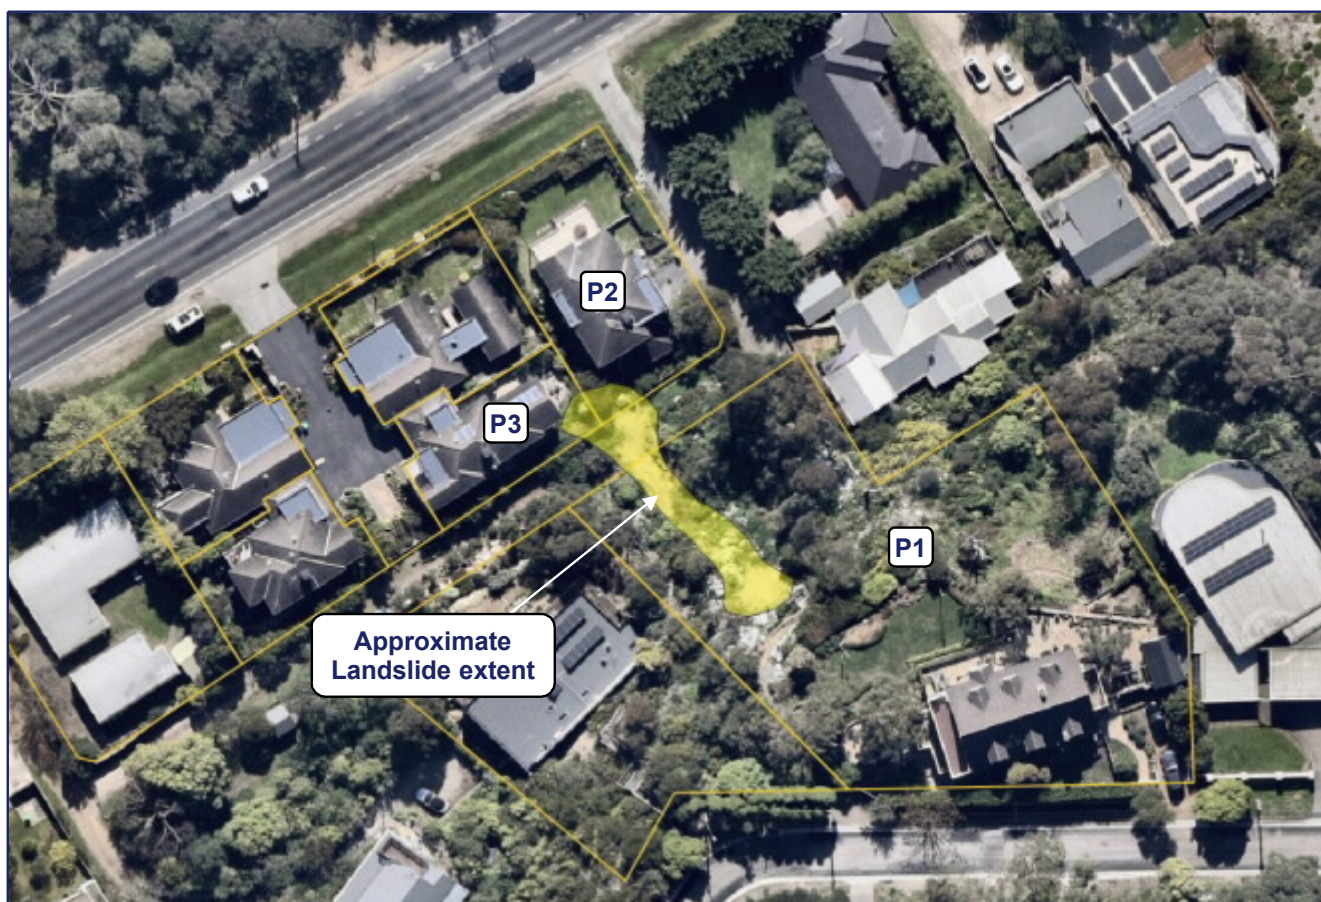
Inset 1: Plan of properties affected by the Landslide (Aerial Image from Nearmap dated 25 August 2023)

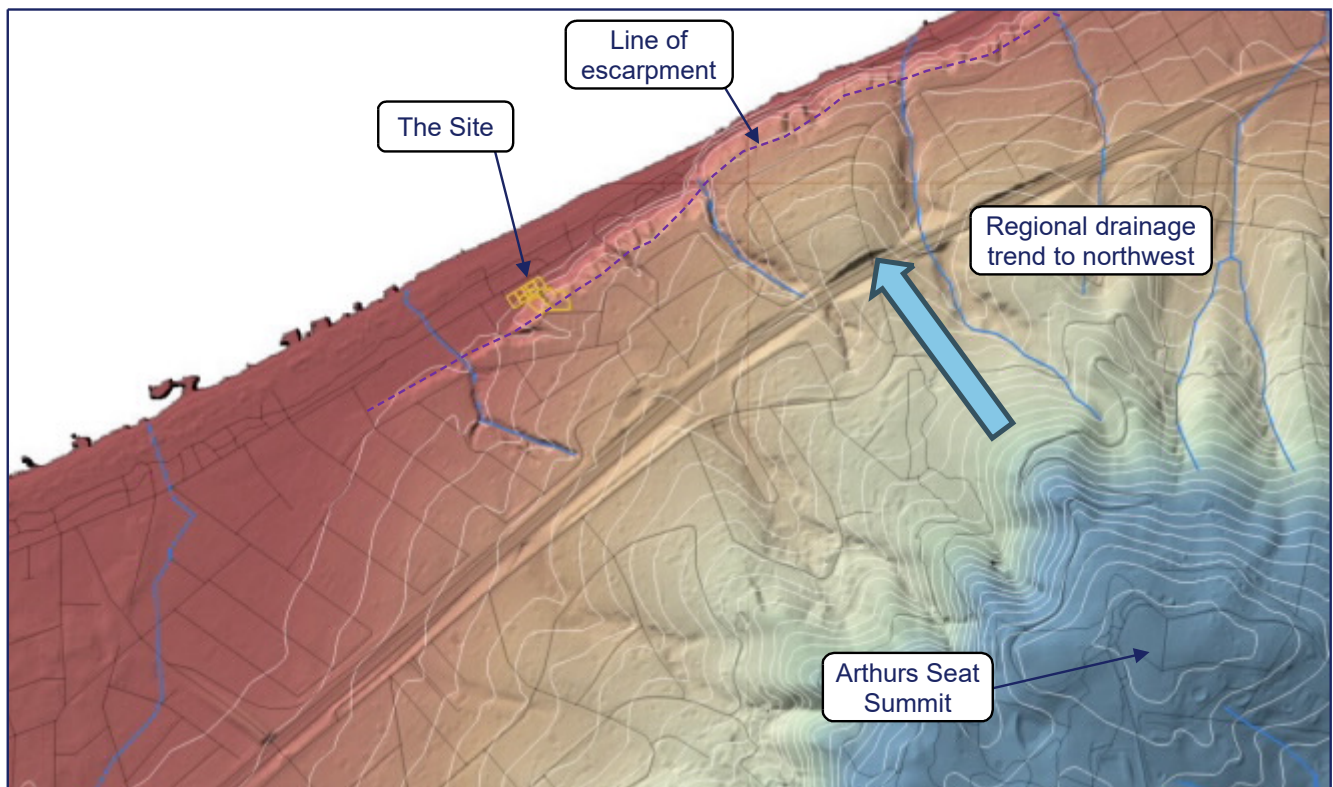
33. The Coastal LiDAR indicates that the Site is located at the lower escarpment of Arthurs Seat, Inset 6. There is approximately 270 of metres of relief measured in a northwest direction from the summit of Arthurs Seat to the escarpment at the Site. I note that several drainage paths strike in a north to northwest direction and that the Mornington Peninsula Freeway provides significant disruption to surface and sub-surface water flows in the region.

Inset 6: Topography and drainage paths of Arthurs Seat

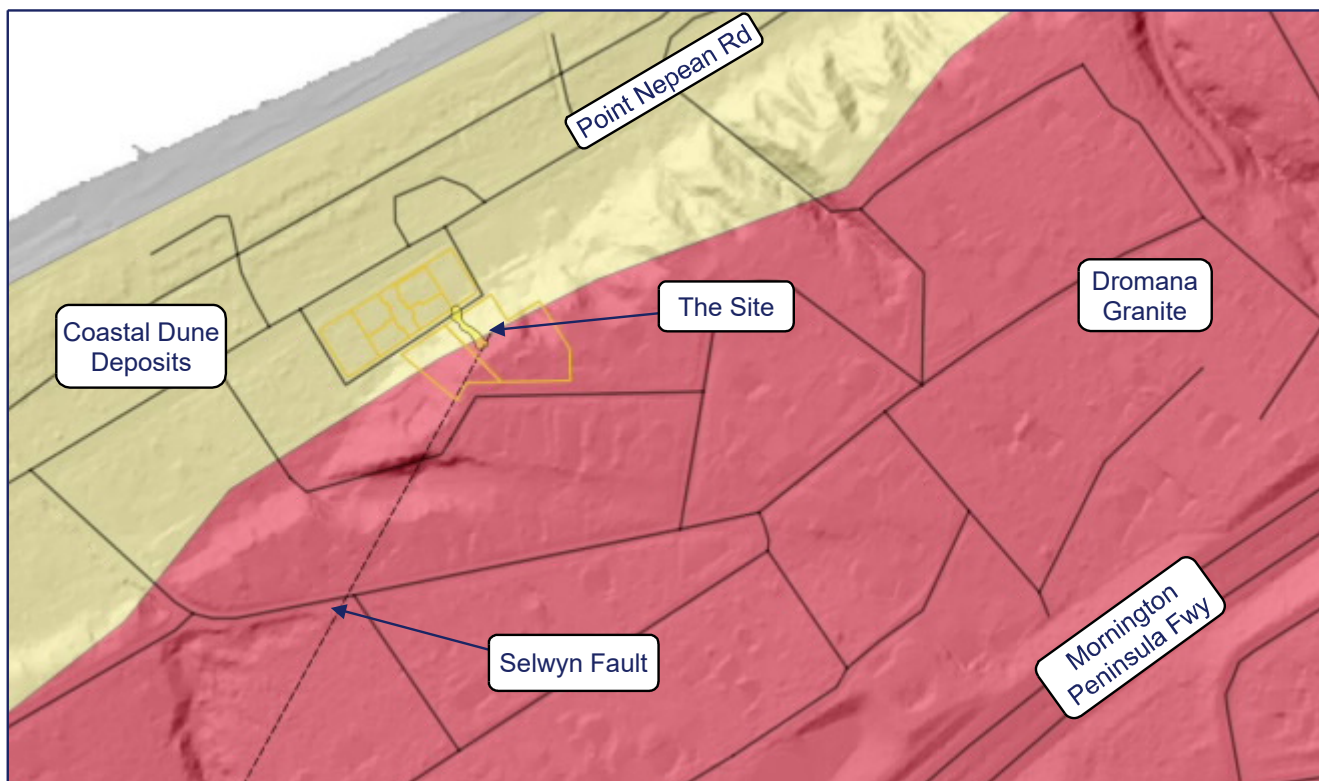
36. The Victoria Seamless Geology (Earth Resources publications (efirst.com.au), (2014)) model indicates that the Site is close to the boundary of Quaternary aged coastal dune deposits (with siliceous and calcareous sands) and Devonian aged Dromana granite. The Earth Resources mapping portal (GeoVic Anonymous (gsv.vic.gov.au), accessed 1 November 2023) indicates that the inferred location of the Selwyn Fault traverses the Site, Inset 8.

Inset 8: Earth resources seamless geology map of the area, with Selwyn Fault highlighted.

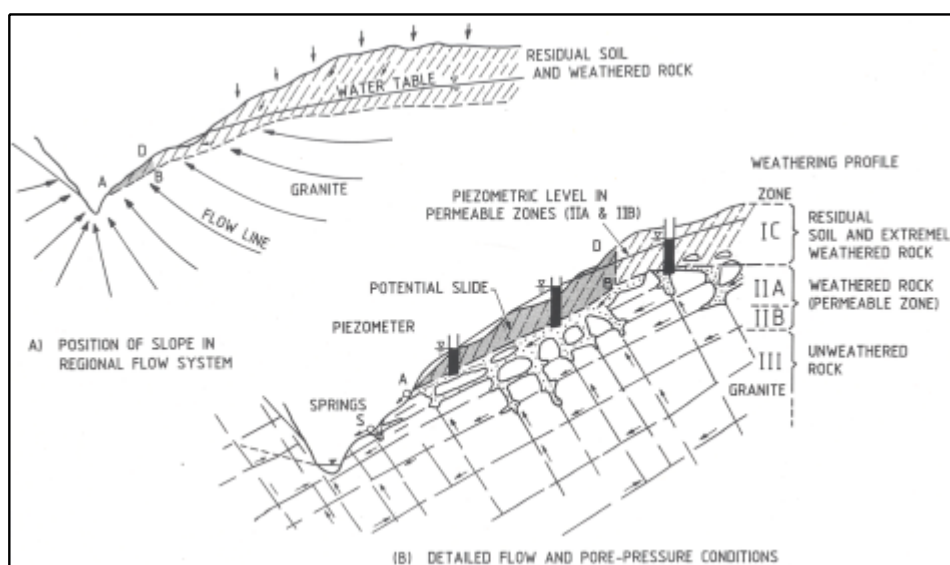
- (b) Furthermore, the CivilTest observation is consistent with published groundwater models in weathered granitic profiles, Inset 11.
 - (c) Observations of seepage during the Site visit (refer to paragraph [29(c)]).

Inset 11: Possible piezometric conditions in weathered granitic soils (Fell et al, 2004)¹.

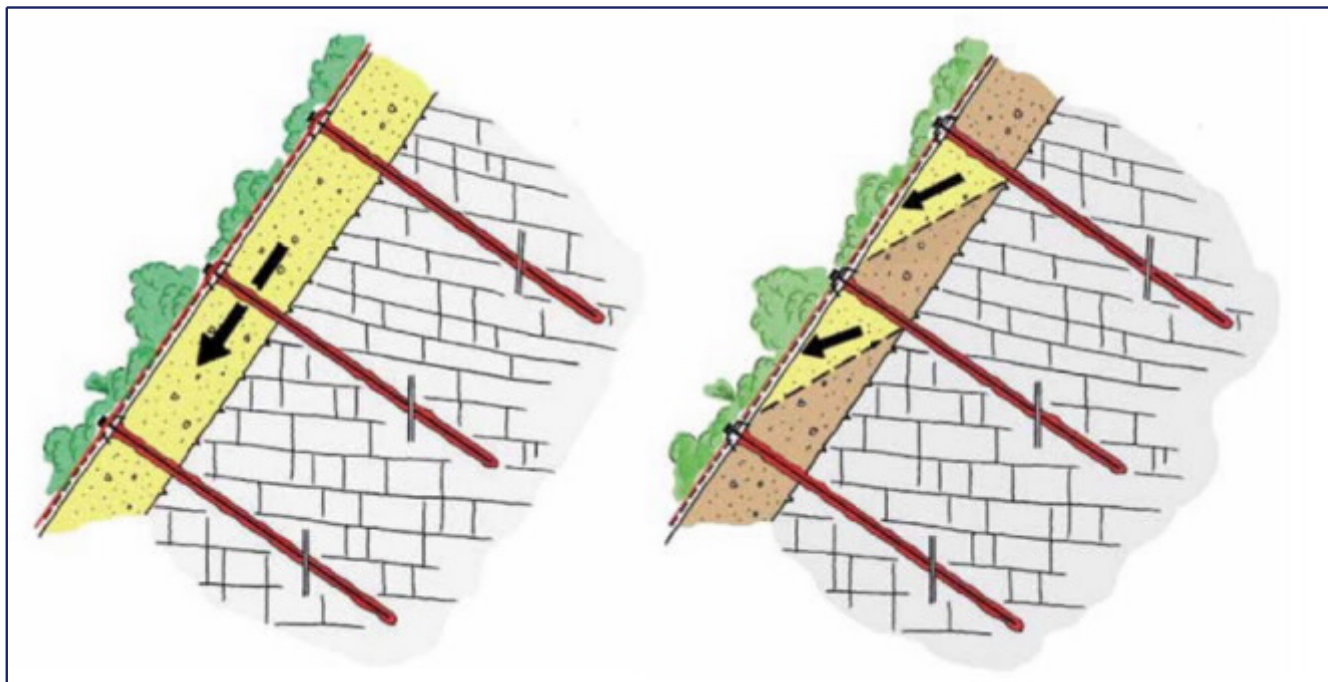
58. I have checked for sizing and spacing of the soil nail and steel netting system using Geobruigg's Ruvolum dimension tool (www.geobruigg.com). Ruvolum assesses superficial slope-parallel instabilities as well as local instability between individual nails, Inset 12. I have adopted a thickness of unstable material of 0.5 m parallel to slope.
59. Ruvolum is used to assess working soil nail loads, mesh load and to perform checks against component capacities. Ruvolum also provides a first pass of soil nail spacing. I note that this software package is used iteratively with SLIDE2, Section 8.3.4.
60. The analysis indicates for the spacings in Table 4, unfactored soil nail loads of 38 kN.

Inset 12: Diagram of mechanisms assessed by Ruvolum (Geobrigg, 2019)²

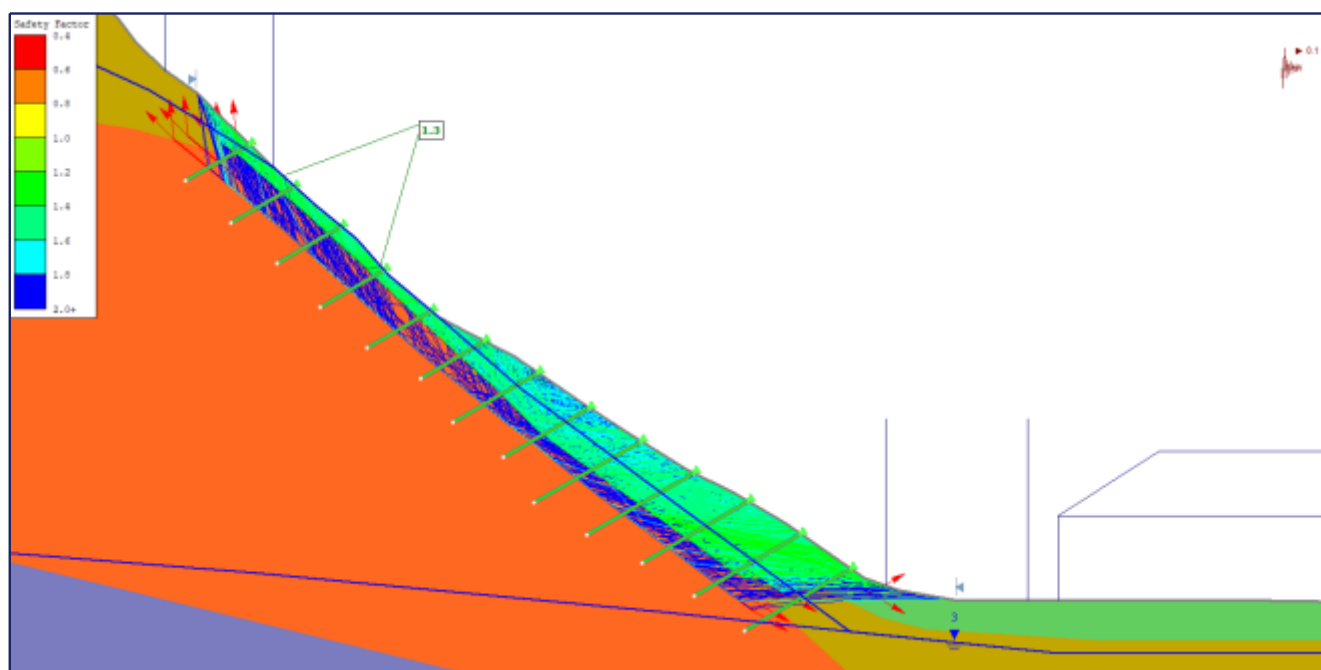
- (f) Shear capacity of the soil nail was conservatively not included in the analysis.
64. The output for static and seismic loading conditions is presented in Inset 14 and Inset 15.

Inset 15: Slide 2 analysis output for seismic loading conditions

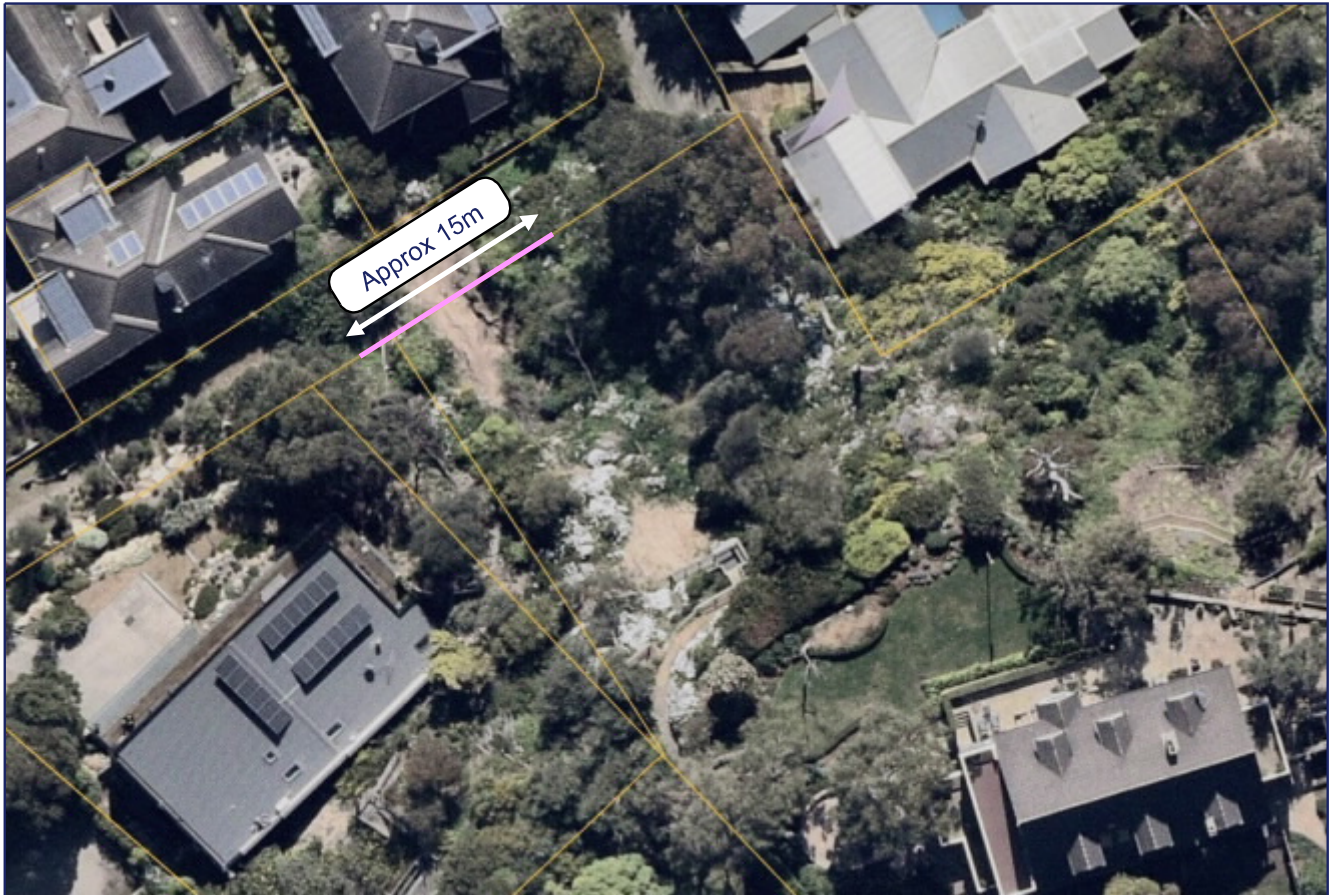
81. I have assumed the following:
- (a) The short-term solution (**STS**) as per my Brief is to consist of a debris fence installed at the toe of the slope below Property P1 in Penny Lane.
 - (b) The debris fence is to provide approximately 15 m in length of protection below Property P1, Inset 17.
 - (c) The debris fence is to be an appropriately designed and constructed shallow landslide barrier manufactured by Geobruigg.
 - (d) Landslide debris is cleared from the slope prior to the installation of the debris fence.
82. I note that a fundamental principle of the debris fence is to protect people and property below the landslide rather than to prevent a landslide from occurring. In my opinion the STS can be designed to reduce risk to properties P2 and P3 and risk to life of occupants of P2 and P3 to a tolerable level.

83. In my opinion the STS does not reduce risk to life and property for Property P1. As per paragraph [82], a debris fence does not prevent a landslide from occurring, therefore in my opinion landslides may still occur on Property P1. In my opinion a residual risk assessment post clean-up of Landslide and for:
- (a) A pedestrian on the slopes of P1 is likely to indicate an unacceptable risk to life for future landslide events as no controls have been introduced to control repeat landslides.
 - (b) The dwelling at P1 is likely to indicate a tolerable risk to the dwelling and occupants within the dwelling with risks unchanged owing to the offset to the Landslide.

Inset 17: Assumed extent of debris fence shown in pink (Aerial image from Nearmap)

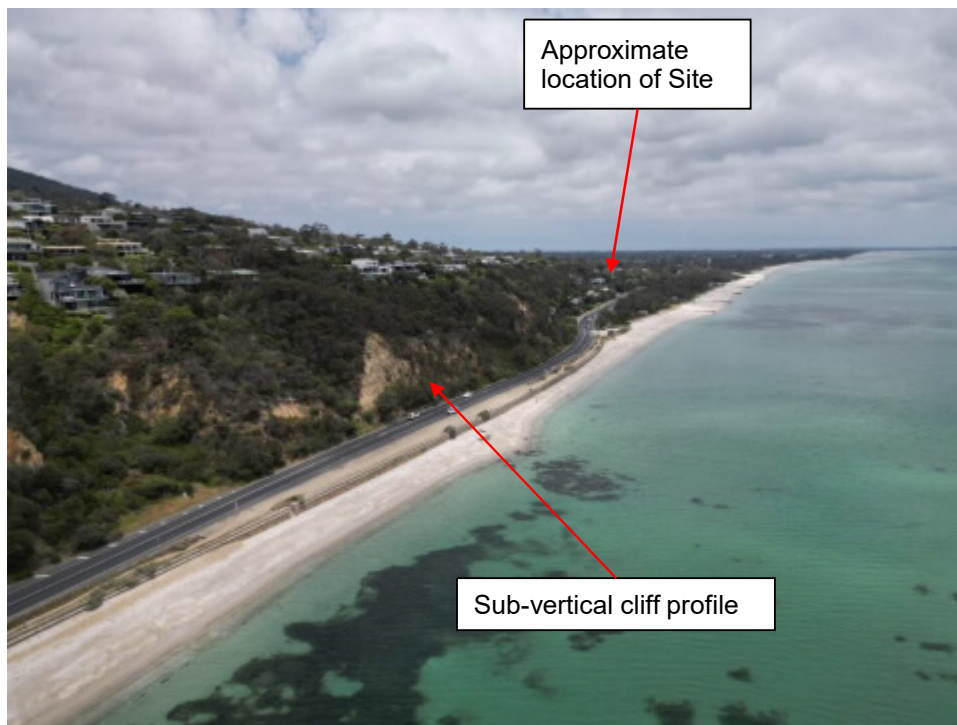
- i. Natural voids and internal erosion (i.e. piping) is common in upper soil profile, Photo 12 Appendix C.
 - ii. A sub vertical cliff profile in extremely weathered and highly weathered granite, Photo 13 Appendix C. I note this sub-vertical may be the result of road construction activities in the 1920's and 1930's.

Photo 13 - Anthony's Nose
