Expert Opinion Report - Rectification

10-12 View Point Road, McCrae

PSM5226-005R 11 June 2024

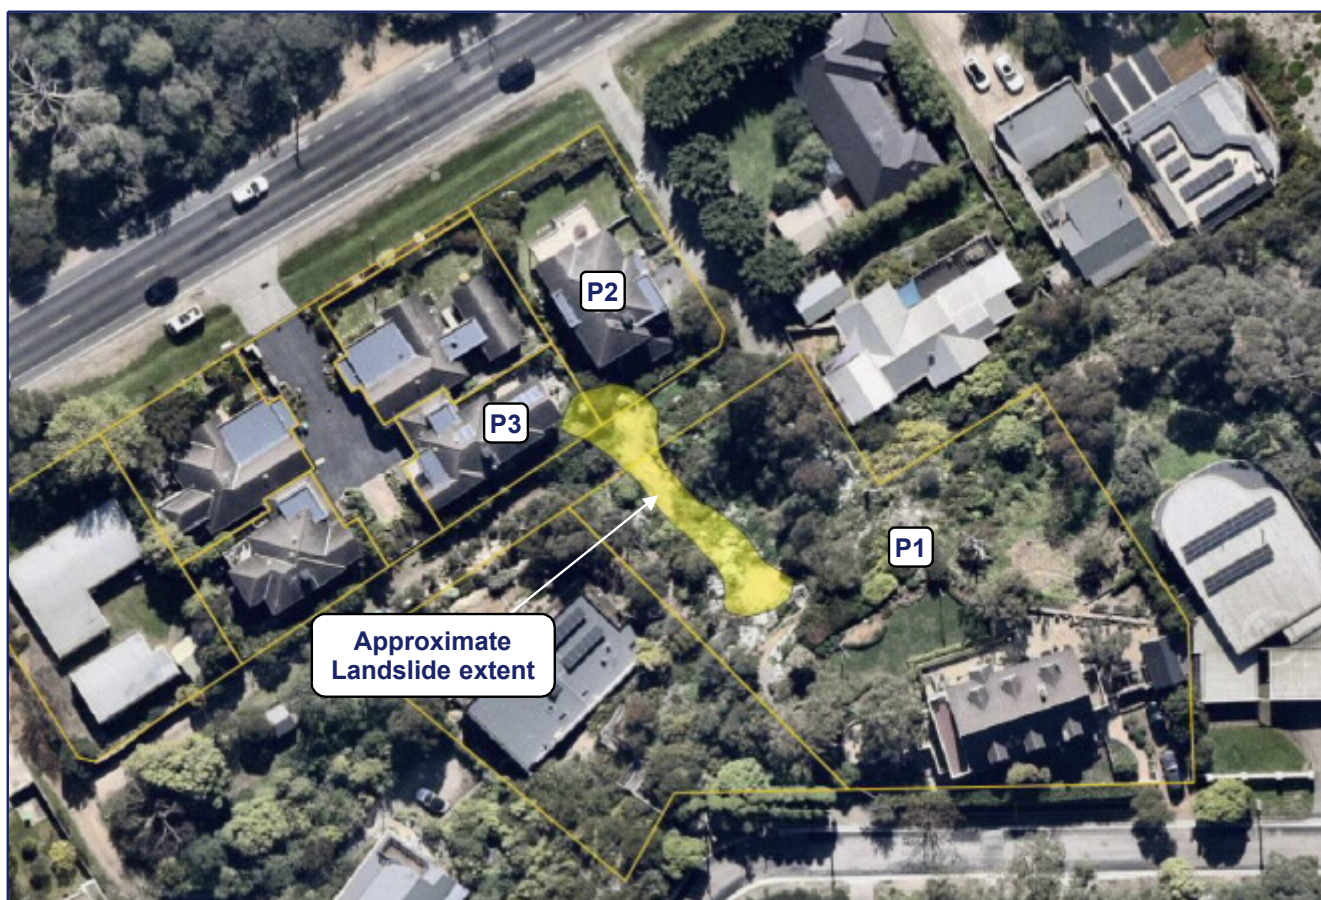
Inset 1: Plan of properties affected by the Landslide (Aerial Image from Nearmap dated 25 August 2023)

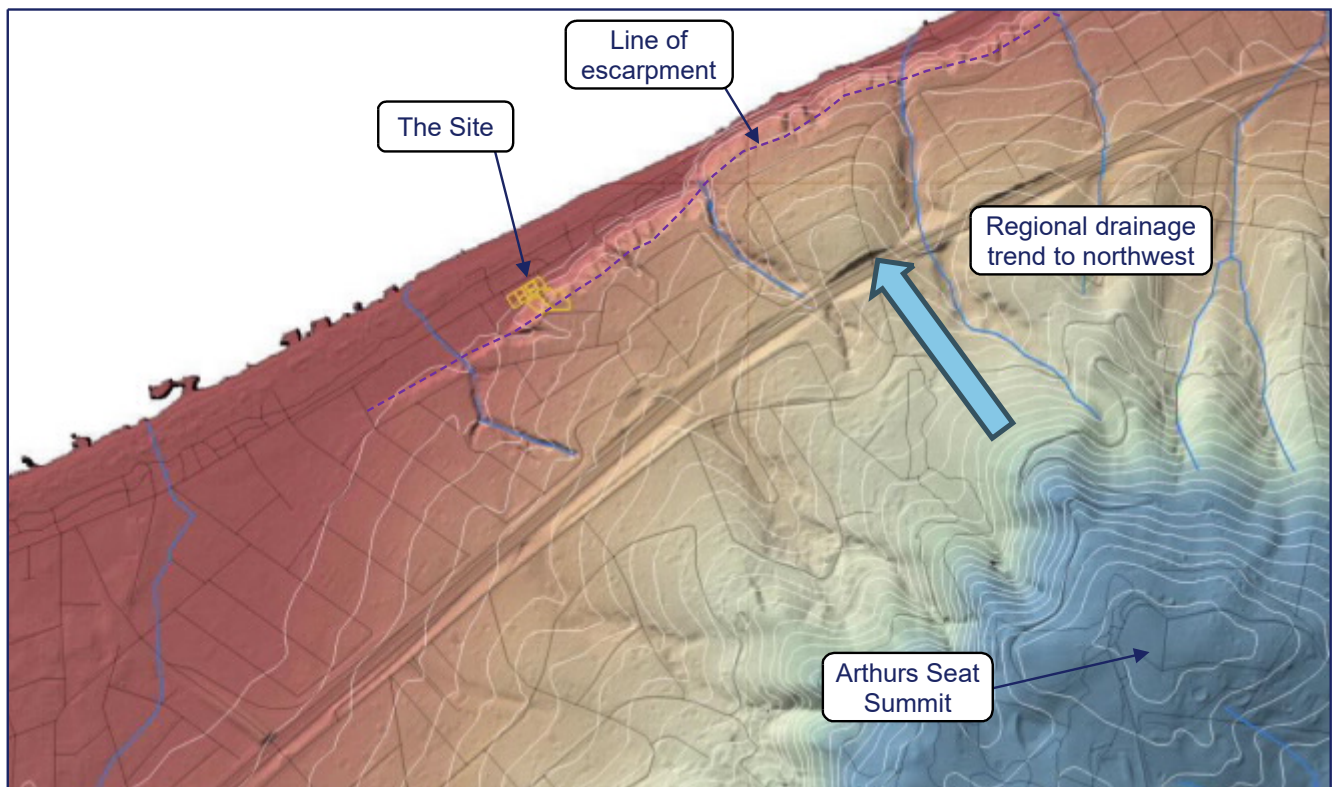
33. The Coastal LiDAR indicates that the Site is located at the lower escarpment of Arthurs Seat, Inset 6. There is approximately 270 of metres of relief measured in a northwest direction from the summit of Arthurs Seat to the escarpment at the Site. I note that several drainage paths strike in a north to northwest direction and that the Mornington Peninsula Freeway provides significant disruption to surface and sub-surface water flows in the region.

Inset 6: Topography and drainage paths of Arthurs Seat

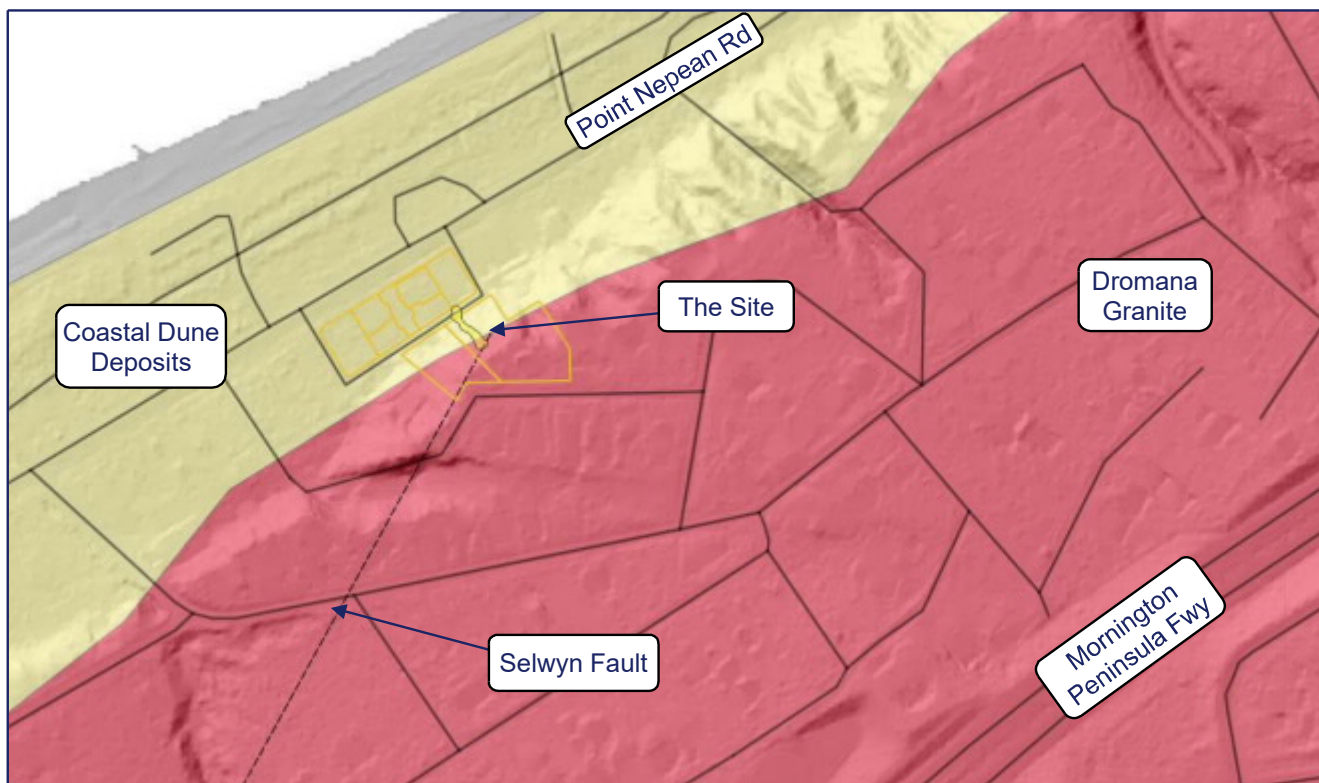
36. The Victoria Seamless Geology (Earth Resources publications (efirst.com.au), (2014)) model indicates that the Site is close to the boundary of Quaternary aged coastal dune deposits (with siliceous and calcareous sands) and Devonian aged Dromana granite. The Earth Resources mapping portal (GeoVic Anonymous (gsv.vic.gov.au), accessed 1 November 2023) indicates that the inferred location of the Selwyn Fault traverses the Site, Inset 8.

Inset 8: Earth resources seamless geology map of the area, with Selwyn Fault highlighted.

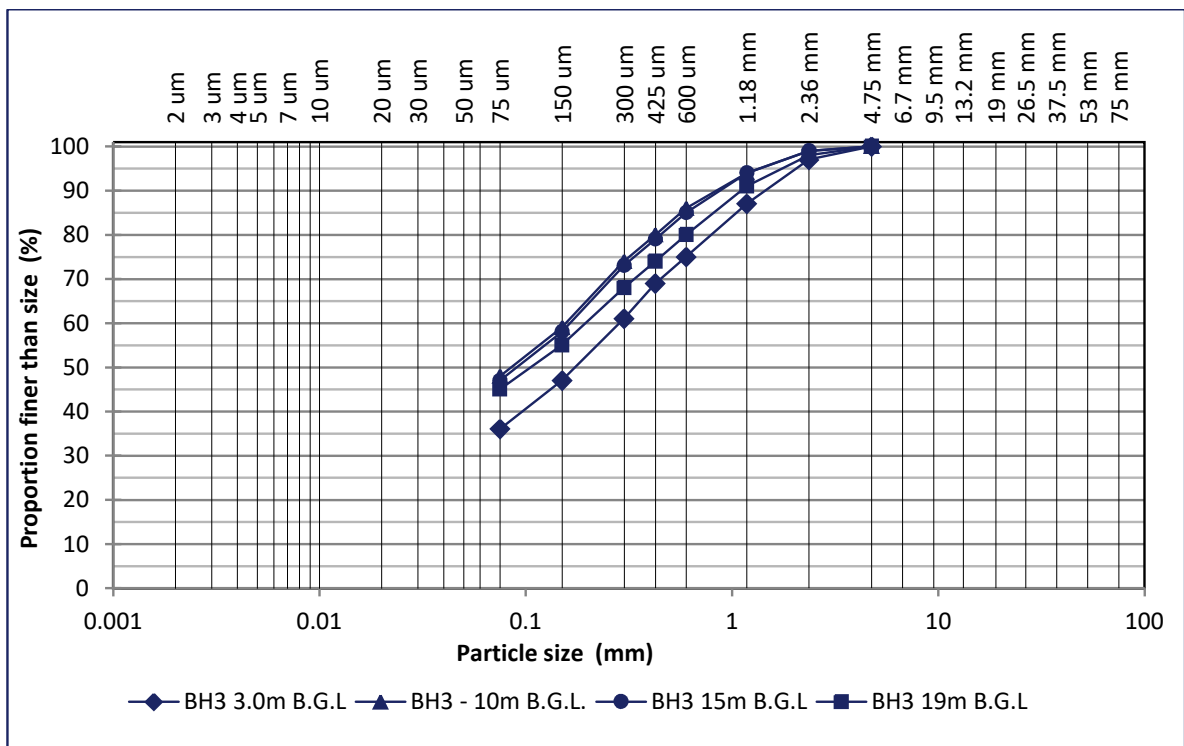
Inset 10: CivilTest Particle Size Distributions

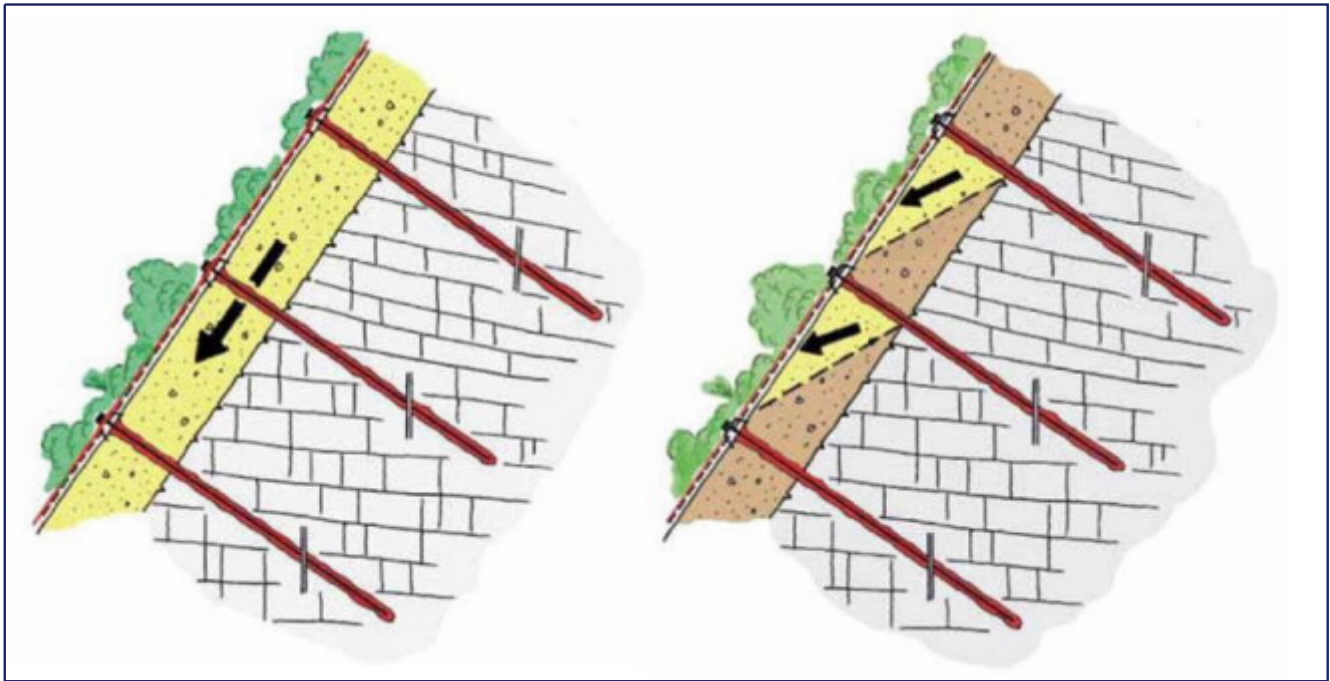
Inset 12: Diagram of mechanisms assessed by Ruvolum (Geobrugg, 2019)²

58. I have checked for sizing and spacing of the soil nail and steel netting system using Geobruigg's Ruvolum dimension tool (www.geobruigg.com). Ruvolum assesses superficial slope-parallel instabilities as well as local instability between individual nails, Inset 12. I have adopted a thickness of unstable material of 0.5 m parallel to slope.
59. Ruvolum is used to assess working soil nail loads, mesh load and to perform checks against component capacities. Ruvolum also provides a first pass of soil nail spacing. I note that this software package is used iteratively with SLIDE2, Section 8.3.4.
60. The analysis indicates for the spacings in Table 4, unfactored soil nail loads of 38 kN.

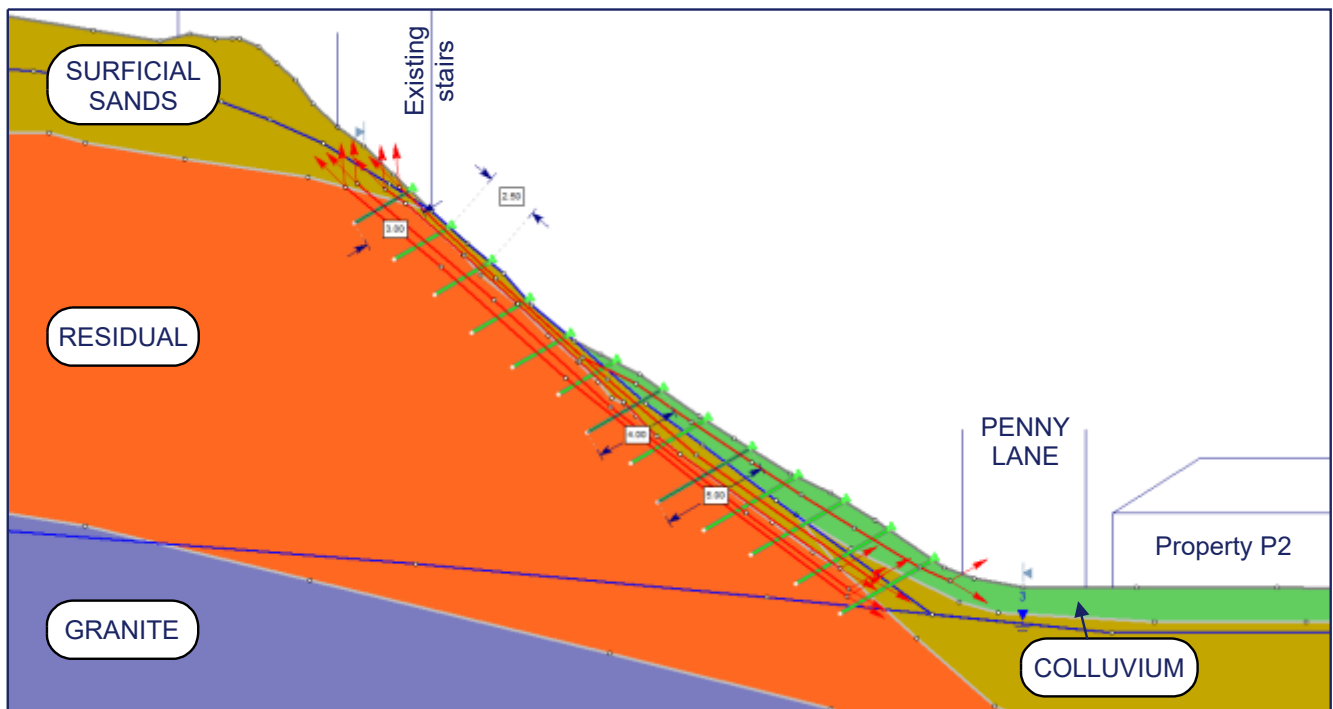
Inset 13: Slide 2 design cross section

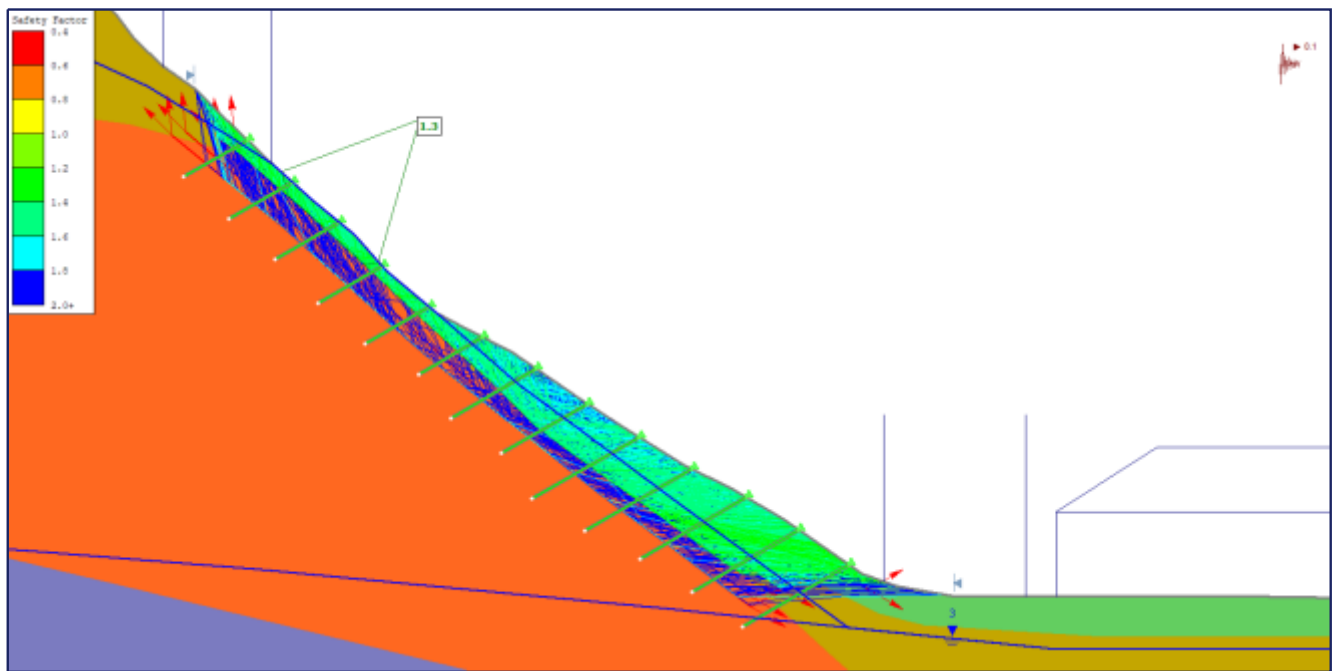
Inset 15: Slide 2 analysis output for seismic loading conditions

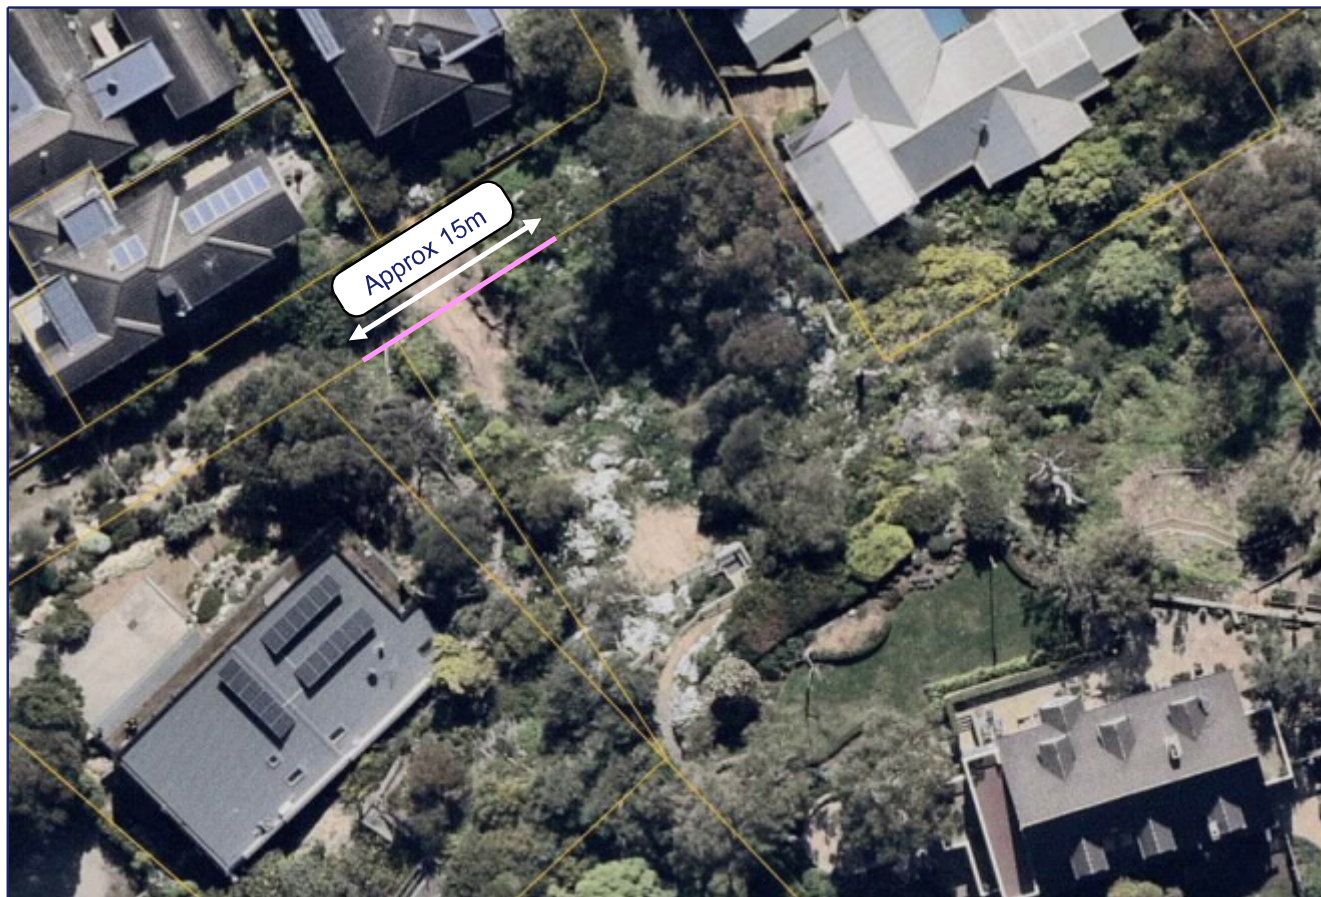
83. In my opinion the STS does not reduce risk to life and property for Property P1. As per paragraph [82], a debris fence does not prevent a landslide from occurring, therefore in my opinion landslides may still occur on Property P1. In my opinion a residual risk assessment post clean-up of Landslide and for:
- (a) A pedestrian on the slopes of P1 is likely to indicate an unacceptable risk to life for future landslide events as no controls have been introduced to control repeat landslides.
 - (b) The dwelling at P1 is likely to indicate a tolerable risk to the dwelling and occupants within the dwelling with risks unchanged owing to the offset to the Landslide.

Inset 17: Assumed extent of debris fence shown in pink (Aerial image from Nearmap)

81. I have assumed the following:
- (a) The short-term solution (**STS**) as per my Brief is to consist of a debris fence installed at the toe of the slope below Property P1 in Penny Lane.
 - (b) The debris fence is to provide approximately 15 m in length of protection below Property P1, Inset 17.
 - (c) The debris fence is to be an appropriately designed and constructed shallow landslide barrier manufactured by Geobruigg.
 - (d) Landslide debris is cleared from the slope prior to the installation of the debris fence.
82. I note that a fundamental principle of the debris fence is to protect people and property below the landslide rather than to prevent a landslide from occurring. In my opinion the STS can be designed to reduce risk to properties P2 and P3 and risk to life of occupants of P2 and P3 to a tolerable level.

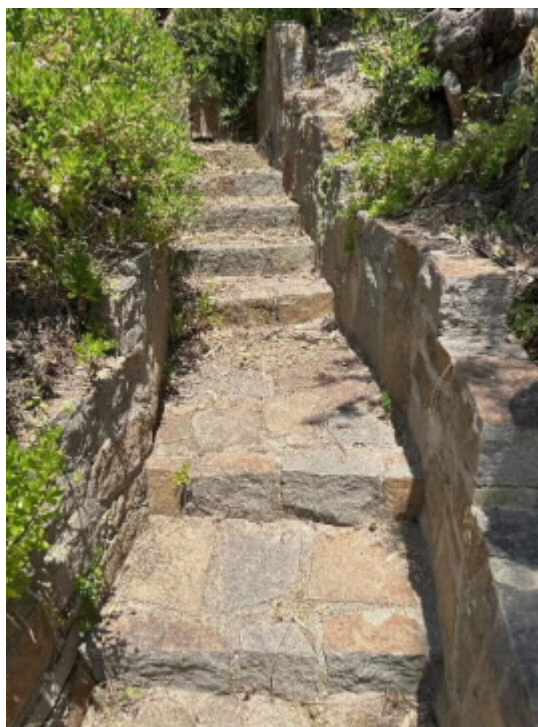
- i. Subsurface 'agi-drains'
 - ii. Water pipes including taps.
 - (e) A series of paths had been constructed across the slope to provide access from the top of the escarpment to the bottom of the escarpment, Photo 8 & 9 Appendix C. The paths are constructed from varying materials. Other infrastructure associated with the paths include minor RWs, board walks and stairs.

Photo 9 - Granite stairs leading from garden area to path at top of landslide

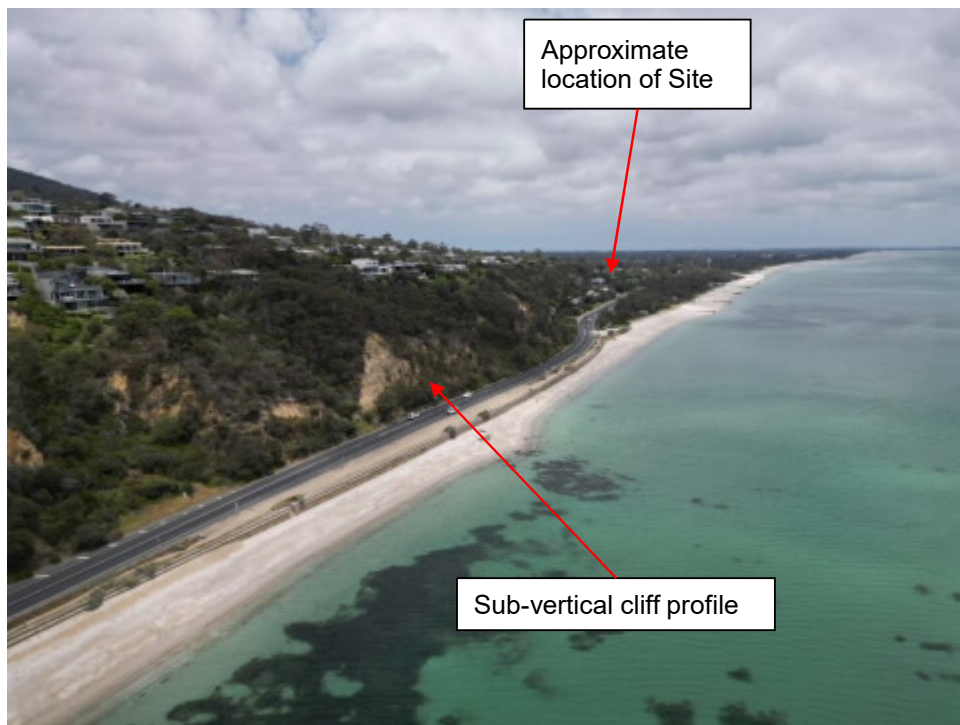
- i. Natural voids and internal erosion (i.e. piping) is common in upper soil profile, Photo 12 Appendix C.
 - ii. A sub vertical cliff profile in extremely weathered and highly weathered granite, Photo 13 Appendix C. I note this sub-vertical may be the result of road construction activities in the 1920's and 1930's.

Photo 13 - Anthony's Nose
