**GEOTECHNICAL INVESTIGATION OF
STABILITY OF GULLY BETWEEN
THE EYRIE & POINT NEPEAN ROAD,
MCCRAE**

**MORNINGTONPENINSULA SHIRE
COUNCIL**

SEPTEMBER 2007

REF NO: 207141Report01.1.doc

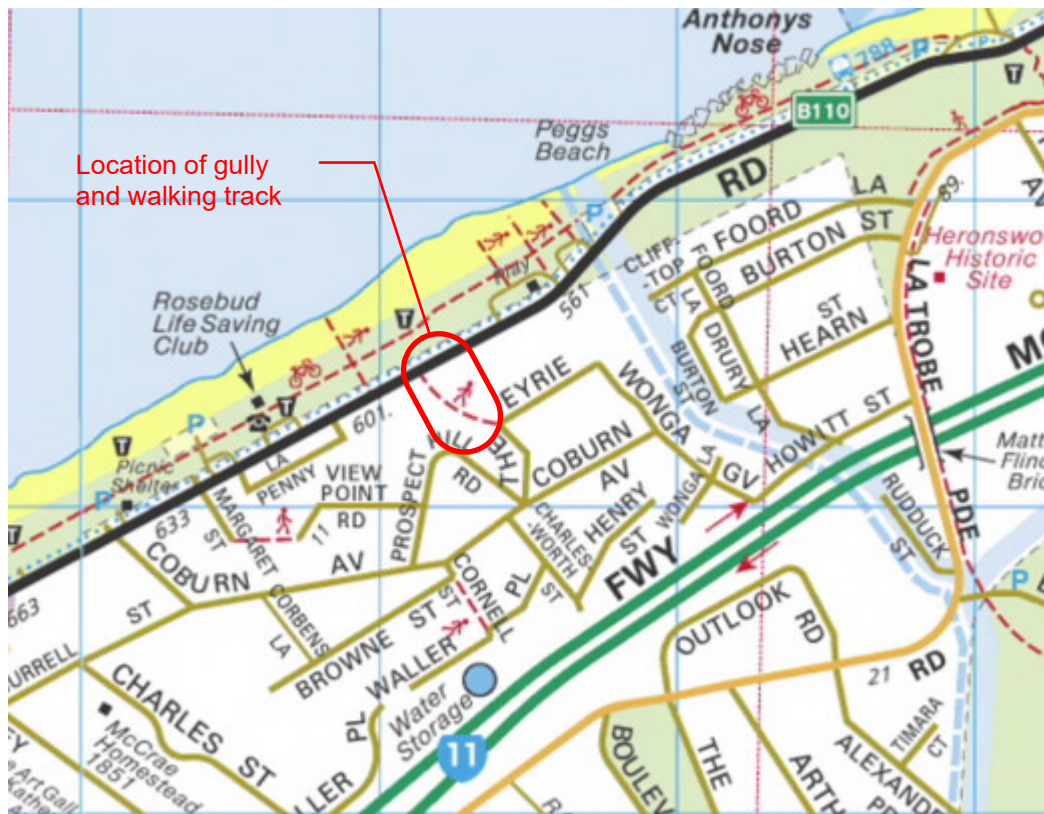
Plate 3.A: Location of Site Investigation

The gully falls from the top to the bottom of the escarpment that is between The Eyrie and Point Nepean Road. The gully falls approximately 40m over a length of approximately 180m with a grade of approximately 1V:4.5H. A walking track follows the gully from top to bottom. The location of the walking track and gully is indicated on the plate below.

The gully is deep and narrow with a general depth in the order of 10-20m. The banks are generally covered with trees, shrubs and a grass cover. However, in the steeper sections the banks are often void of vegetation. At the base of the gully the ground levels off and has a slight slope to the beach. The figures on the following pages show the gully progressively from the top of the escarpment to the bottom of the escarpment.

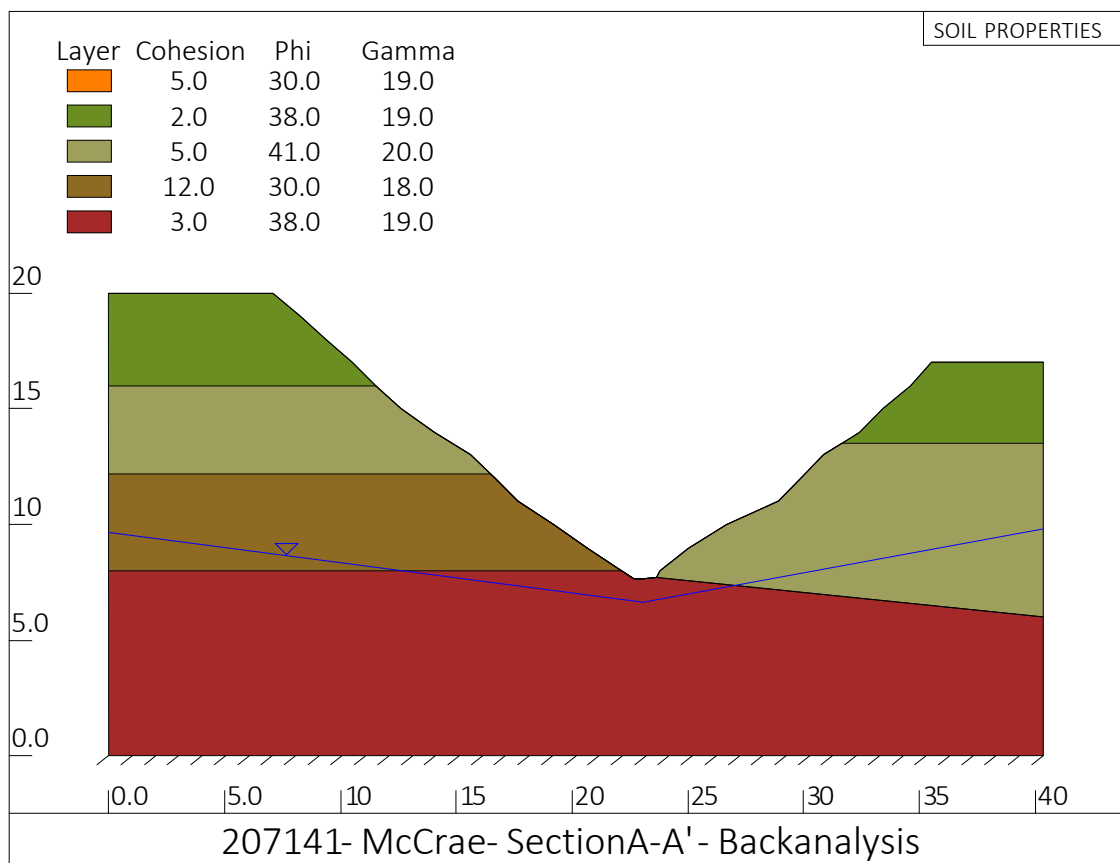
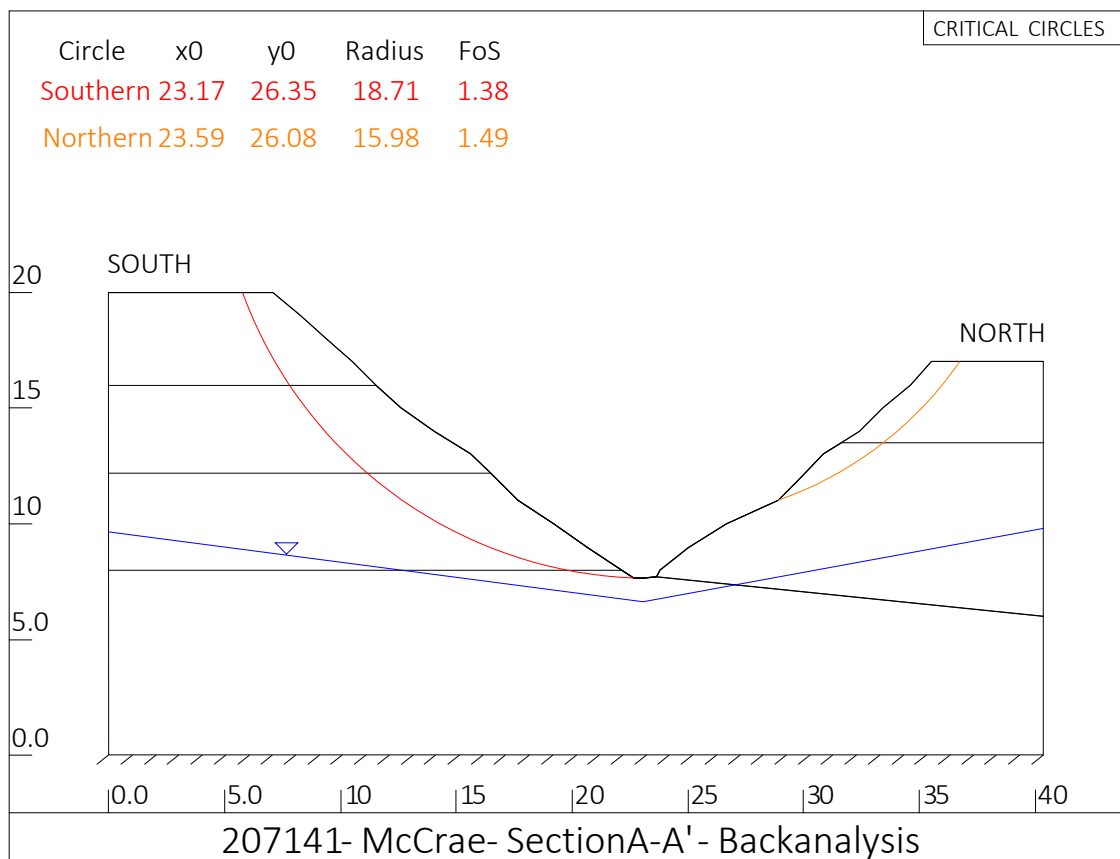
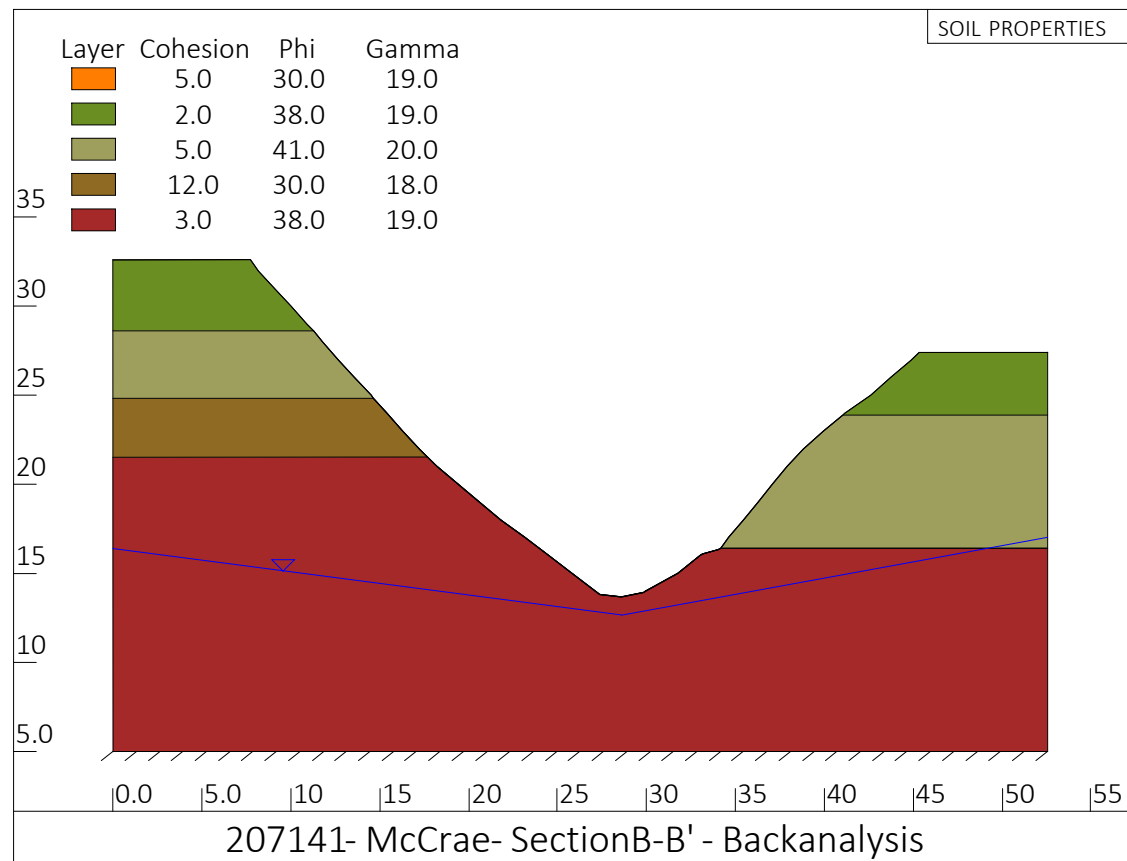
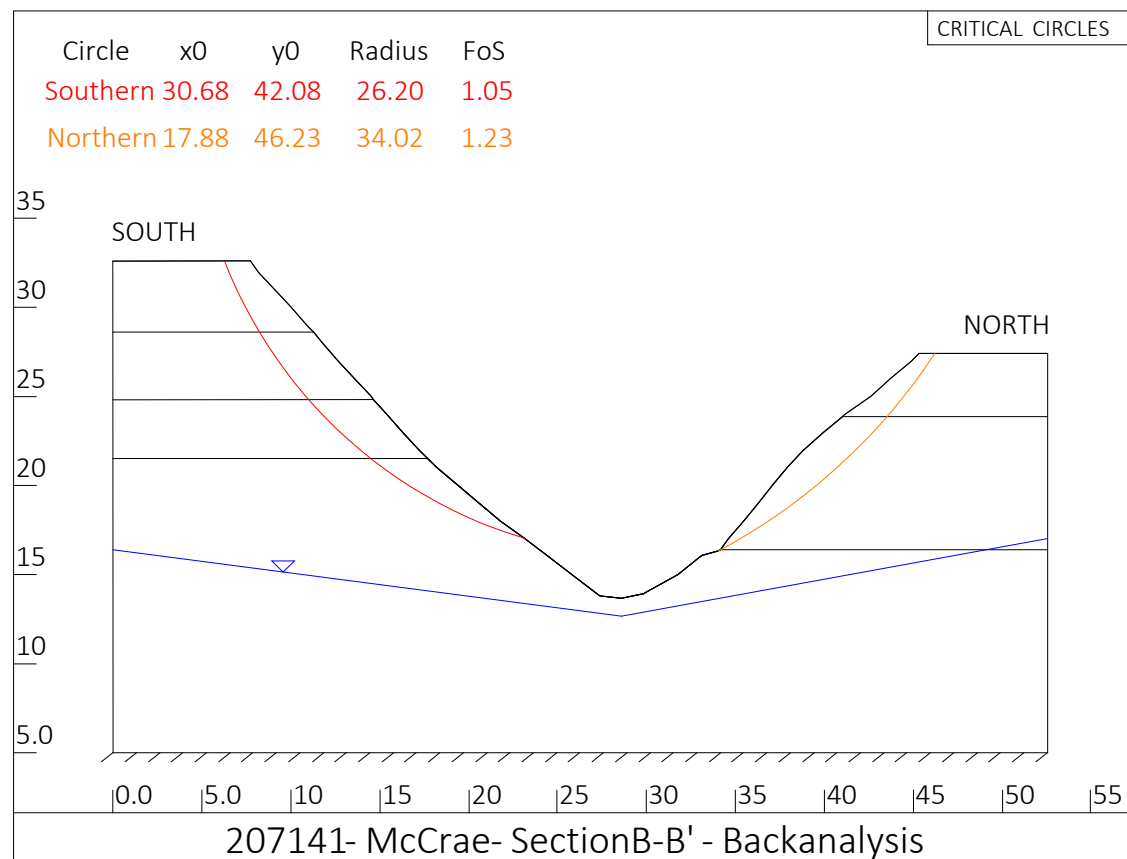
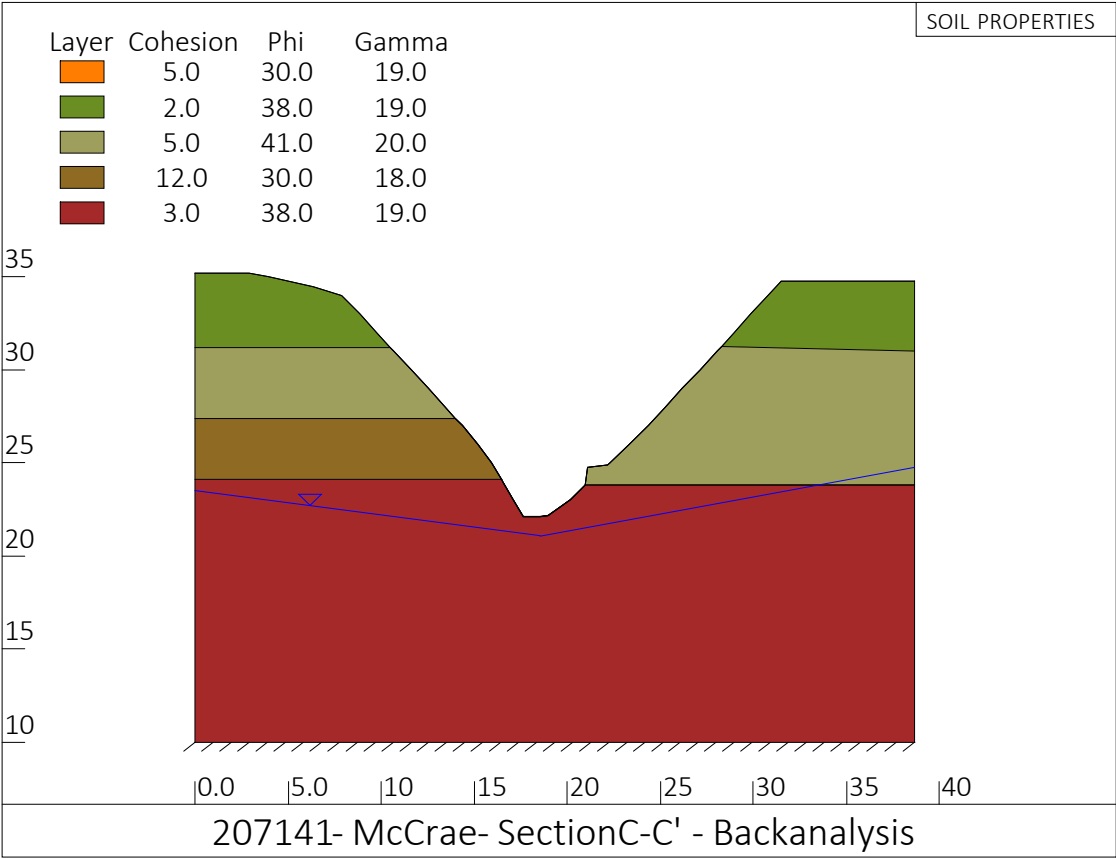
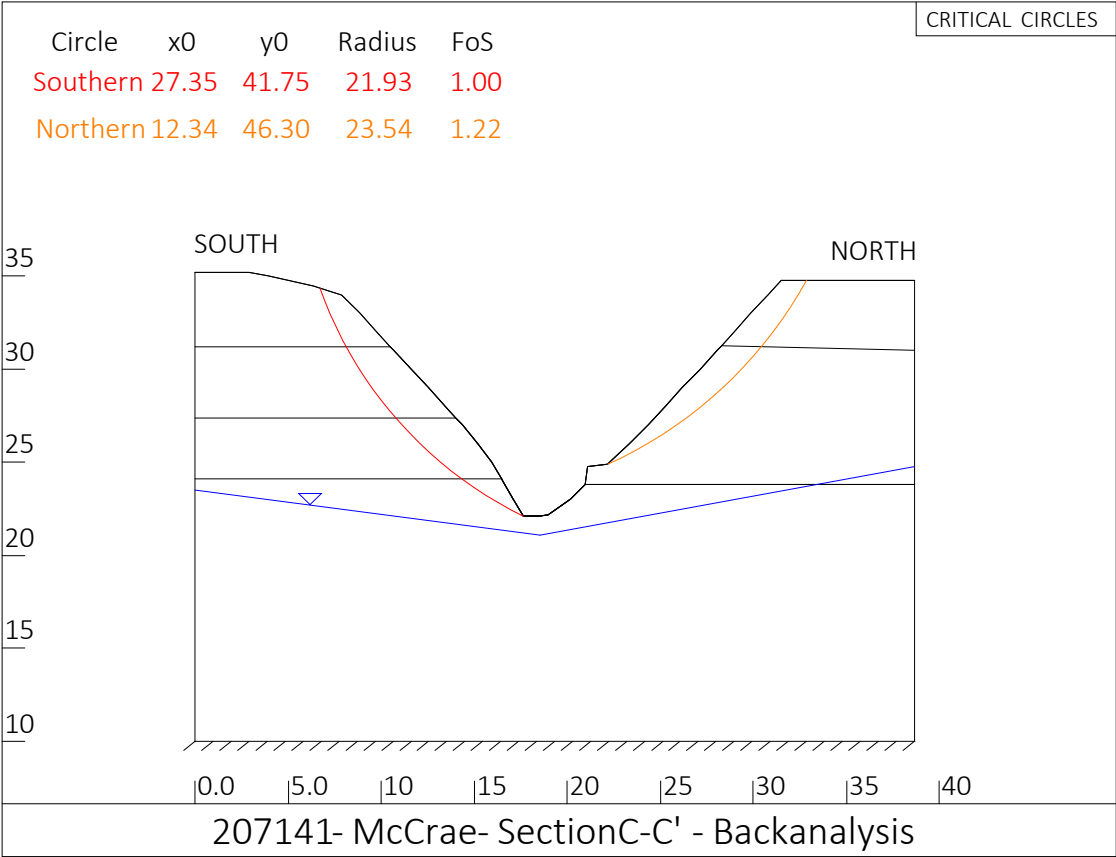
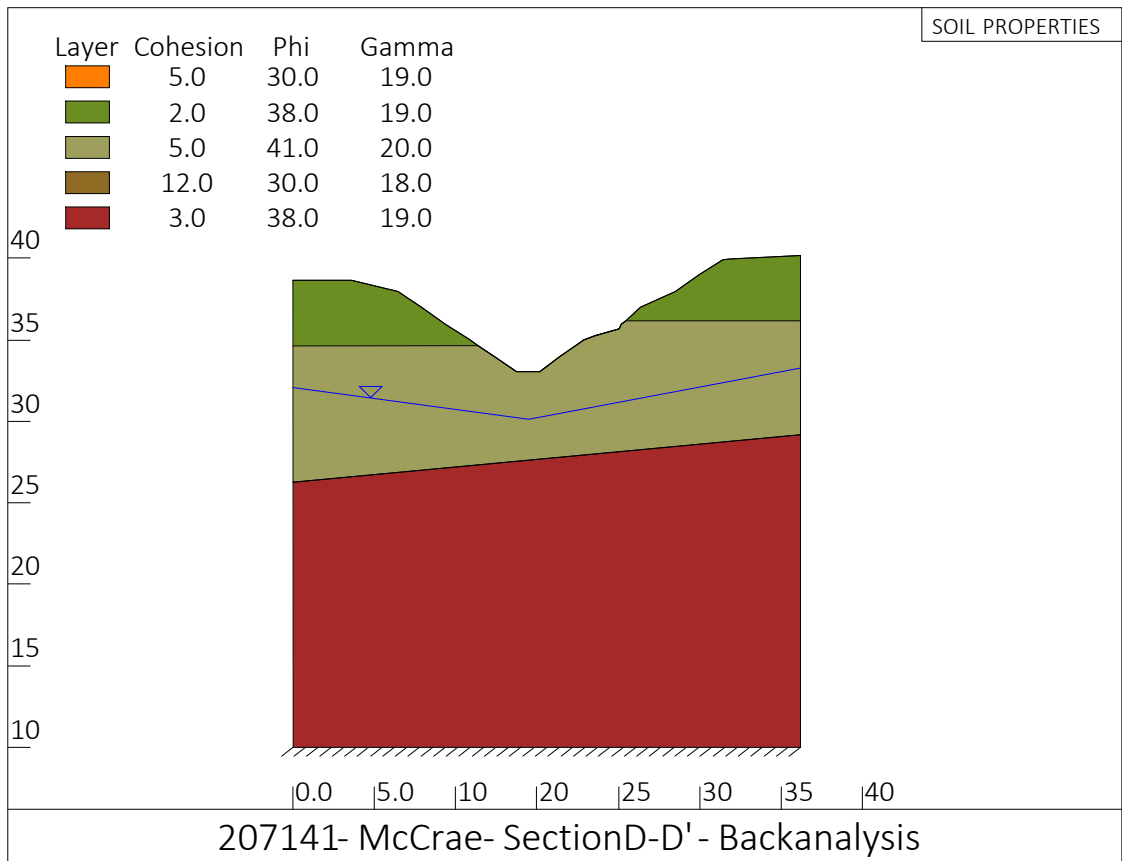
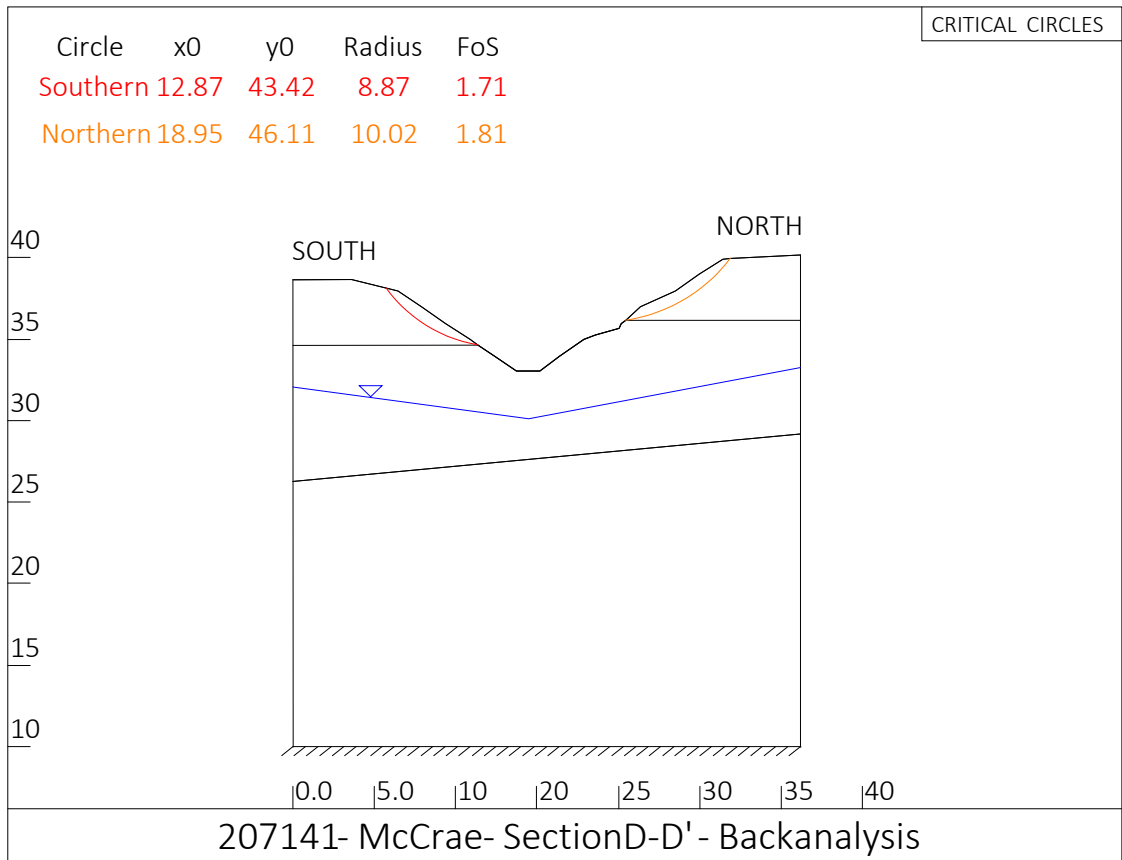
TITLE		XSLOPE OUTPUT	
SCALE (A4)	SHOWN	JOB NO	207141
DRAWN	DBS	DATE	3 SEP 2007
		REV.	0 FIG. 4
REF: 207141XSlope Results

It should be noted that the presence of the sandy clays only on the left side of the analysis, as indicated by the clays only being present in BH02, generally resulted in lower factors of safety for the southern batter slip circles.

Three of the four sections (Sections 1 to 3) that were analysed in the model calibration were found to have factors of safety in both the southern and northern directions that were in the range of 1.00 to 1.49. i.e. marginally stable.
