# TECHNICAL MEMORANDUM

| <b>Project</b> | Penny Lane, McCrae | <b>Date</b> | 7/12/2022 |
| <b>Subject</b> | Geotechnical Assessment | <b>Ref No.</b> | V220600Report01.1 |

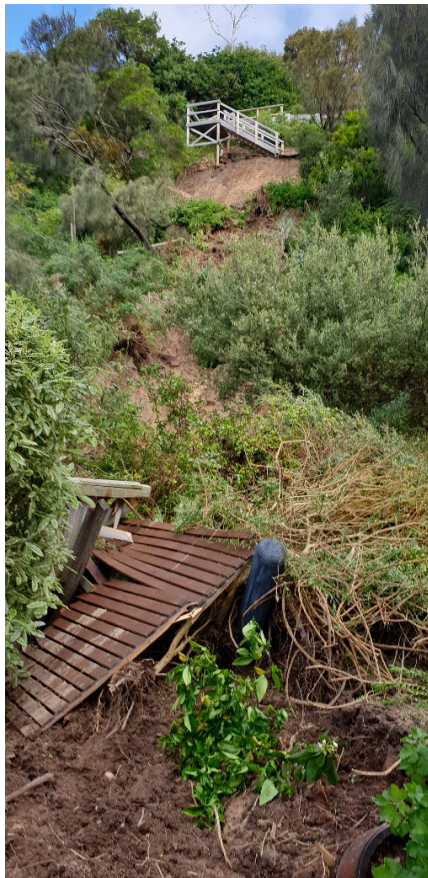
Figure 4-8: Accumulation zone of debris flow and view to top of landslide

Figure 4-7 shows the accumulation zone of the debris flow. It can be seen that the debris flow crossed over Penny Lane, which lies between 10-12 View Point Road and the houses along Pt Nepean Road, and into the rear of two properties.

The conditions on either side of where the debris flow occurred were observed to be significantly different. On the right (western) side the conditions were quite dry and there was no evidence of water seepage. However, on the left (eastern) side there were a number of water seeps observed. These water seeps were observed to be flowing freely more than 24 hours after the heavy rainfall event.

An example of one of the water seeps is shown in Figure 4-8.
