# Expert Opinion Report - Landslide Assessment

10-12 View Point Road, McCrae

PSM5226-006R Rev0      11 June 2024

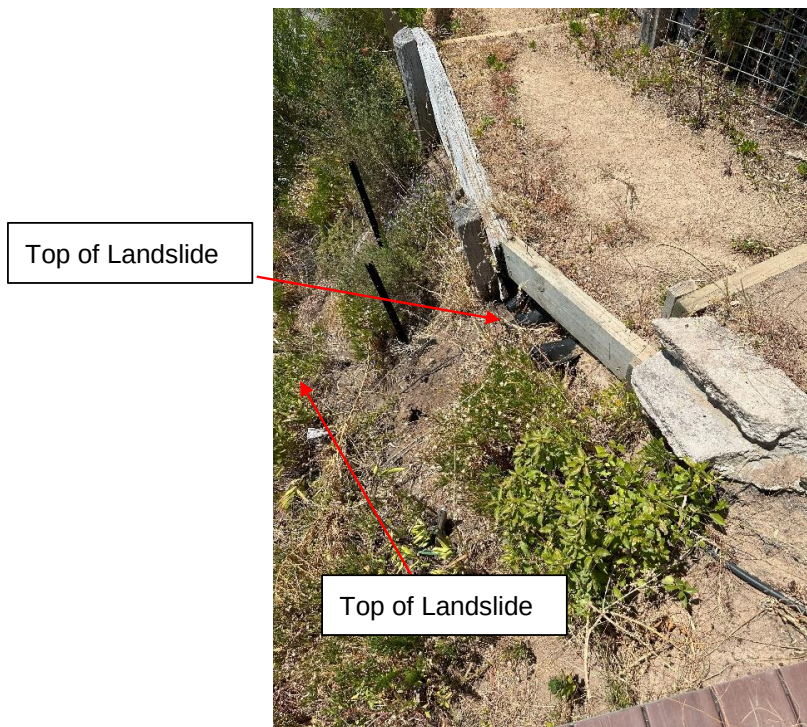
- (e) A series of paths had been constructed across the slope to provide access from the top to the bottom of the escarpment, Photo 8 & 9 Appendix E. The paths are constructed from varying materials. Other infrastructure associated with the paths include minor RWs, board walks and stairs.

Photo 8 - Path above Landslide, note minor retaining walls and 'agi drains' from Photo 7

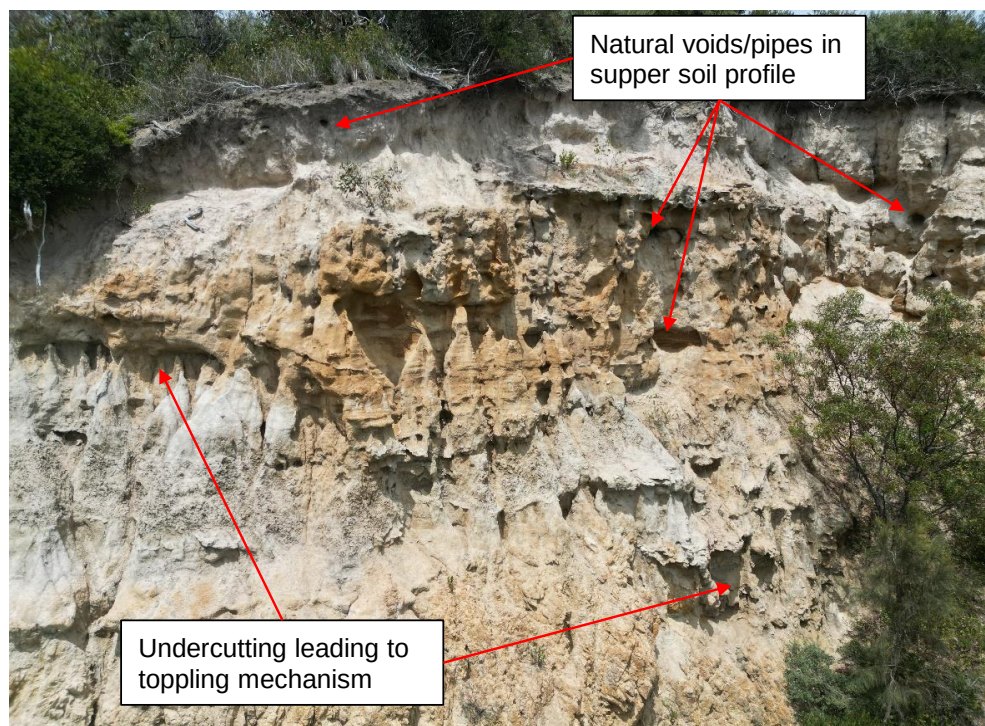
- i. Natural voids and internal erosion (i.e., piping) is common in upper soil profile, Photo 13 Appendix E.
    - ii. A sub vertical cliff profile in extremely weathered and highly weathered granite, Photo 14 Appendix E. I note this sub-vertical may be the result of road construction activities in the 1920's and 1930's.

Photo 13 - Natural cliff profile near Anthony's Nose

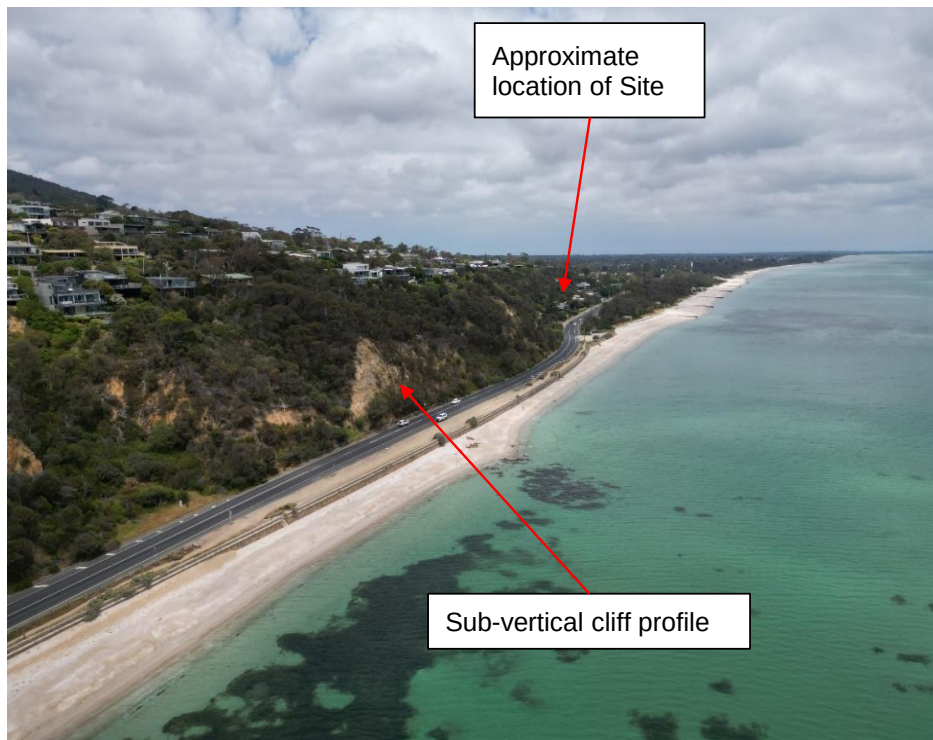
- (c) The Site is located on the lower slopes of Arthurs Seat where those slopes meet Port Phillip Bay and have formed an escarpment, Photo 14 Appendix E. In proximity to the Site the general topography of the areas slopes to the northwest. There is extensive residential development above the Site on the lower slopes of Arthurs Seat.

Photo 14 - Anthony's Nose
