# Expert Opinion Report - Landslide Assessment

10-12 View Point Road, McCrae

PSM5226-006R Rev0      11 June 2024

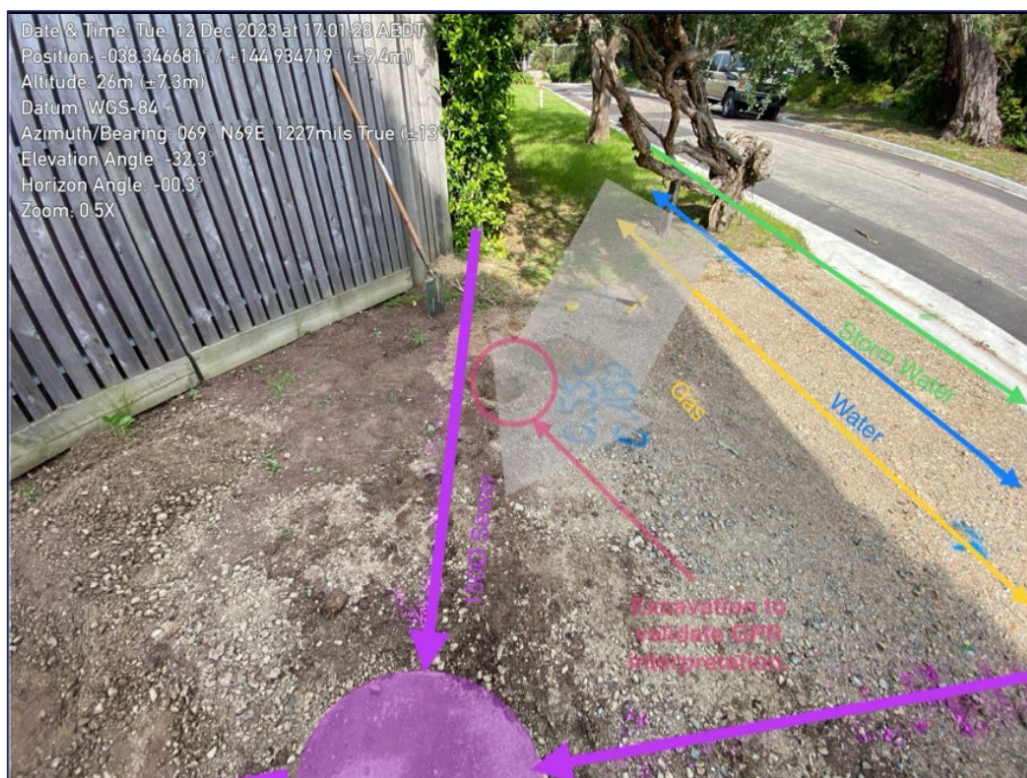
**Inset 5:** Figure 2 of Safety Scan scanning report showing location of sub-surface utilities

- Sewer, gas, water, and stormwater sub-surface utilities were identified in the nature strip, Inset 5.
13. I note that I have not observed any direct evidence of connectivity between this "void" and the Landslide.

37. I note these records match the findings of Safety Scan who verified the location of these sewer, gas, water and stormwater utilities in the nature strip in front of 10-12 View Point Rd, refer paragraph [12(b)ii(C)]. I have marked the approximate location of sub-surface utilities on Figure 1.

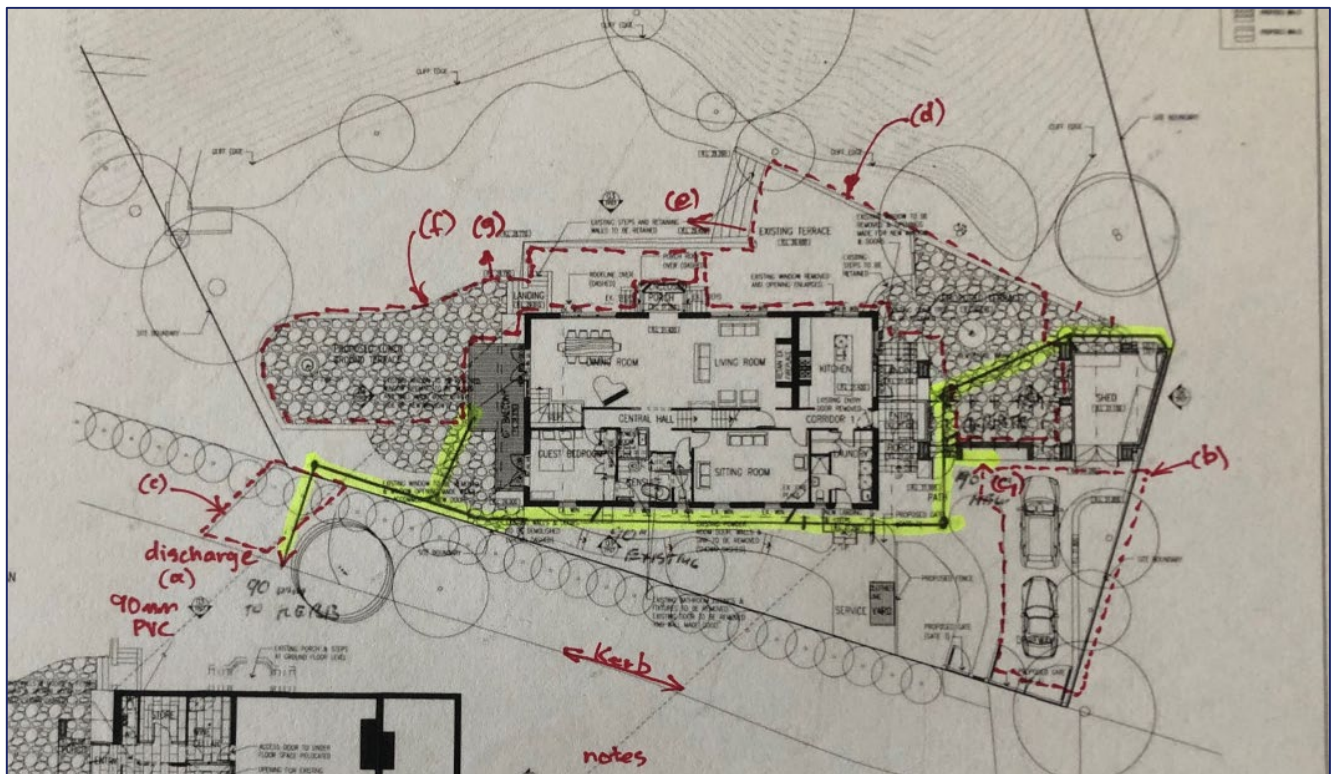
**Inset 9: Plan of P1 stormwater system (pdf page 95 of the Brief).**

22. I have assumed that the P1 stormwater system drawing is an as constructed representation.
23. Document 6 of the Brief includes a letter from Ian Chudleigh Plumbers detailing the results of a pressure test that was performed on the water lines within P1 (pdf page 96 of the Brief). It indicates to me that:

- (a) There are no leaks within the tested water lines.
  - (b) An automatic irrigation system is present on Site.

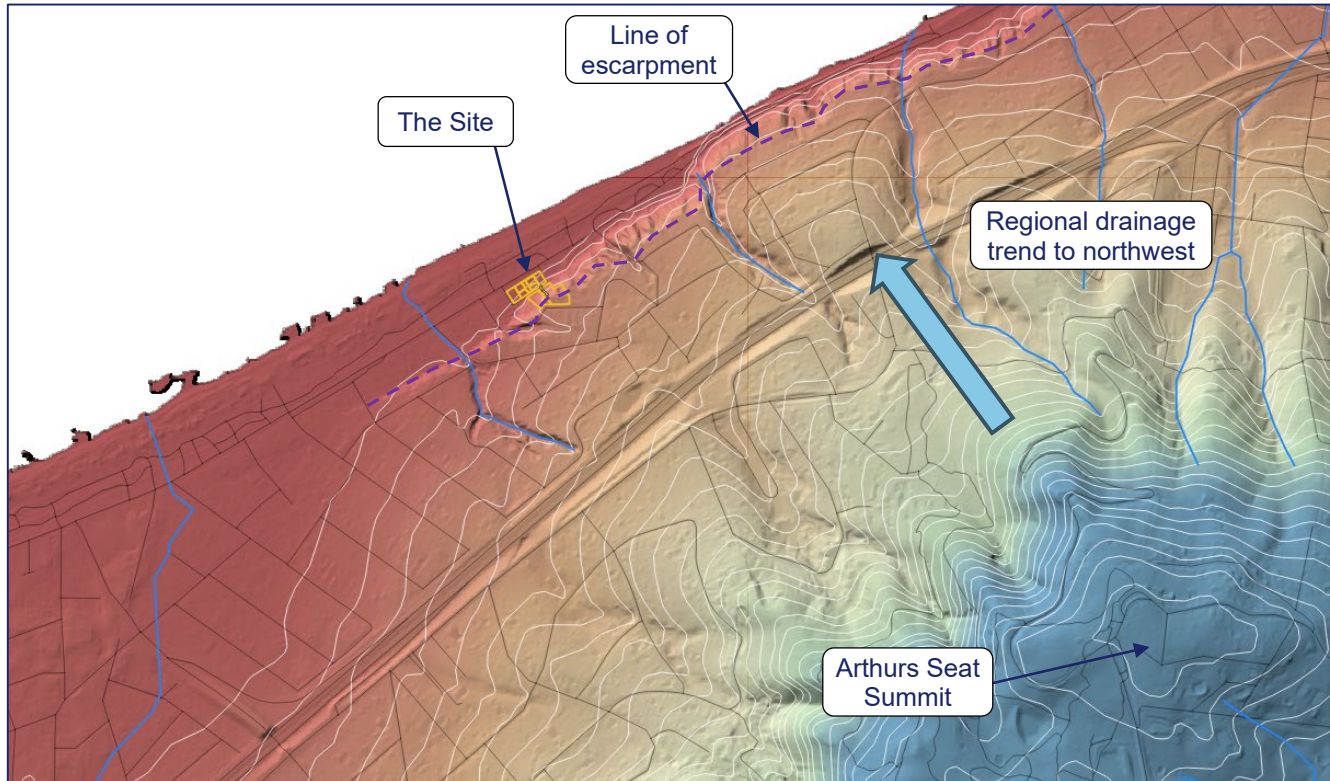
**Inset 12: Topography and drainage paths of Arthurs Seat.**

48. The Coastal LiDAR indicates that the Site is located at the lower escarpment of Arthurs Seat, Inset 12. There is approximately 270 metres of relief measured in a northwest direction from the summit of Arthurs Seat to the escarpment at the Site. I note that drainage paths typically strike in a north to northwest direction and that the Mornington Peninsula Freeway provides significant disruption to surface and sub-surface water flows in the region.

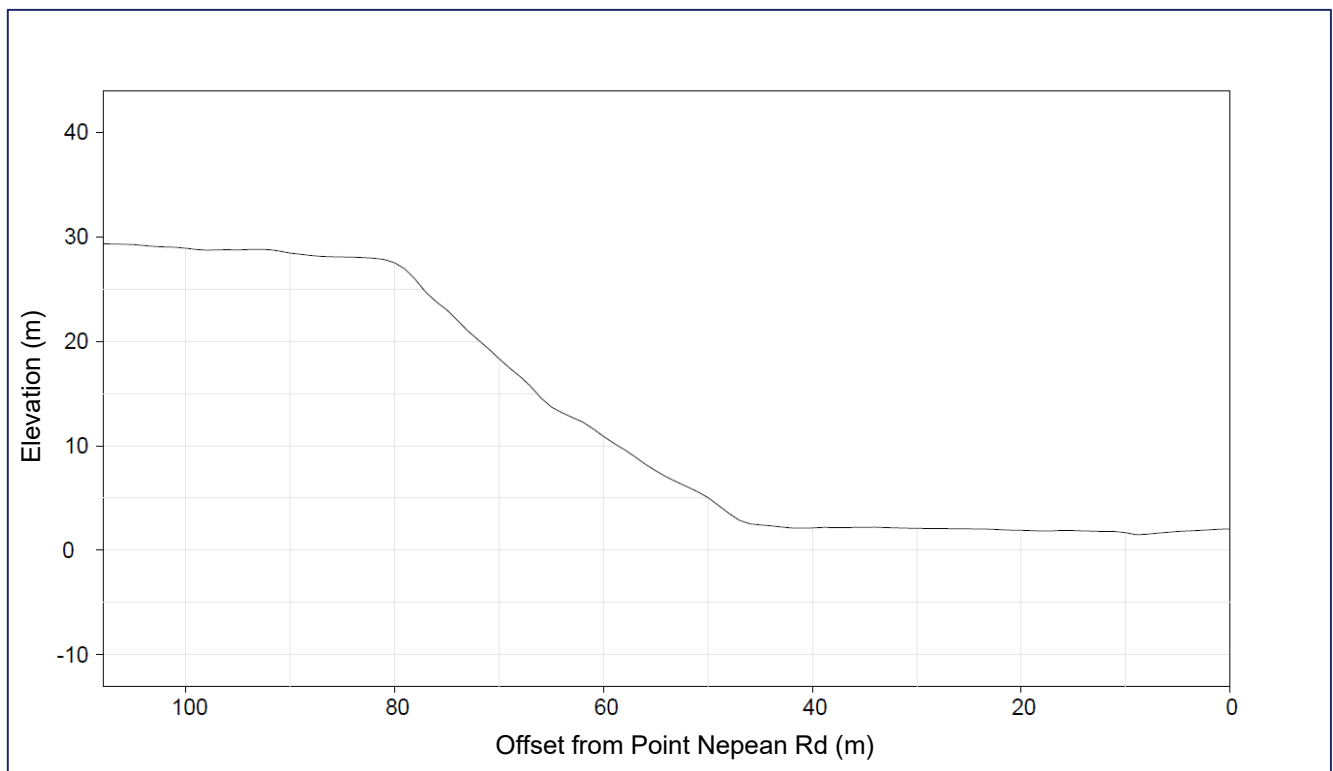
**Inset 13: Prefailure slope geometry through the centre of the Landslide from Coastal LiDAR 1 DEM.**

- (e) Pre-failure slope geometry of the Landslide is shown in Inset 13.
  - (f) A lack of large-scale features other than gullies, that may indicate the presence of a large, full height slope failure mechanism.

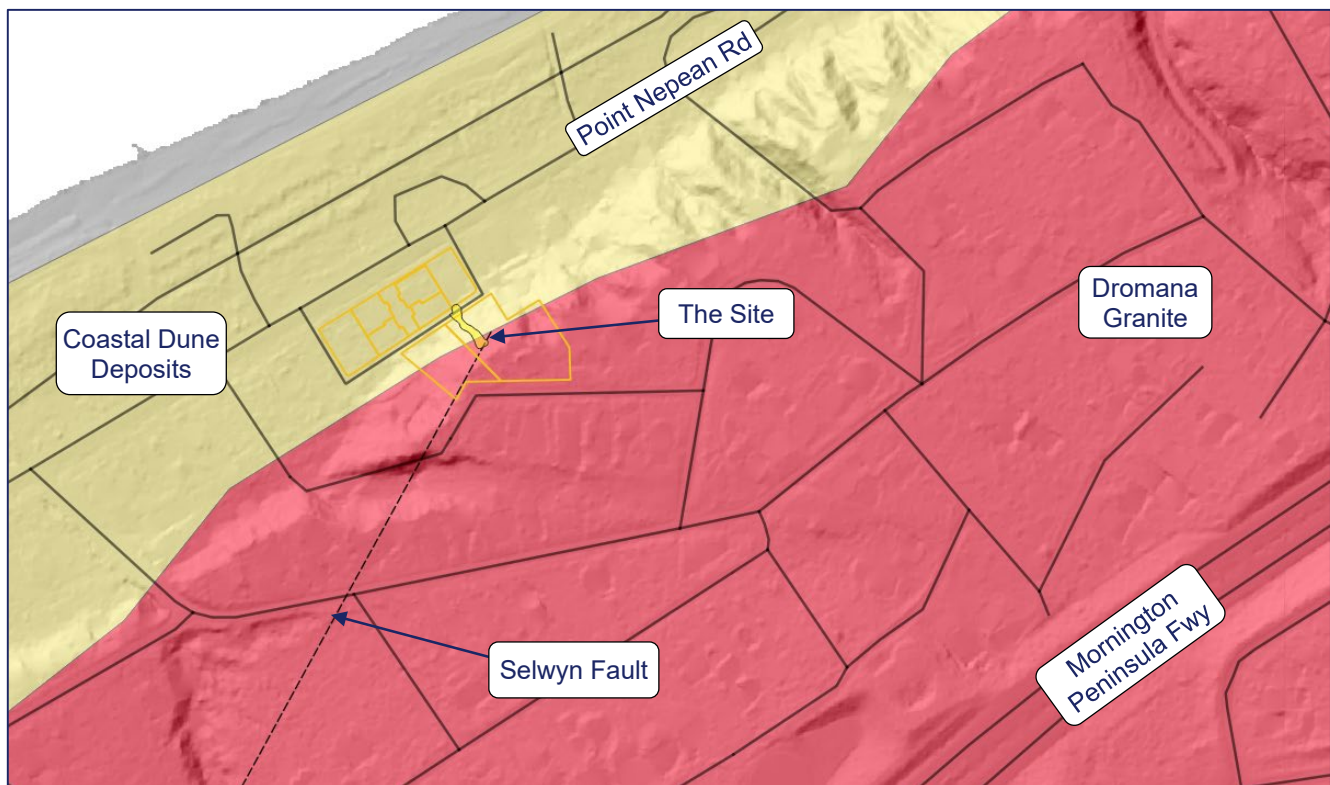
**Inset 14: Earth resources seamless geology map of the area, with Selwyn Fault highlighted.**

51. The Victoria Seamless Geology (Earth Resources publications (efirst.com.au), (2014)) model indicates that the Site is close to the boundary of Quaternary aged coastal dune deposits (with siliceous and calcareous sands) and Devonian aged Dromana granite. The Earth Resources mapping portal (GeoVic Anonymous (gsv.vic.gov.au), accessed 1 November 2023) indicates that the inferred location of the Selwyn Fault traverses the Site, Inset 14.

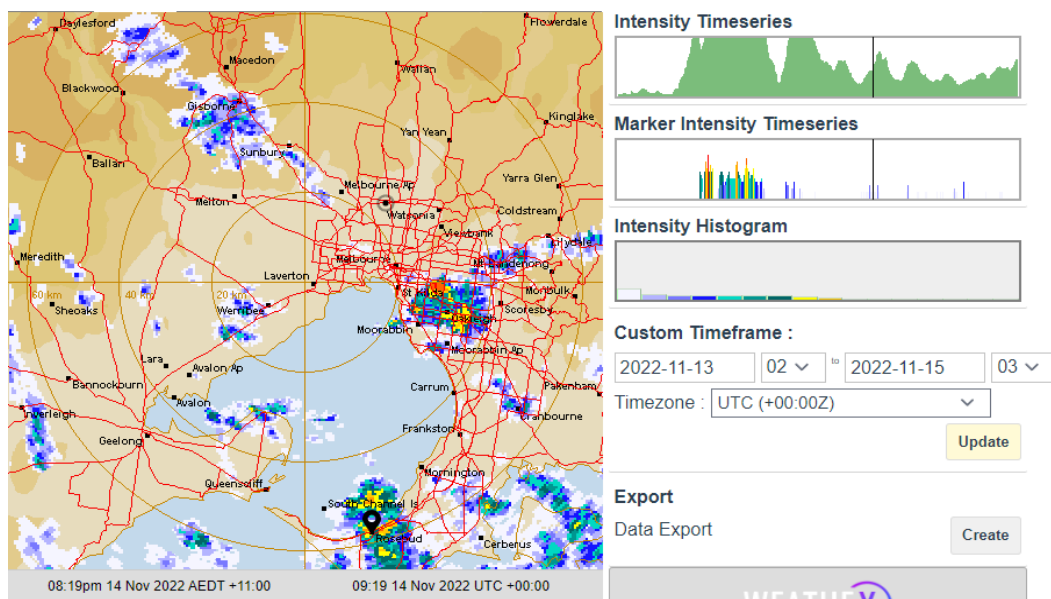
Figure D3: Radar plot 8:19 pm on 14/11/2022

28. Review of the Melbourne radar archive (Melbourne Radar - 128km Rain Rate (theweatherchaser.com), accessed 31/10/2023) indicates that:
- (a) The majority of moderate to heavy rainfall was observed between 11pm on 13/11/2023 and 7am on 14/11/2023, Figures C1 to C2 of Appendix C.
  - (b) Some showers were recorded for the remainder of the 14/11/2023, Figure C3 of Appendix C.

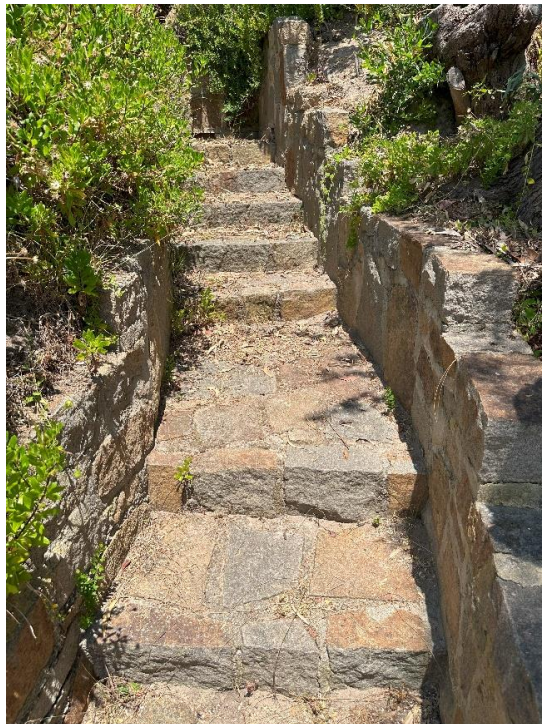
Photo 9 - Granite stairs leading from garden area to path at top of landslide

- (e) A series of paths had been constructed across the slope to provide access from the top to the bottom of the escarpment, Photo 8 & 9 Appendix E. The paths are constructed from varying materials. Other infrastructure associated with the paths include minor RWs, board walks and stairs.

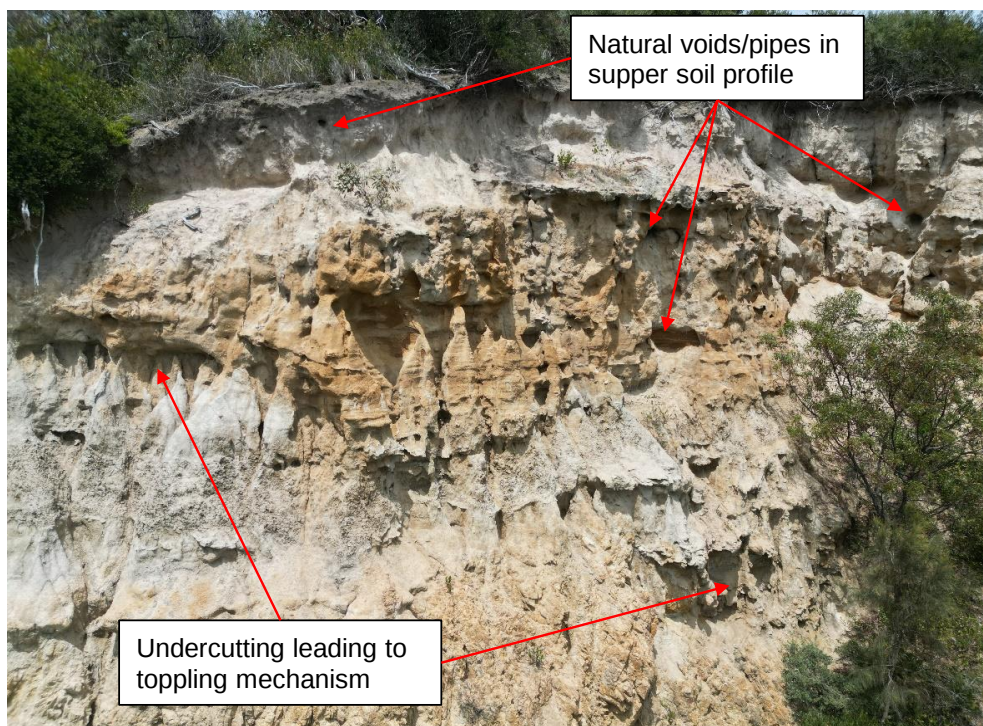
Photo 13 - Natural cliff profile near Anthony's Nose

- i. Natural voids and internal erosion (i.e., piping) is common in upper soil profile, Photo 13 Appendix E.
    - ii. A sub vertical cliff profile in extremely weathered and highly weathered granite, Photo 14 Appendix E. I note this sub-vertical may be the result of road construction activities in the 1920's and 1930's.

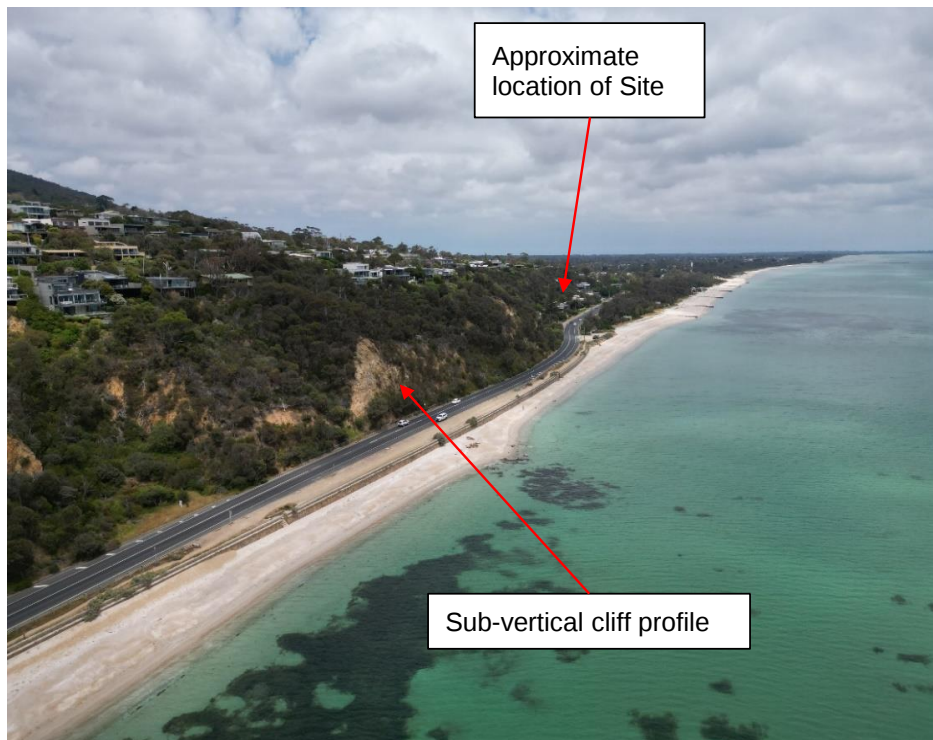
Photo 14 - Anthony's Nose

- (c) The Site is located on the lower slopes of Arthurs Seat where those slopes meet Port Phillip Bay and have formed an escarpment, Photo 14 Appendix E. In proximity to the Site the general topography of the areas slopes to the northwest. There is extensive residential development above the Site on the lower slopes of Arthurs Seat.
