# Expert Opinion Report - Landslide Assessment

10-12 View Point Road, McCrae

PSM5226-006R Rev0      11 June 2024

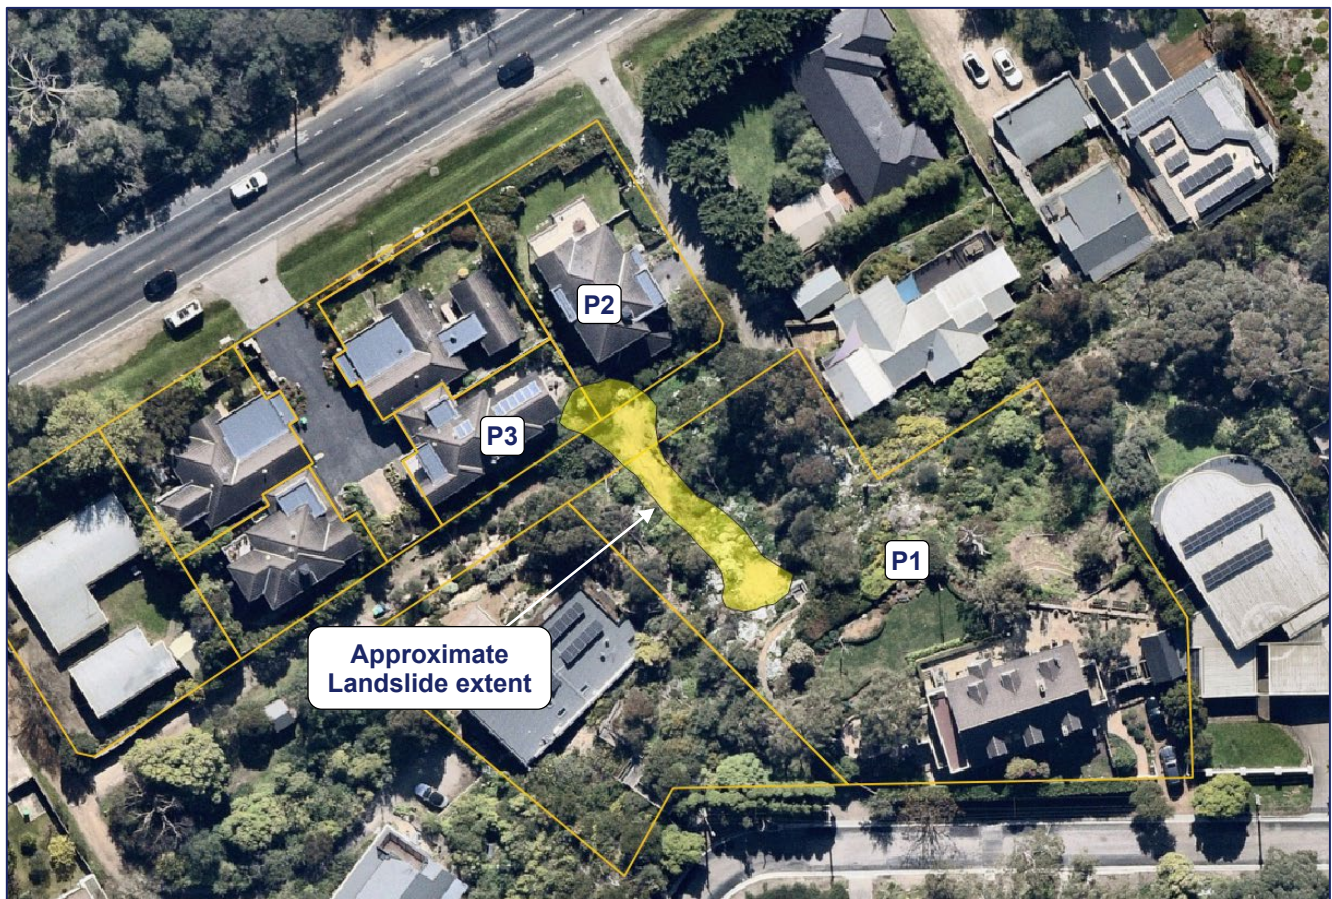
**Inset 1: Plan of properties affected by the Landslide (Aerial Image from Nearmap dated 25 August 2023).**

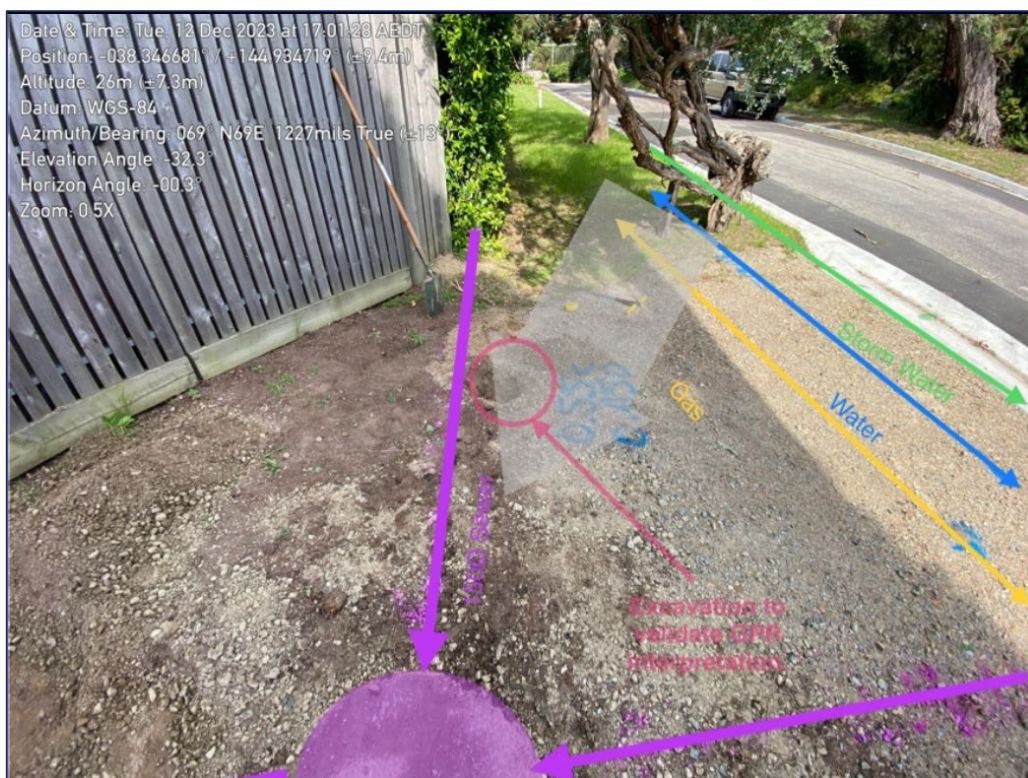
- Sewer, gas, water, and stormwater sub-surface utilities were identified in the nature strip, Inset 5.
13. I note that I have not observed any direct evidence of connectivity between this "void" and the Landslide.

**Inset 5:** Figure 2 of Safety Scan scanning report showing location of sub-surface utilities

37. I note these records match the findings of Safety Scan who verified the location of these sewer, gas, water and stormwater utilities in the nature strip in front of 10-12 View Point Rd, refer paragraph [12(b)ii(C)]. I have marked the approximate location of sub-surface utilities on Figure 1.

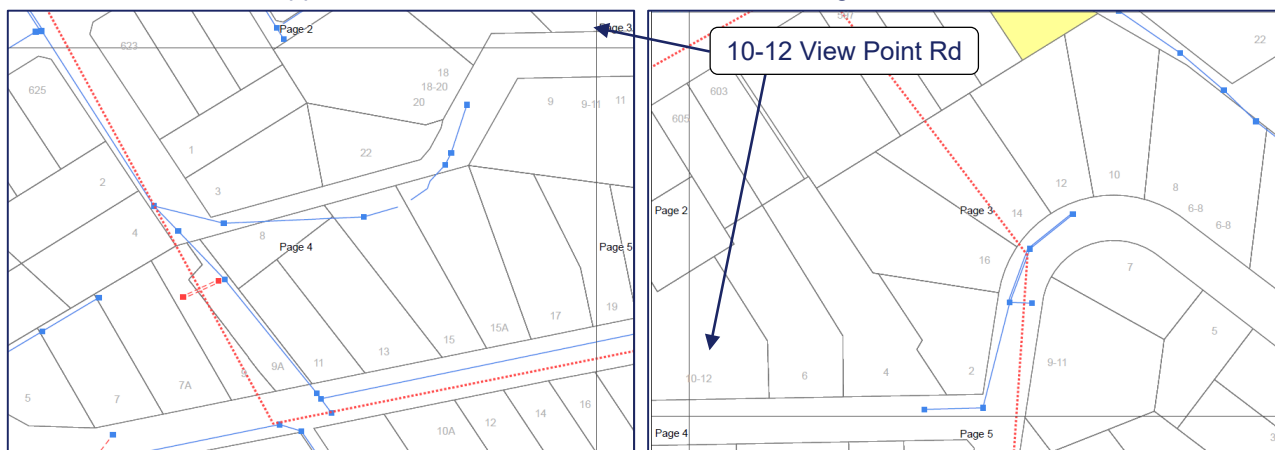
- (b) APA gas line is present in nature strip on the north side of View Point Rd, it is located approximately 3.0 m from the property boundary line.
36. I understand that the stormwater system was reconstructed in mid-2023 and it now includes stormwater pits and pipes for the whole length of View Point Road, refer paragraph [24(b)].

**Inset 11: MPSC drainage network. Drainage pits are shown as blue squares, and drainage pipes as blue lines (([www.byda.com.au](http://www.byda.com.au)) on 16 November 2023).**

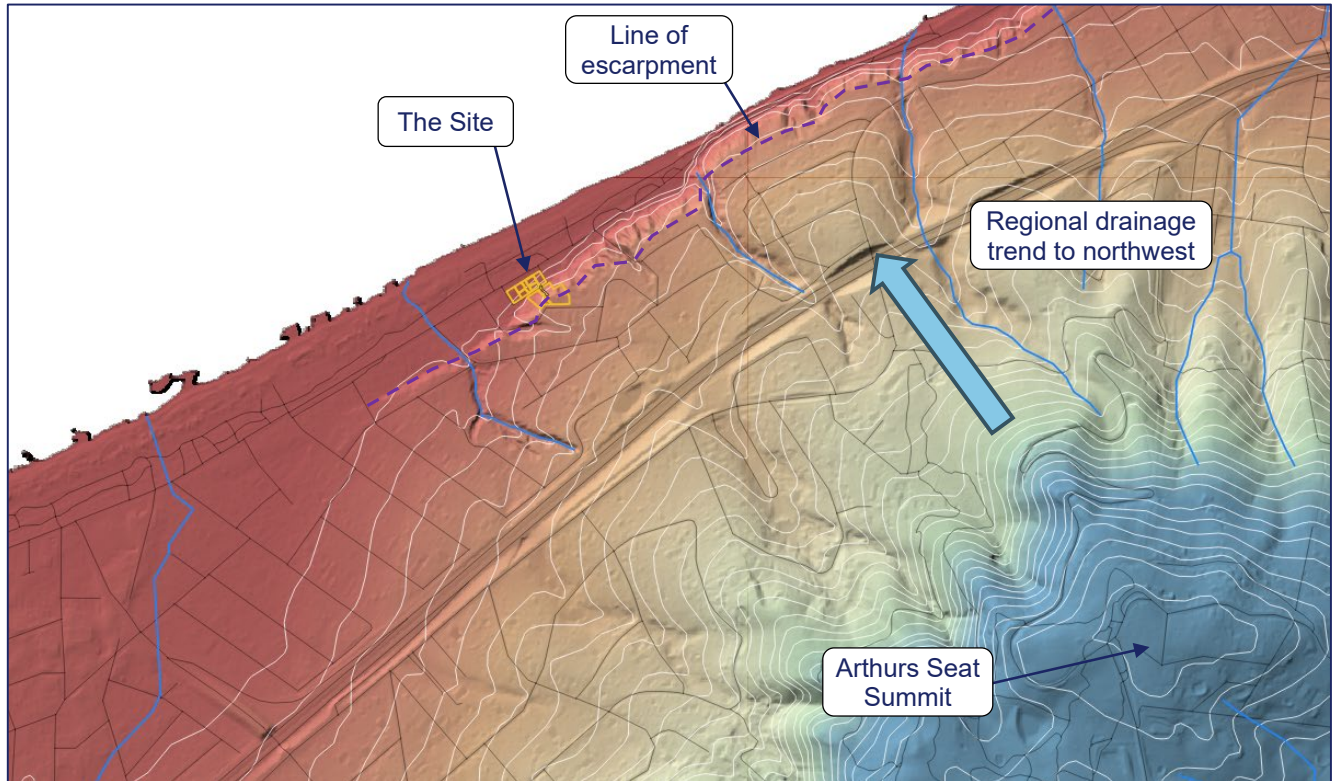
48. The Coastal LiDAR indicates that the Site is located at the lower escarpment of Arthurs Seat, Inset 12. There is approximately 270 metres of relief measured in a northwest direction from the summit of Arthurs Seat to the escarpment at the Site. I note that drainage paths typically strike in a north to northwest direction and that the Mornington Peninsula Freeway provides significant disruption to surface and sub-surface water flows in the region.

**Inset 12: Topography and drainage paths of Arthurs Seat.**

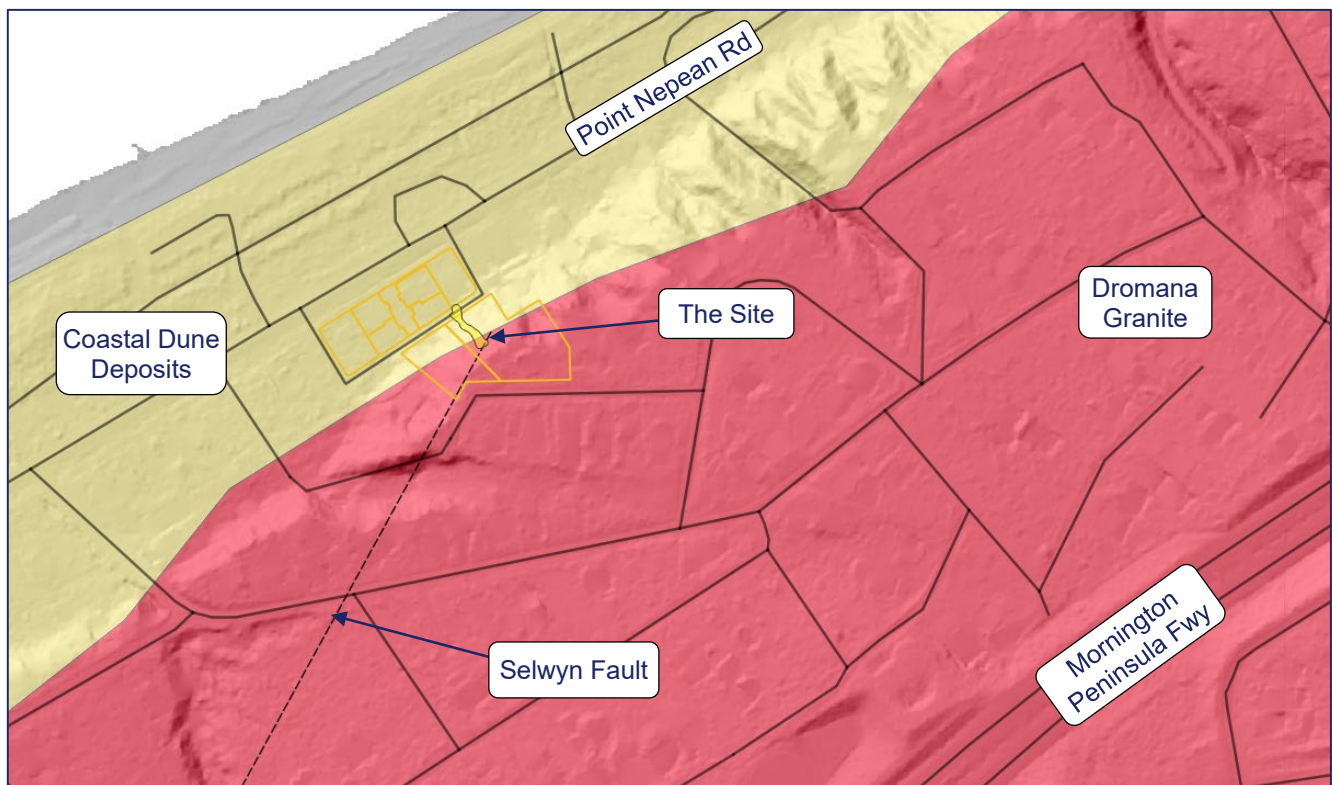
51. The Victoria Seamless Geology (Earth Resources publications (efirst.com.au), (2014)) model indicates that the Site is close to the boundary of Quaternary aged coastal dune deposits (with siliceous and calcareous sands) and Devonian aged Dromana granite. The Earth Resources mapping portal (GeoVic Anonymous (gsv.vic.gov.au), accessed 1 November 2023) indicates that the inferred location of the Selwyn Fault traverses the Site, Inset 14.

**Inset 14: Earth resources seamless geology map of the area, with Selwyn Fault highlighted.**

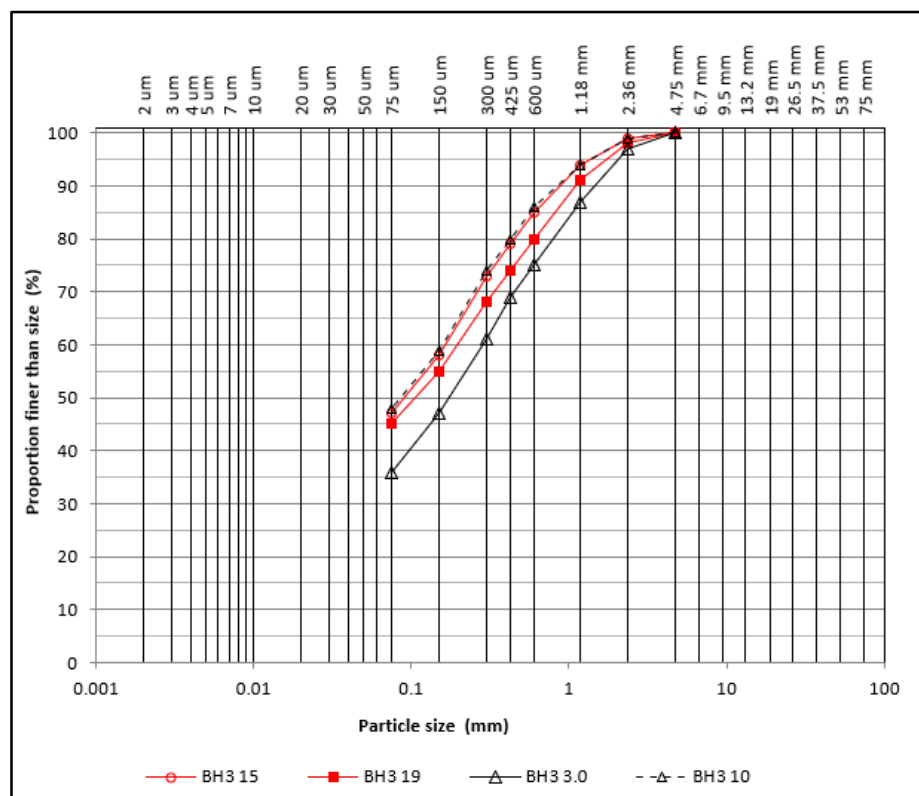
Inset 16: CivilTest Particle Size Distributions.

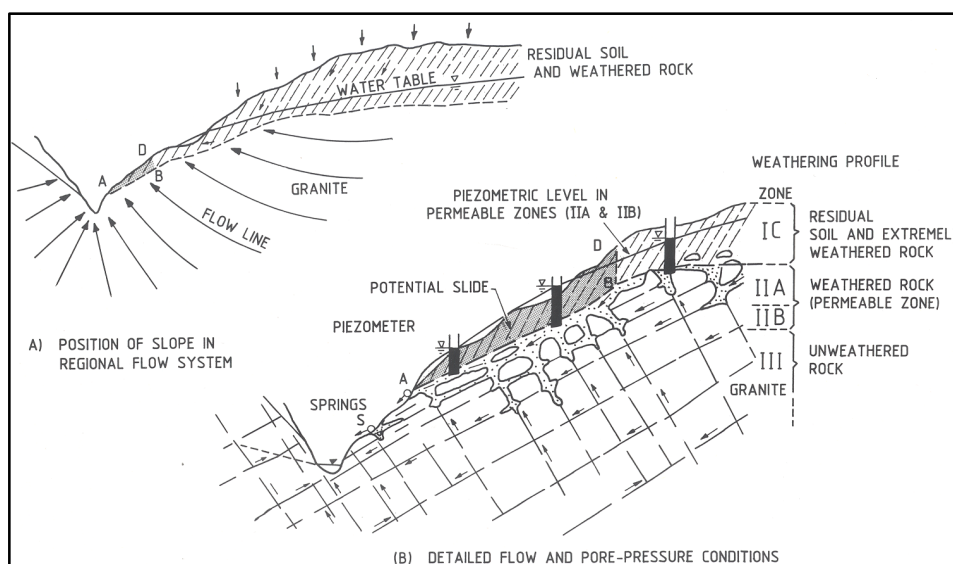
58. With regards to groundwater flow, it is my opinion that:
- (a) The deposition of the SURFICIAL SAND unit will have conformed to the pre-existing slopes of the RESIDUAL GRANITE unit.

- (b) The slope aspect of the RESIDUAL GRANITE is towards the northwest (refer paragraph [49(c)]).
  - (c) Groundwater flow will follow the SURFICIAL SAND/RESIDUAL GRANITE interface; therefore it is expected groundwater flow direction will be to the northwest.

**Inset 17: Possible piezometric conditions in weathered granitic soils (Fell et al, 2004)<sup>1</sup>.**

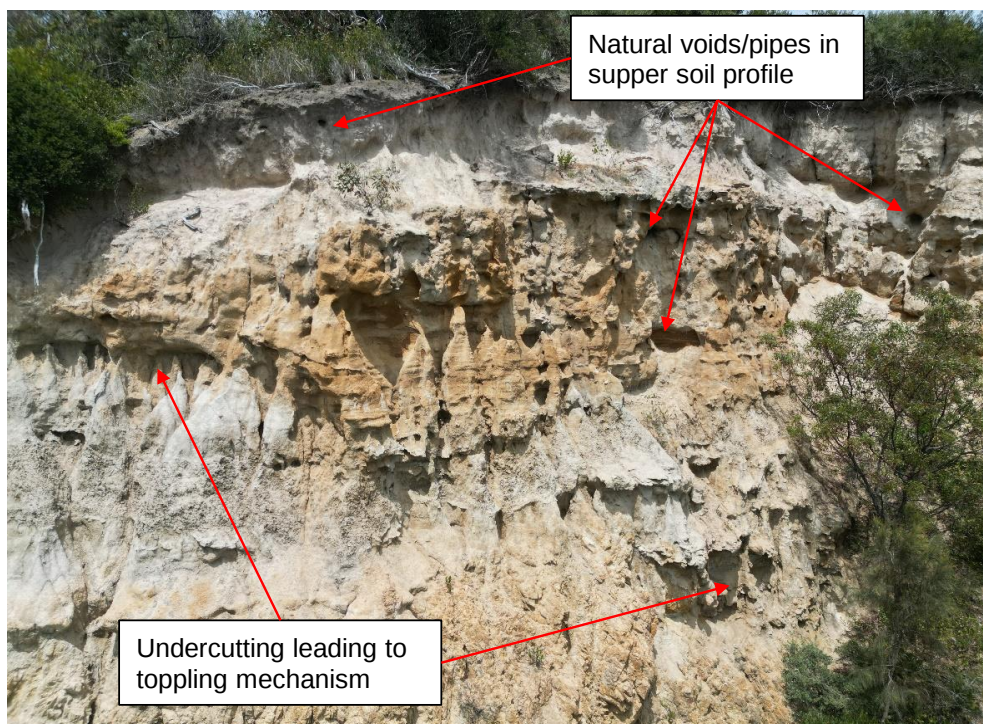
- i. Natural voids and internal erosion (i.e., piping) is common in upper soil profile, Photo 13 Appendix E.
    - ii. A sub vertical cliff profile in extremely weathered and highly weathered granite, Photo 14 Appendix E. I note this sub-vertical may be the result of road construction activities in the 1920's and 1930's.

Photo 13 - Natural cliff profile near Anthony's Nose
