Our Ref: PSM5226-002L

**RE: RISK ASSESSMENT. 10-12 VIEW POINT ROAD, MCRAE**

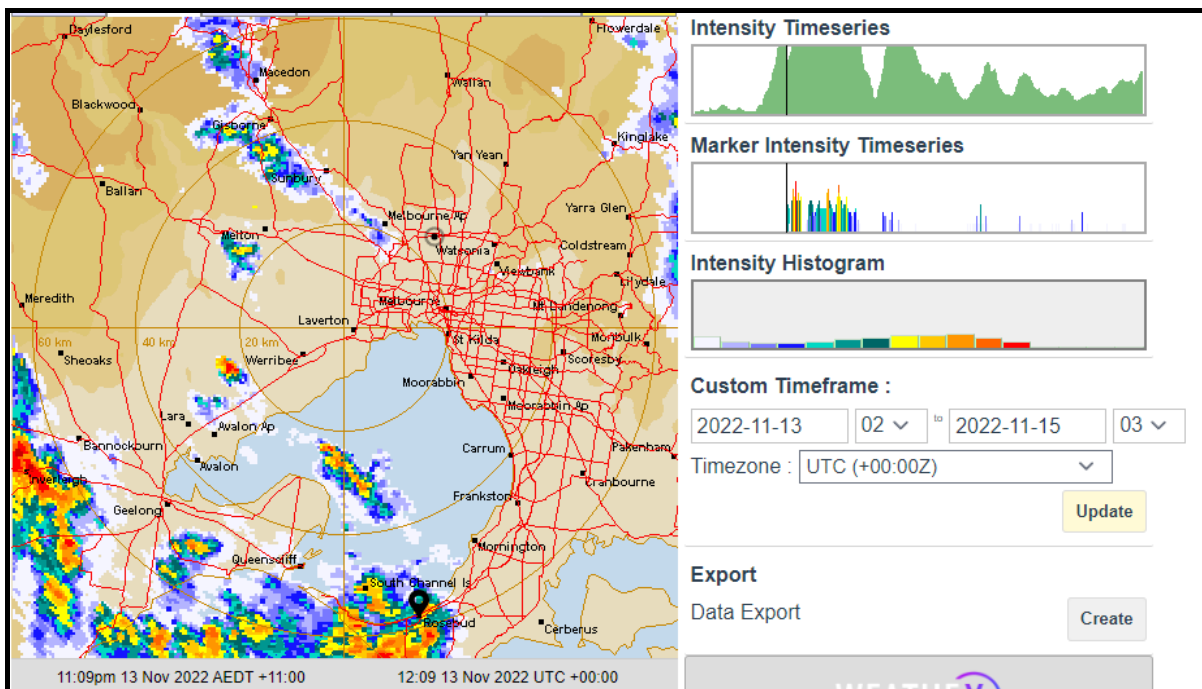
Figure A7: Radar plot 11:09 pm on 13/11/2022

- The majority of moderate to heavy rainfall was observed between 11pm on 13/11/2023 and 7am on 14/11/2023, Figures A7 to A8 of Appendix A.
- Some showers were recorded for the remainder of the 14/11/2023, Figure A9 of Appendix A.
