Our Ref: PSM5226-002L Rev1

**RE: RISK ASSESSMENT. 10-12 VIEW POINT ROAD, MCRAE**

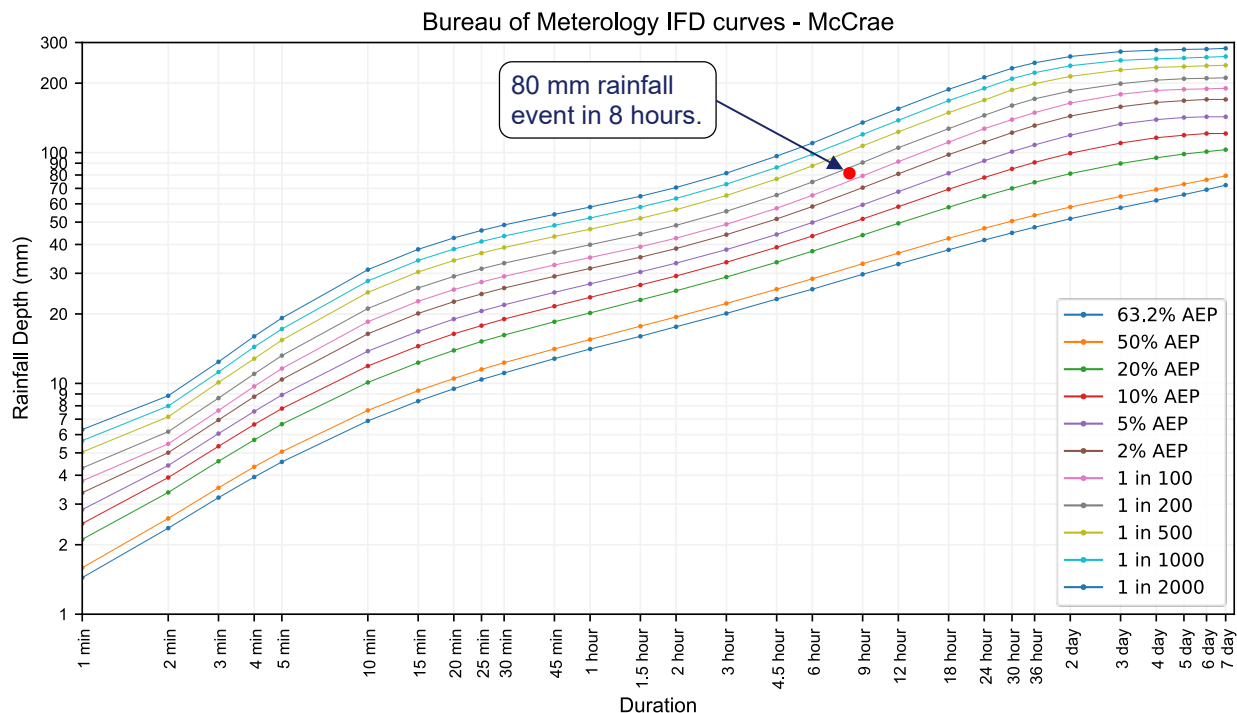
**Inset 3: BOM IFD curves for McCrae, with Rain Event marked**

- The Rain Event intensity over the 8-hour period had 1 in 100 years to 1 in 200 years probability of occurring
- 80 mm of rainfall in a 24-hour period has a 1 in 20 probability of occurring in any given year
- The Rain Event was an infrequent and intense event.

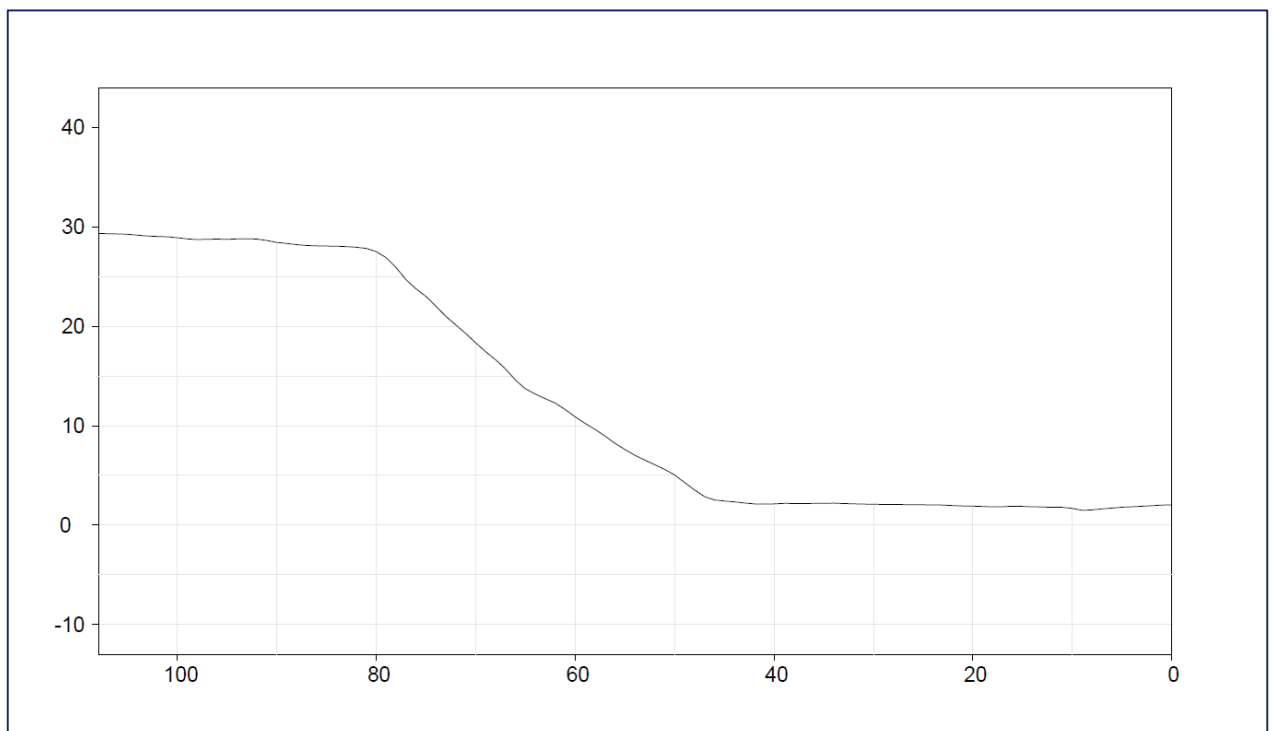
**Inset 5: Prefailure slope geometry through the centre of the Landslide from Coastal LiDAR 1 DEM.**

- (e) Pre-failure slope geometry of the Landslide is shown in Inset 5.
- (f) A lack of large-scale features other than gullies, that may indicate the presence of a large, full height slope failure mechanism.

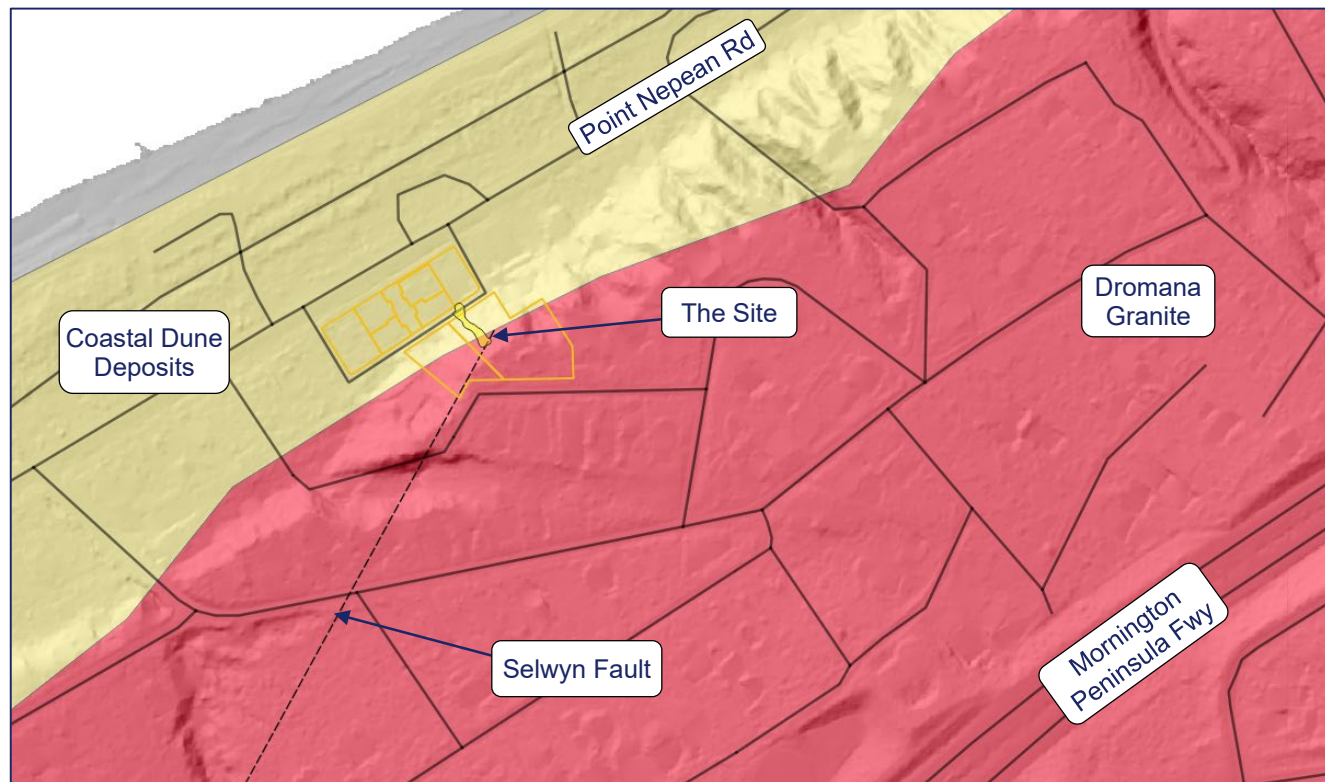
**Inset 6: Earth Resources seamless geology map of the area, with Selwyn Fault highlighted.**

The Victoria Seamless Geology ([Earth Resources publications \(efirst.com.au\)](https://earthresources.vic.gov.au/publications/efirst.com.au) , (2014)) model indicates that the Site is close to the boundary of Quaternary aged dune deposits (with siliceous and calcareous sands) and Devonian aged Dromana granite. The Earth Resources mapping portal ([GeoVic Anonymous \(gsv.vic.gov.au\)](https://geovis.vic.gov.au)), accessed 1 November 2023) indicates that the inferred location of the Selwyn Fault traverses the Site, Inset 6.

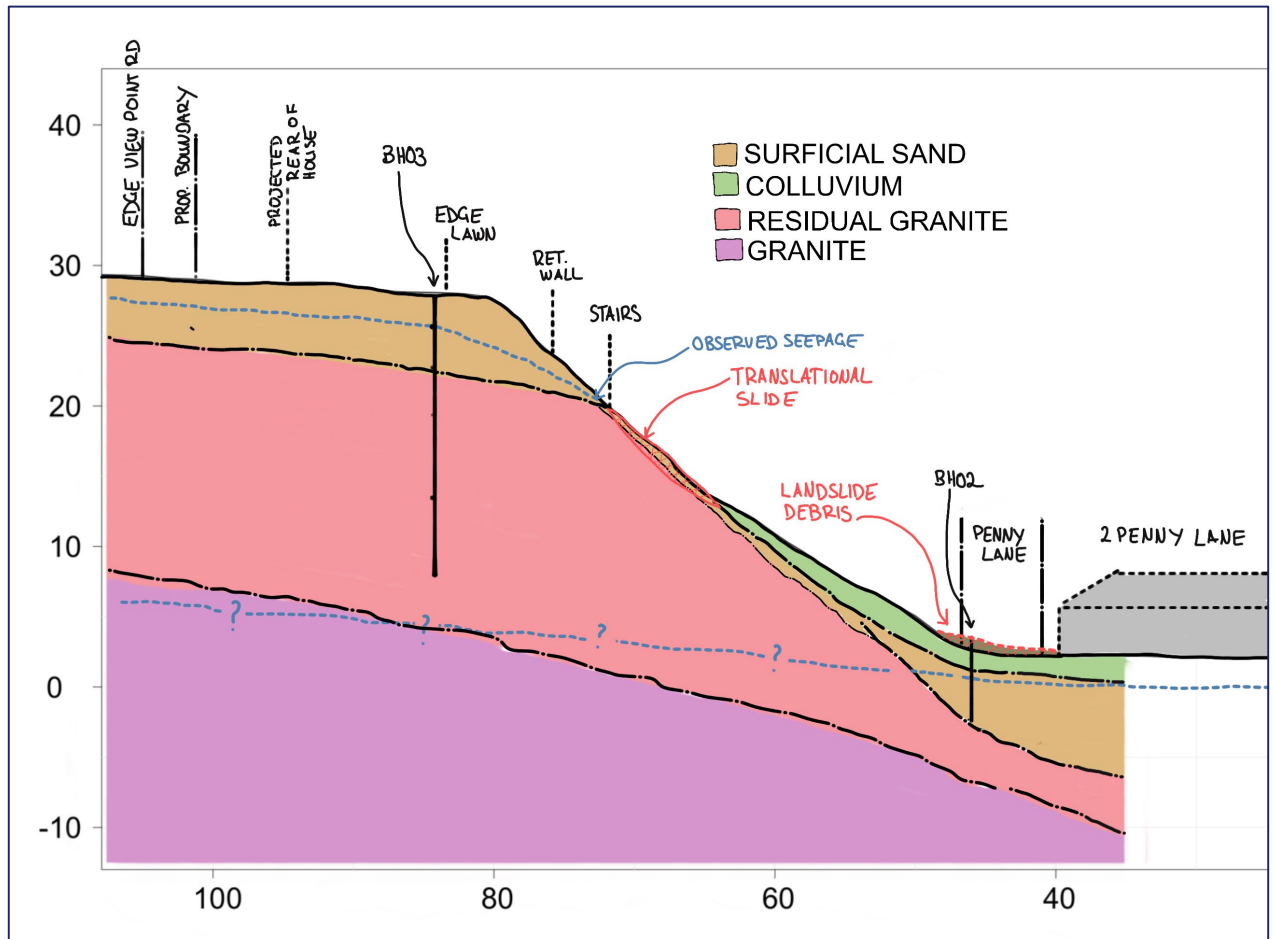
**Inset 7: PSM geological model**

Our interpretation of the geological conditions is presented in Inset 7. With regards to the geological model PSM notes the following key observations:

- There is uncertainty regarding the contact between the SURFICIAL SAND and the RESIDUAL GRANITE owing to the likelihood of some of the parent material of the SURFICIAL SAND being derived from erosion of the Dromana Granite. PSM has assumed that the wet soils are an indicator of the contact between the two geotechnical units.
- The laboratory testing indicates that all samples between 3 m and 19 m bgl have very similar Particle Size Distributions, Inset 8, and Atterberg limits indicate low plasticity CLAY fines.

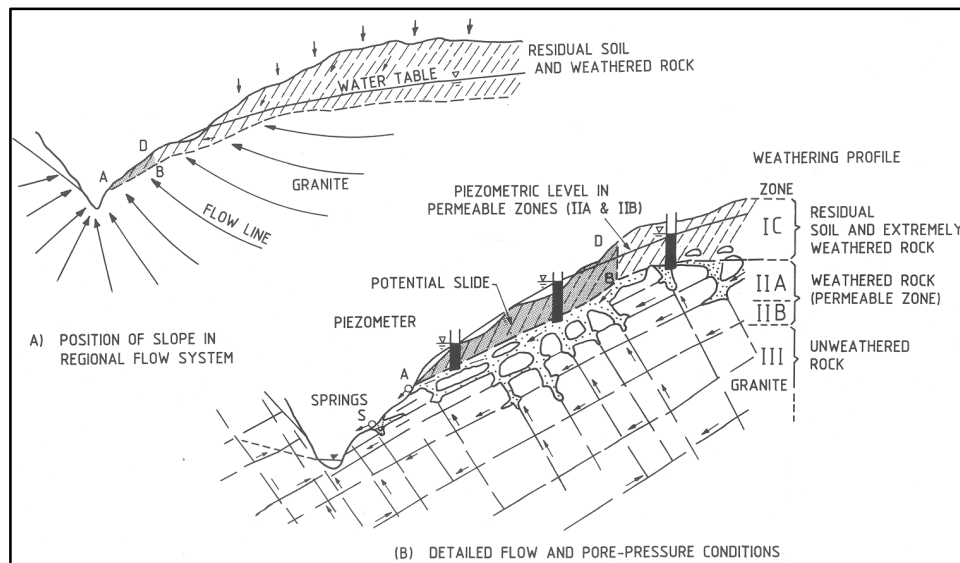
**Inset 9: Possible piezometric conditions in weathered granitic soils (Fell et al, 2004)<sup>2</sup>.**

- The observation by CivilTest of wet soils encountered in borehole 3 between 1.8 m and 5.2 m bgl in March 2023. I note that this was not during or following a period of high rainfall, Section 2.4.1.
- Furthermore, the CivilTest observation is consistent with published groundwater models in weathered granitic profiles, Inset 9.
- Observations of seepage during the Site visit (refer to Section 3).

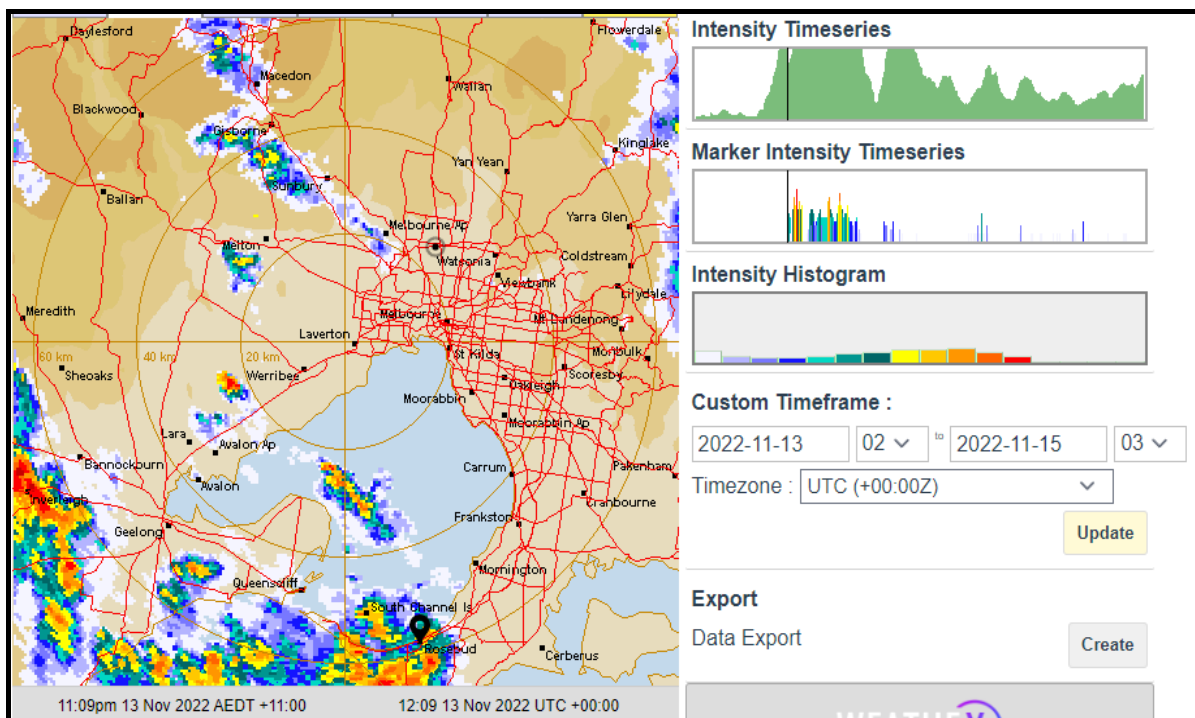
Figure A7: Radar plot 11:09 pm on 13/11/2022

- The majority of moderate to heavy rainfall was observed between 11pm on 13/11/2023 and 7am on 14/11/2023, Figures A7 to A8 of Appendix A
- Some showers were recorded for the remainder of the 14/11/2023, Figure A9 of Appendix A.

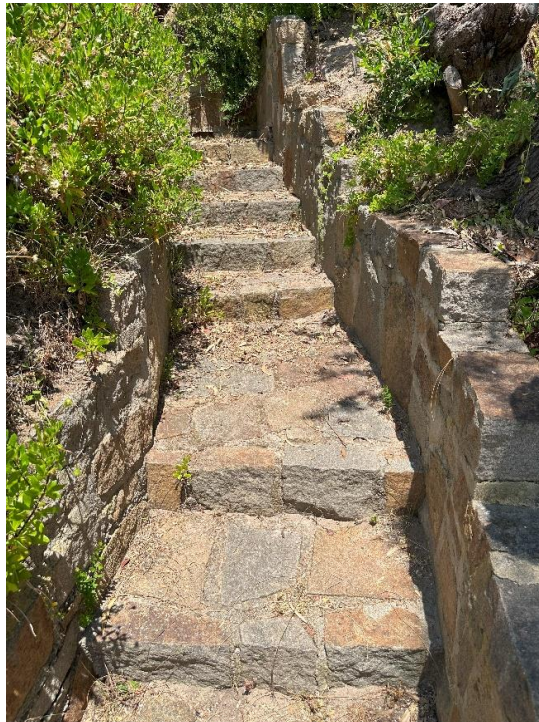
- A series of paths had been constructed across the slope to provide access from the top to the bottom of the escarpment, Photo 8 & 9 Appendix B. The paths are constructed from varying materials. Other infrastructure associated with the paths include minor RWs, board walks and stairs.

Photo 9 - Granite stairs leading from garden area to path at top of landslide

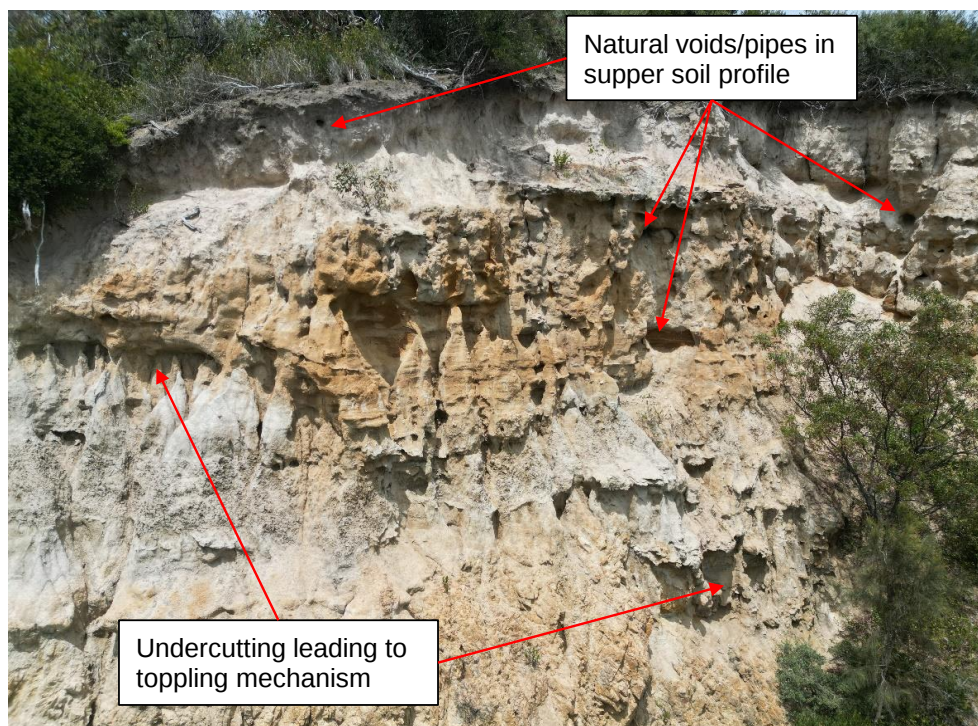
- Natural voids and internal erosion (i.e., piping) is common in the upper soil profile, Photo 13 Appendix B.
  - A sub vertical cliff profile in extremely weathered and highly weathered granite, Photo 14 Appendix B. PSM note the sub-vertical profile may be the result of road construction activities in the 1920's and 1930's.

Photo 13 - Natural cliff profile near Anthony's Nose

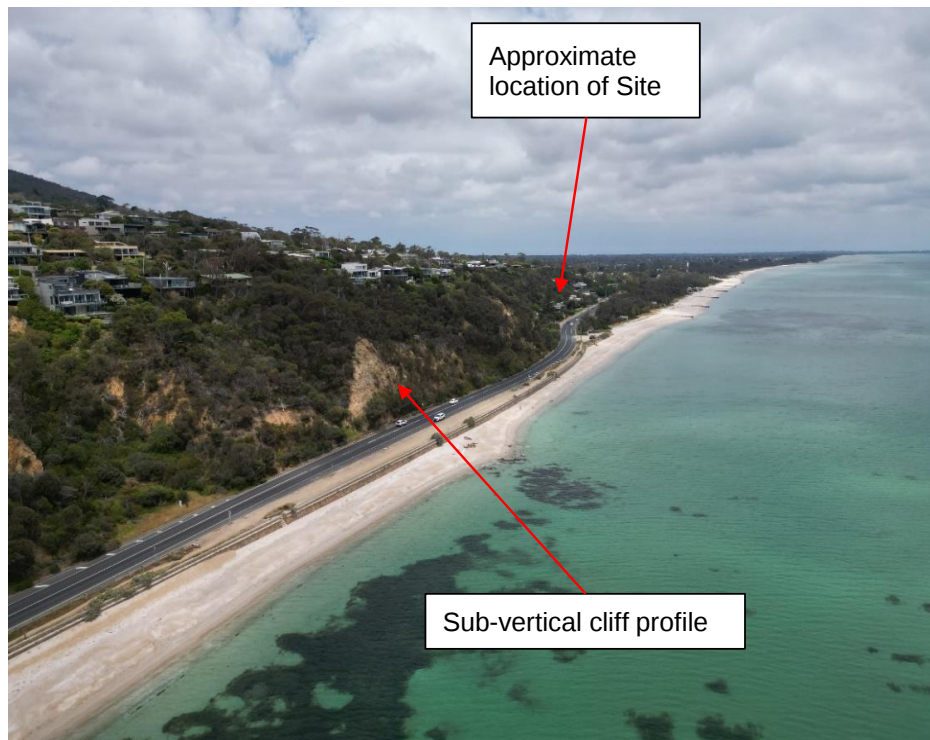
Photo 14 - Anthony's Nose
