Our Ref: PSM5226-002L Rev1

**RE: RISK ASSESSMENT. 10-12 VIEW POINT ROAD, MCRAE**

PSM were commissioned by Harwood Andrews (**HA**) on behalf of Mornington Peninsula Shire (**MPS**) to carry out a Landslide Risk Assessment (**LRA**) at 10-12 View Point Road, McRae (the "**Site**") in accordance with the Australian Geomechanics Society (**AGS**) Guidelines on Landslide Risk Assessment (AGS, 2007). The scope of the LRA is restricted to the following:

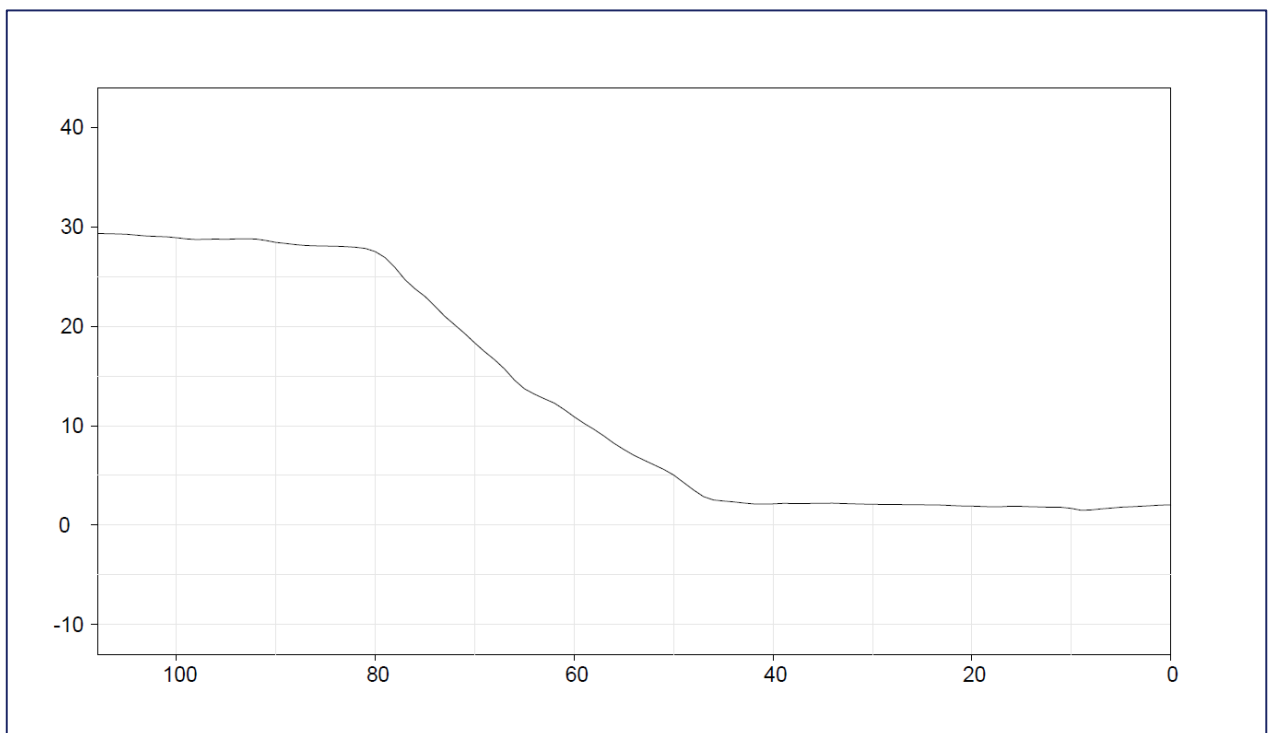
- (e) Pre-failure slope geometry of the Landslide is shown in Inset 5.
- (f) A lack of large-scale features other than gullies, that may indicate the presence of a large, full height slope failure mechanism.

**Inset 5: Prefailure slope geometry through the centre of the Landslide from Coastal LiDAR 1 DEM.**

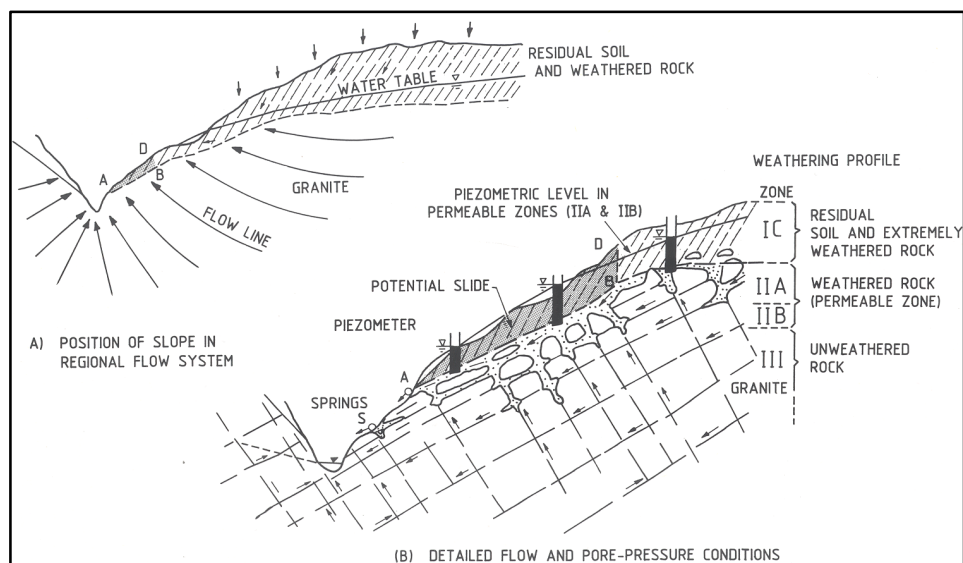
- The observation by CivilTest of wet soils encountered in borehole 3 between 1.8 m and 5.2 m bgl in March 2023. I note that this was not during or following a period of high rainfall, Section 2.4.1.
- Furthermore, the CivilTest observation is consistent with published groundwater models in weathered granitic profiles, Inset 9.
- Observations of seepage during the Site visit (refer to Section 3).

**Inset 9: Possible piezometric conditions in weathered granitic soils (Fell et al, 2004)<sup>2</sup>.**

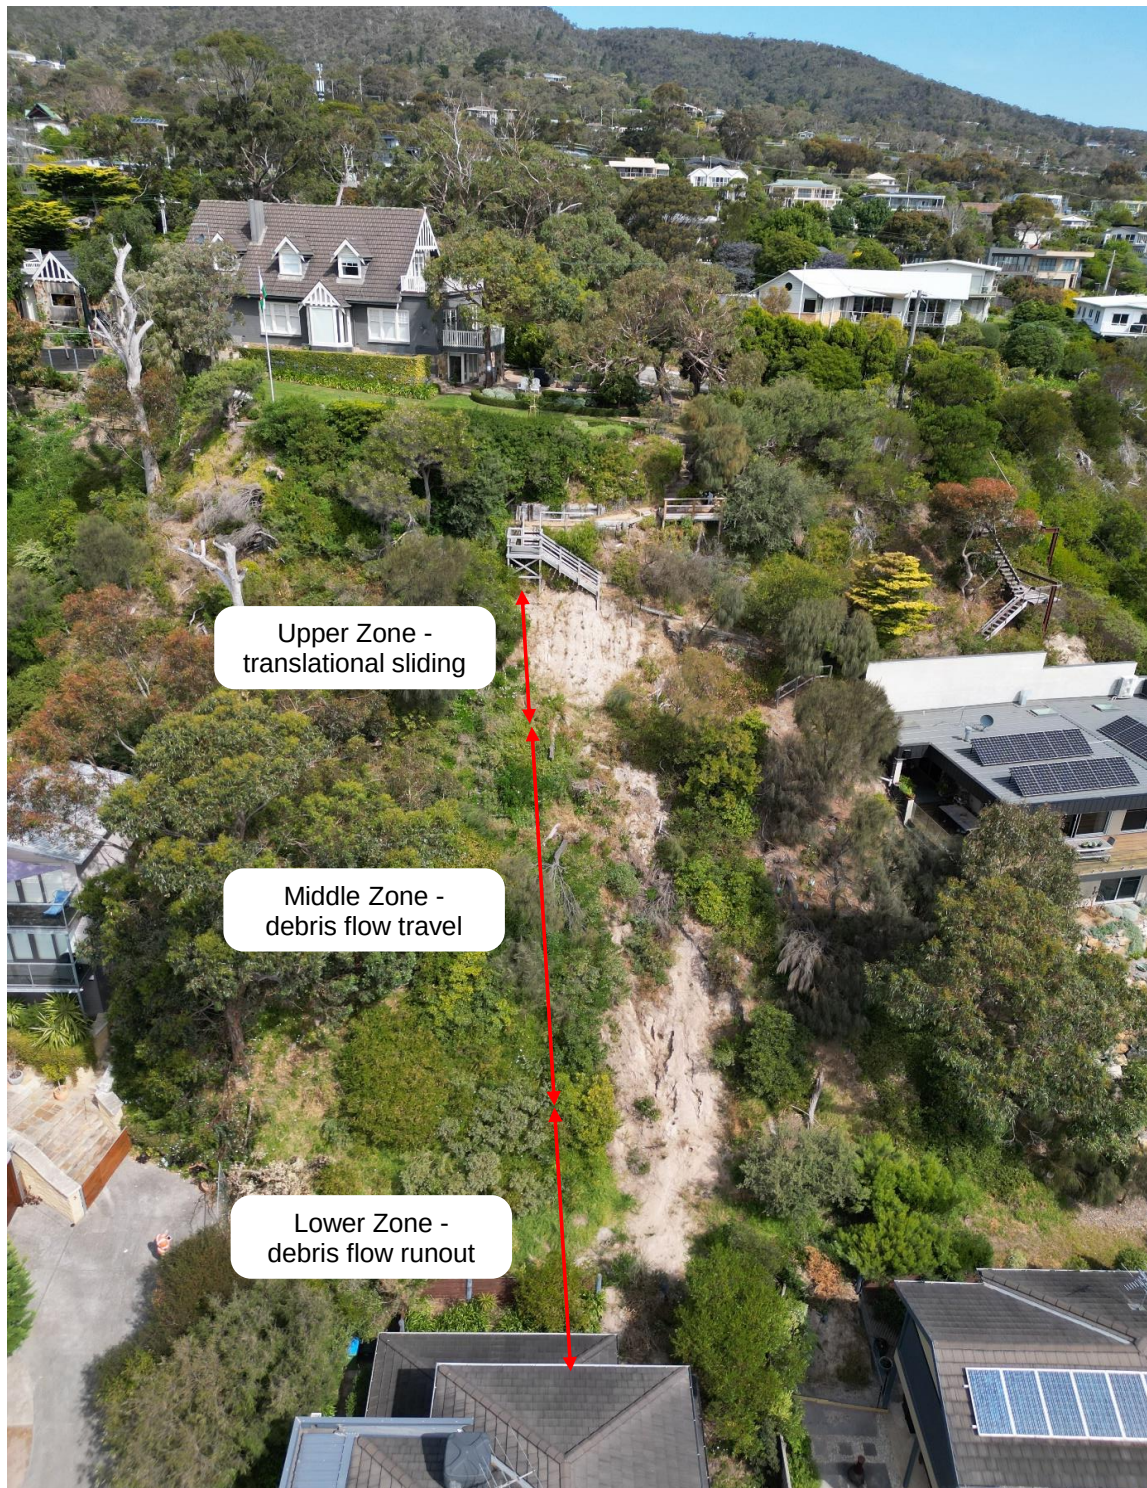
- A steep “**Upper Zone**” where the initial translational sliding occurred with approximate dimensions of 8 to 10 m wide x 8 to 10 m long x 0.3 m thick, Photo 3 Appendix B.

- A steep “**Middle Zone**” approximately 15 m long by 3 m wide through which the debris flow travelled, with some scour and erosion, Photo 3 Appendix B.

- A flatter “**Lower Zone**” of debris runout where the debris flow deposited at the toe of the slope, Photo 3 Appendix B. The approximate dimensions of deposited debris are 8 to 10 m wide, 9 to 10 m long, and 0.2 to 0.7 m thick.

Photo 3 - Landslide Overview, with zones indicated

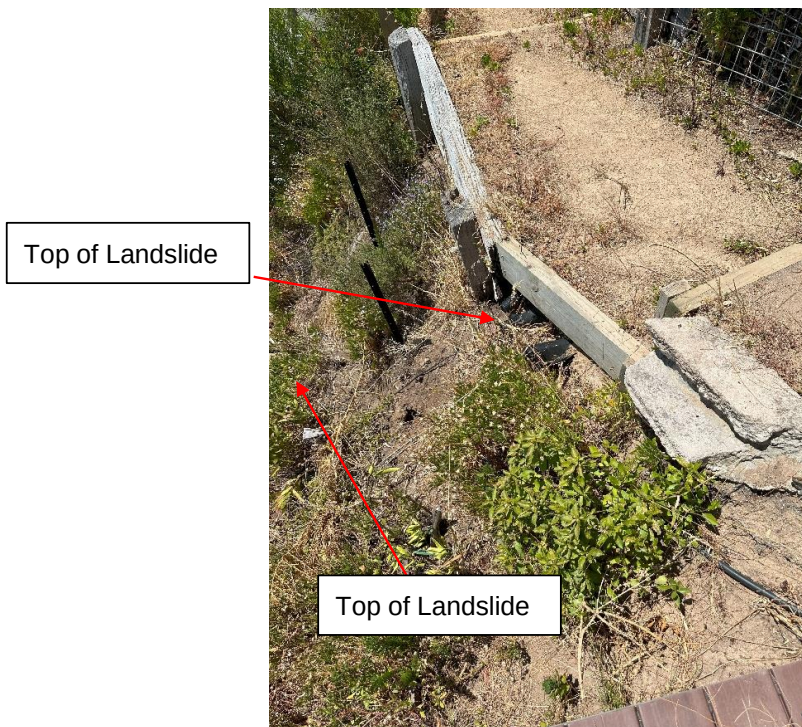
- A series of paths had been constructed across the slope to provide access from the top to the bottom of the escarpment, Photo 8 & 9 Appendix B. The paths are constructed from varying materials. Other infrastructure associated with the paths include minor RWs, board walks and stairs.

Photo 8 - Path above Landslide, note minor retaining walls and 'agi drains' from Photo 7

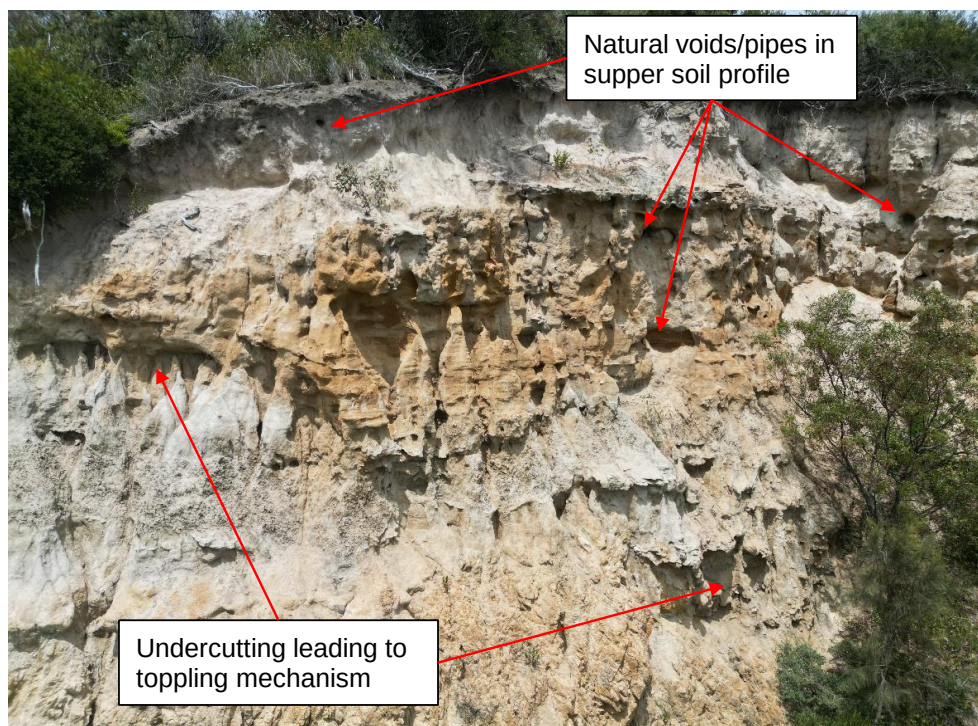
- Natural voids and internal erosion (i.e., piping) is common in the upper soil profile, Photo 13 Appendix B.
  - A sub vertical cliff profile in extremely weathered and highly weathered granite, Photo 14 Appendix B. PSM note the sub-vertical profile may be the result of road construction activities in the 1920's and 1930's.

Photo 13 - Natural cliff profile near Anthony's Nose

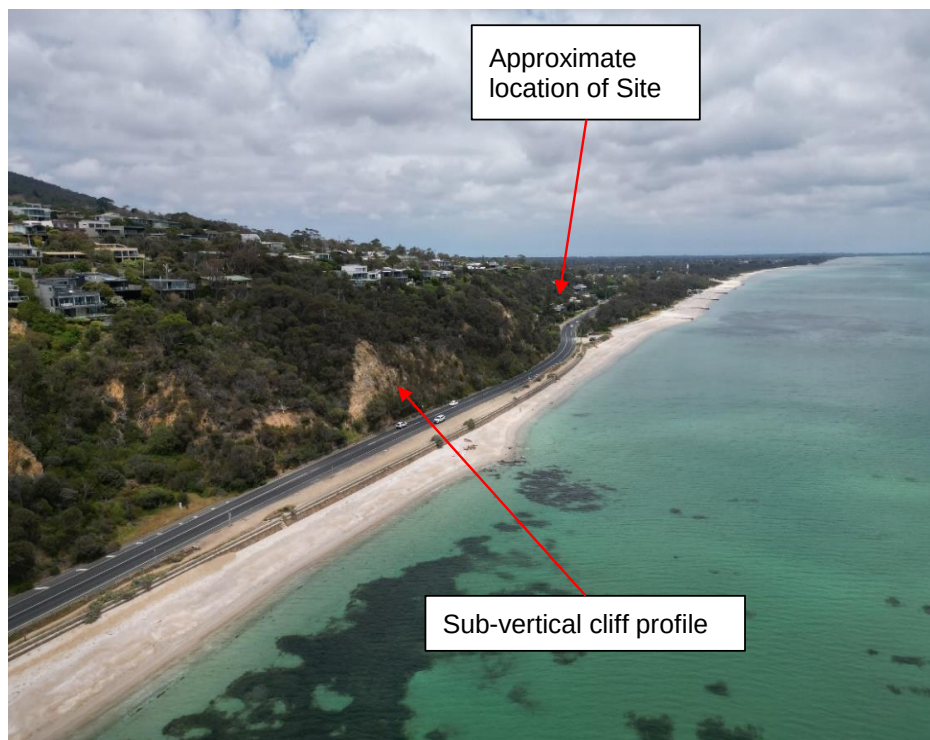
- A new stormwater drainage system has been constructed in View Point Rd. A constant flow of water was observed to be running in this drainage system.
- The Site is located on the lower slopes of Arthurs Seat where those slopes meet Port Phillip Bay and have formed an escarpment, Photo 14 & 15 Appendix B. In proximity to the Site the general topography of the areas slopes to the northwest. There is extensive residential development above the Site on the lower slopes of Arthurs Seat.

Photo 14 - Anthony's Nose
