Prepared for Mornington Peninsula Shire  
 Asset ID NP12212117  
 Location Prospect Hill Road, 7 McCrae  
 Date 30/08/2023  
 Operator Craig Hunt

Upstream Node 929094  
 Downstream Node 962658  
 Survey Direction Upstream  
 Inspected Length 34.88 meters  
 Camera Type Tractor  
 Standard WSA 05-2008 2.2

Conduit Shape Circular  
 Material RC  
 Size 300

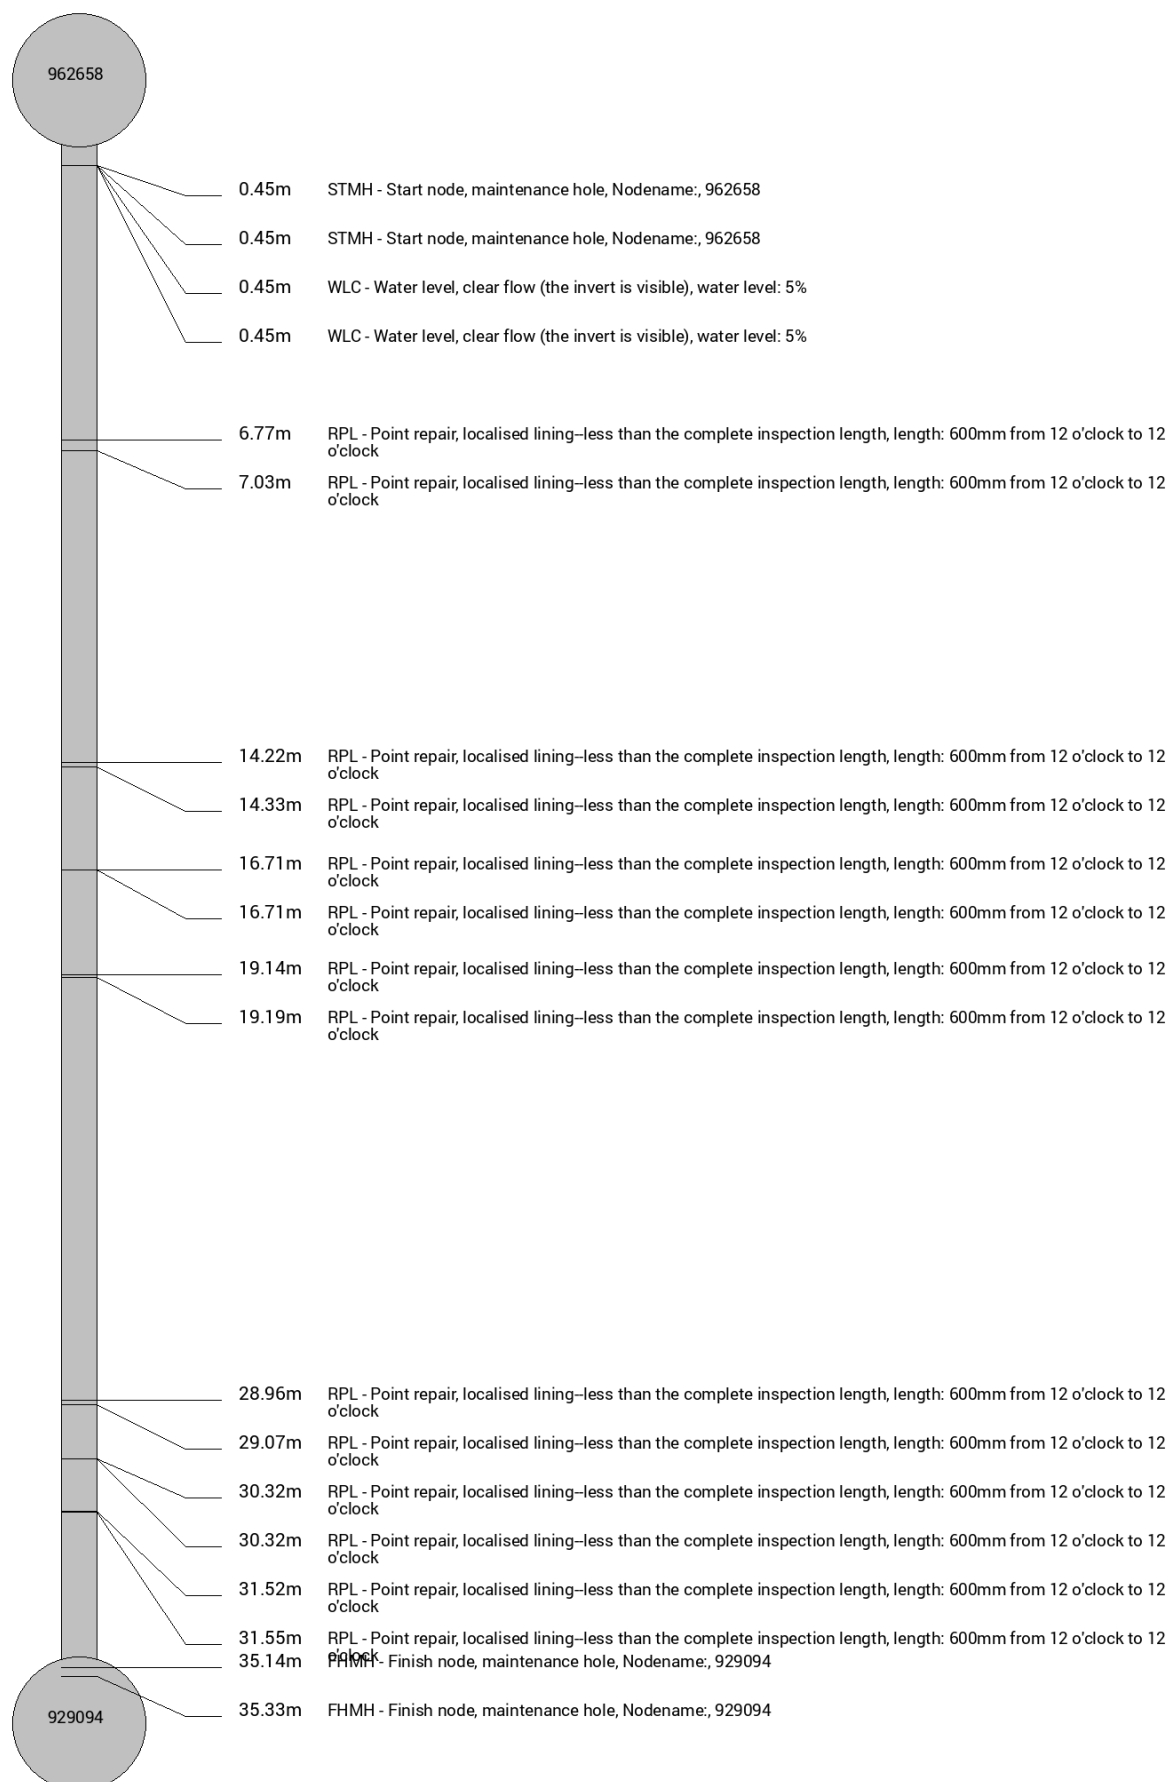
Location of Observation: 0.45m Video Position: 00:00:00

# No Photo

Photograph not taken by operator

Observation Code: STMH

Start node, maintenance hole, Nodename:, 962658
