Section Inspection - 15/01/2025 - A TOO B

Date of inspection 15/01/2025	Time of inspection 9:00 AM	Land ownership Public land	Pipe Asset ID A TOO B	Nr. 1
Project name <small>FULTONHOGAN - AE407 10-12 VIEW POINT ROAD MCCRAE</small>	Contractor's Job Number	Coding Standard WSA 2020	Name of operator Alex Elliott	Job ID 10-12 VIEW POINT ROAD MCCRAE

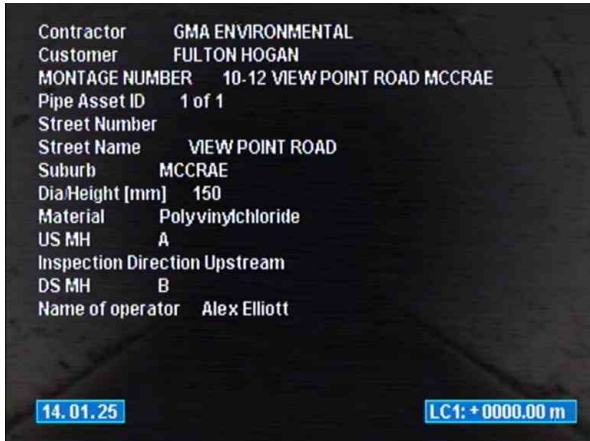
10-12 VIEW POINT ROAD MCCRAE_15.01.2025_090054_A
 TOO B _005.jpg, 00:00:00, 0.00
 Start node, maintenance hole, Nodename:, B

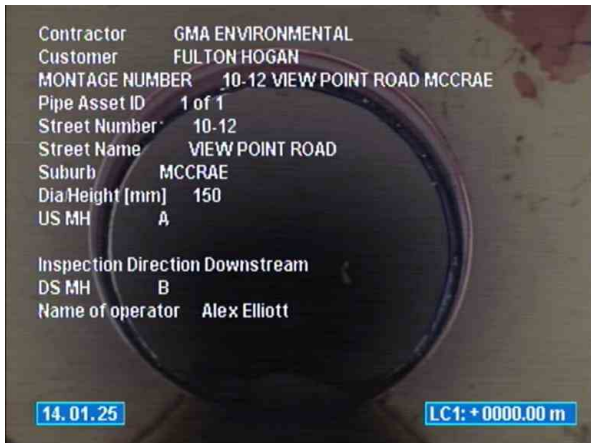
10-12 VIEW POINT ROAD MCCRAE_15.01.2025_083859_A
 TOO B _001.jpg, 00:00:00, 0.00
 Start node, maintenance hole, Nodename:, A

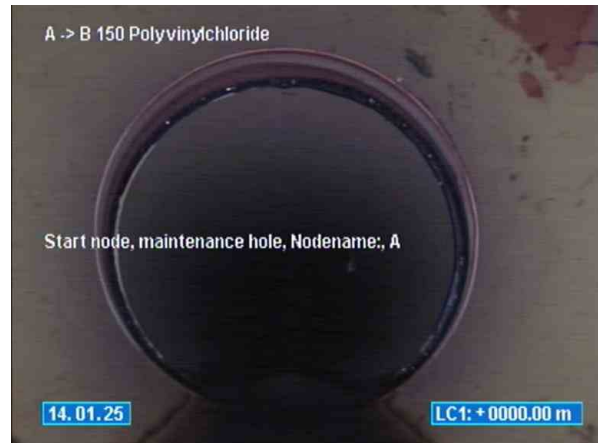
10-12 VIEW POINT ROAD MCCRAE_15.01.2025_083859_A
 TOO B _002.jpg, 00:00:00, 0.00
 Start node, maintenance hole, Nodename:, A

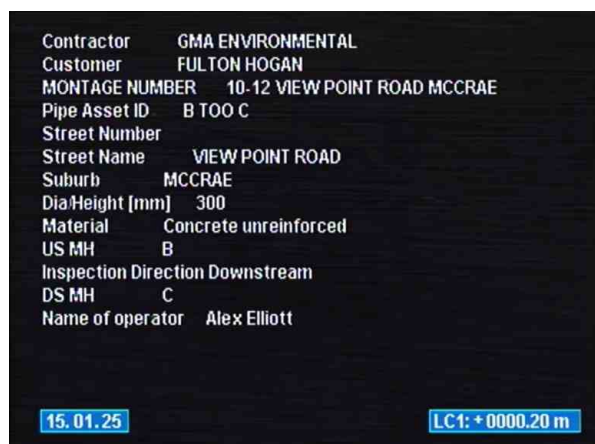
10-12 VIEW POINT ROAD MCCRAE_15.01.2025_102122_B
 TOO C _008.jpg, 00:00:00, 0.00
 Start node, maintenance hole, Nodename:, B

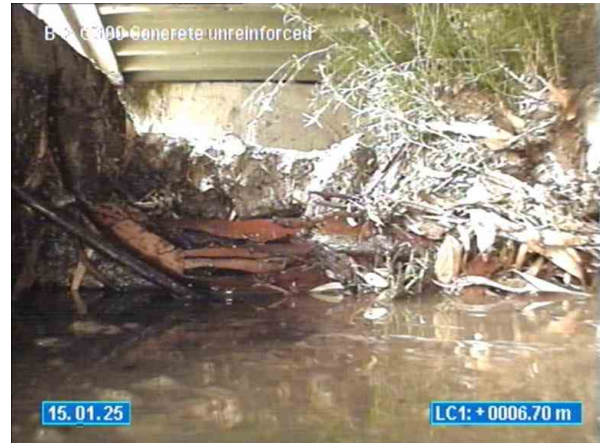
10-12 VIEW POINT ROAD MCCRAE_15.01.2025_102122_B
 TOO C _013.jpg, 00:04:19, 6.70
 Finish node, maintenance hole, Nodename:, C

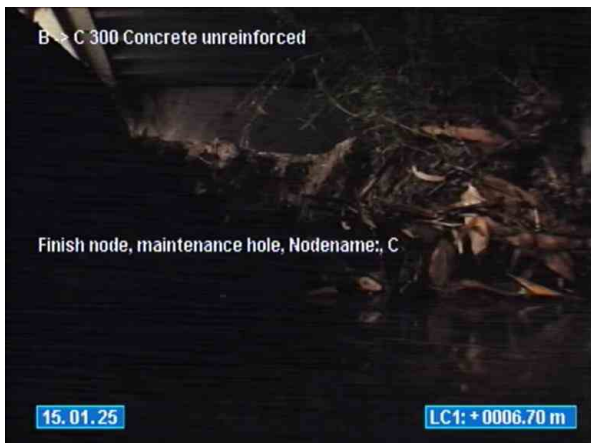
10-12 VIEW POINT ROAD MCCRAE_15.01.2025_102122_B
 TOO C _014.jpg, 00:04:19, 6.70
 Finish node, maintenance hole, Nodename:, C

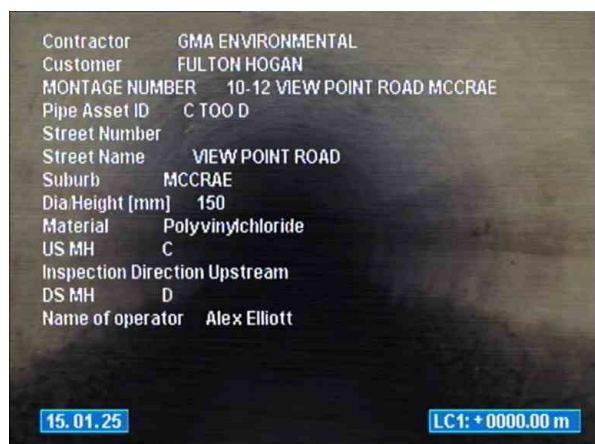
10-12 VIEW POINT ROAD MCCRAE_15.01.2025_114611_C
 TOO D_021.jpg, 00:04:25, 0.00
 Start node, maintenance hole, Nodename:, D

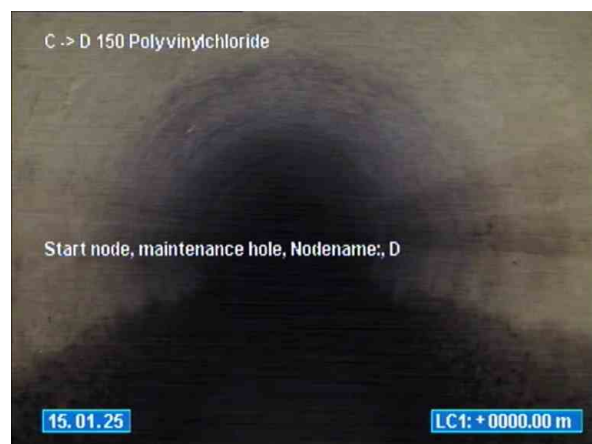
10-12 VIEW POINT ROAD MCCRAE_15.01.2025_114611_C
 TOO D_022.jpg, 00:04:25, 0.00
 Start node, maintenance hole, Nodename:, D

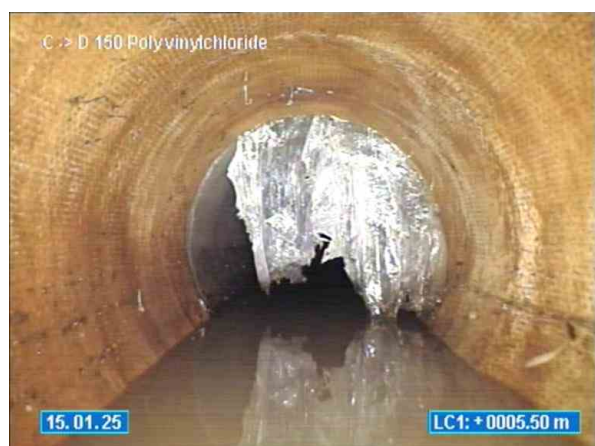
10-12 VIEW POINT ROAD MCCRAE_15.01.2025_114611_C
 TOO D_023.jpg, 00:04:25, 5.50
 Change of conduit material. New material, Fibre reinforced
 cement, at joint

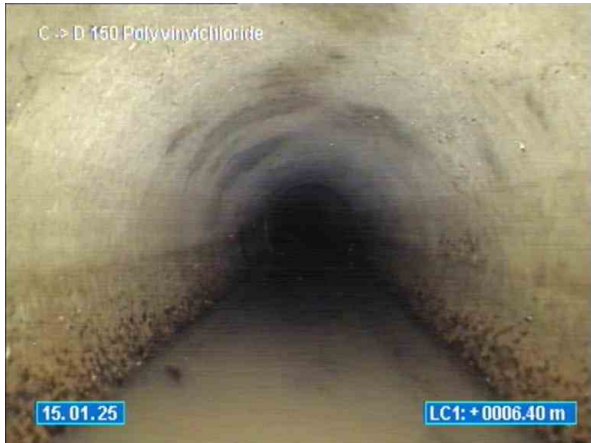
10-12 VIEW POINT ROAD MCCRAE_15.01.2025_114611_C
 TOO D_025.jpg, 00:04:25, 6.40
 Change of conduit material. New material, Concrete segments,
 at joint

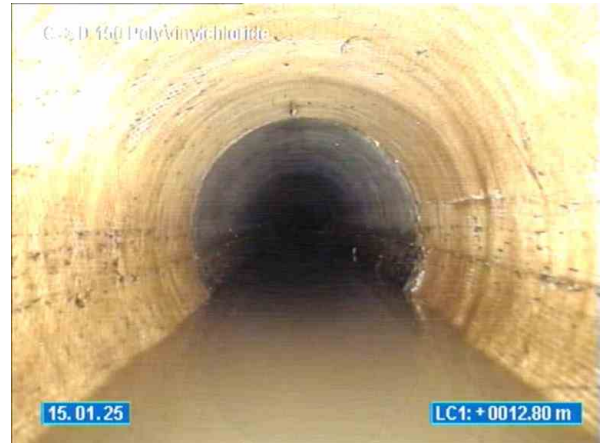
10-12 VIEW POINT ROAD MCCRAE_15.01.2025_114611_C
 TOO D_026.jpg, 00:04:25, 12.80
 Change of conduit material. New material, Fibre reinforced
 plastic

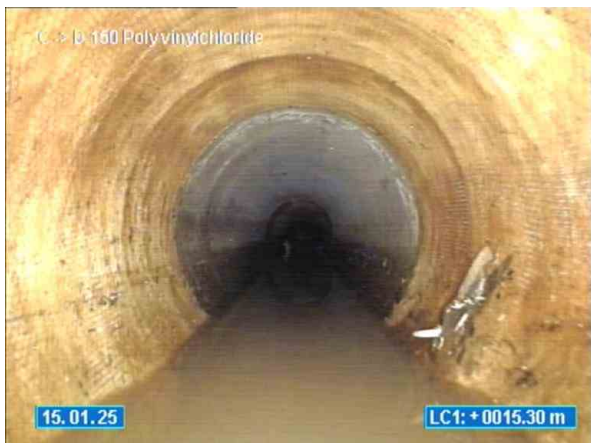
10-12 VIEW POINT ROAD MCCRAE_15.01.2025_114611_C
 TOO D_027.jpg, 00:04:25, 15.30
 Change of conduit material. New material, Fibre reinforced
 plastic, at joint

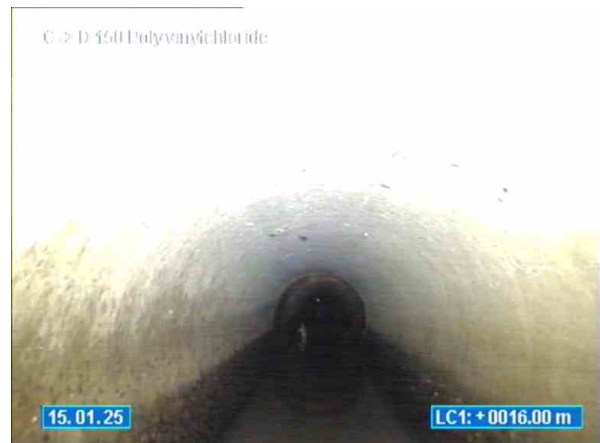
10-12 VIEW POINT ROAD MCCRAE_15.01.2025_114611_C
 TOO D_028.jpg, 00:04:25, 16.00
 Change of conduit material. New material, Concrete segments,
 at joint

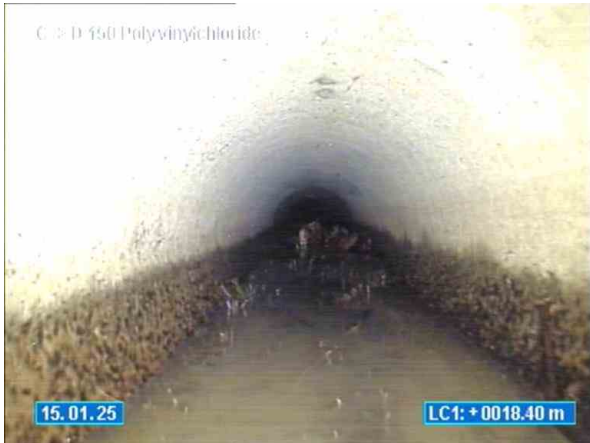
10-12 VIEW POINT ROAD MCCRAE_15.01.2025_114611_C
 TOO D_029.jpg, 00:04:25, 18.40
 Change of conduit material. New material, Fibre reinforced
 plastic, at joint

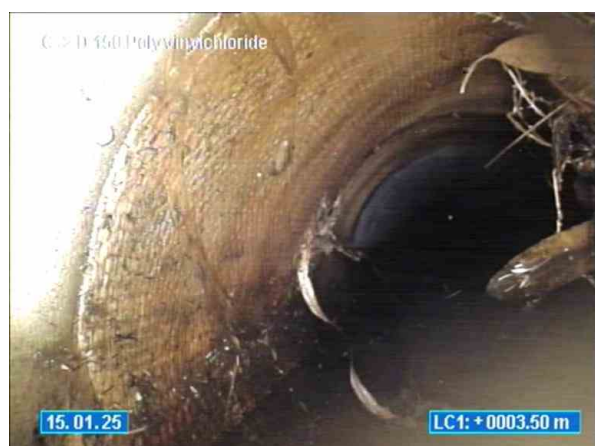
10-12 VIEW POINT ROAD MCCRAE_15.01.2025_104134_C
 TOO D_017.jpg, 00:02:45, 3.50
 Change of conduit material. New material, Fibre reinforced plastic

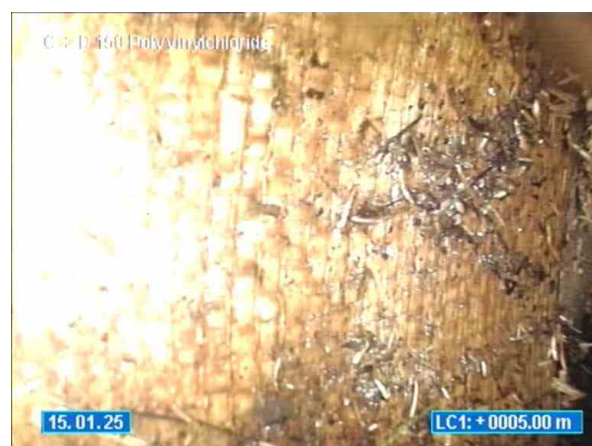
10-12 VIEW POINT ROAD MCCRAE_15.01.2025_104134_C
 TOO D_018.jpg, 00:03:47, 5.00
 Change of conduit material. New material, Fibre reinforced plastic

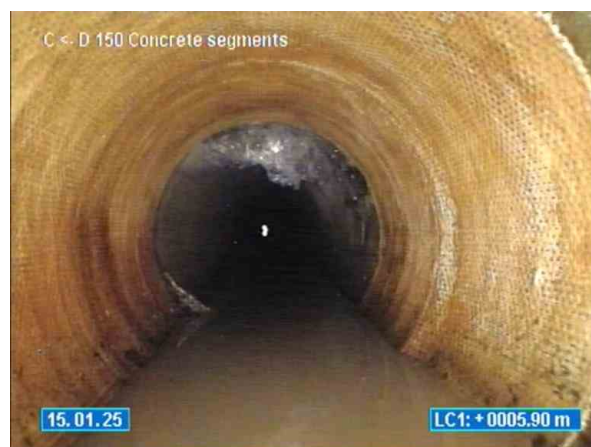
10-12 VIEW POINT ROAD MCCRAE_15.01.2025_132020_D TOO C _038.jpg, 00:33:07, 5.90
 Change of conduit material. New material, Fibre reinforced plastic, at joint

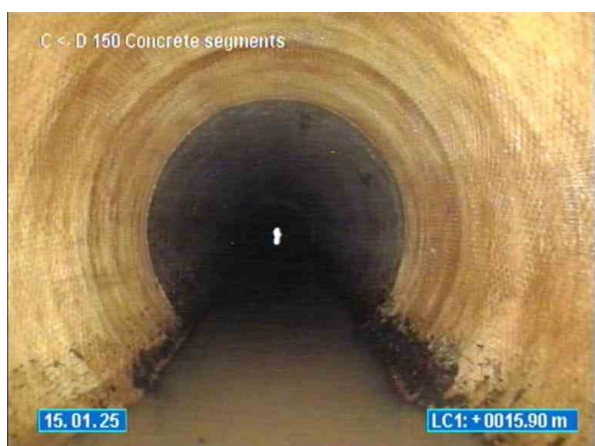
10-12 VIEW POINT ROAD MCCRAE_15.01.2025_132020_D TOO C _039.jpg, 00:33:07, 15.90
 Change of conduit material. New material, Fibre reinforced plastic, at joint

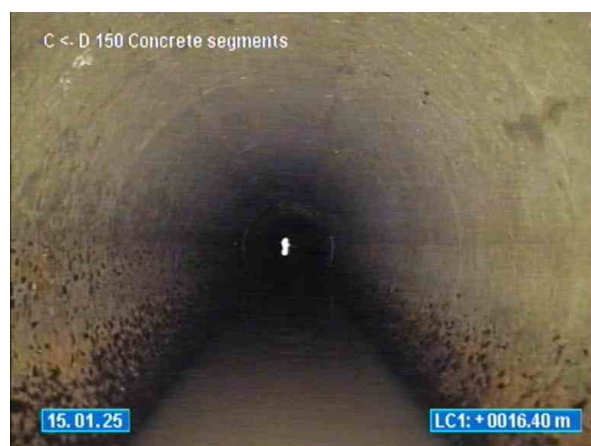
10-12 VIEW POINT ROAD MCCRAE_15.01.2025_132020_D TOO C _040.jpg, 00:33:07, 16.40
 Change of conduit material. New material, Concrete reinforced, at joint

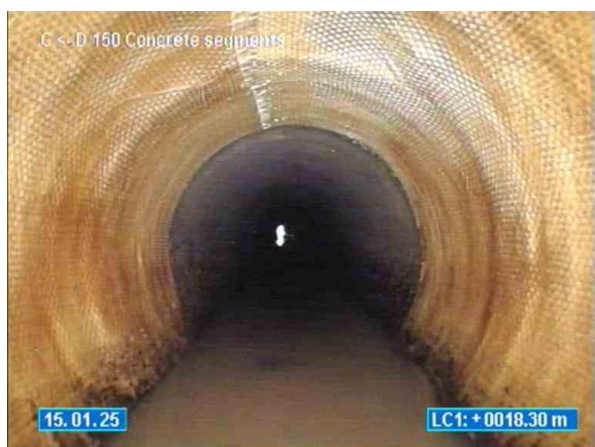
10-12 VIEW POINT ROAD MCCRAE_15.01.2025_132020_D
 TOO C _041.jpg, 00:33:07, 18.30
 Change of conduit material. New material, Fibre reinforced
 plastic, at joint

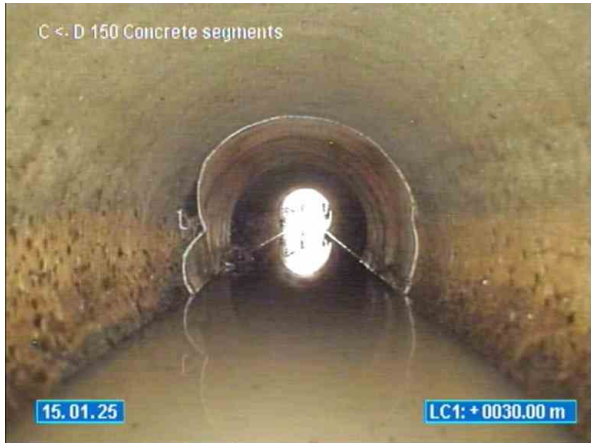
10-12 VIEW POINT ROAD MCCRAE_15.01.2025_132020_D
 TOO C _045.jpg, 00:33:07, 30.00
 Change of conduit material. New material, Concrete
 reinforced, at joint

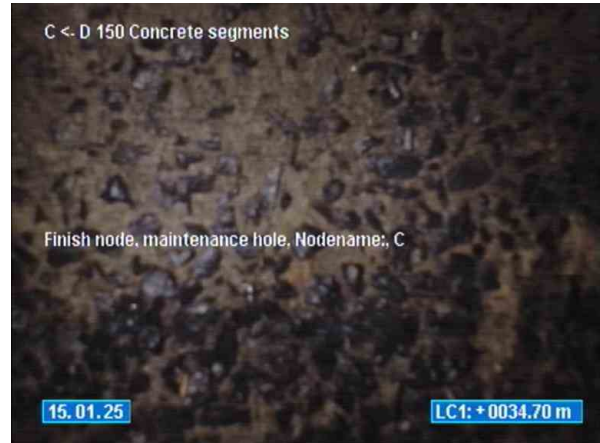
10-12 VIEW POINT ROAD MCCRAE_15.01.2025_132020_D
 TOO C _046.jpg, 00:00:00, 34.70
 Finish node, maintenance hole, Nodename:, C

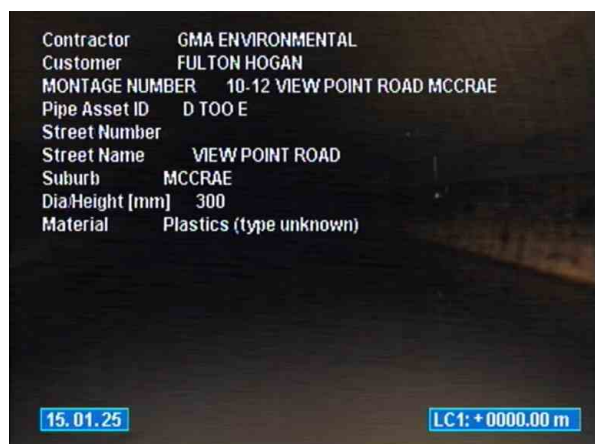
10-12 VIEW POINT ROAD MCCRAE_15.01.2025_135956_D
 TOO E _047.jpg, 00:00:00, 0.00
 Start node, maintenance hole, Nodename:, D

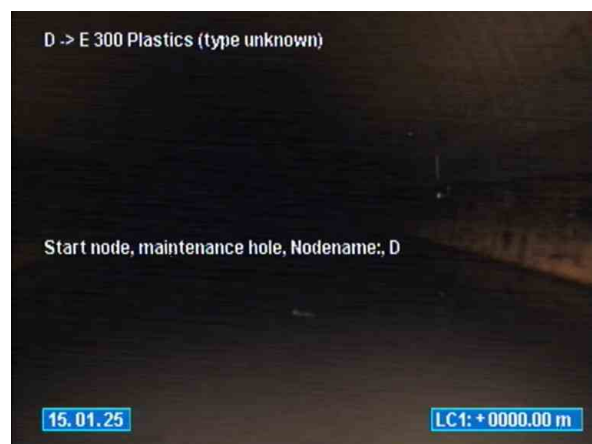
10-12 VIEW POINT ROAD MCCRAE_15.01.2025_135956_D
 TOO E _048.jpg, 00:00:00, 0.00
 Start node, maintenance hole, Nodename:, D

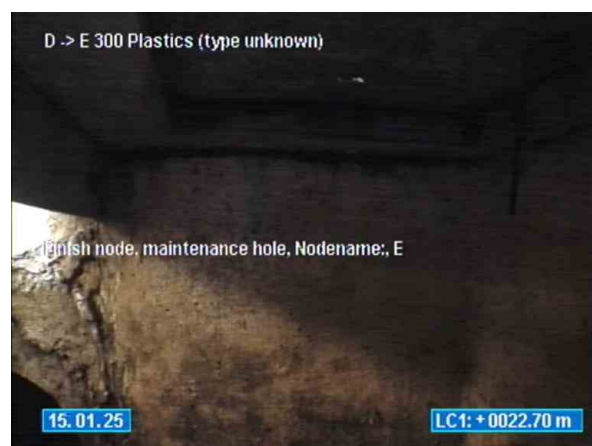
10-12 VIEW POINT ROAD MCCRAE_15.01.2025_135956_D
 TOO E _050.jpg, 00:03:01, 22.70
 Finish node, maintenance hole, Nodename:, E
