# South East Water Submission to the Board of Inquiry into the McCrae Landslide

April 2025

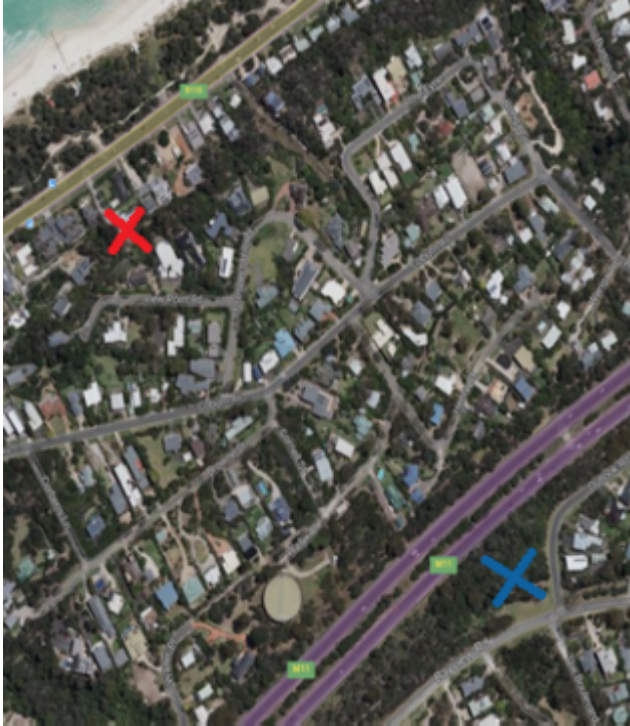
On 30 December 2024 at approximately 1pm SEW first became aware there was a burst on Water Main 104961. The burst was located on the edge of densely vegetated bushland between Bayview Road and the Mornington Peninsula Freeway, approximately 50 metres

west of Outlook Road. A map showing the location of the water main burst, approximately 450 metres from the Landslide site, is at Figure 2. A photo showing the site of the water main burst is at Figure 3.

*Figure 2 - Map showing locations of Bayview Road burst (blue) and the Landslide site (red)*
