McCrae Landslide

Causation Report

McCrae Landslide
Causation Report

Board of Inquiry into the McCrae Landslide

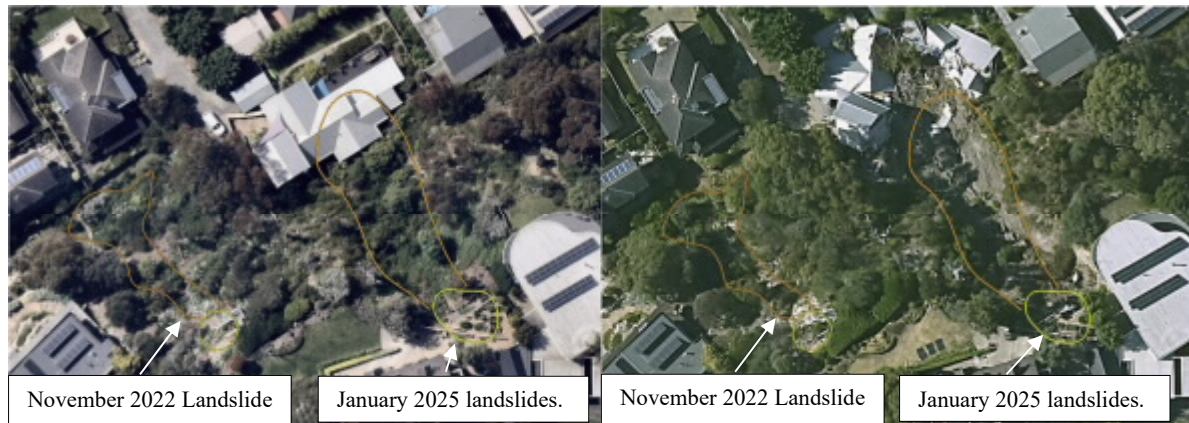
Figure 1.1 Comparison of McCrae escarpment before and after the landslides of November 2022 and January 2025. Left: Nearmap image dated 18 October 2022, Right: Nearmap image dated 6 January 2025.

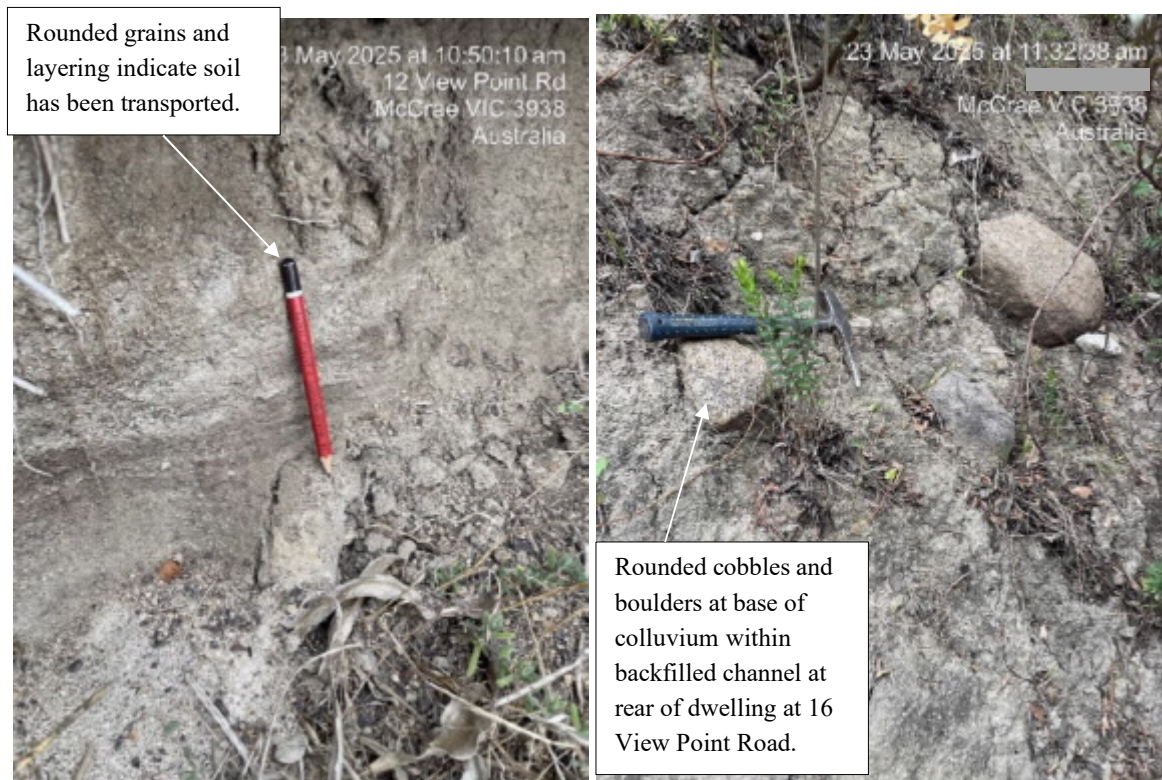
- c. Colluvium comprising sandy material and rounded cobbles and boulders was observed in the headscarp formed by the 14 January 2025 landslide and on the slopes to the west of the headscarp. Rounded grains, sorting and layering in these deposits are indicative of sediments that have been transported. In this case likely by debris flow or fluvial (carried in water flow) processes. Examples are shown in Figure 6.8, Figure 6.9 and Figure 6.10.

Figure 6.9 Examples of materials exposed on the escarpment

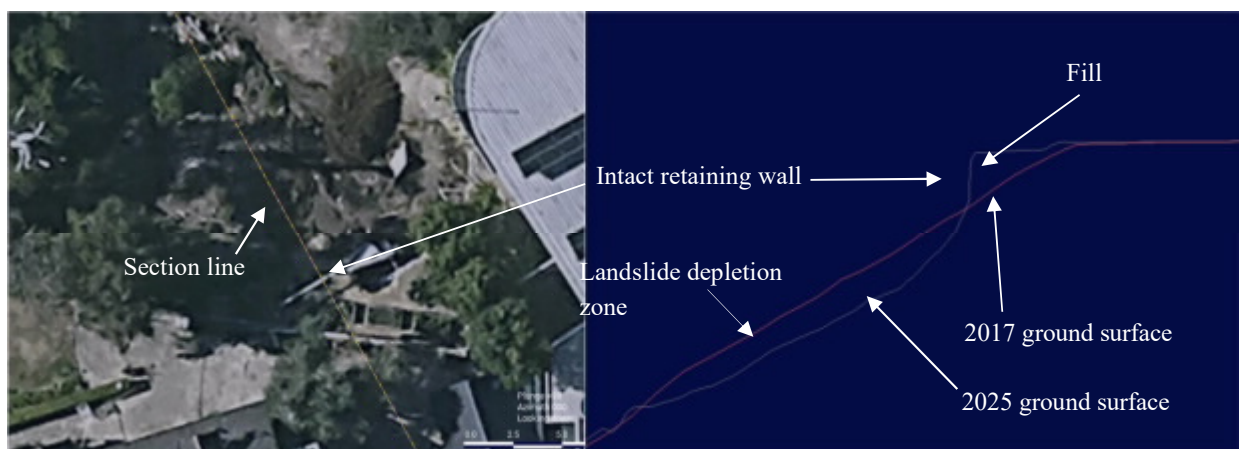
Figure 6.13 Example of fill placed after 2017.

- 111) Whilst the zones of depletion and accumulation associated with the November 2022 and January 2025 landslides are clear in Figure 6.12, there are several locations near the crest of the escarpment, including near the headscarp formed by the 14 January 2025 landslide where new fill appears to have been placed between 2017 and 2024. Based on the comparison between 2017 and 2025, the maximum thickness of fill placed near where the January 2025 landslide occurred is about 2.4 m as indicated by the cross section presented in Figure 7.10. This material is inferred to have been placed between 2022 and 2024 as part of works to build retaining walls at 10-12 View Point Road (RES.0001.0003.0002).

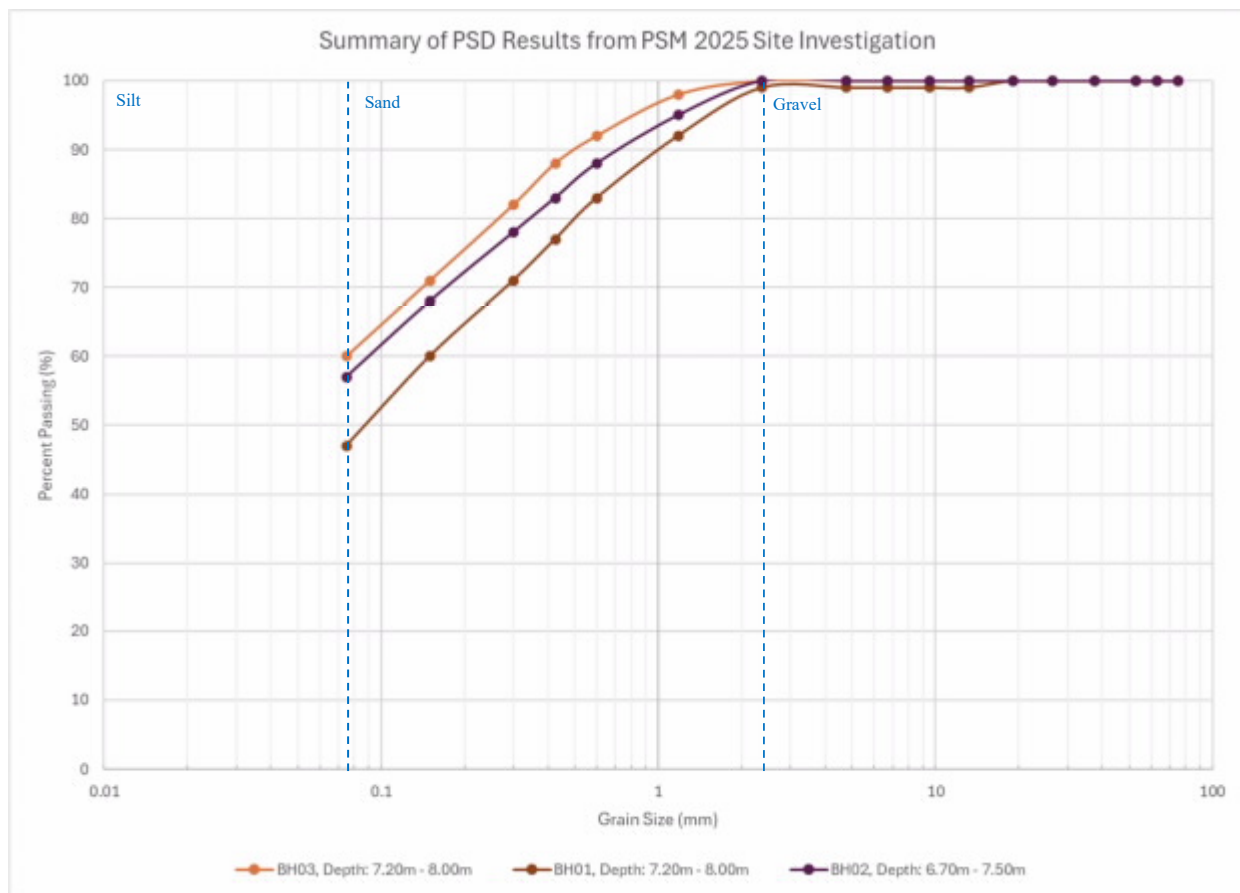
- 85) The residual granitic soils are derived from in situ weathering of granite whereby the granite rock has completely weathered to a material with soil properties. Based on particle size distribution testing undertaken in residual soils and set out in Appendix E of reference MSC.5007.0004.0078 and reproduced in Figure 7.1, the residual soils are sandy clays or silts, containing 45% to 60% fines (clay or silt sized material). Materials with this particle size are able to develop and preserve soil suctions which can give them strength. This effect is evident given the subvertical headscarp that has formed and remained in place as a result of the 14 January 2025 landslide and noting that the headscarp is well above the water table. Based on the PSM groundwater monitoring in Borehole BH01 (PSM.5002.0001.0002) the water table is 25 m to 26.5 m below the ground surface (VWP1C installed at 29 m).

Figure 7.1 Particle size distribution in residual granite soils based on laboratory results presented in reference PSM factual report, MSC.5007.0004.0078.

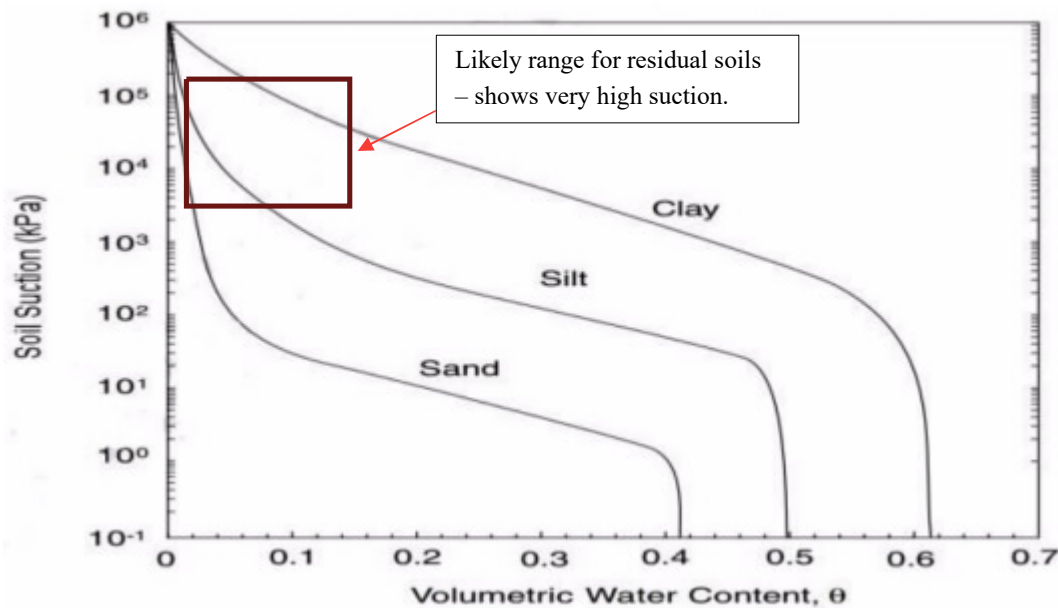
Figure 7.2 Typical soil water characteristic curve for various soil types annotated to show expected range of soil suction based on particle size distribution measurement for residual soils included in MSC.5007.0004.0078.

- 87) Also, with reference to Figure 7.2, as water content increases in the soil, suction is lost and so to is soil strength.
- 88) With a high degree of certainty, the residual granitic soils are able to preserve high suctions, which gives them relatively high soil strength and allows them to form steep slopes. The presence of these soils is a preparatory factor for landslide because they can rapidly lose suction upon an increase in water content and pore water pressure and therefore lose strength. If sufficient strength is lost the soil can develop into a landslide.

- 97) Solving equation (1) for σ^s , and assuming the inputs set out above, the suction stress of the residual granite at the point of landsliding would be in the order of 800 kPa. With reference to Figure 7.2, a reduction in suction stress to 800 kPa, might require only an increase in volumetric moisture content of say 10% up to 30%. Albeit based on assumptions, this provides an indication that a nominal increase in water content within the soils, combined with the steep slope angles could be sufficient to trigger landslide.

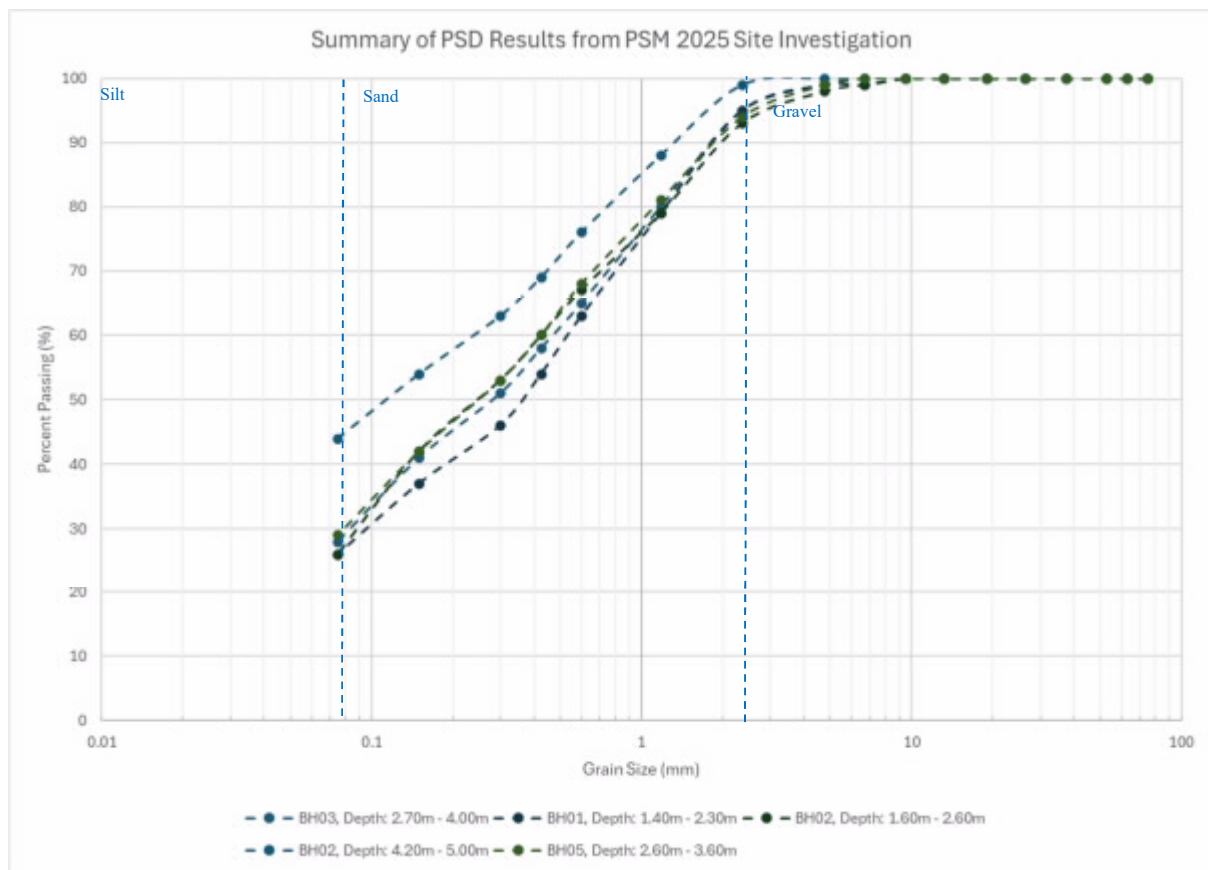
- 89) The transported soils are comprised of a mixture of soils transported through landslide processes (colluvium) and soils transported by wind (aeolian). Particle size distribution testing within the transported soils indicate them to be more granular than the residual soils, as shown in Figure 7.3, containing between 25% and 45% fines. They are typically classified as clayey or silty sand.

Figure 7.3 Particle size distribution in transported soils based on laboratory results presented in PSM factual report, reference MSC.5007.0004.0078.

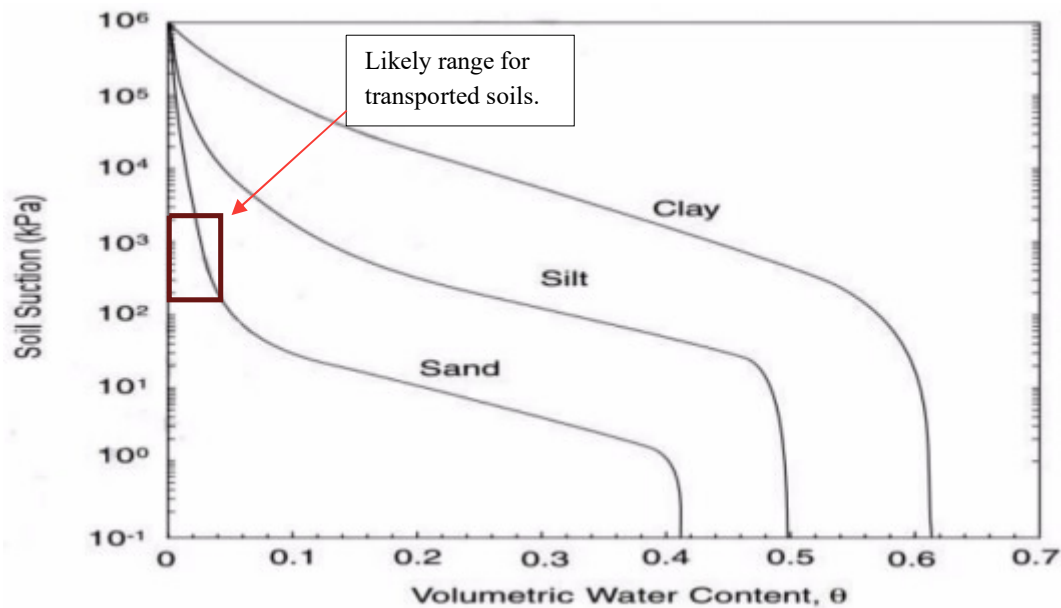
Figure 7.4 Typical soil water characteristic curve for various soil types⁹ annotated to show expected range based on particle size distribution measurement for transported soils included in MSC.5007.0004.0078.

- 90) Based on observations made of exposures in the transported soils including in the headscarp of the 2025 landslide, the transported soils contain some cobbles and boulders of granite (Figure 6.10), which cannot be sampled from a borehole and tested to derive a particle size distribution curve. The transported soils may therefore be biased to finer materials and the in situ materials may be more granular than is indicated in Figure 7.4. Because the particles comprising the soils are coarser, these materials cannot support suction stresses as high as those in the residual granite, and the change in moisture content required to lose suction and therefore strength in this material is relatively lower.

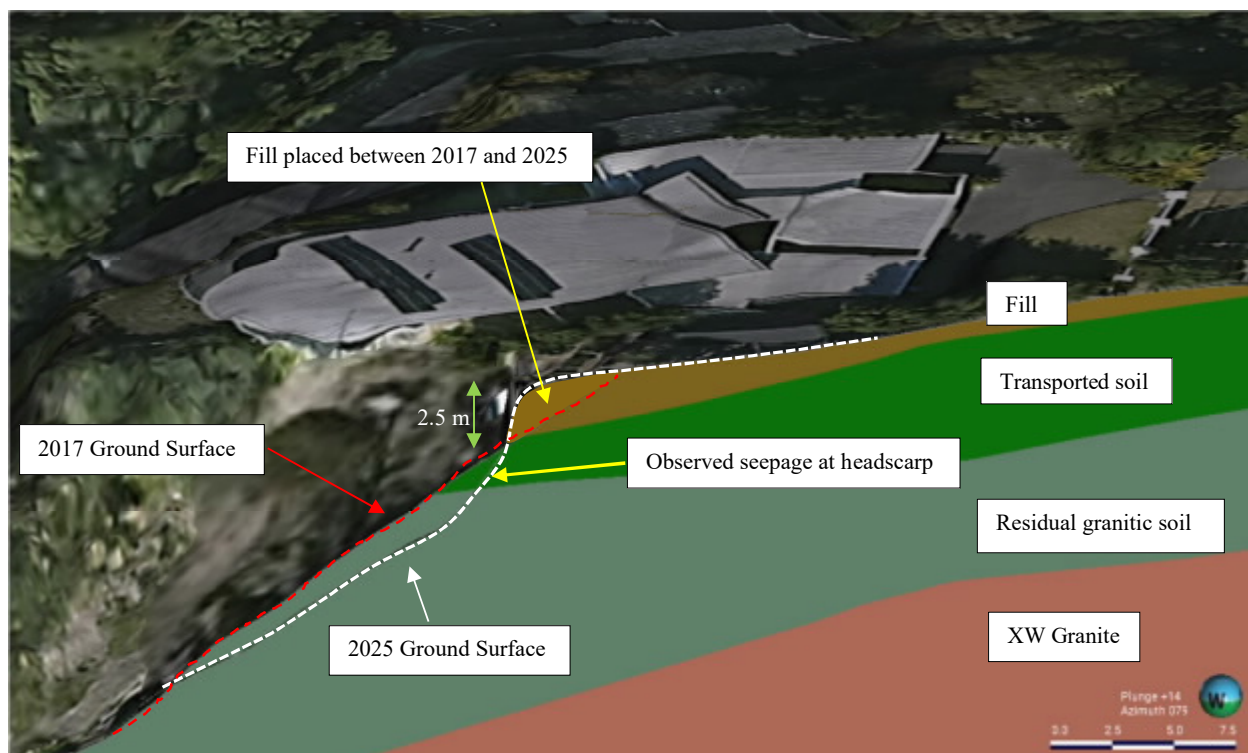
- H_{ss} is the depth to the sliding plane from the ground surface, assumed to be 4 m based on the height of the landslide headscarp (see Figure 7.10).

Figure 7.10 Cross sections through headscarp of January 2025 landslides showing comparison between 2017 and 2025 ground surface and interpreted subsurface profile.

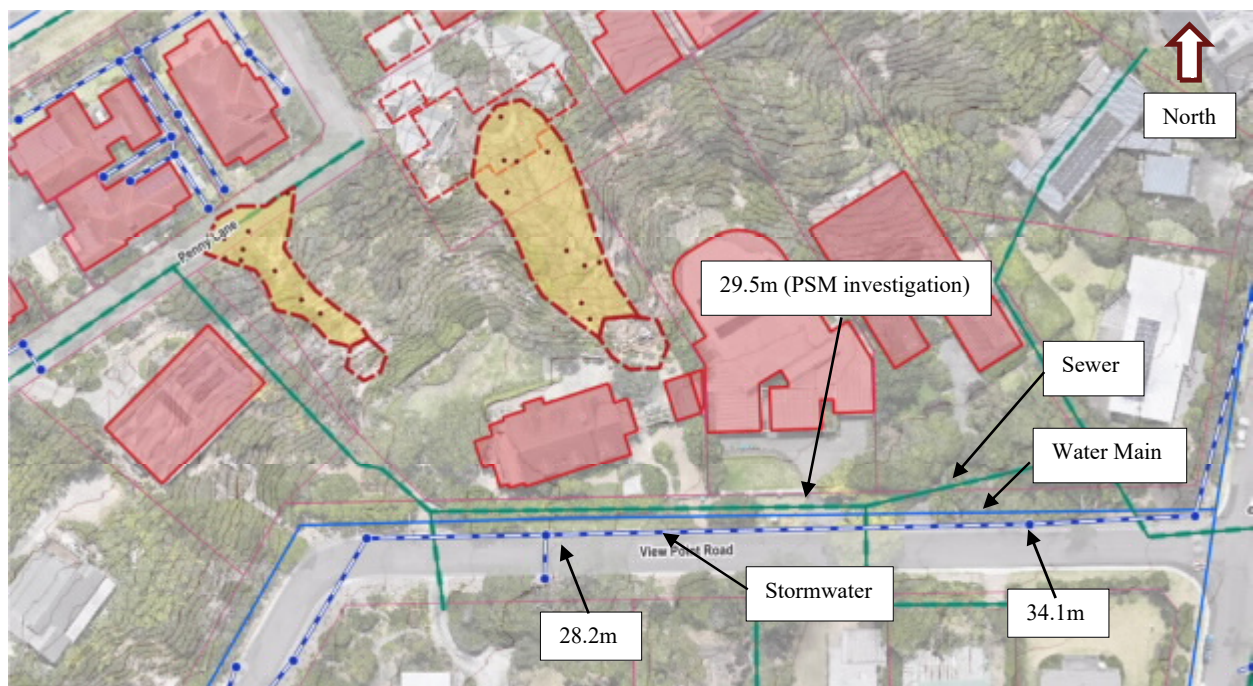
- a. Water mains comprised of asbestos cement installed predominately in the 1950's and 1960's (SME.0001.0001.0147).
 - b. Sewers comprised of vitreous clay pipe installed in 1981 (SME.0001.0001.0147).
 - c. Stormwater comprised mainly of concrete pipe and installed at various times (dates of installation range between 1971 and 2023 based on SME.0001.0001.0309) as part of stormwater upgrade works in View Point Road. Some stormwater pipes have been placed as part of infilling natural water courses, including the natural upstream extension to the south east of what is now the Margaret Street drain.
 - d. Other non-water bearing trenches including telecommunications and gas.
- 115) A plan showing the locations of water bearing services including their invert elevations in the vicinity of the November 2022 and January 2025 landslides is shown in Figure 7.12 and Figure 7.13.

Figure 7.12 Service trenches for water infrastructure in the vicinity of the McCrae Landslide. Numbers indicate sewer invert elevations in meters AHD (elevation relative to Australian Height Datum).

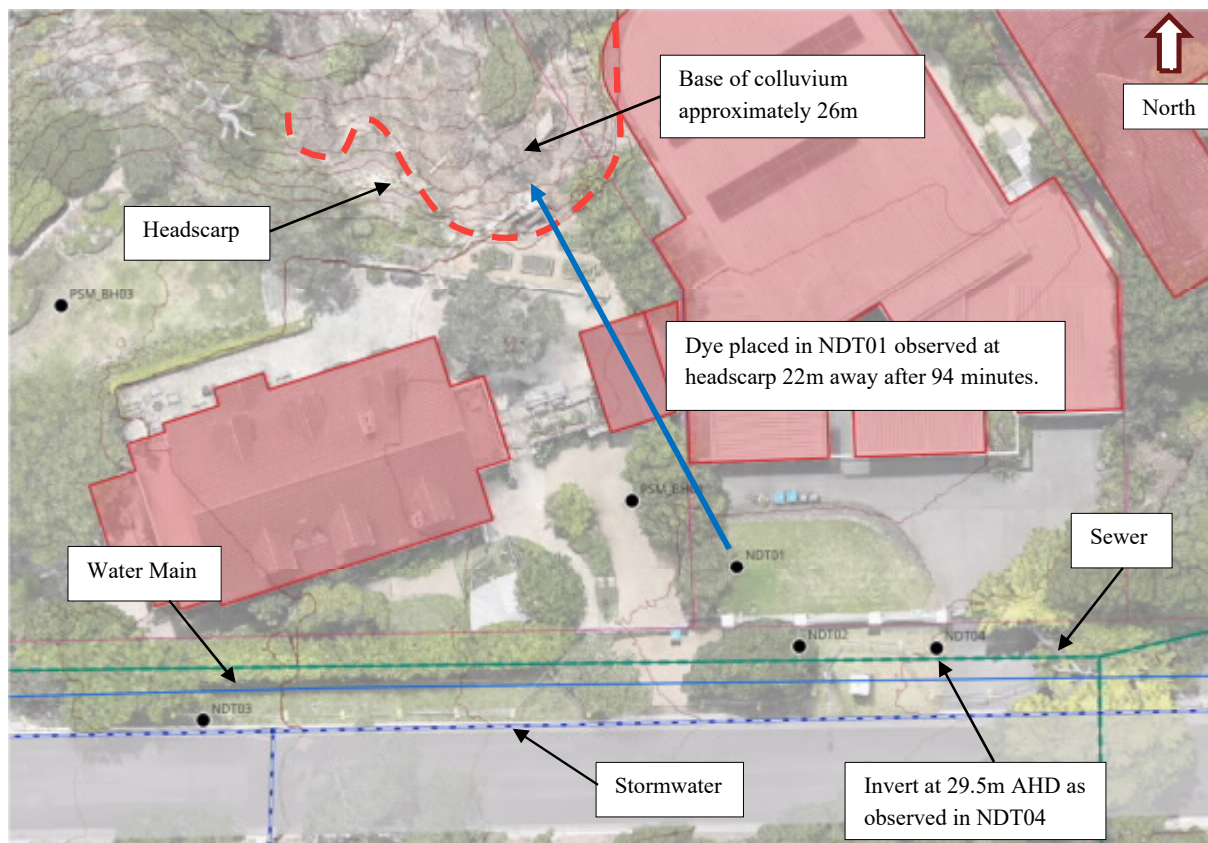
Figure 7.13 Inset of Figure 7.12 showing service trenches for water infrastructure in the vicinity of the McCrae Landslide

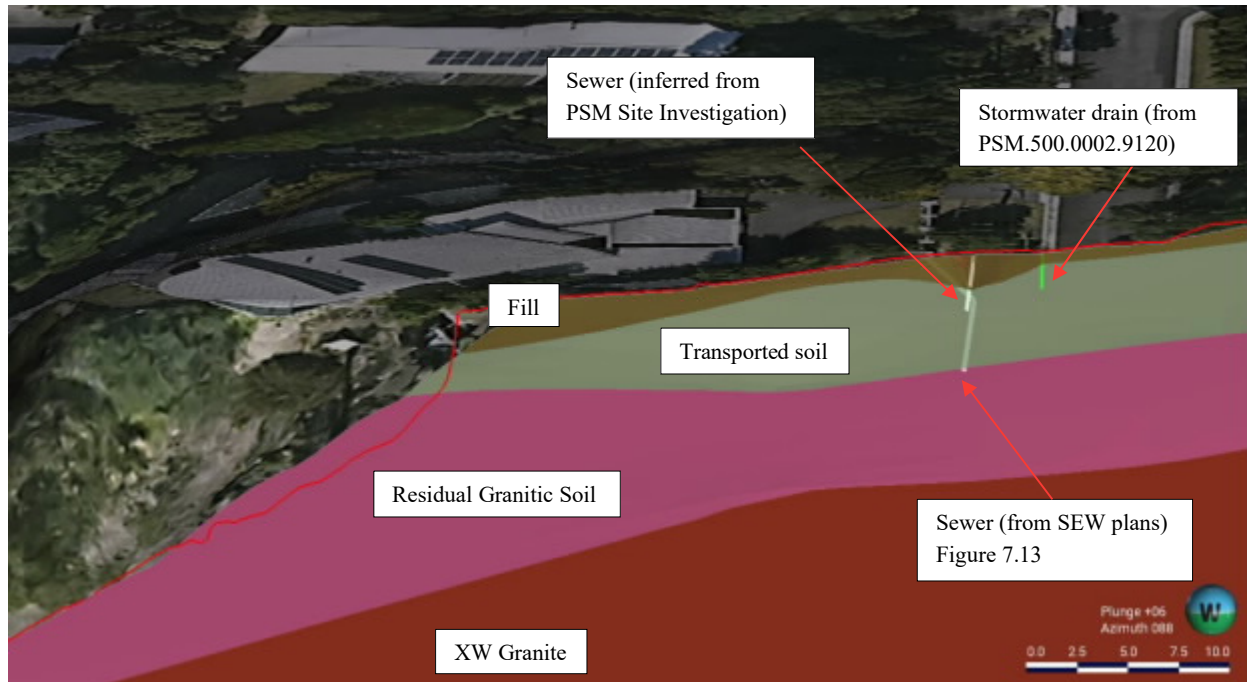
- 116) Figure 7.14 shows the services in an isometric image relative to the landslide headscarp. Note that two sewer pipe elevations are shown. One was indicated by borehole NDT04 drilled as part of the PSM investigation into trenches (ref: MSC.5067.0001.0018) and the other as indicated on sewer plans provided in ref: SME.0001.0001.0148. There is approximately a 3 m vertical difference between these elevations. Given the direct observations made in the PSM borehole, the higher elevation is assumed to be correct. Note that for both alignments the sewers are within the colluvial soils at the point where they are closest to the location of the January 2025 landslides.

Figure 7.14 Isometric image of sewer and stormwater drain along View Point Road in relation to the modelled geological units. Note there is an approximately 3 m discrepancy between the sewer invert levels indicated on the SEW plans and the depths inferred through observations in the 2025 PSM site investigation.

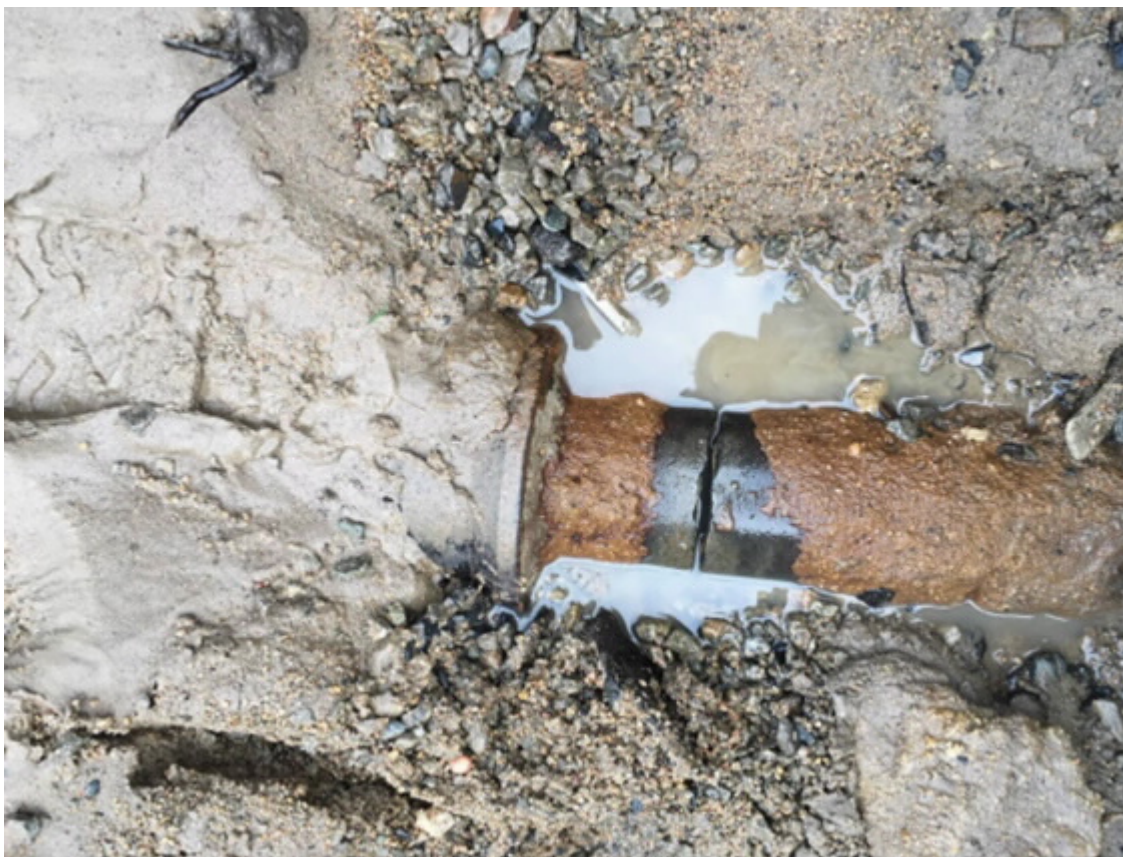
Figure 7.16 Water main trench

- b. Works to expose a water main near 26 Coburn Avenue which burst in November 2022 indicate trenches are backfilled with a mixture of fine grained and granular material (SME.0001.0001.0149) as shown in Figure 7.16.

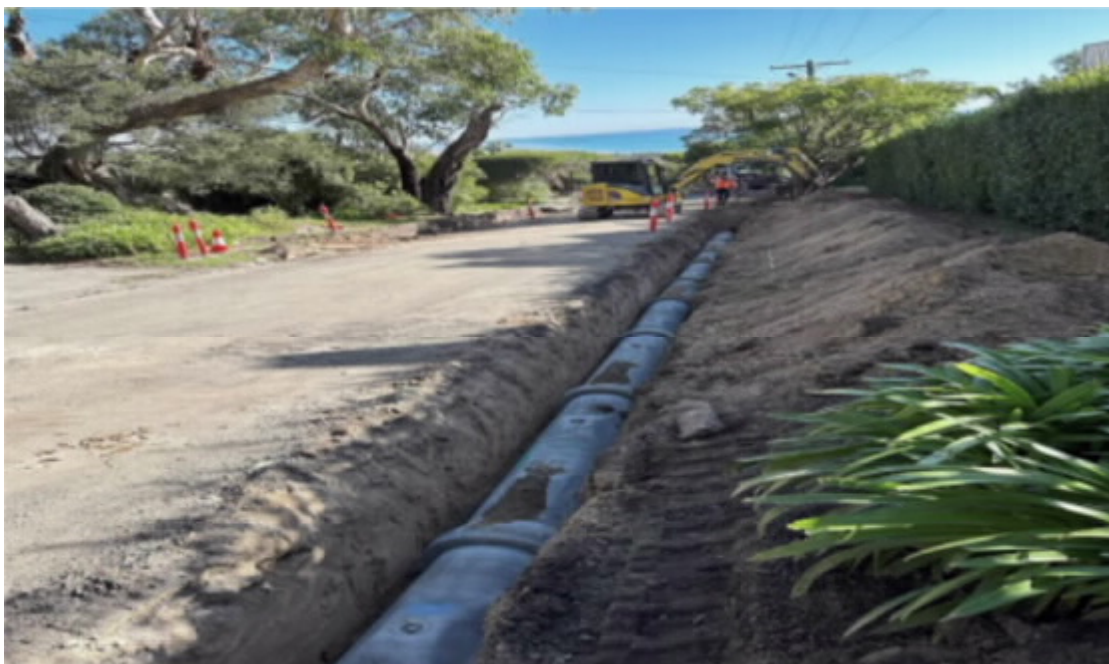
- c. Details on how stormwater trenches were backfilled have not been sourced. However, photos from the works to upgrade the stormwater pipes in 2023 in View Point Road suggest backfill with soil arising from the excavation.

Figure 7.17 Stormwater trench backfill (RES.0001.0003.0001).

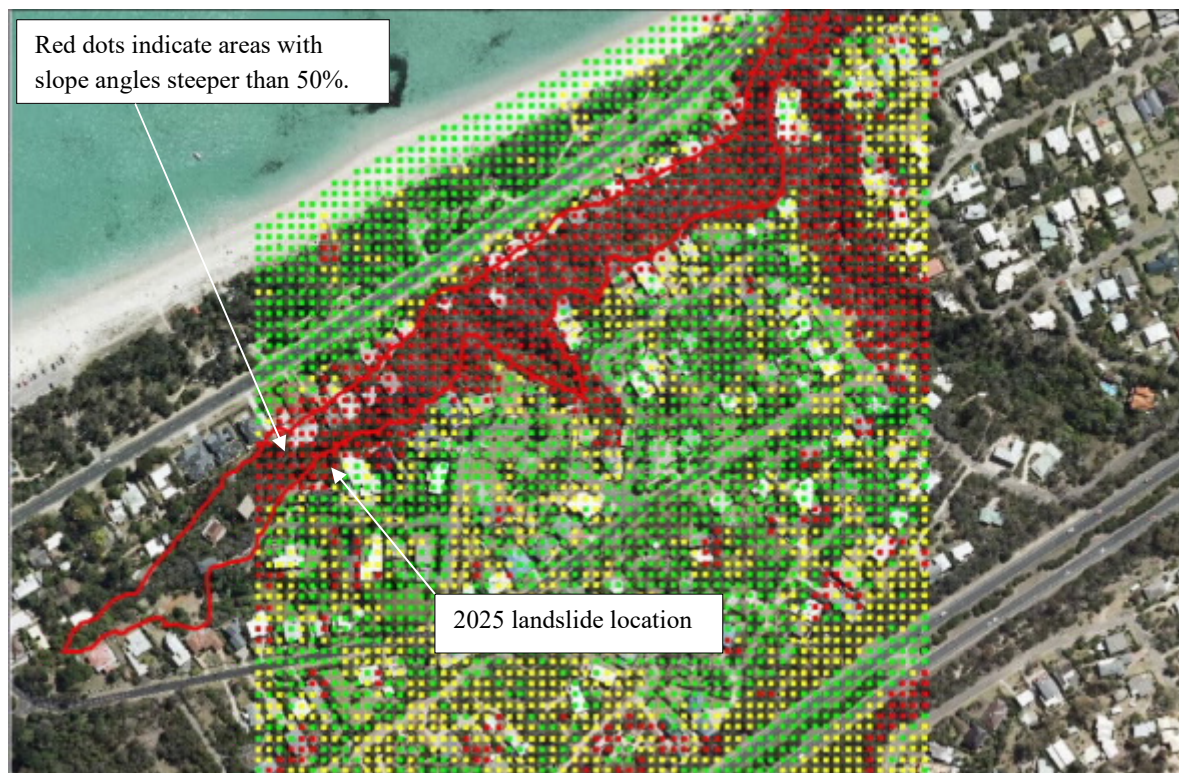
- 122) The McCrae escarpment has been included in the susceptibility mapping in the 2012 Lane Piper report as having a high susceptibility to landslide. This characterisation has been made on the basis that the McCrae escarpment has two key preparatory factors for landslide, being that it is underlain by Devonian Granite and has a slope angle steeper than 50% (approximately 27°). The slope angle of the McCrae escarpment is about 40° and therefore well above the threshold nominated in the 2012 Lane Piper report to be considered highly susceptible to landslide. An extract from the 2012 Lane Piper report is presented in Figure 7.18. The red dots show areas susceptible to landslide based on measuring average slope angle across an 8 m by 8 m grid. Notably, the high susceptibility grids appear to align with the crest and toe of the escarpment as identified from air photos. The susceptibility map does not appear to explicitly include landslide runout (areas below the escarpment that might be relatively flat but that could be impacted by debris arising from a landslide), nor landslide regression (areas upslope of the escarpment that might be relatively flat but that could be undermined due to a landslide on the escarpment).

Figure 7.18 Extract from Lane Piper 2012 report showing assessed landslide susceptibility on the McCrae escarpment, with my annotations added.

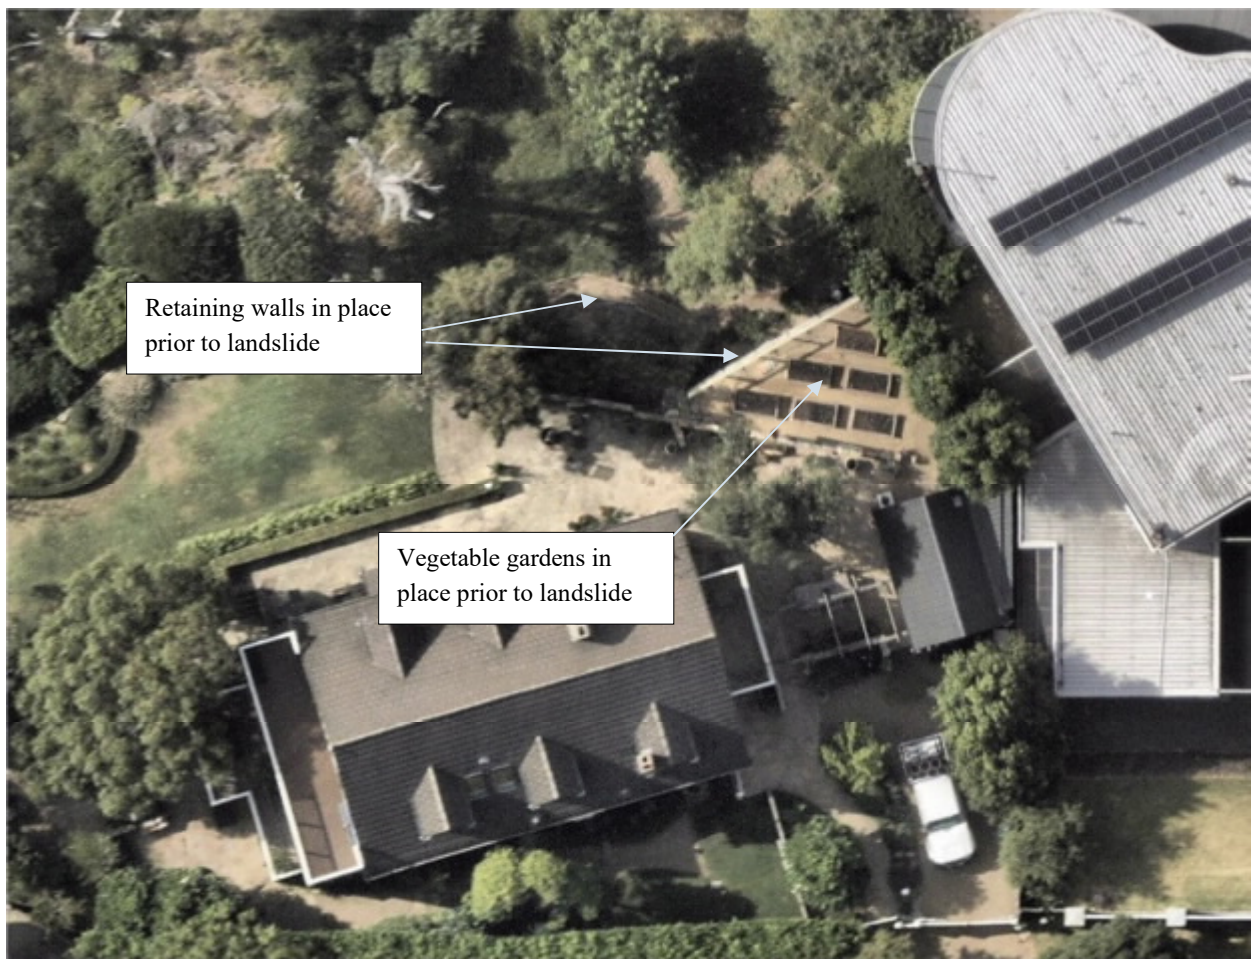
- 137) There is no evidence to suggest anthropogenic change to the escarpment through either earthworks activities or the addition of surcharge loading within a reasonable time period preceding the January 2025 landslides, noting that construction of the retaining walls at 10-12 View Point Road was complete at least 10 months prior to occurrence of the January 2025 landslides. Aerial imagery shown in Figure 8.2 supports this suggesting that surcharge loading on top of the escarpment had been relatively unchanged since around February 2024, and meaning that the addition of surcharge load at the time of the landslide was not the trigger for the January 2025 landslides.

Figure 8.2 Aerial image of the site from Nearmap dated February 15 2024.

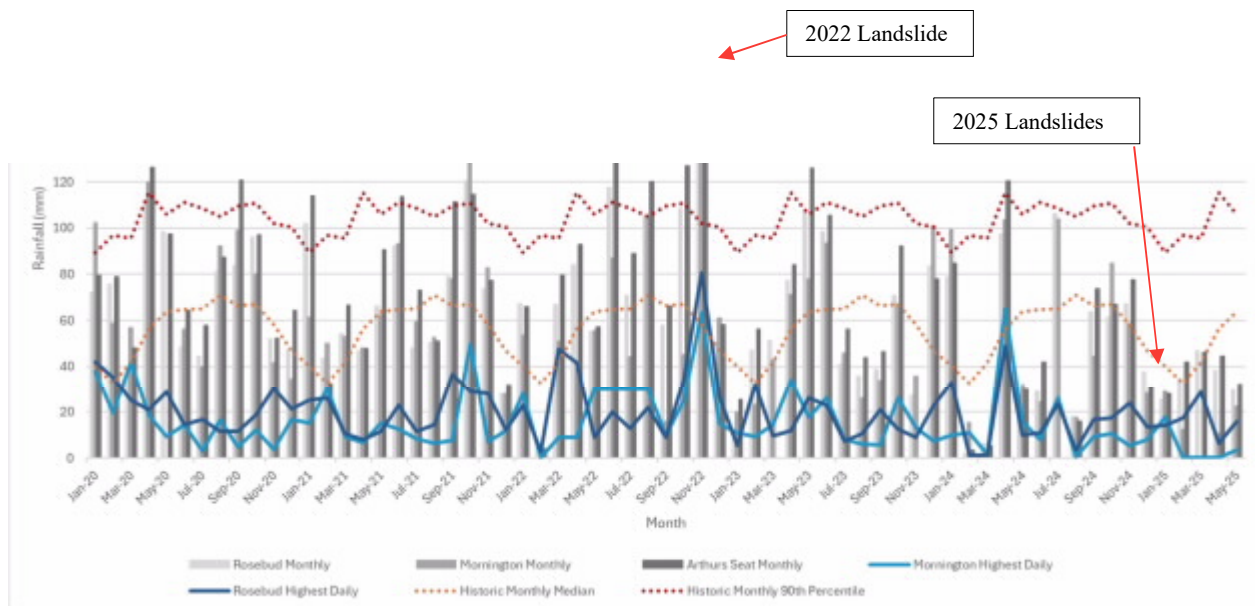
- 139) A graph showing monthly rainfall totals between January 2020 and May 2025 is shown in Figure 8.3. This shows that antecedent rainfall (cumulative rainfall) in the months leading up to the January 2025 landslides was reasonably typical, and less than the historical monthly median rainfall.

Figure 8.3 Monthly Rainfall Totals 2020 to 2025 for Rosebud 86213, Mornington 86079 (Bureau of Meteorology) and Arthurs Seat 586202 (Melbourne Water).

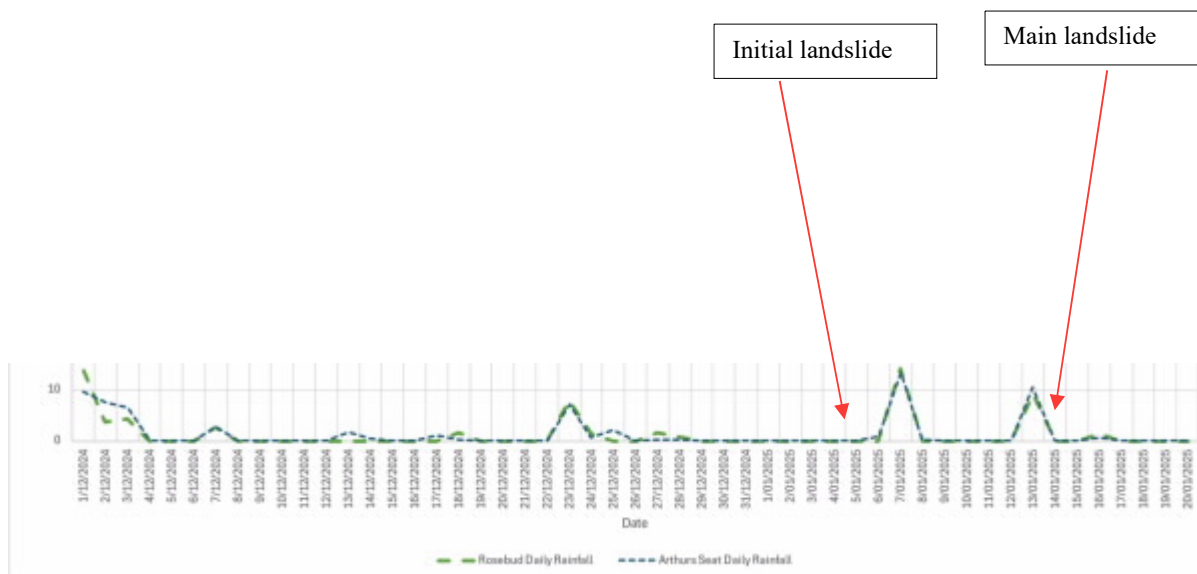
- 140) A plot showing daily rainfall totals between 1 December 2024 and 20 January 2025 is shown in Figure 8.4. This plot shows that there were no extreme rainfall events in the lead up to the January 2025 landslides. In contrast, daily rainfall preceding the November 2022 landslide is shown in Figure 8.5.

Figure 8.4 Daily rainfall totals December 2024 to January 2025 for Rosebud (Bureau of Meteorology) and Arthurs Seat (Melbourne Water). Mornington data has been omitted from this figure due to inconsistent reporting of daily rainfall totals resulting in cumulative totals being reported.

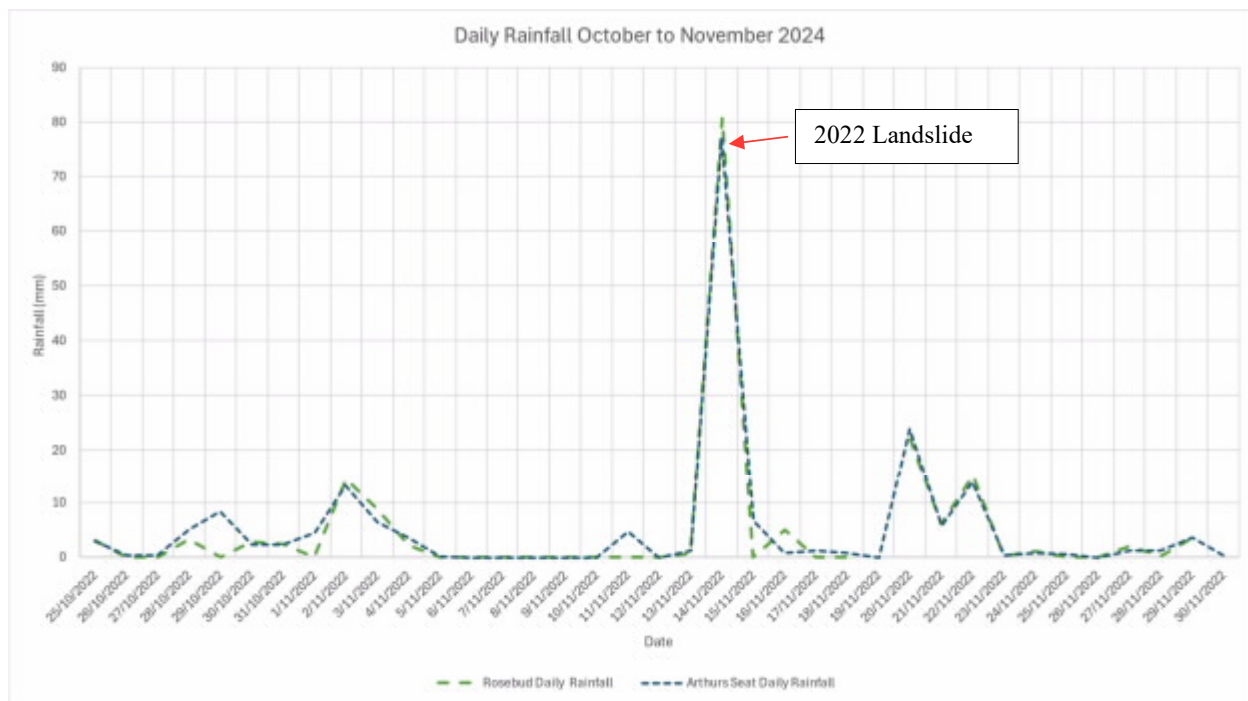
Figure 8.5 Daily Rainfall Totals October 2022 to November 2022 for Rosebud (Bureau of Meteorology) and Arthurs Seat (Melbourne Water).

- 141) The anomalously high rainfall on the day preceding the 15 November 2022 landslide gives cause to suspect rainfall as one of the sources of water that infiltrated into the ground and migrated to the escarpment causing the 2022 landslide, although the pathway along which water migrated is not certain. Infiltration was observed through the kerb on View Point Road (RES.0001.0003.0002) prior to 2022. It is also noted that there had been water main leaks observed in the road out the front of 23 Coburn Avenue about 23 m upslope of the November 2022 landslide (SEW.0001.0001.0142). This leak was observed and identified on the day before the landslide and the volume of leakage was up to 0.9 ML over 13 hours (SEW.0001.0001.5773). Some of this water exfiltrated at the road surface near the leak, and some must have infiltrated the ground because the point of water exfiltration at the ground surface was about 5 m away from the burst location and the sinkhole had opened in the private property at 23 Coburn Avenue.

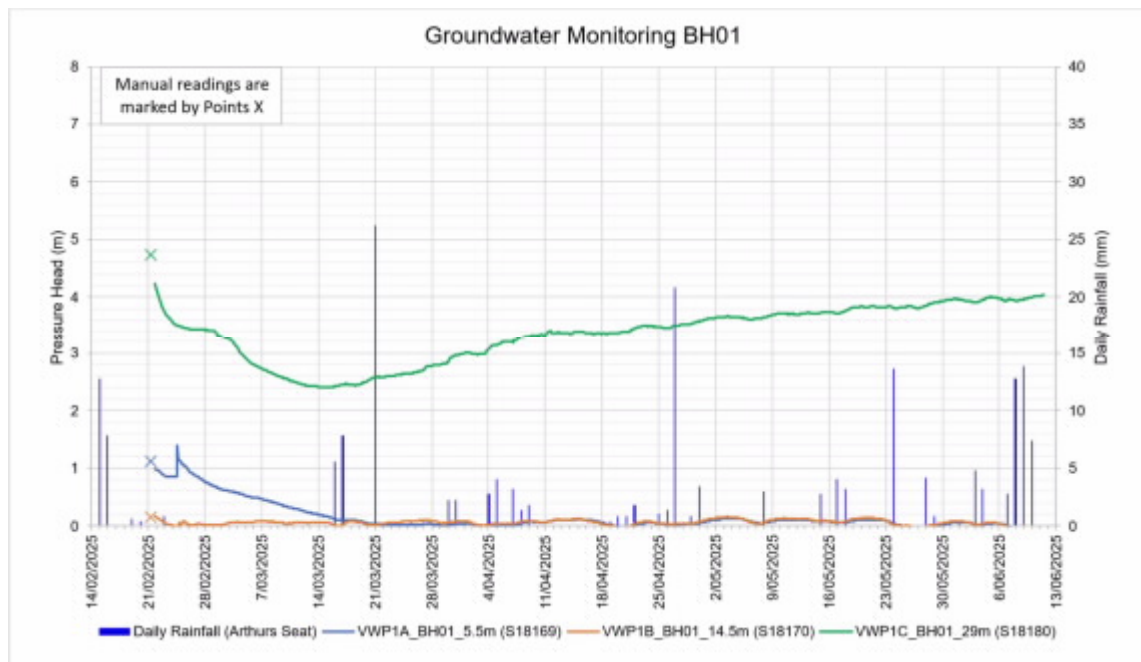
- 144) Further supporting evidence is provided by considering the results of groundwater monitoring installed after the January 2025 landslides and the response of groundwater pressures to rainfall that occurred after their installation. Figure 8.6 presents the pore pressure response in Borehole BH1, located on the driveway of 10-12 View Point Road within natural ground. The shallowest instrument, VWP1A at a depth of 5.5 m shows a decrease in pore water pressure from 21 February 2025 through to 18 March 2025 then records negligible pressure. There is little to no evidence for correlation with rainfall. Introducing a lag of 2 weeks as shown in Figure 8.7 to account for time between the rainfall and then infiltration and travel to the Borehole BH1 near the landslide location improves correlation although the correlation remains relatively weak.

Figure 8.6 Groundwater monitoring in BH01, installed in natural ground underlying driveway of 10-12 View Point Road (PSM.5002.0001.0001)

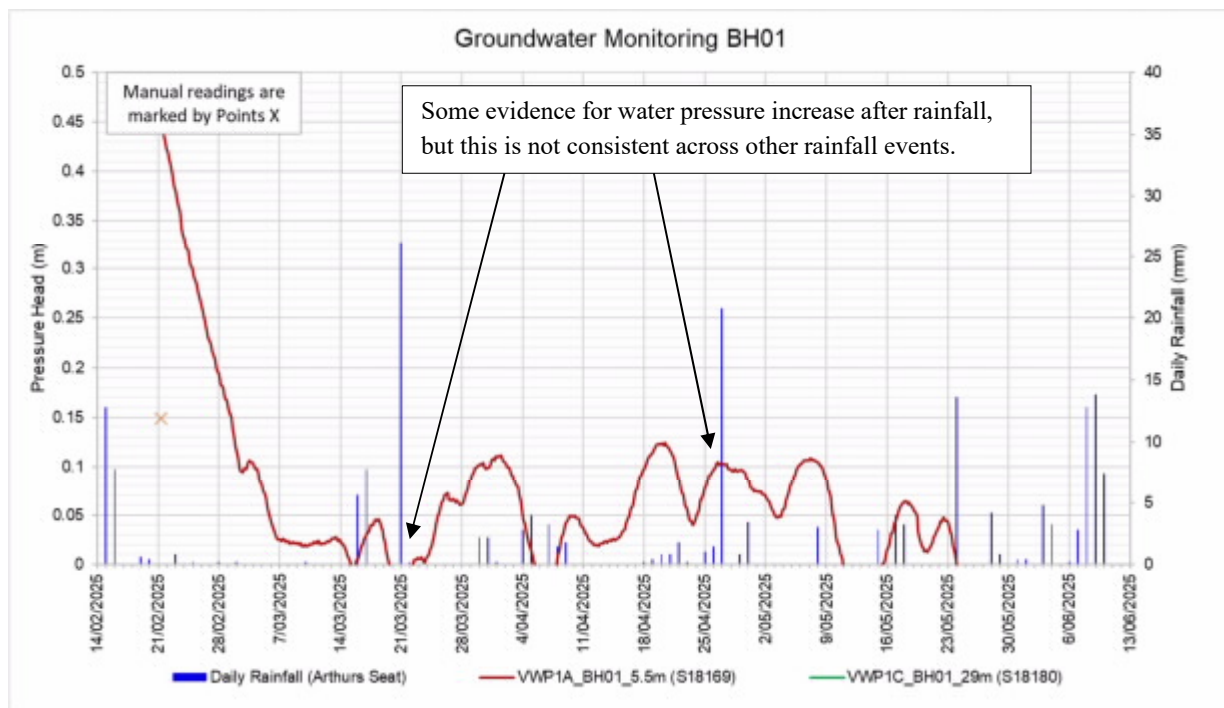
Figure 8.7 Groundwater monitoring in Borehole BH01, installed in the driveway of 10-12 View Point Road, adapted from (PSM.5002.0001.0001). Vibrating wire response shifted by 2 weeks to assess correlation with rainfall given a 2 week lag between rainfall and pressure response.

- 154) The pore pressure measurements in Borehole BH01 depicted in Figure 8.7 shows pore pressure dissipation from February 2025 to March 2025 over which time no further instability was observed. This borehole is located up gradient of the irrigation system and so dissipation of pore pressure measured in the Borehole BH01 is not consistent with the cessation of irrigation around January 2025. Furthermore, water was observed to flow from the toe of the headscarp formed by the January 2025 landslide during the May 2025 site visit, 5 months after the irrigation ceased which cannot be explained given the cessation of irrigation in January 2025 and the 5 months that had lapsed since.

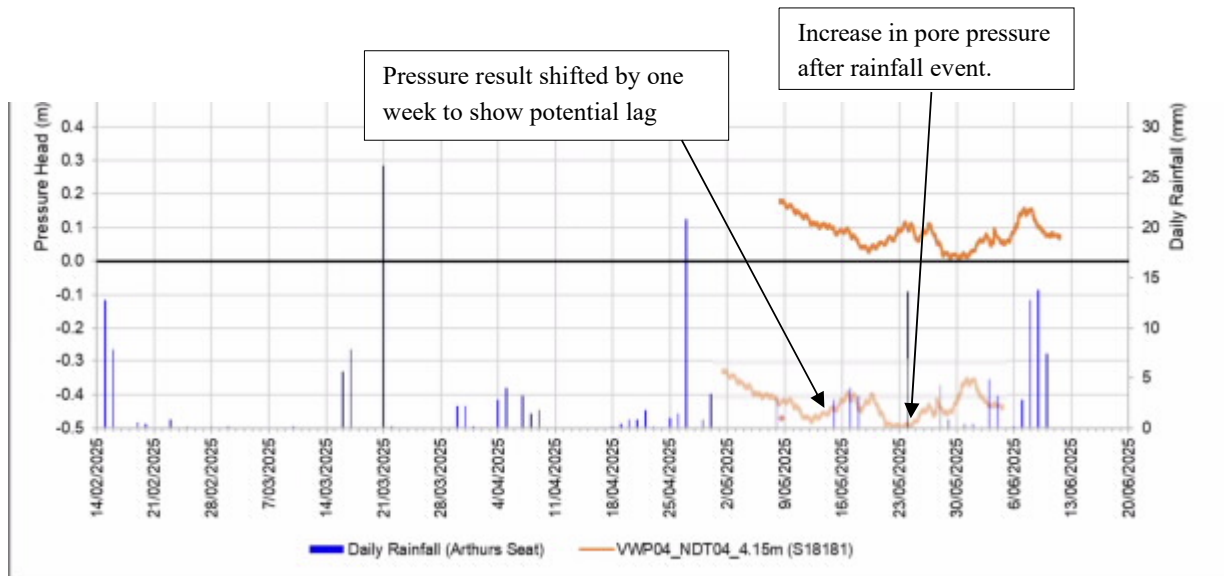
- 145) A plot of pore pressure measured using a vibrating wire piezometer installed in borehole NDT04 at the base of a sewer trench within View Point Road at 10 – 12 View Point Road is shown in Figure 8.8, and indicates a weak correlation with rainfall. The spikes in rainfall do not correspond to the points where pore pressure begins to increase. However, if there is assumed to be a lag of about 1 week between rainfall and measured pore pressure response, a better but still relatively weak correlation is observed.

Figure 8.8 Groundwater monitoring in NDT04, installed in sewer trench (PSM.5002.0001.0002) added annotations.
