McCrae Landslide

Causation Report

McCrae Landslide
Causation Report

Board of Inquiry into the McCrae Landslide

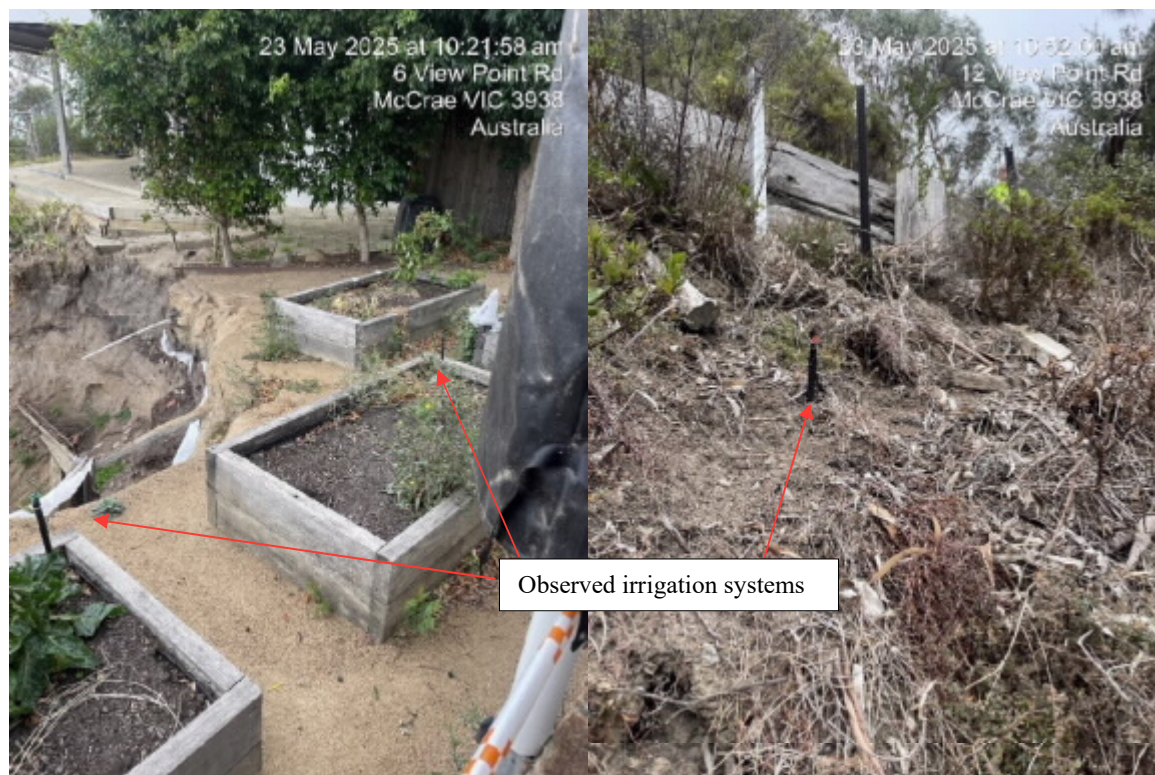
- 147) Site observations undertaken on 23 May 2025 identified garden irrigation surrounding the escarpment at 10-12 View Point Road (Figure 8.9), including small diameter irrigation pipes and sprinklers typical of a domestic garden irrigation system.

Figure 8.9 Evidence of irrigation on and around the escarpment at 10-12 View Point Road.

- 153) Irrigation systems observed at 10-12 View Point Road were predominately surface level watering systems supplying water to the surface of gardens. If water infiltration associated with excess irrigation was a significant contribution to the January 2025 landslides, it would be expected that following the 14 January 2025 landslide, the soils would be saturated from the ground surface down to the base of the landslide headscarp (the flow path between the surface and the base of the landslide headscarp would be wet). This is not what was observed in both the January 5 landslide (Figure 8.12) and January 14 landslide (Figure 8.13) and there is no evidence for connectivity between the irrigation system and the point at which water was observed to be seeping from the escarpment.

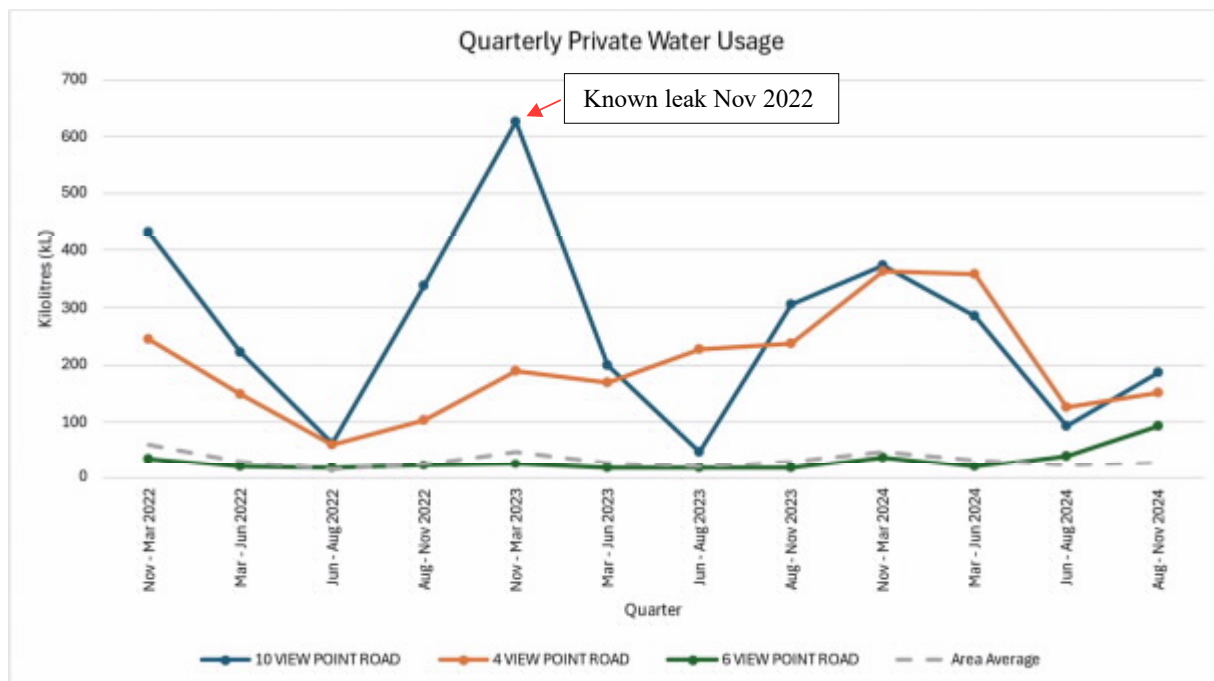
- 149) Figure 8.10 shows the quarterly private water usage for the three properties immediately above the landslide; 10-12 View Point Road, 6-8 View Point Road and 4 View Point Road. It has been noted that a leaking pipe in Q3 2022 caused abnormally high readings for that quarter. Whilst water use at 10-12 View Point Road and 4 View Point Road is higher than typical for the area, usage over time has remained relatively consistent with no step change in water consumption since 2021.

Figure 8.10 Quarterly private water usage, generated from data provided in SME.0001.0001.0083.

- 151) The water usage at 10-12 View Point Road was abnormally high around the time of the November 2022 landslide due to a leak as indicated on Figure 8.10. However, the daily rate of water delivery of approximately 6,600 L/day (based on averaging 600kL across 3 months) is very low in proportion to the water that could have been delivered by rainfall and a water main burst on the day preceding the landslide. Although the water

- 152) The water usage at 10-12 View Point Road for the latest quarter of 2024 is about 4000 to 5000 L/day based on the data shown in Figure 8.10 which averages to around 0.05 L/sec. Noting this is total household water consumption, and that the area of the January 2025 landslides represents only a small portion of total irrigated area at 10-12 View Point Road. The average rate at which an irrigation system could have applied water to that area of the landslide would be less than this. On 6 January, PSM measured 0.1 Litres/sec to 0.2 l/sec issuing from the 14 January 2025 landslide headscarp and measured at the boundary between 3 Penny Lane and 10-12 View Point Road (5000.0004.4640). The rate that water was issuing from the landslide headscarp is at least 10 times greater than what could have been supplied by the irrigation system given the data cited above. Whilst this is an approximate comparison and takes no account of factors such as water absorption that could occur into the soil over time, it indicates potential inconsistency between the water observed issuing from the soils at the escarpment and what could have been provided by the portion of the irrigation system near the landslide at 10-12 View Point Road.

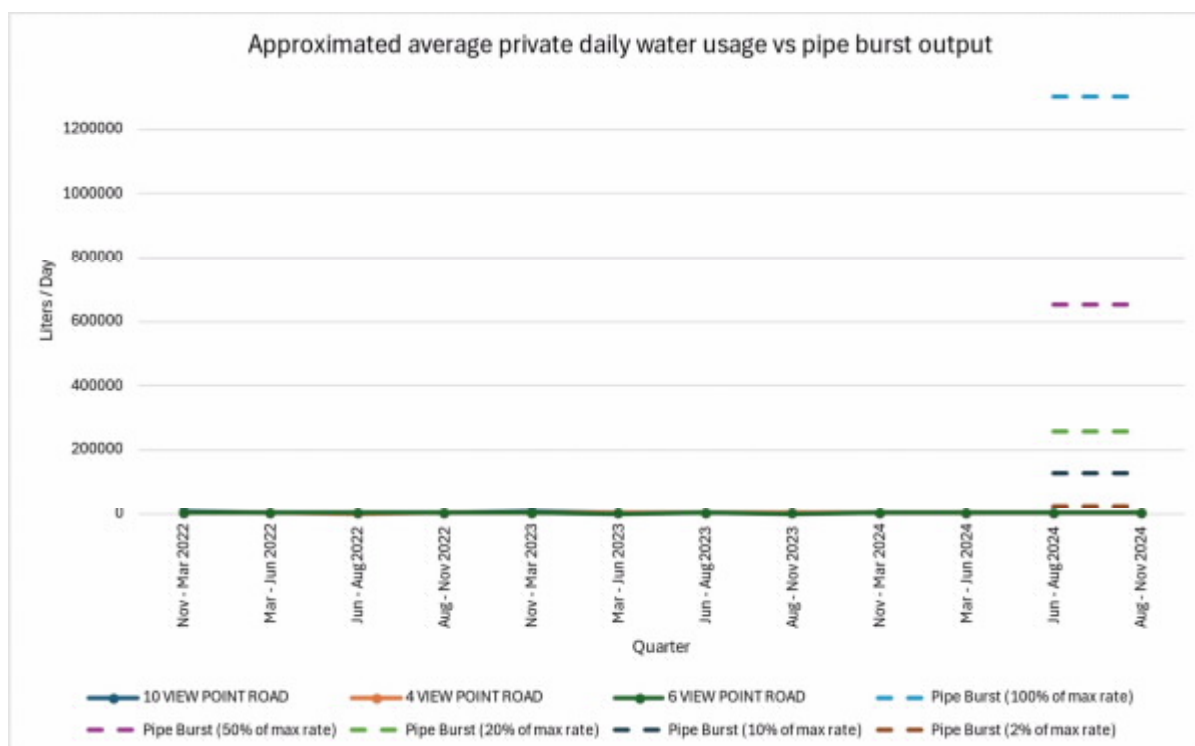
- 150) Figure 8.11 shows the approximate average daily water usage for the three properties assuming an average of 92 days per quarter. When the approximated daily usage is compared to the estimated daily output volume during the course of a South East Water pipe burst event 450 m away from the landslide (discussed in further detail in 8.7) throughout November and December 2024, orders of magnitude difference in rate and volume of leakage is observed. Whilst data on domestic water use is unavailable at the time of the January 2025 landslides, private water usage at each property is about 0.3% of the daily burst output during the late stages of the pipe burst event (4,500/day domestic water use vs 1.3 ML/day from the pipe burst).

Figure 8.11 Approximated average daily private water usage, based on an average of 92 days per quarter. Estimated output from pipe burst in late December 2024 indicated.

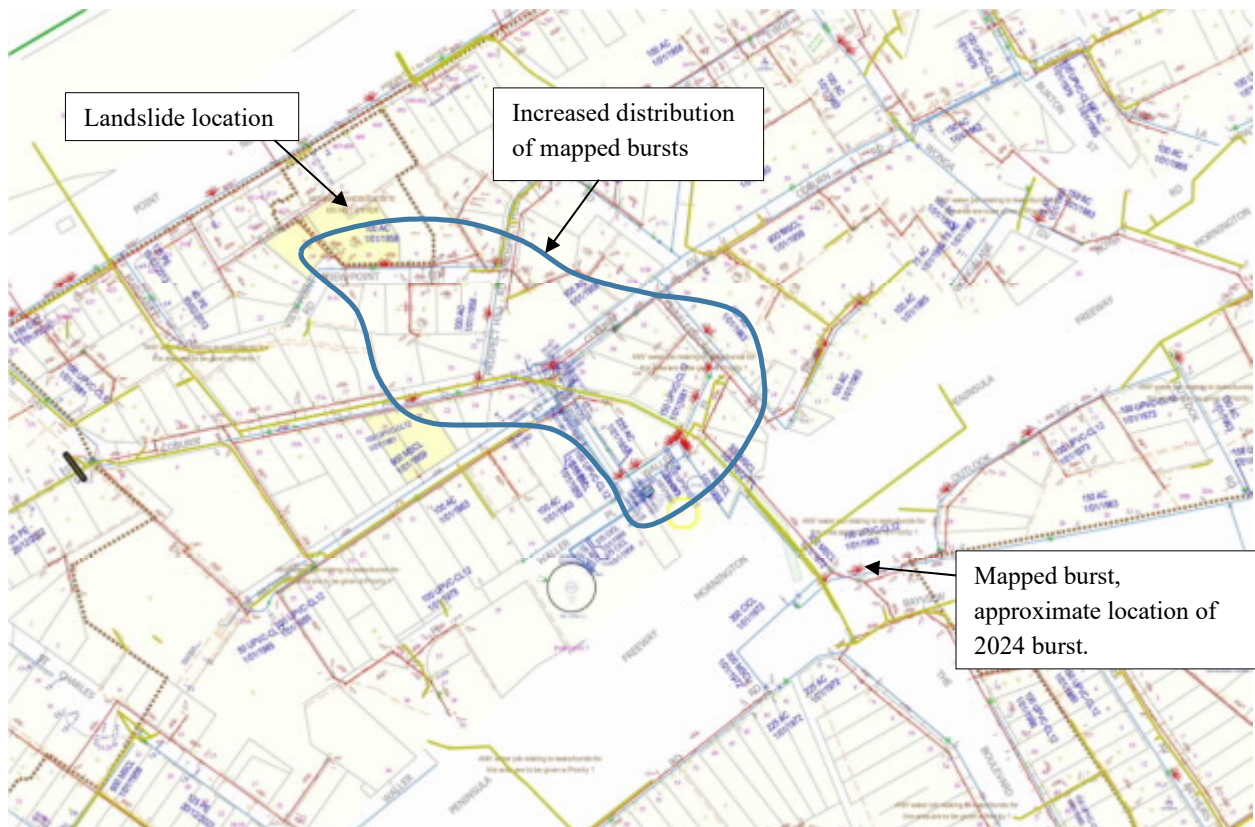
- 156) An alternative source of water that would likely have infiltrated into the ground and then migrated along a pathway to the location of the 2025 landslide is a leaking underground service. Based on South East Water plans as shown in Figure 8.14, there appears to be a greater frequency of leaking water mains in the McCrae area compared to surrounding areas.

- 157) With low certainty, the increased rate of pipe leakage in the McCrae area is related subsurface flow paths through the area. Because the soils are dispersive, and if trenches have been backfilled with native soils, fines in the soils can also migrate, allowing water to flow along trenches and form voids around the pipes. Asbestos cement pipes are brittle and can be prone to cracking and leakage if voids are able to form in the backfill around the pipes, noting this was a key causal factor of the 1997 Thredbo Landslide. Alternatively, incidents noted as leaks could be related to water exfiltration at the surface with the source of water infiltration being up-gradient of the location at which water was observed at the surface.

Figure 8.14 South East water plan showing frequency of water leaks within water mains in the McCrae area (SME.0001.0001.0148) with my annotations.

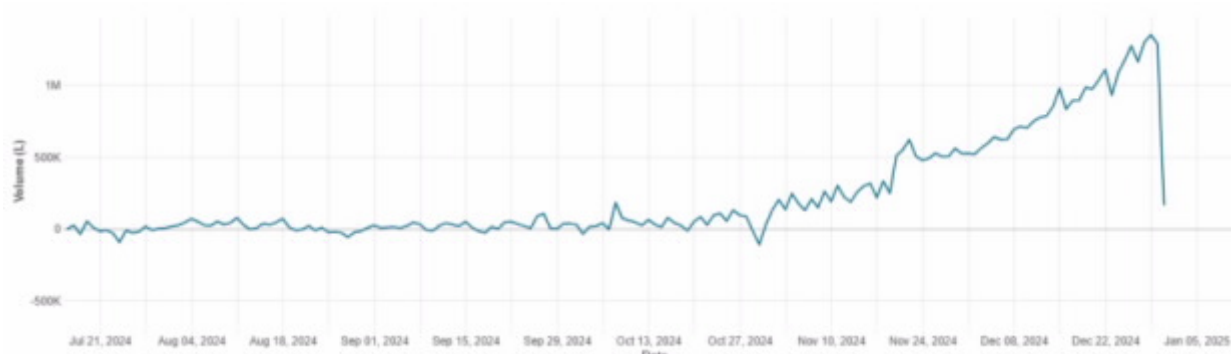
- 158) As described in the witness statement of Jonathan Crook and the accompanying report (SEW.0001.0001.0746), a leak occurred in a 150 mm water main near the intersection of Outlook Drive and Bayview Crescent (south of the Mornington Peninsula Freeway) with leakage occurring between approximately 5 October 2024 and 31 December 2024 and resulting in total water losses estimated at between 34 ML and 39 ML, but with the rate of leakage increasing over that time and exceeding 1ML/day over the week preceding repair of the pipe on 31 December 2024. A chart showing the interpreted water balance in the McCrae area is included in (SEW.0001.0001.0746). I understand there is some uncertainty associated with this estimate. Also, I assume that the y axis in this figure represents L/day, not total L.

Figure 8.15 Adjusted water balance in McCrae area, July to December 2024 (from SEW.0001.0001.0746).

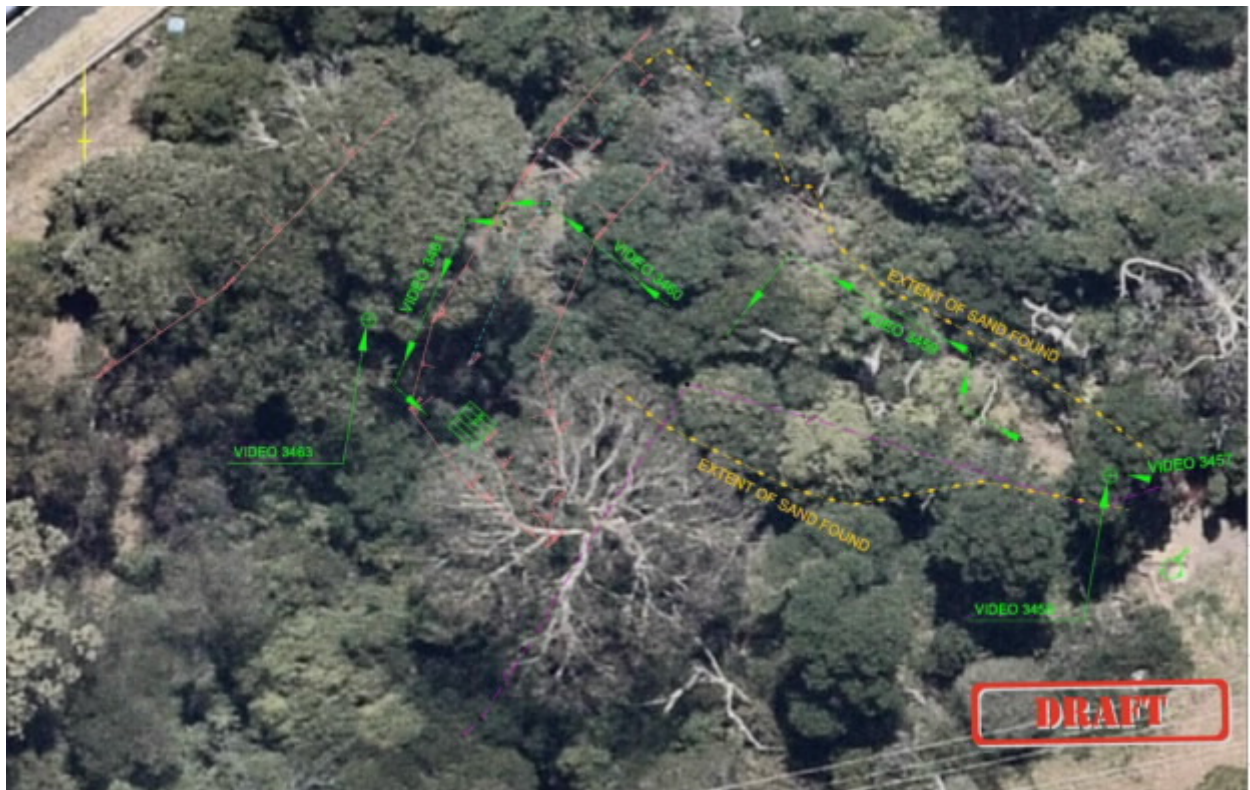
- 159) There is some uncertainty as to where the water that leaked from the pipe went. Observations made at the site of the leak indicate that at least some of the water bubbled up to the surface and flowed into the stormwater system via entry pits between the leak and the Mornington Peninsula Freeway. However, the earliest observation of excessive water in the stormwater pipes is reported in mid-December at Waller Place (witness statement of Brett Cooper, RES.0004.0002.0008). Water infiltration into the ground would be expected initially upon the occurrence of the leak and water would continue to infiltrate until the pores are saturated and the pressure required for water to infiltrate the ground is greater than what is required for water to migrate upwards and exfiltrate at the ground surface. Once this occurred, there could have been some surface infiltration as water travelled along a surface flow path. Sand mapped at the surface downslope of the leak provides evidence of the surface flow direction and pathway to the entry pits, as shown in Figure 8.16.

Figure 8.16 Plan showing inferred water flow path (green arrows) for water that issued at the surface from the leaking main towards pit entry (ref: SME.0001.0001.0139).

- iii. Sediment deposition between the pipe burst and stormwater pit as shown in Figure 8.16.

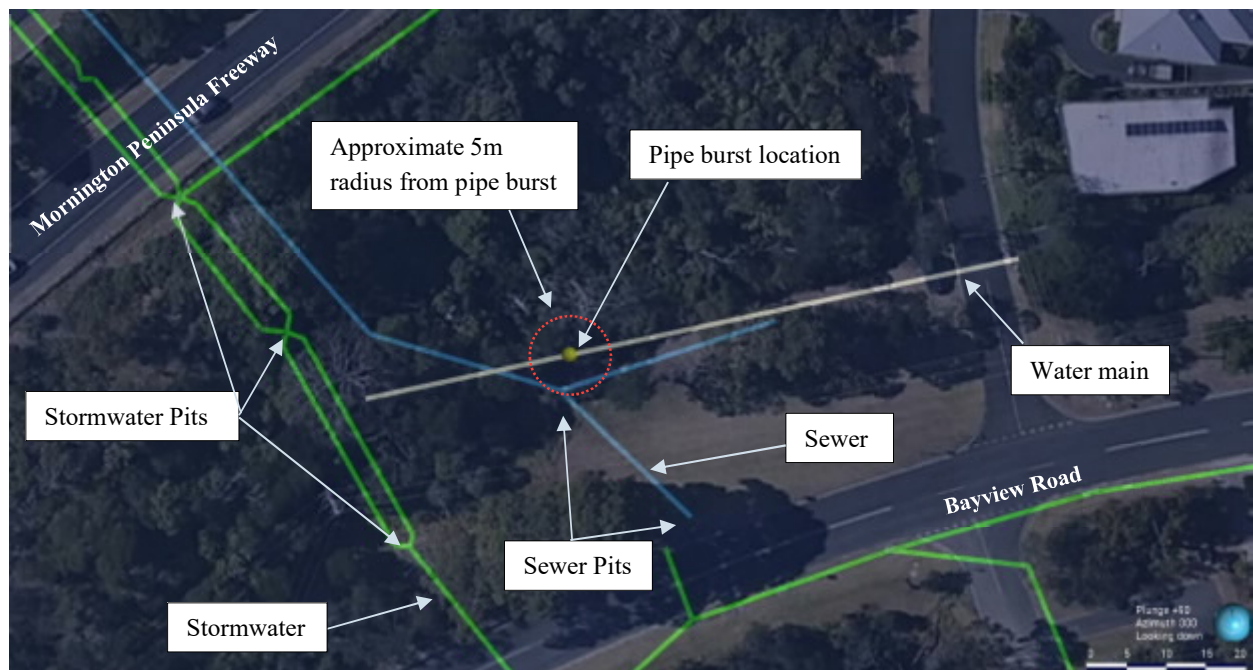
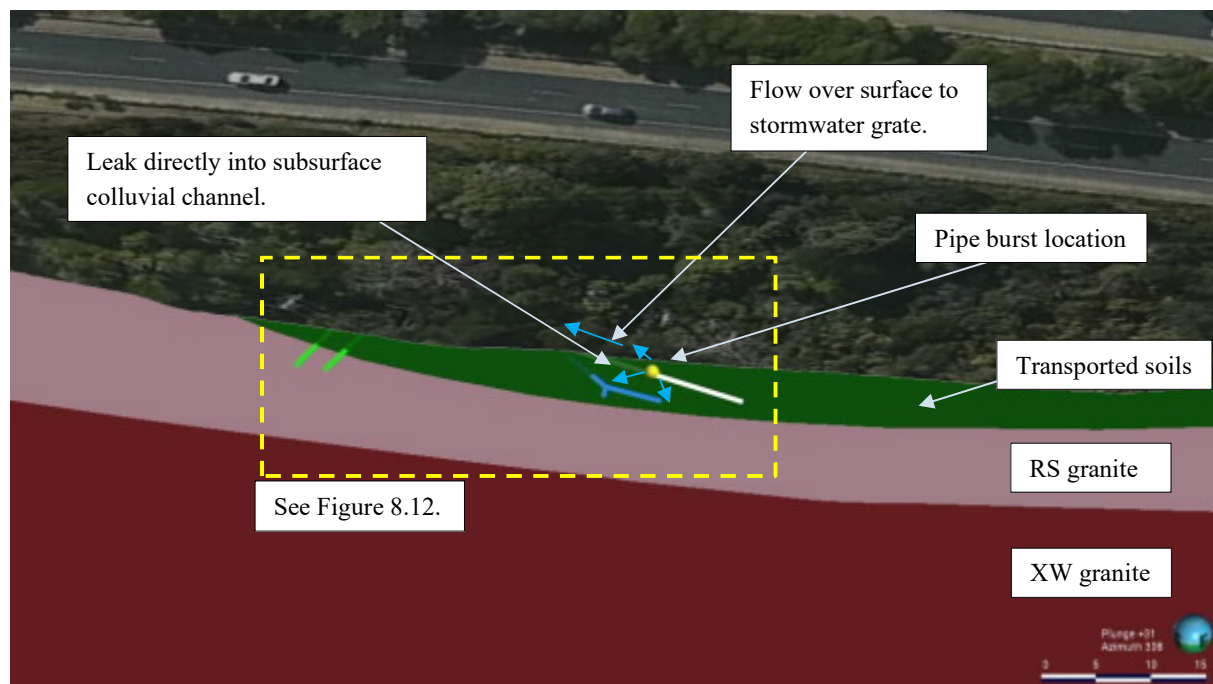
- 161) Water that infiltrated into the ground, could have flowed into a natural colluvium infilled channel or could have flowed through colluvium and entered the nearby sewer or stormwater trenches which are located within about 3 m and 30 m of the leak respectively. Water could have also flowed along the water main trench and into the stormwater or sewer trenches noting that these trenches must intersect the water main trench. Figure 8.18 and Figure 8.19 shows the spatial relationship between the pipe burst location, the sewer and stormwater trenches.

Figure 8.18 Isometric view showing relationship between pipe burst location, and infilled colluvial channel.

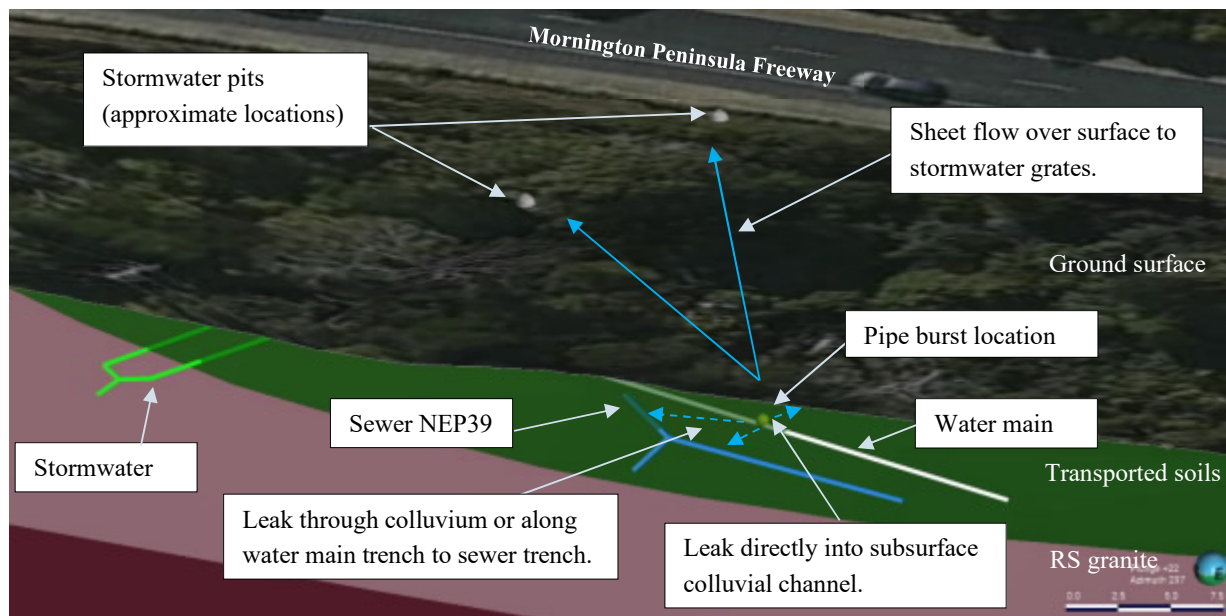
Figure 8.19 Isometric view showing relationship between pipe burst location, sewer and stormwater trenches and potential flow paths.

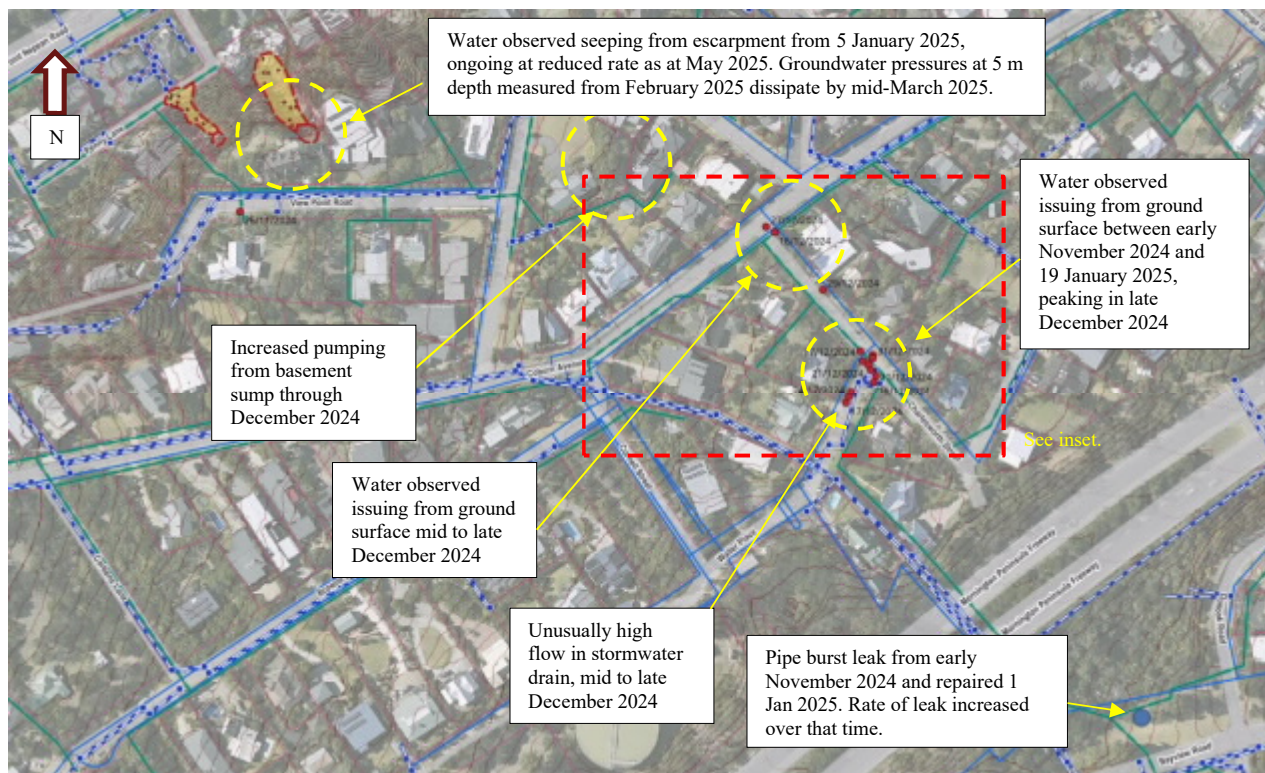
- 162) To assist with identifying the actual pathways taken by water that leaked from the pipe burst, Table 8.1 summarises evidence for anomalous ground and surface water observations made downslope of the pipe leak over the time it occurred. These observations are compiled from witness statements and South East Water maintenance records as indicated and are provided to give an indication of the timing of events. These observations are shown spatially in Figure 8.20. The sequence of events relating to the timing of the pipe burst and observations is also set out sequentially in Appendix G.

Figure 8.20 Plan showing locations and timing of surface water observations between October 2024 and March 2025. Locations estimated based on report of leak.

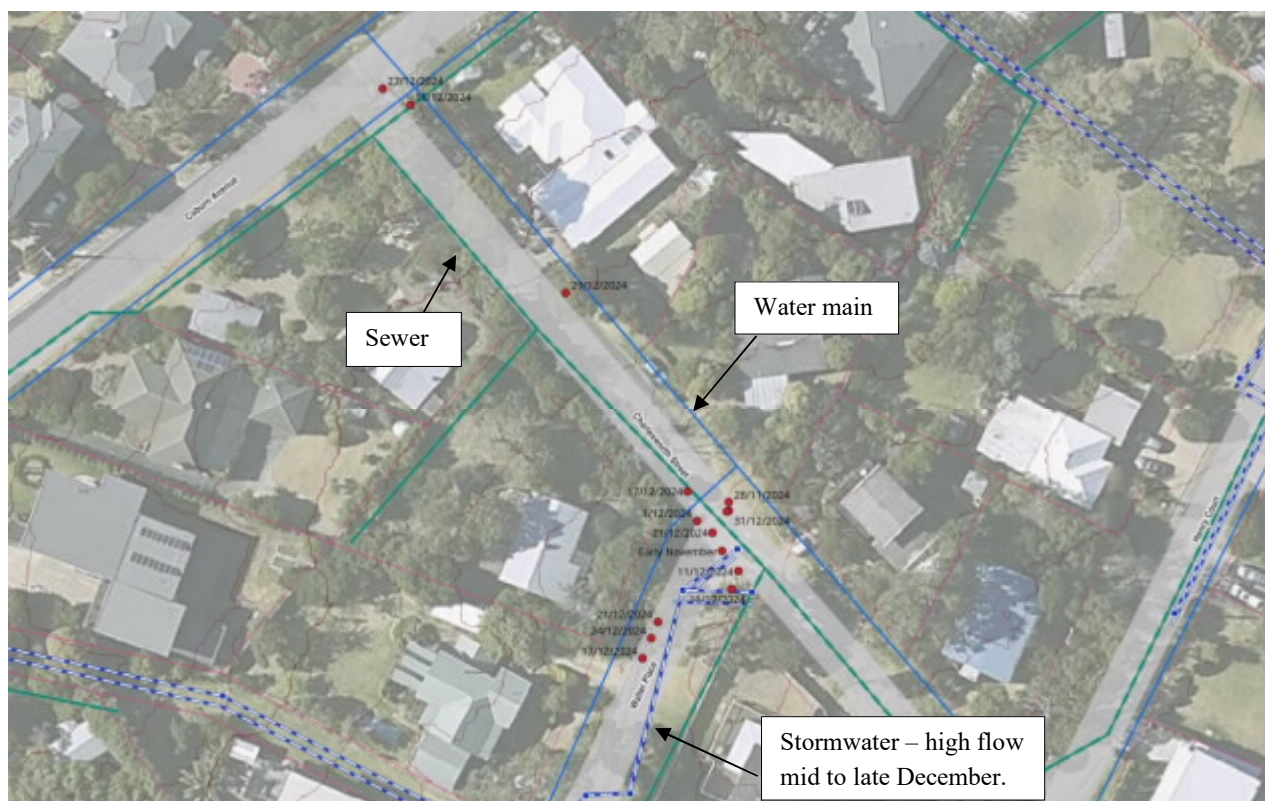
Figure 8.21 Inset from Figure 8.20 Showing location and timing of reported surface water observations around Charlesworth Street and Coburn Avenue.

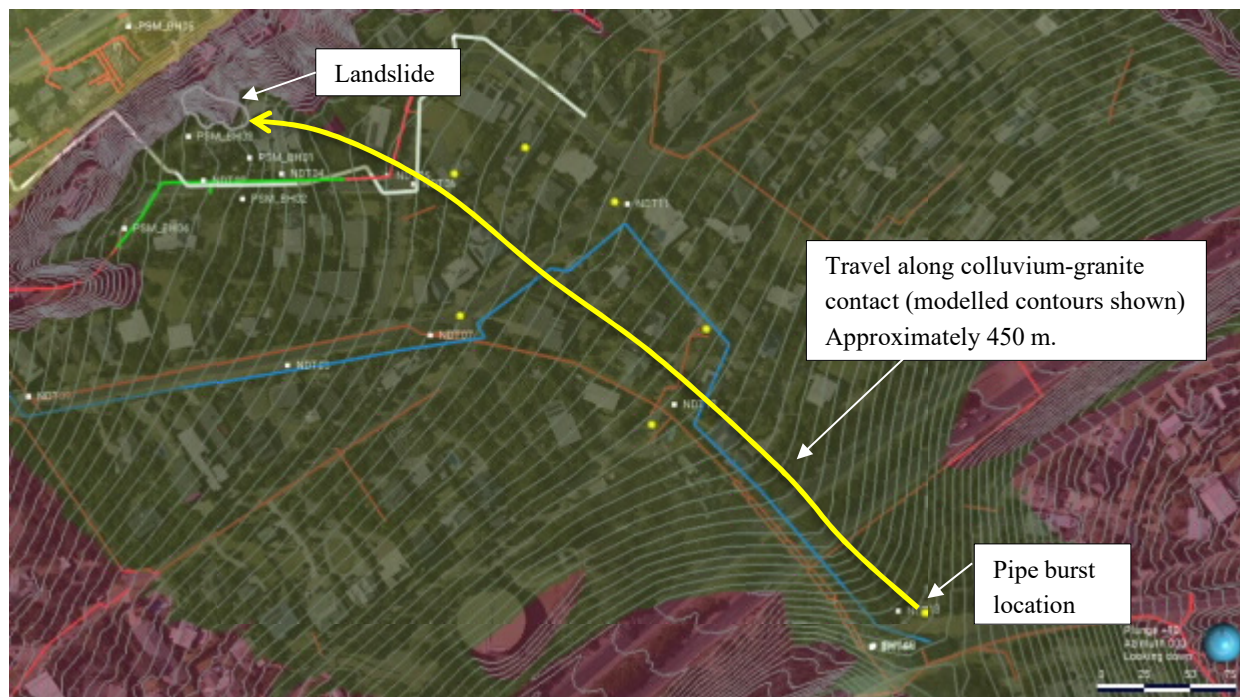
- a. Through natural soils only, specifically along the base of channels infilled with colluvium containing silt, sand, gravel and cobbles. Water enters the colluvium directly from the pipe burst. See Figure 8.25. Evidence for the feasibility of this flow path includes:

- i. the observation that the leaking pipe is in contact with colluvial material at the pipe burst site and that water exits from colluvial material at the 2025 landslide headscarp.

Figure 8.25 Plan showing potential flow path through natural soils. Modelled surface geology shown where green is transported soil and red is RS/XW granite.

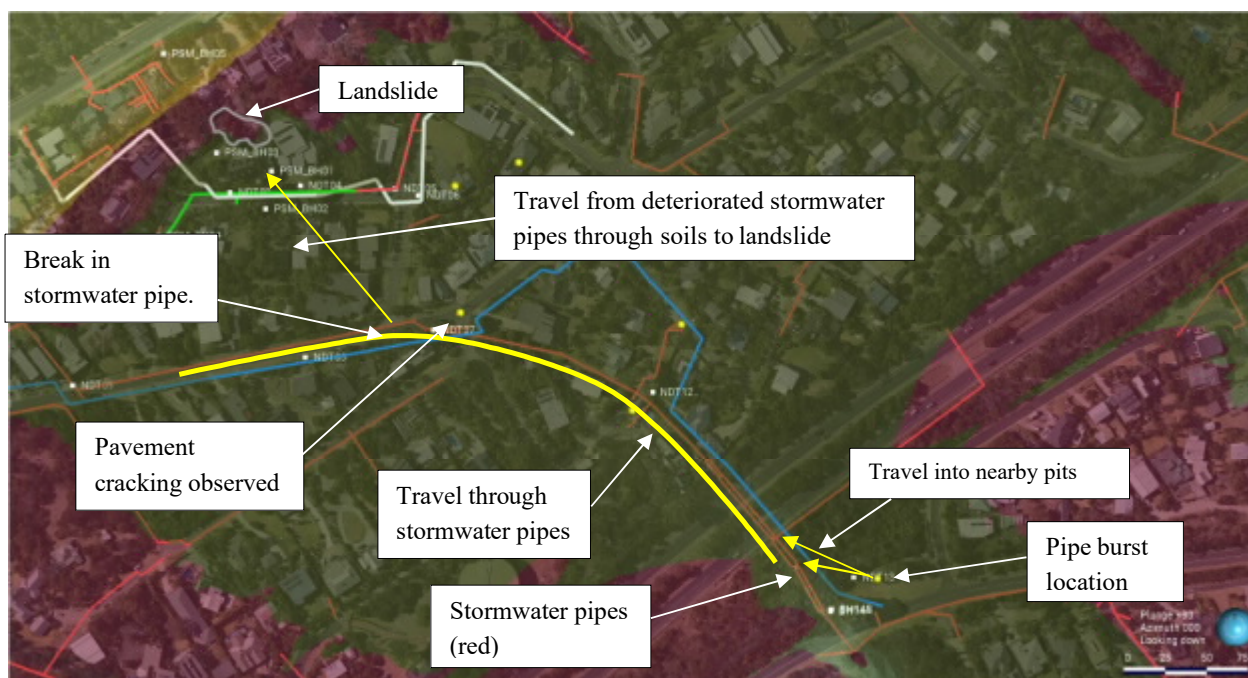
- iii. Increased pumping required from the basement at 5 Prospect Hill Road which does not intersect major service trenches.
 - b. Through the stormwater pipes, with water issuing from the pipe burst entering the stormwater pipes via the inlet pits between the pipe burst and freeway. The water is then assumed to exit the stormwater pipe through breaches in the pipe, noting a breach near 25 Coburn Avenue which is directly upslope of the 2025 landslide before flowing through natural transported soils to the escarpment. The break in the stormwater pipe at this location is described via an email issued on 25 March 2025 as a cavity adjacent to the break measured as being 900 mm along the pipe, 200 mm to the side and 800 mm up. The break is near the base of a stormwater pit 2.2 m below the surface (MSC.5031.0001.4490) as shown in Figure 8.22 . The pit is inferred to have been installed in 1981 (SME.0001.0001.0309). It is not clear when the pipe break occurred nor whether the break existed prior to the January 2025 landslides, however if caused by erosion which is consistent with the photograph, this would have taken some time, likely years to form. See Figure 8.26. Evidence for this flow path includes:

- ii. Witness reports of high stormwater flows along the stormwater pipes in December 2024, for example the witness statement of Brett Cooper (RES.0004.0002.0008) that coincide with the time during which the SEW pipe was known to be leaking.

Figure 8.26 Plan showing potential flow path through stormwater pipe. Modelled surface geology shown where green/yellow is transported soil and red is RS/XW granite.

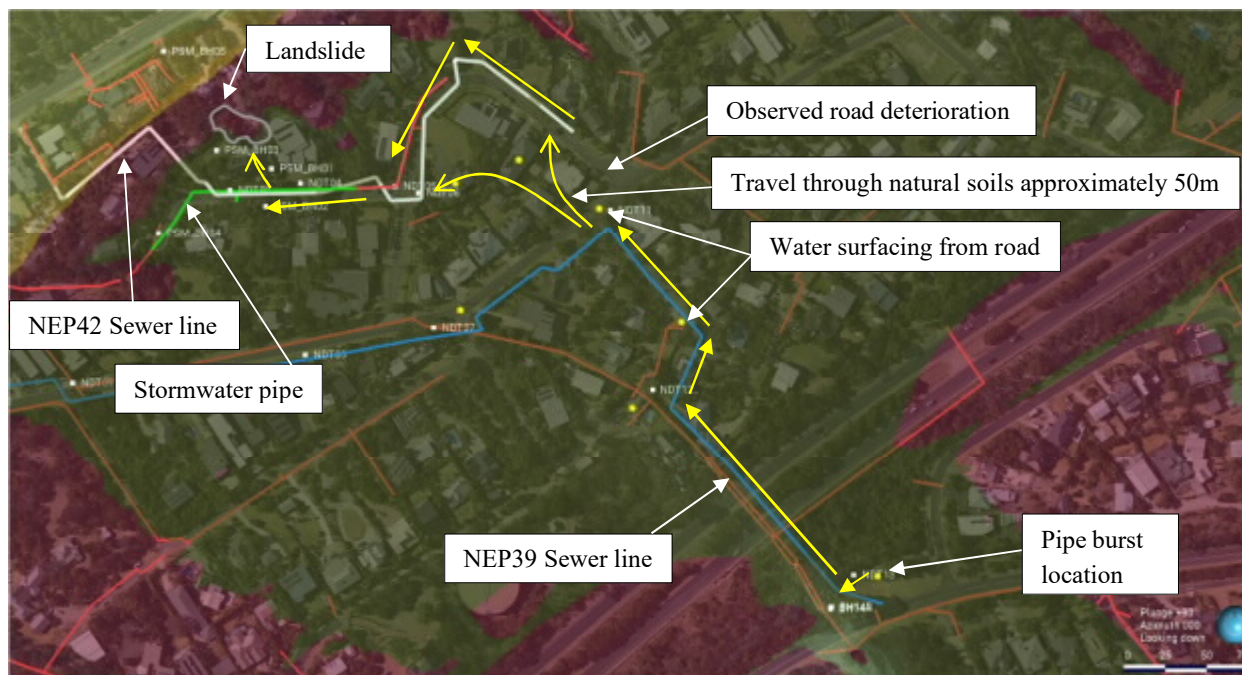
- c. Through sewer trenches with water from the pipe burst flowing through either natural soils or along the water pipe trench for about 20 m before entering the sewer trench. Water would need to further flow through sections of natural soils between the intersection of Charlesworth Street and Coburn Avenue and the sewer in Prospect Hill Road then again from the sewer at View Point Road to the landslide headscarp. See Figure 8.27. Evidence for this flow path includes:

- ii. Dye tracer test between borehole NDT01 which is adjacent to a sewer trench at 6 Prospect Hill Road and the 2025 landslide headscarp in which dye was observed to issue from the landslide headscarp (PSM.5000.0004.4640) after a relatively short time.

- iii. Subsurface voids detected near the stormwater and sewer trench in View Point Road. Figure 8.24 shows an image of a void observed during the 2023 council works to upgrade the stormwater drainage on View Point Road (RES.0001.0003.0001). Evidence of subsurface voiding was also identified in a 2023 CivilTest report (MSC.5000.0001.0246) following ground penetrating radar (GPR) of the area. The results of the GPR identified a void near the sewer pipe at 10-12 View Point Road and noted voids deeper than the 1.5m range of GPR would not be identified.

Figure 8.27 Plan showing potential flow path through sewer trenches. Modelled surface geology shown where green/yellow is transported soil and red is RS/XW granite.

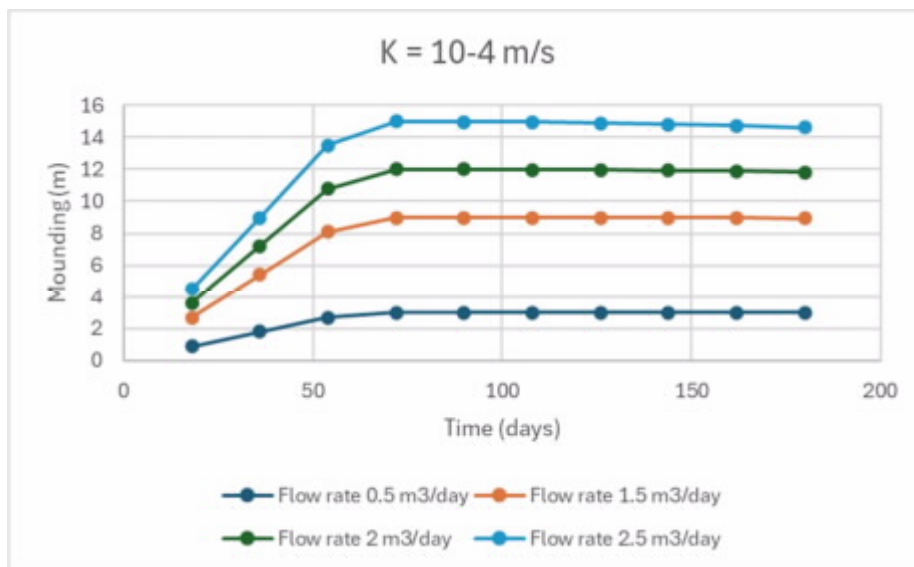
- 165) The hydrological assessment set out below has been undertaken by Principal Hydrogeologist, Mr. Stephen Makin.
- 166) An estimate of the potential rate of infiltration from the leak was made using the method of Hantush (1967)¹², as implemented in Aqteolv Pro software. For a constant rate of recharge for 60 days over a rectangular area of 10 m by 5 m, the height of groundwater mounding is shown in Figure 8.28 for hydraulic conductivity, K of 10^{-4} m/s, such as may be typical of sandy gravel, and Figure 8.29 for K of 10^{-3} m/s, typical of a gravel material. This indicates that depending on the flow rate and the available thickness of the colluvial aquifer below the leak, the aquifer would become fully saturated at varying times after the start of the leak. After that time, continued recharge could result in water exfiltration at the ground surface over the leak. For example, for a 10 m thick gravel aquifer, recharge rates over around 2 m³/day would fully saturate the aquifer after around 60 days. Higher recharge rates would bring water to the ground surface earlier, noting that the flow rates from the pipe reached 1,400,000 litres, 1,400 m³ per day. Given excessive water flow was not observed through stormwater pipes until mid-December 2025, the ground in the vicinity of the pipe burst was likely relatively permeable to absorb the very high volume of water it did over the time it did before excessive water could no longer be absorbed by the ground and issued at the ground surface to be collected by the stormwater pit between the pipe burst and Mornington Peninsula Freeway.

Figure 8.28 Groundwater mounding at $K = 10^{-4}$ m/s

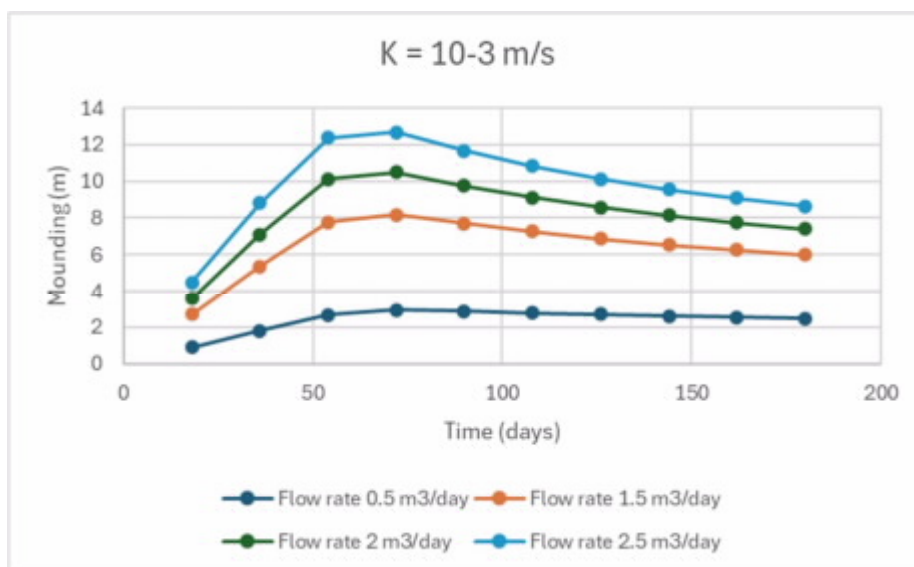
Figure 8.29 Groundwater mounding at $K = 10^{-3}$ m/s

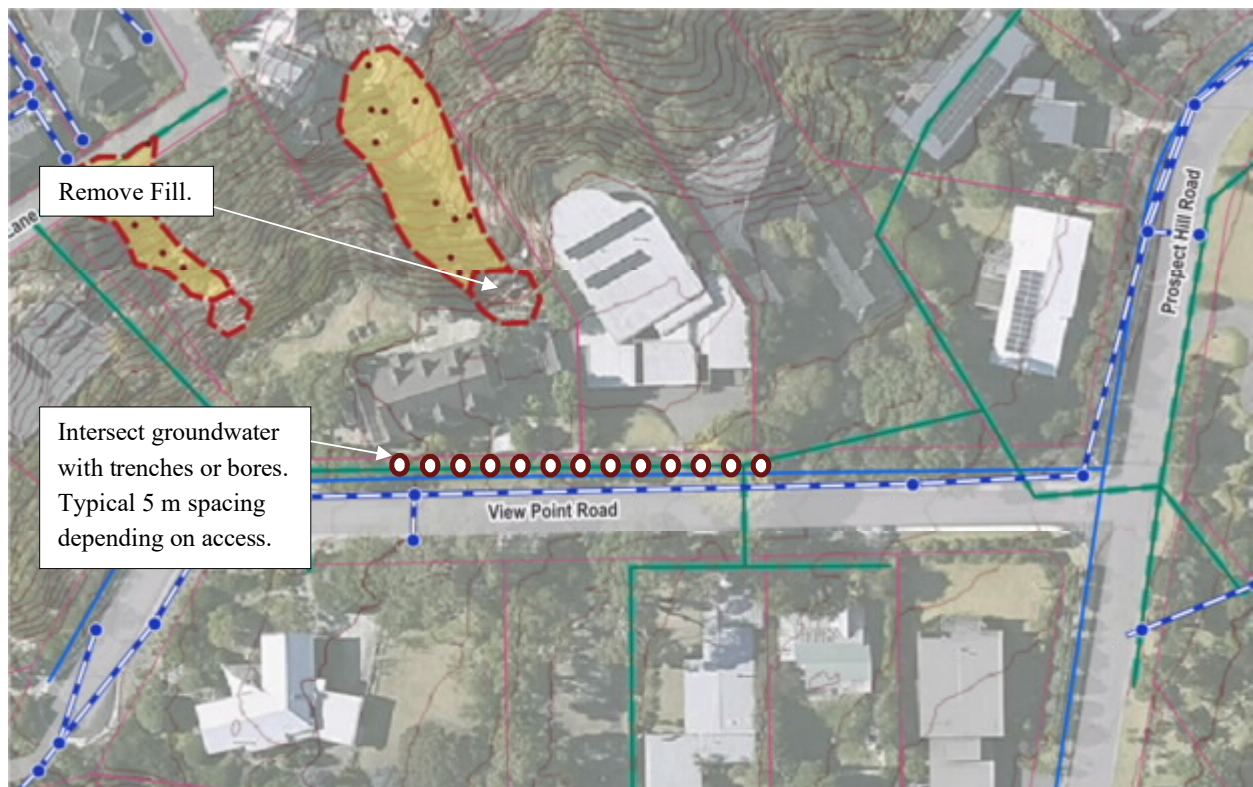
Figure 8.37 Summary of potential mitigations that could have been implemented after 5 January Landslide.

would be needed, for example arranged in a row parallel to the escarpment to increase the chance of intersecting the subsurface flow path as shown on Figure 8.37 and it is uncertain whether groundwater could be intersected and removed quickly enough to have prevented the 14 January 2025 landslide.

- ii. Inserting dewatering spears which are steel rods driven into the ground to sufficient depth to intersect subsurface water which is then pumped from the ground through the spear. These are a less certain approach to excavation because there may be obstructions to driving in spears to the depth required to intersect groundwater.
- iii. Excavating a trench, for example a trench on View Point Road with the objective of intersecting groundwater and allowing water to be pumped out. Given the trench depth may need to approach 6 m, it is likely that support would need to be provided to the excavation or it would not have been practical to excavate.

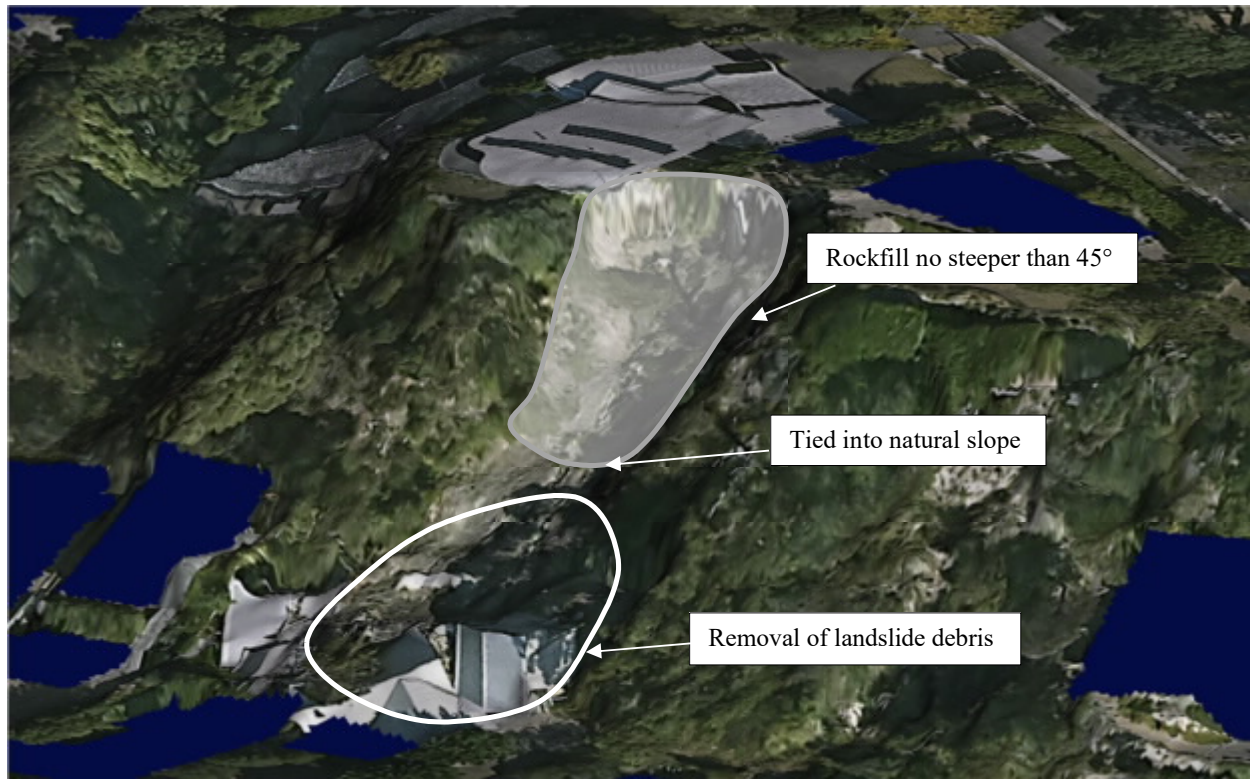
Figure 9.2 3D image showing possible extent of rockfill required to reinstate zone of depletion arising from the 2025 landslide.

- Reinstate the material that detached from the landslide using engineered fill. The material placed back against the escarpment must be permeable such that water that issues from the landslide headscarp can flow freely through and discharge into stormwater at the base of the slope avoiding pore pressure build up in the slope. Rockfill comprised of angular interlocking boulders could be placed to a slope angle of up to 45° similar to the angle of the slope before the landslide. Rockfill would need to be comprised of high strength, interlocking boulders which could be further reinforced using geogrid. The volume of rock required would be relatively large, however unlike soil nails, this approach would return the slope geometry back to a state close to what it was prior to the 2025 landslide and could be undertaken by placing the rock with machinery mounted in a safe location. If required, an engineered buttress could be constructed to keep the toe of the rockfill in place. Geofabric would need to be placed over the currently exposed soil to prevent fine soil washing into and clogging the pores in the rockfill, with geofabric carefully selected such that it performs a function as a filter material as well as allowing water to issue from the escarpment and to flow freely through. If desired, the aesthetics of the rockfill surface could be improved by including provision to plant vegetation over parts of the surface, for example isolated contained pockets of soil embedded within the rockfill. A 3D image showing the

extent of rockfill likely required is shown in Figure 9.2, and an image of another landslide remediated using this method is presented in Figure 9.3. An indicative schematic is shown in Figure 9.4.

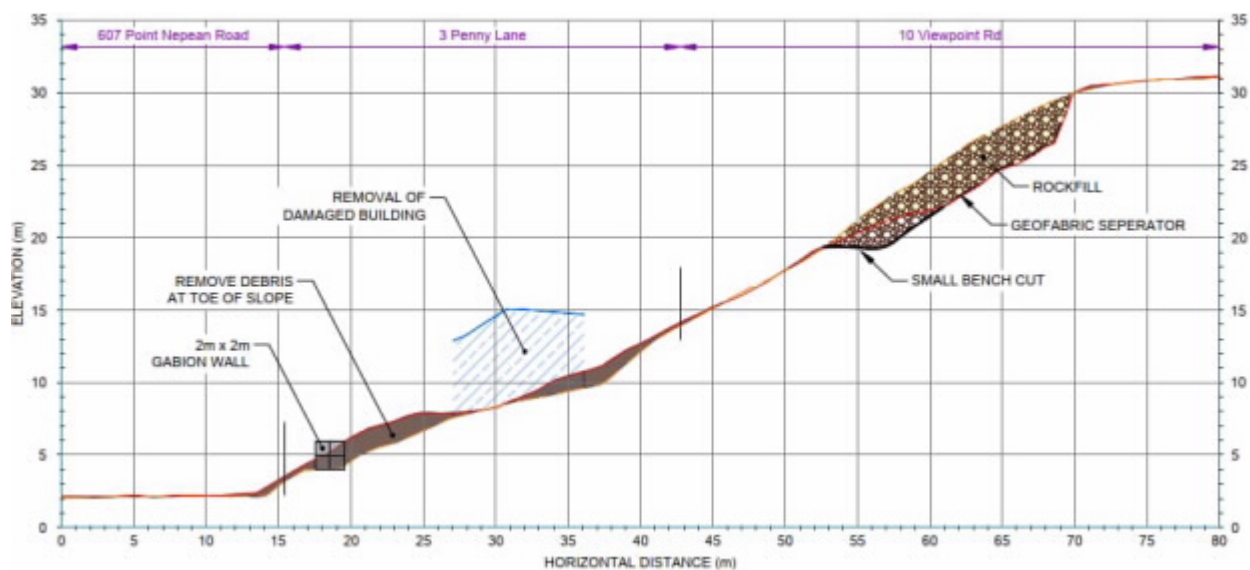
Figure 9.4 Indicative cross section through remediation using rockfill (see Appendix F for further detail)

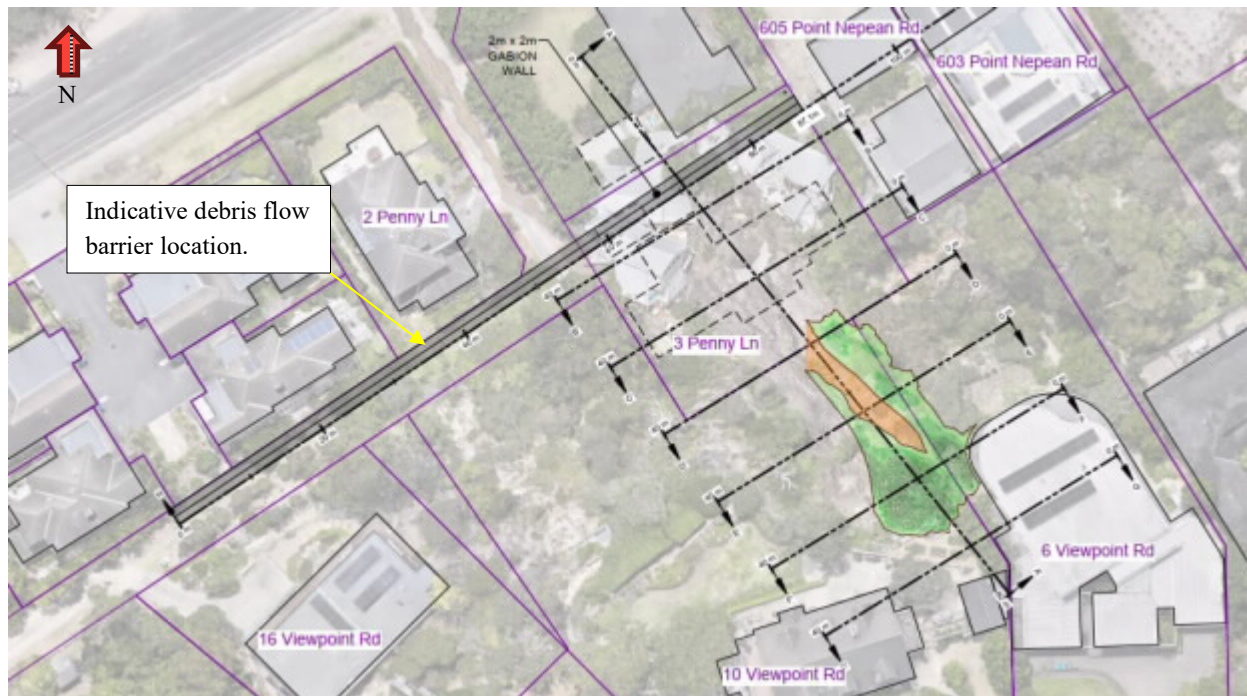
Figure 9.5 Indicative location for bund to intercept debris flowing to base of escarpment.

- 214) There are landslide risk reduction measures that might ordinarily have been installed as part of the development undertaken on and around the McCrae escarpment that were not, likely due to the lack of planning control at the time of development. There may be an opportunity to retrospectively install risk mitigation measures to protect the existing dwellings. Both the 2022 and 2025 landslides involved soil flowing down the escarpment to dwellings on Penny Lane. Debris flow barriers could be constructed along the Penny Lane road reserve for the purpose of intercepting debris flows and reducing the potential for impact to the houses at the toe of the escarpment. There may be various options that could be considered for debris flow barriers including an earthen bund, gabion baskets, anchored concrete barriers, a post and panel wall or proprietary debris flow barrier. Drainage will need to be a consideration for any barrier to ensure it can direct water to the stormwater system or is sufficiently permeable to allow surface water to flow through. Any barrier will require maintenance which includes periodically clearing debris from behind the barrier that will accumulate over time. A potential location for a barrier is indicated in Figure 9.5 and typical cross section in Figure 9.4 (extracts from Appendix F). Examples of other types of barriers are shown in Figure 9.6.
