McCrae Landslide

Causation Report

McCrae Landslide
Causation Report

Board of Inquiry into the McCrae Landslide

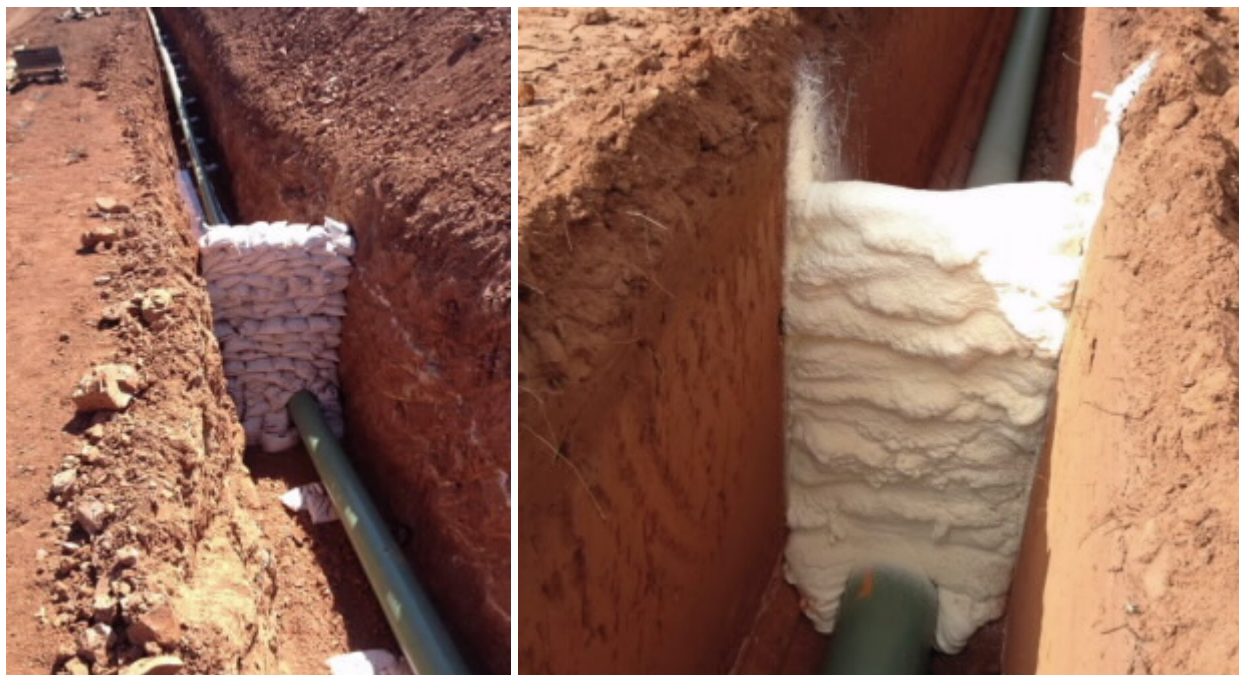
Figure 9.8 Example of trench stops using sandbags (left²⁰), and foam (right²¹)

- 216) Given leaking pipes are likely to have contributed to the 2025 landslide and potentially the 2022 landslide, improved leak detection systems may allow leaks to be addressed early and reduce the potential for significant water build up in the soil. Given the susceptibility of the escarpment to landslide, it may be prudent to upgrade aging vitreous clay sewer pipes and asbestos cement water mains in the McCrae area to reduce the likelihood of future leaks. If this approach is taken, trench backfill could be selected to prevent the migration of water along trenches, for example by using impermeable backfill such liquid cementitious backfill or by using trench stops (impermeable barriers in the trench to intercept flow along the trench, also called trench breakers). These force water flowing along the trench to the surface where it can be detected and repairs implemented before it reaches a point that could cause a landslide. Examples of trench breakers are shown in Figure 9.8.
