Leak Report

22 William Street McCrae Victoria 3938 Australia

Downer

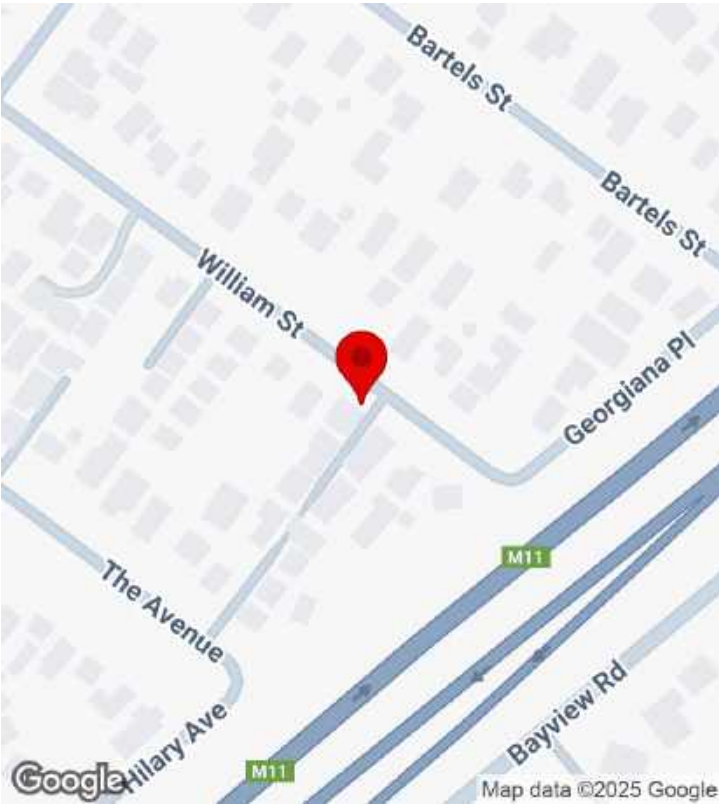
Suspect there's a small leak on the main here. I have ran a quick correlation here, but correlation didn't bring up anything, but there's not much noise here. There's only a very slight noise on the Fire plug further up.

I have probed down in naturestrip, but I'm unable to get onto the main to listen directly as it's 80mm AC here, so im probably just missing the main. I did listen anyway, and I think I might be picking up the faintest of noise, but it's hard to tell.

This is directly in line with the main and its seeping down driveway now, and the customer is concerned due to the incident down Penny Lane. I think it's just a very small leak on the main here, and I'm just unable to hear it. I'm unable to test the water myself.

Suggest excavating around wet patch to expose main.
