# Expert Opinion Report - Rectification

10-12 View Point Road, McCrae

PSM5226-005R 11 June 2024

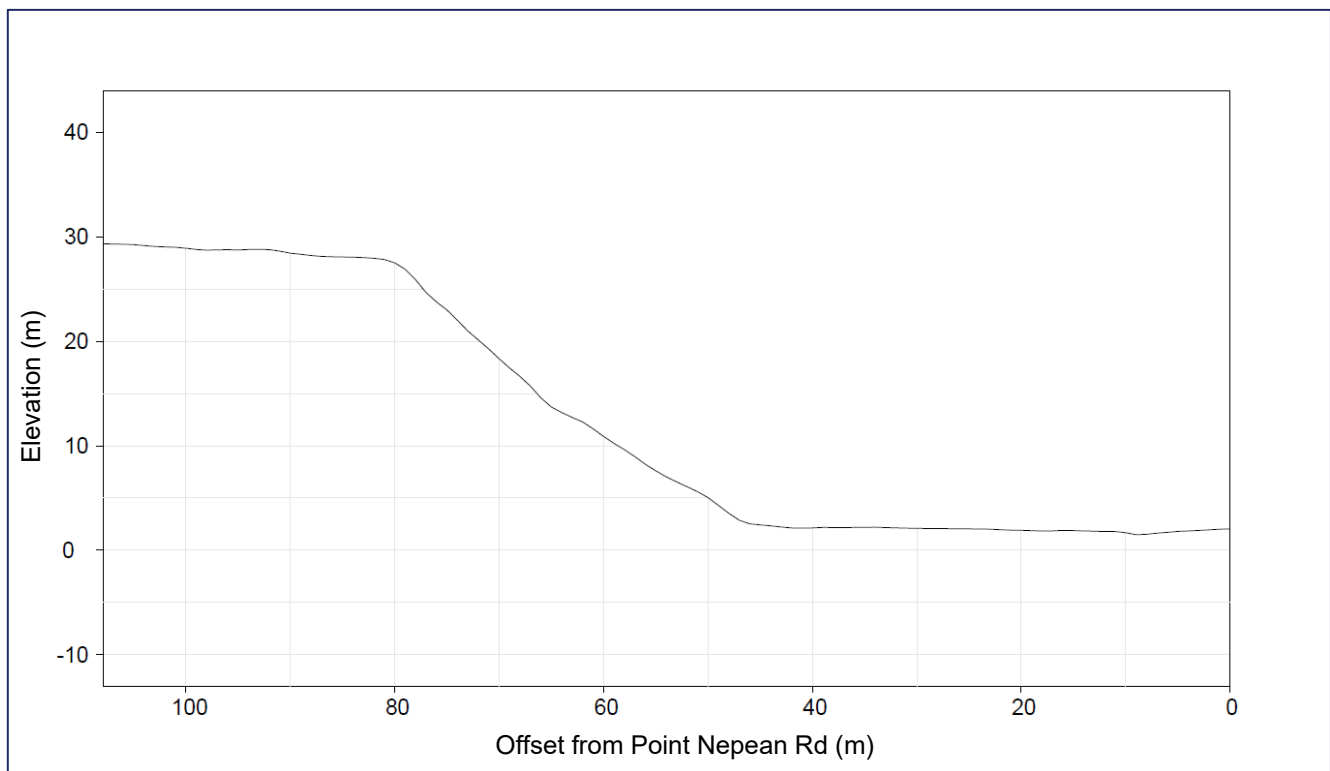
- (a) 25 to 30 metres of relief between the toe of the escarpment and the crest of the escarpment.
- (b) A typical overall slope angle of 30 to 35°.
- (c) A concave slope profile with the upper half of the escarpment being steeper (typically 35 to 40°) than the lower half of the escarpment (typically 25 to 30°).
- (d) Pre-failure slope geometry of the Landslide is shown in Inset 7.
- (e) A lack of large-scale features other than gullies, that may indicate the presence of a large, full height slope failure mechanism.

**Inset 7: Prefailure slope geometry through the centre of the Landslide from Coastal LiDAR 1 DEM**

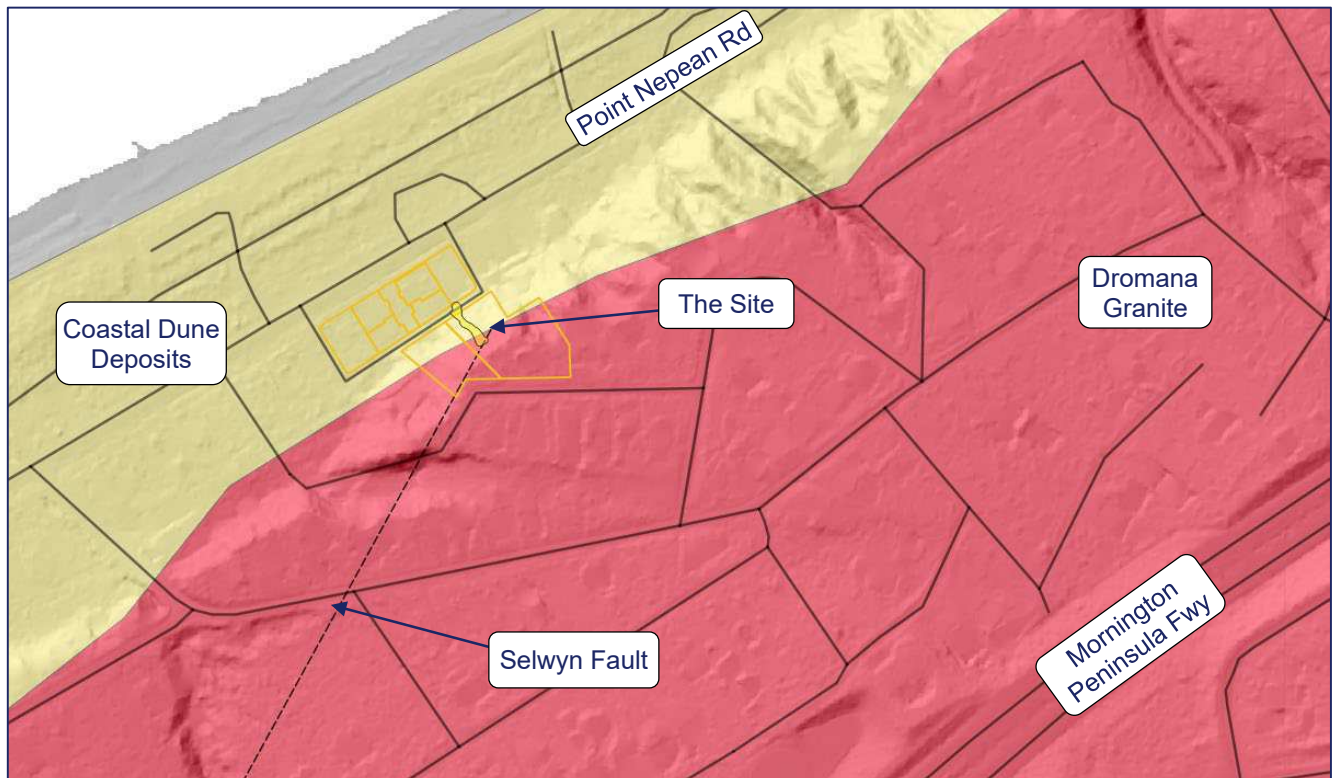
36. The Victoria Seamless Geology (Earth Resources publications (efirst.com.au), (2014)) model indicates that the Site is close to the boundary of Quaternary aged coastal dune deposits (with siliceous and calcareous sands) and Devonian aged Dromana granite. The Earth Resources mapping portal (GeoVic Anonymous (gsv.vic.gov.au), accessed 1 November 2023) indicates that the inferred location of the Selwyn Fault traverses the Site, Inset 8.

**Inset 8: Earth resources seamless geology map of the area, with Selwyn Fault highlighted.**

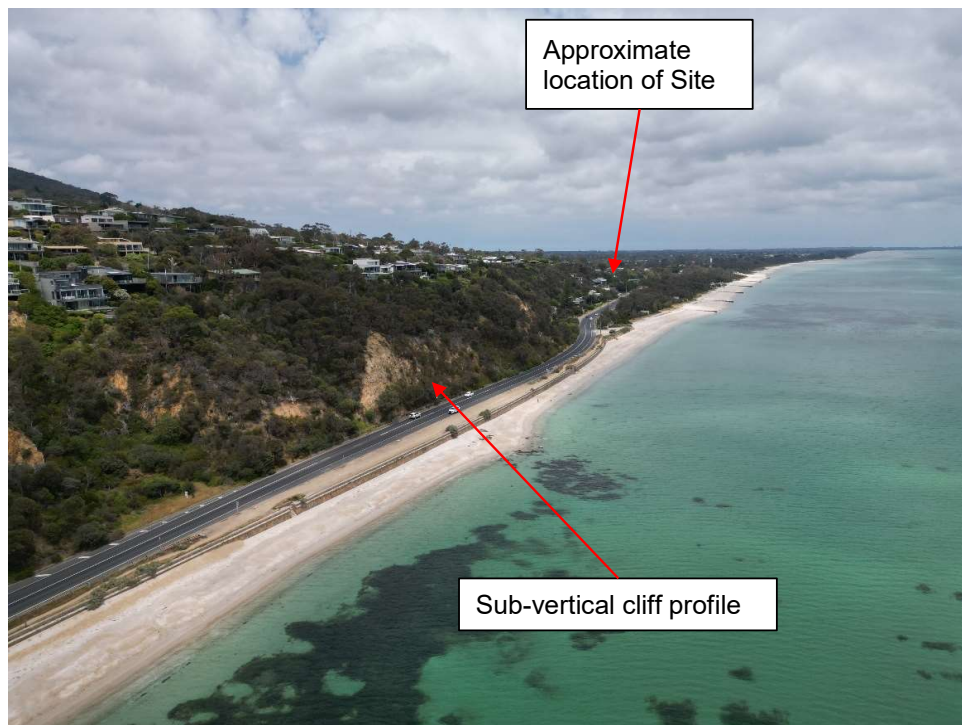
- i. Natural voids and internal erosion (i.e. piping) is common in upper soil profile, Photo 12 Appendix C.
    - ii. A sub vertical cliff profile in extremely weathered and highly weathered granite, Photo 13 Appendix C. I note this sub-vertical may be the result of road construction activities in the 1920's and 1930's.

Photo 13 - Anthony's Nose
