# Expert Opinion Report - Rectification

10-12 View Point Road, McCrae

PSM5226-005R 11 June 2024

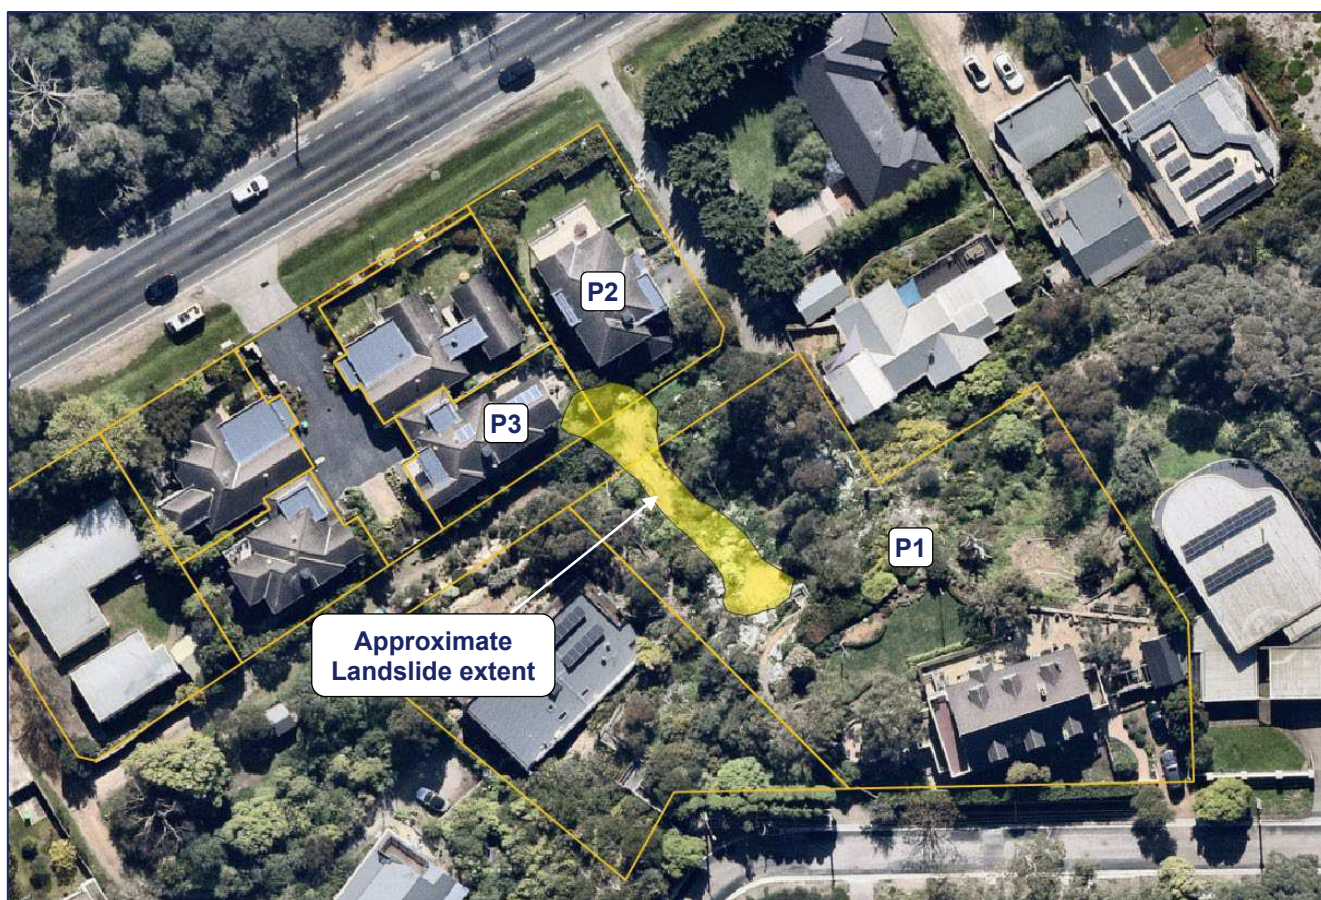
**Inset 1: Plan of properties affected by the Landslide (Aerial Image from Nearmap dated 25 August 2023)**

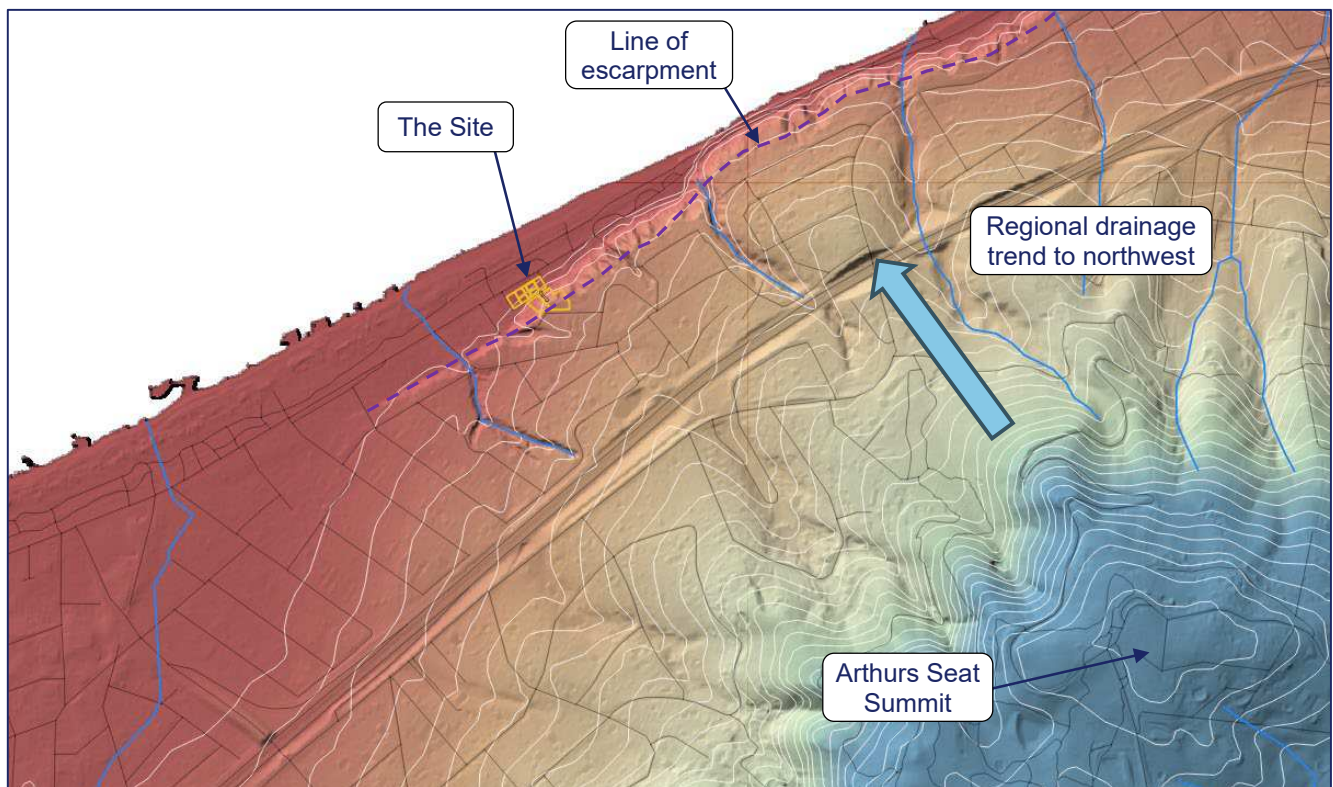
33. The Coastal LiDAR indicates that the Site is located at the lower escarpment of Arthurs Seat, Inset 6. There is approximately 270 of metres of relief measured in a northwest direction from the summit of Arthurs Seat to the escarpment at the Site. I note that several drainage paths strike in a north to northwest direction and that the Mornington Peninsula Freeway provides significant disruption to surface and sub-surface water flows in the region.

**Inset 6: Topography and drainage paths of Arthurs Seat**

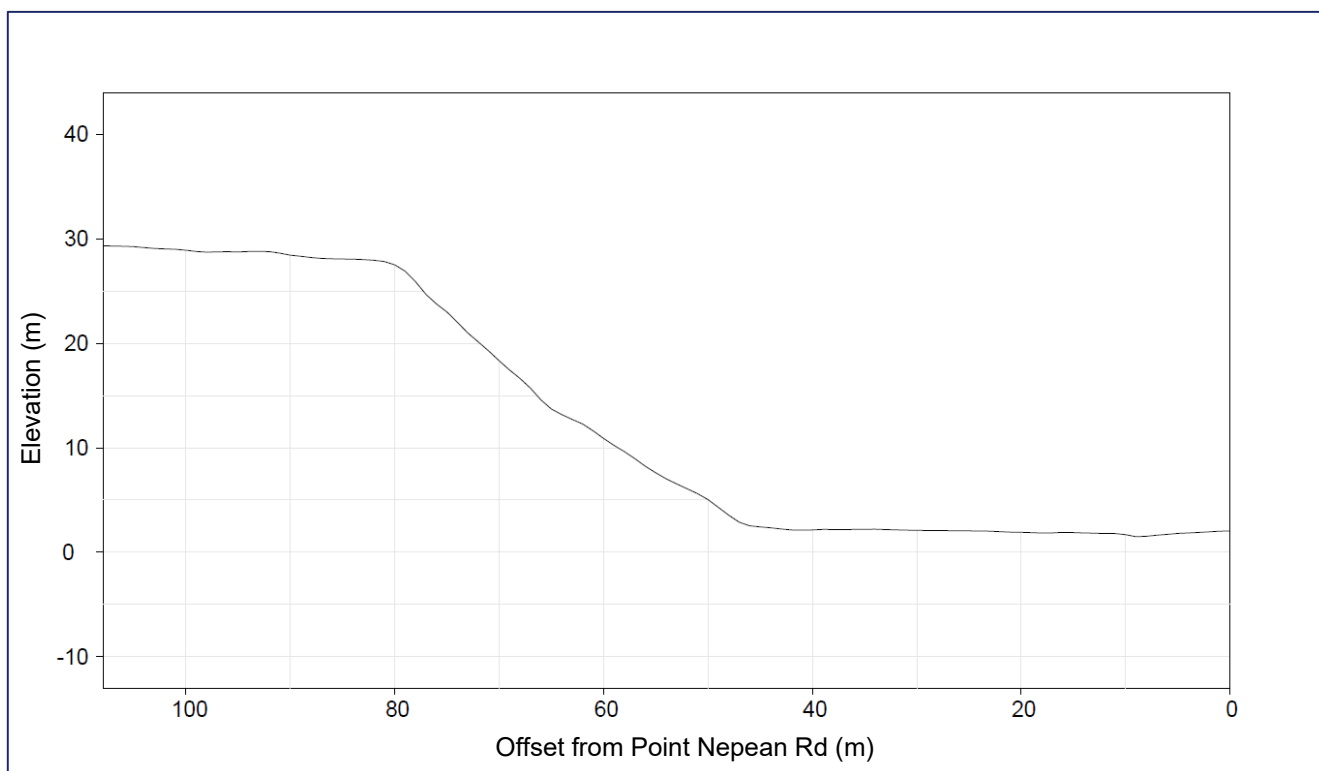
- (a) 25 to 30 metres of relief between the toe of the escarpment and the crest of the escarpment.
- (b) A typical overall slope angle of 30 to 35°.
- (c) A concave slope profile with the upper half of the escarpment being steeper (typically 35 to 40°) than the lower half of the escarpment (typically 25 to 30°).
- (d) Pre-failure slope geometry of the Landslide is shown in Inset 7.
- (e) A lack of large-scale features other than gullies, that may indicate the presence of a large, full height slope failure mechanism.

**Inset 7: Prefailure slope geometry through the centre of the Landslide from Coastal LiDAR 1 DEM**

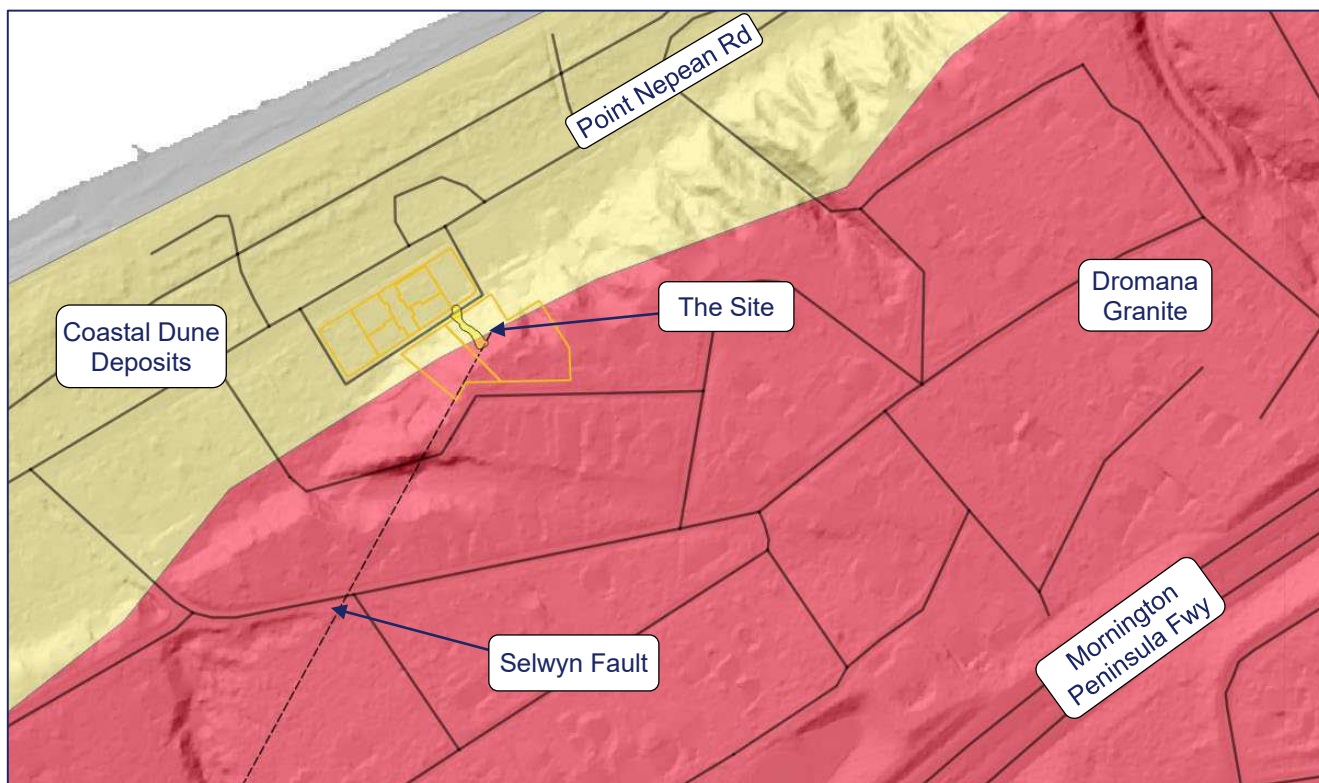
36. The Victoria Seamless Geology (Earth Resources publications (efirst.com.au), (2014)) model indicates that the Site is close to the boundary of Quaternary aged coastal dune deposits (with siliceous and calcareous sands) and Devonian aged Dromana granite. The Earth Resources mapping portal (GeoVic Anonymous (gsv.vic.gov.au), accessed 1 November 2023) indicates that the inferred location of the Selwyn Fault traverses the Site, Inset 8.

**Inset 8: Earth resources seamless geology map of the area, with Selwyn Fault highlighted.**

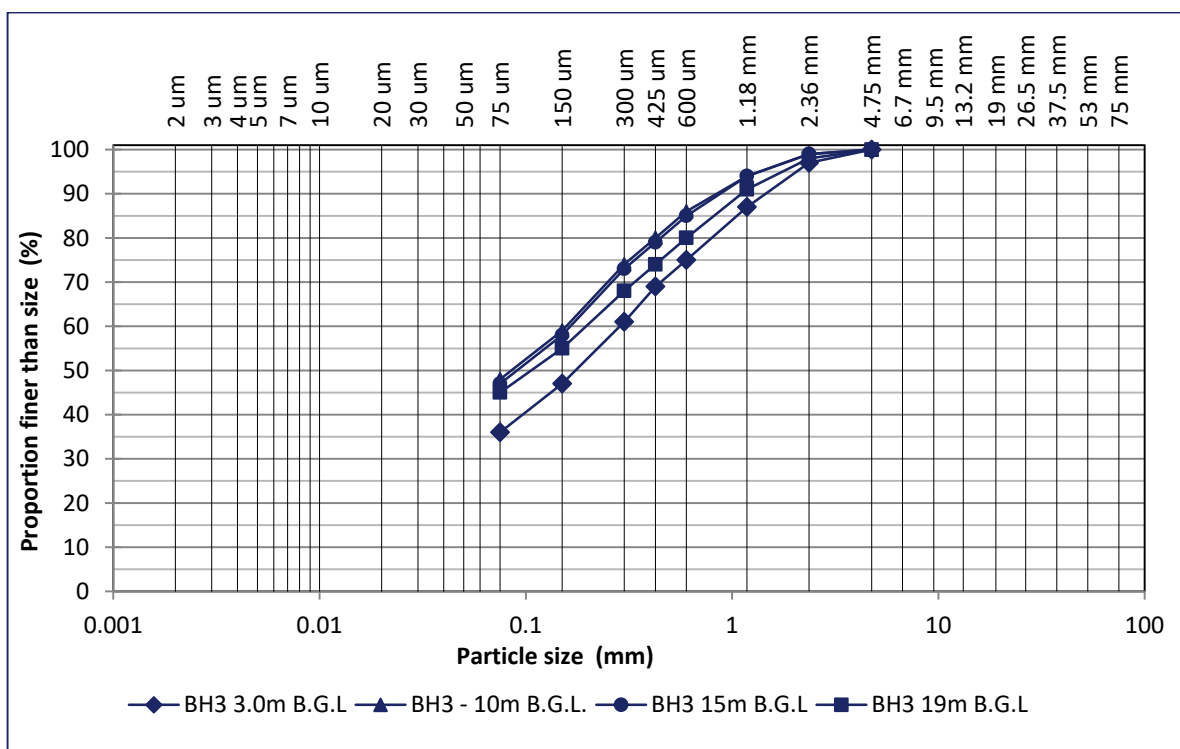
Inset 10: CivilTest Particle Size Distributions

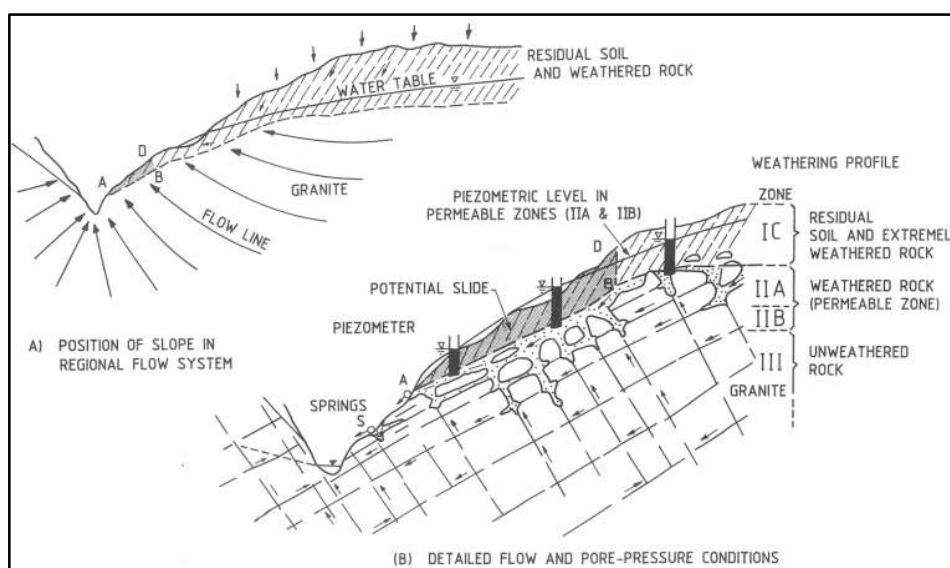
- (b) Furthermore, the CivilTest observation is consistent with published groundwater models in weathered granitic profiles, Inset 11.
  - (c) Observations of seepage during the Site visit (refer to paragraph [29(c)]).

**Inset 11: Possible piezometric conditions in weathered granitic soils (Fell et al, 2004)<sup>1</sup>.**

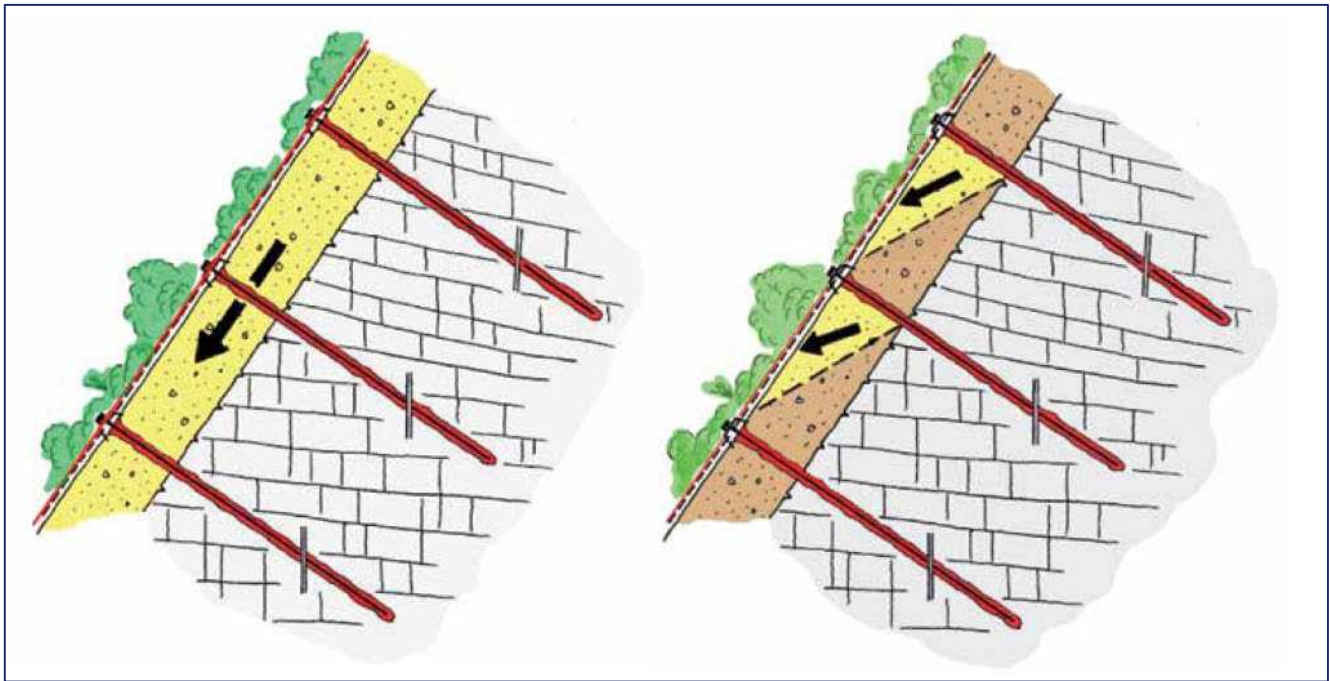
58. I have checked for sizing and spacing of the soil nail and steel netting system using Geobruigg's Ruvolum dimension tool ([www.geobruigg.com](http://www.geobruigg.com)). Ruvolum assesses superficial slope-parallel instabilities as well as local instability between individual nails, Inset 12. I have adopted a thickness of unstable material of 0.5 m parallel to slope.
59. Ruvolum is used to assess working soil nail loads, mesh load and to perform checks against component capacities. Ruvolum also provides a first pass of soil nail spacing. I note that this software package is used iteratively with SLIDE2, Section 8.3.4.
60. The analysis indicates for the spacings in Table 4, unfactored soil nail loads of 38 kN.

**Inset 12: Diagram of mechanisms assessed by Ruvolum (Geobrugg, 2019)<sup>2</sup>**

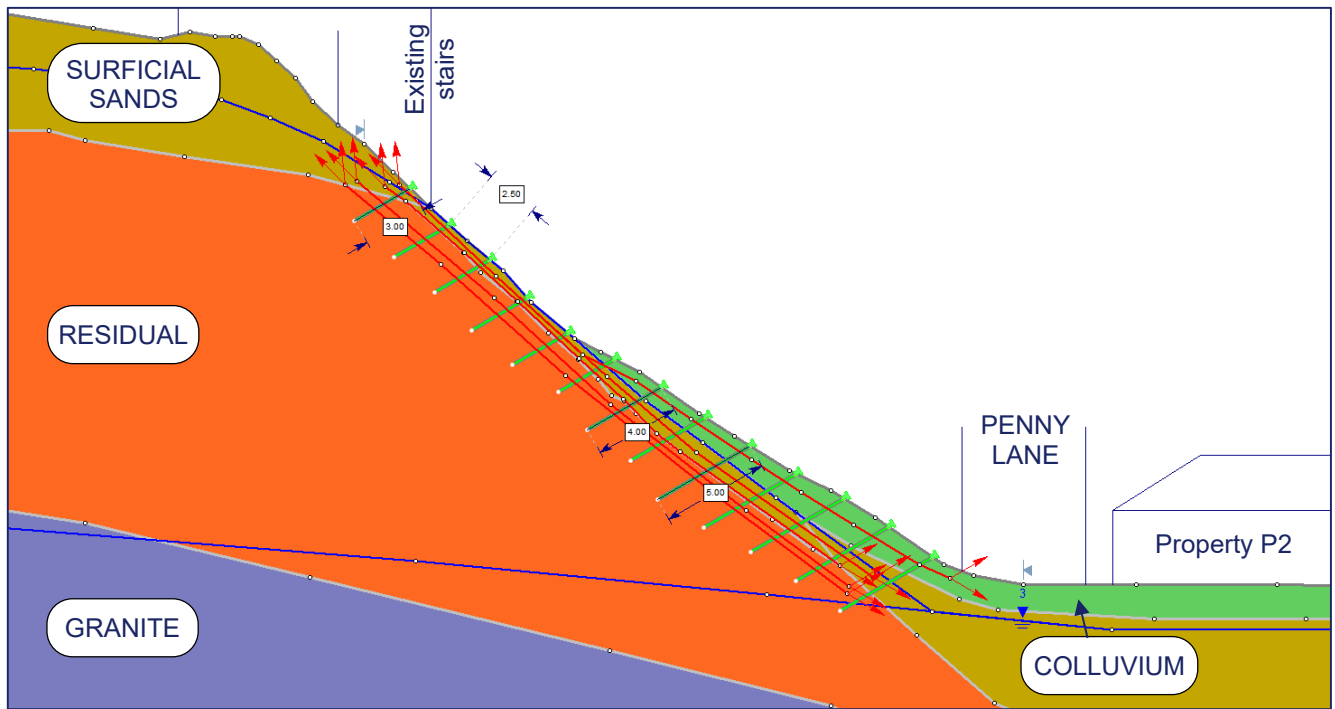
**Inset 13: Slide 2 design cross section**

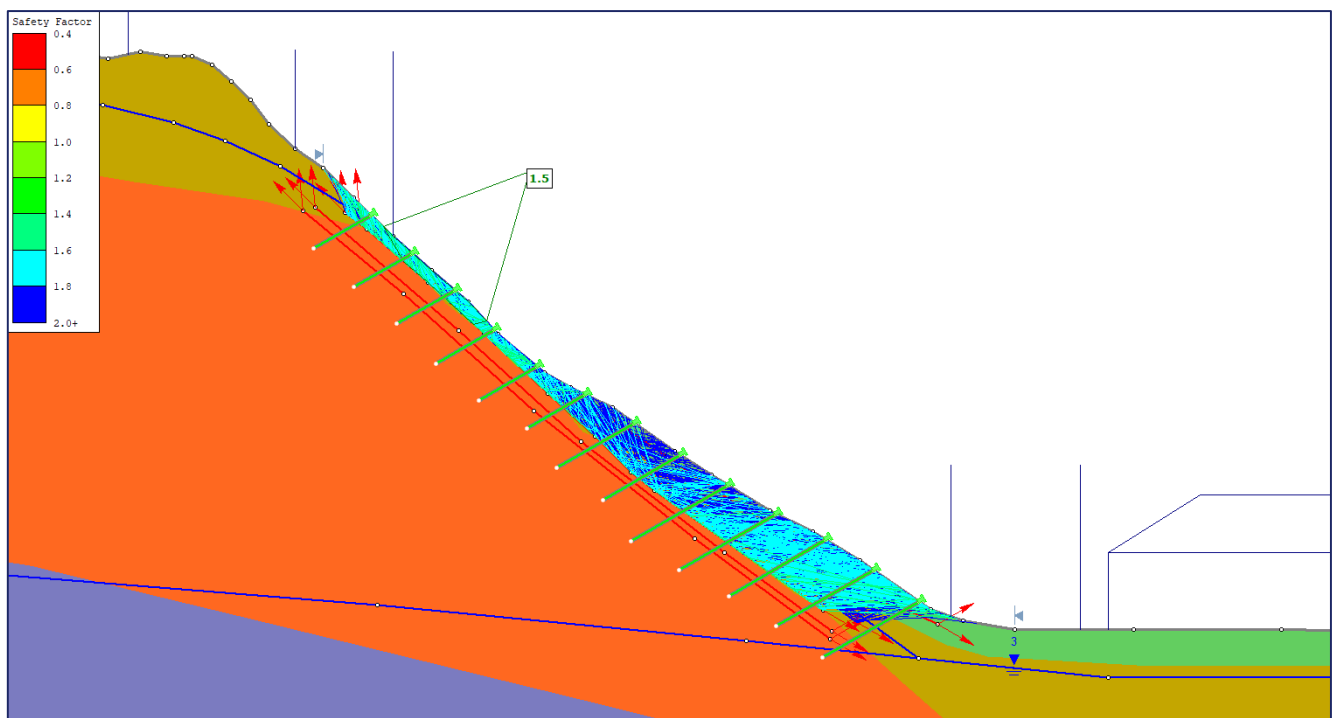
- (f) Shear capacity of the soil nail was conservatively not included in the analysis.
64. The output for static and seismic loading conditions is presented in Inset 14 and Inset 15.

**Inset 14: Slide 2 analysis output for static loading conditions**

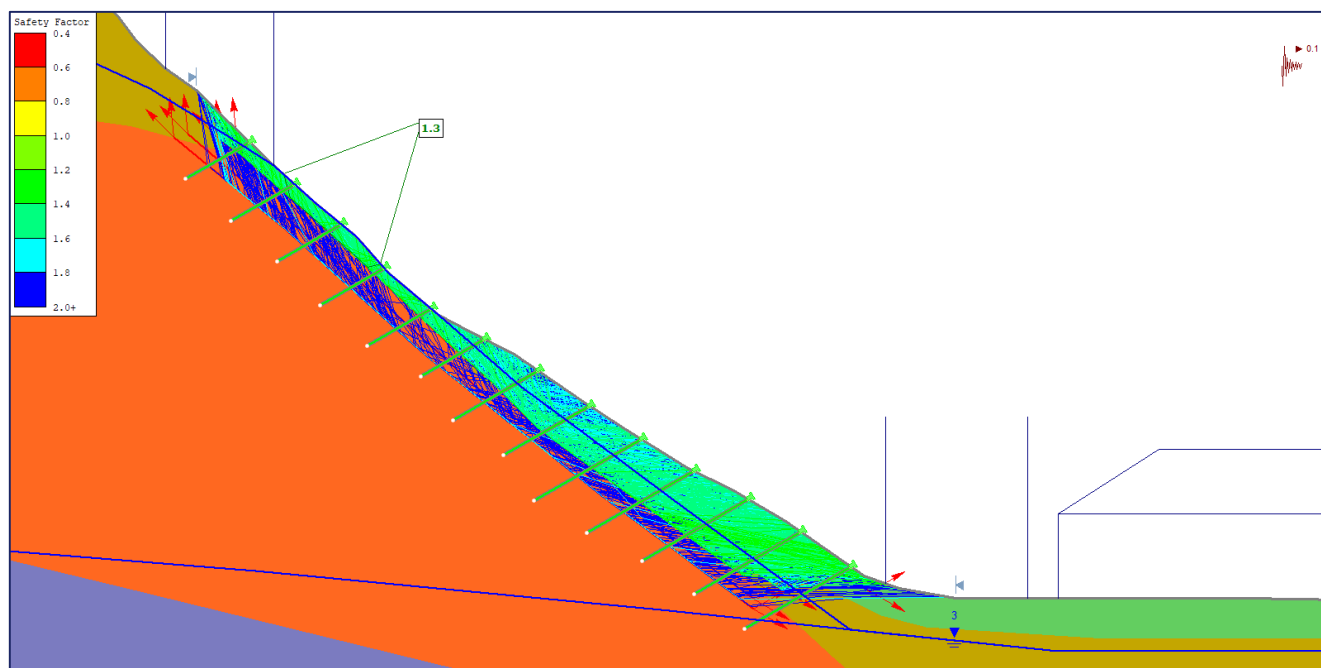
**Inset 15: Slide 2 analysis output for seismic loading conditions**

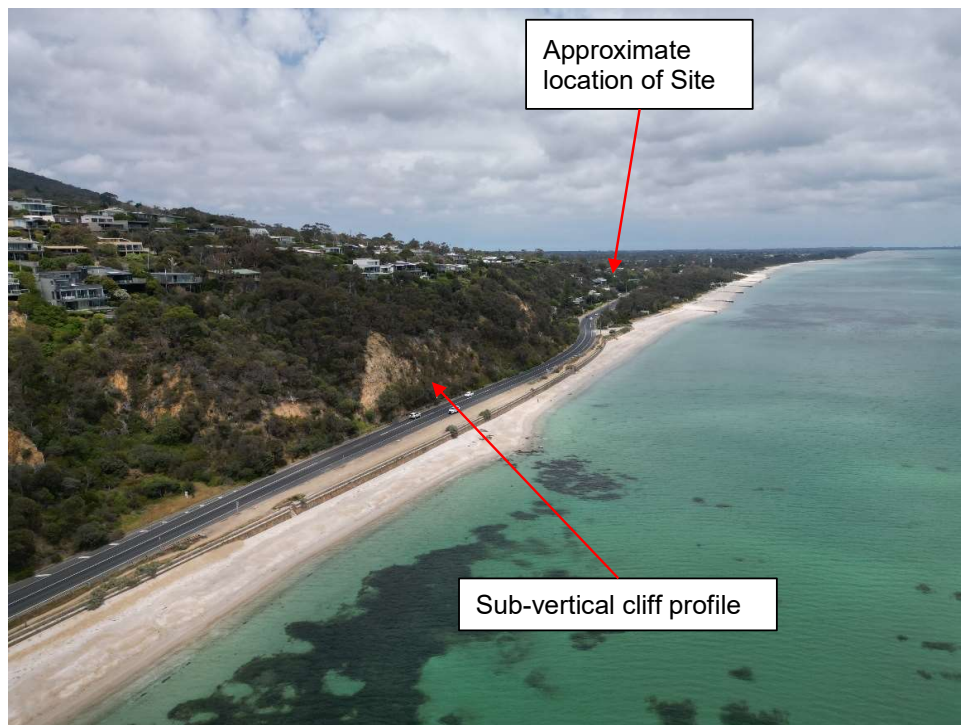
- i. Natural voids and internal erosion (i.e. piping) is common in upper soil profile, Photo 12 Appendix C.
    - ii. A sub vertical cliff profile in extremely weathered and highly weathered granite, Photo 13 Appendix C. I note this sub-vertical may be the result of road construction activities in the 1920's and 1930's.

Photo 13 - Anthony's Nose

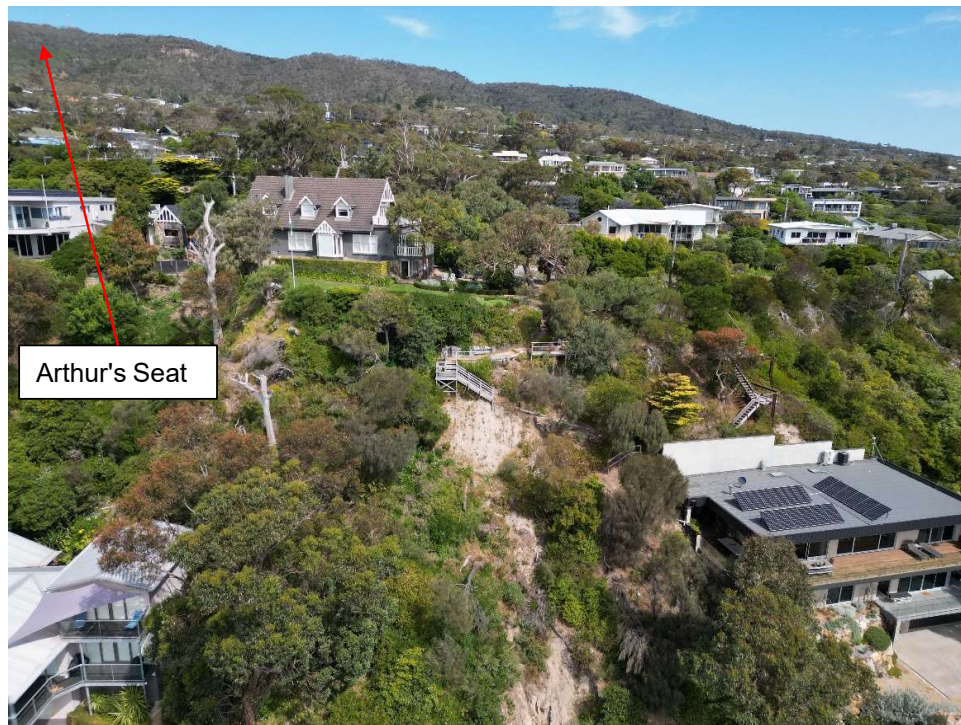
- (c) The Site is located on the lower slopes of Arthurs Seat where those slopes meet Port Phillip Bay and have formed an escarpment, Photo 14 Appendix C. In proximity to the Site the general topography of the areas slopes to the north west. There is extensive residential development above the Site on the lower slopes of Arthurs Seat.

Photo 14 - Arthur's Seat in background
