# Expert Opinion Report - Rectification

10-12 View Point Road, McCrae

PSM5226-005R 11 June 2024

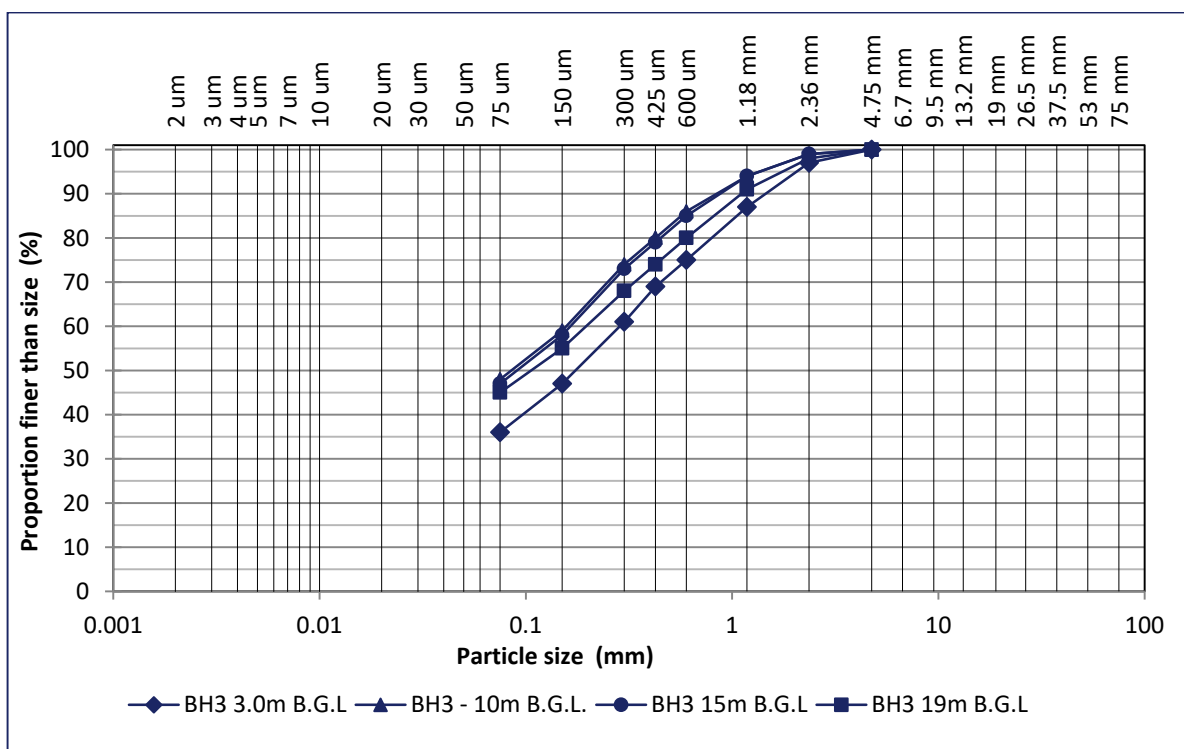
Inset 10: CivilTest Particle Size Distributions

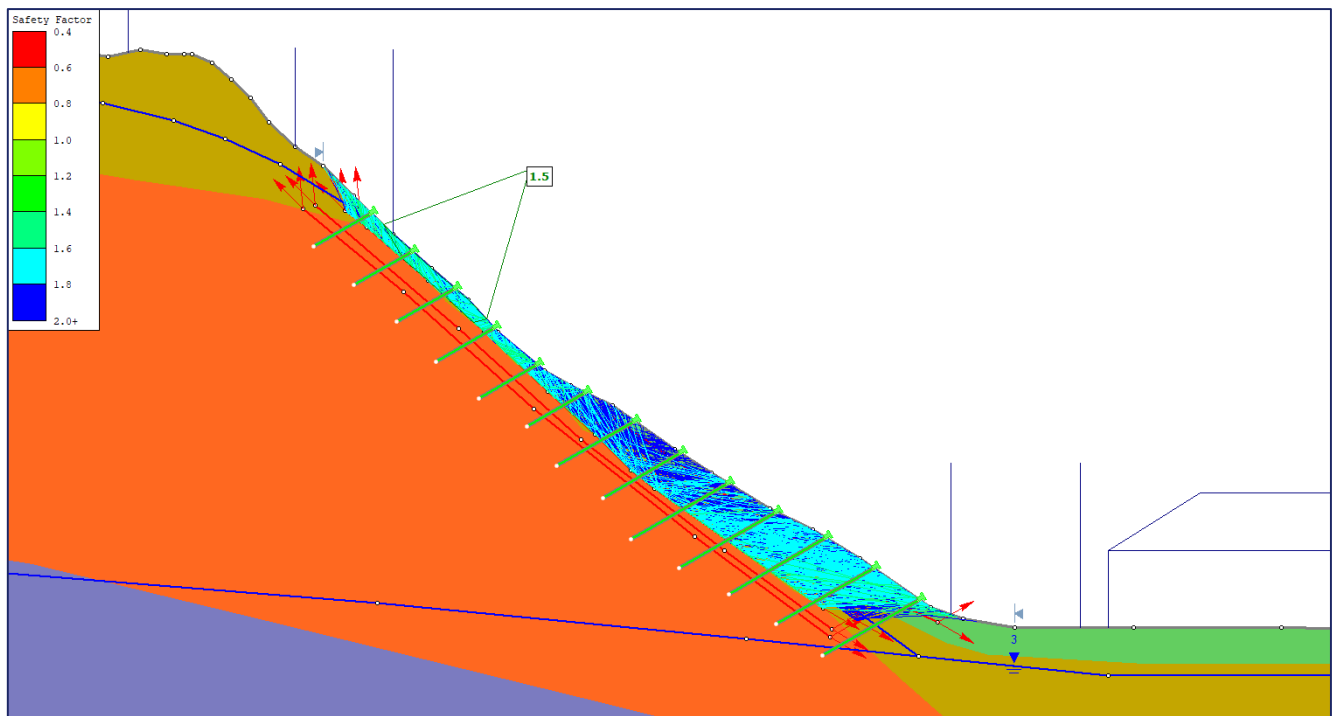
- (f) Shear capacity of the soil nail was conservatively not included in the analysis.
64. The output for static and seismic loading conditions is presented in Inset 14 and Inset 15.

**Inset 14: Slide 2 analysis output for static loading conditions**

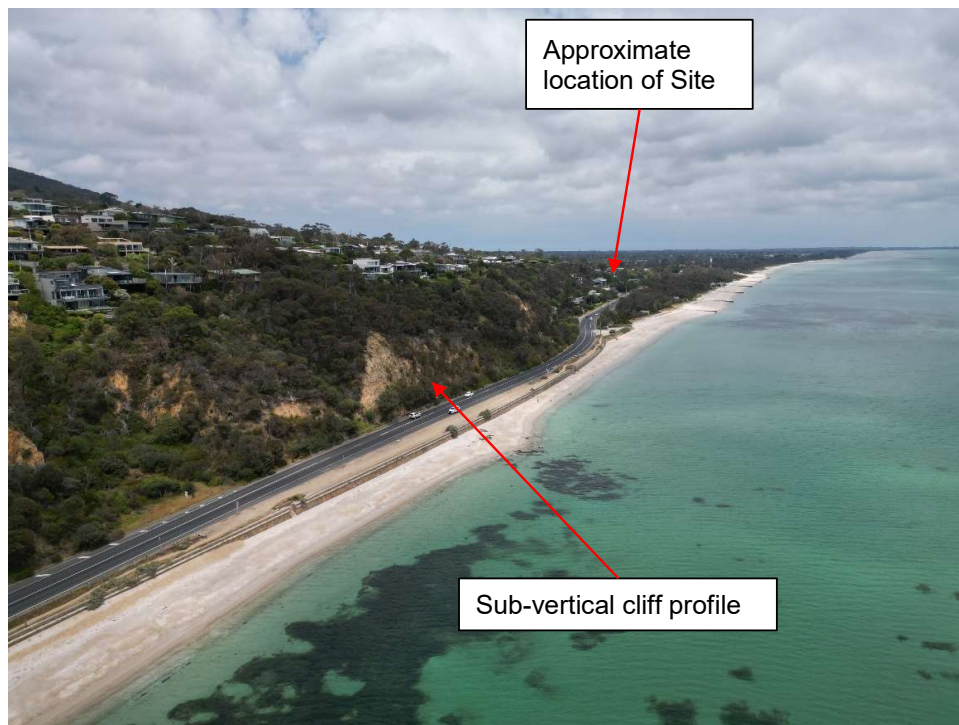
- i. Natural voids and internal erosion (i.e. piping) is common in upper soil profile, Photo 12 Appendix C.
    - ii. A sub vertical cliff profile in extremely weathered and highly weathered granite, Photo 13 Appendix C. I note this sub-vertical may be the result of road construction activities in the 1920's and 1930's.

Photo 13 - Anthony's Nose
