# Expert Opinion Report - Rectification

10-12 View Point Road, McCrae

PSM5226-005R 11 June 2024

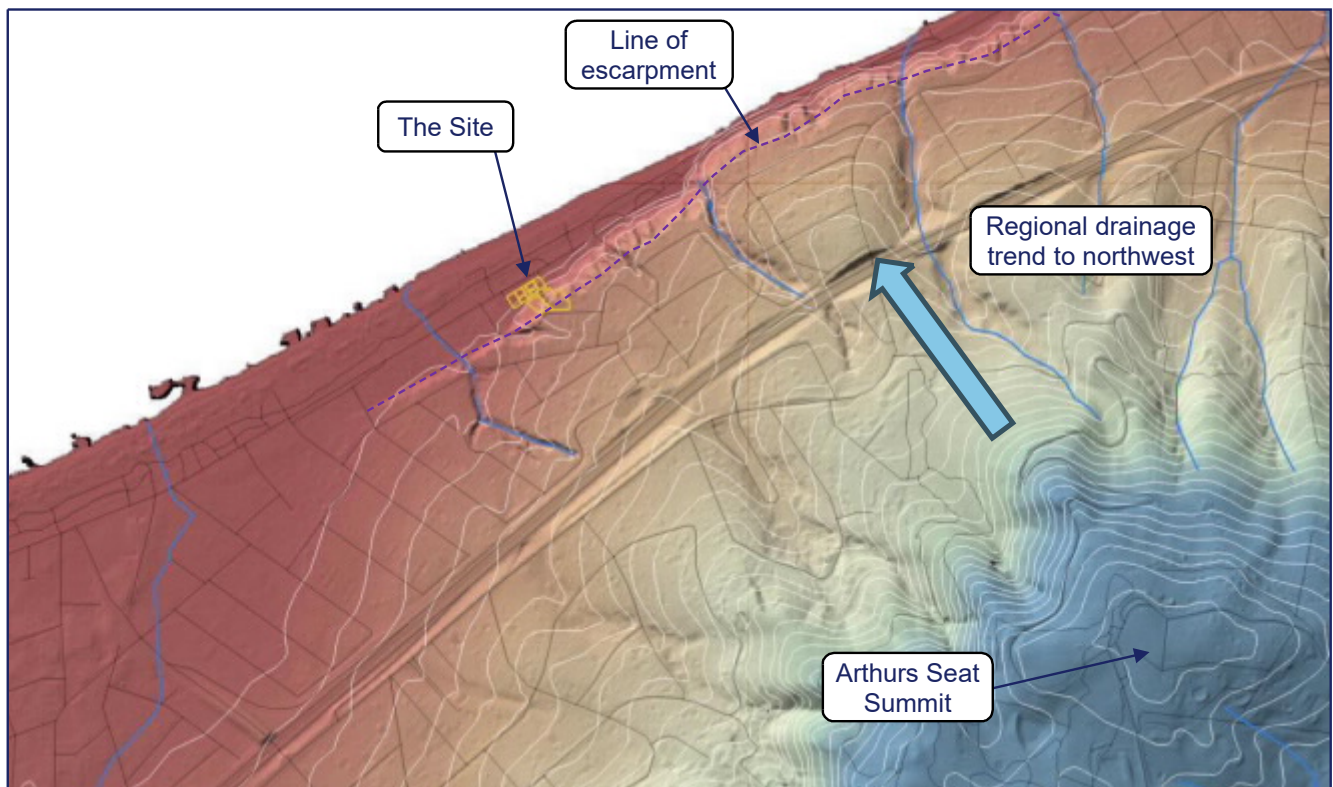
**Inset 6: Topography and drainage paths of Arthurs Seat**

33. The Coastal LiDAR indicates that the Site is located at the lower escarpment of Arthurs Seat, Inset 6. There is approximately 270 of metres of relief measured in a northwest direction from the summit of Arthurs Seat to the escarpment at the Site. I note that several drainage paths strike in a north to northwest direction and that the Mornington Peninsula Freeway provides significant disruption to surface and sub-surface water flows in the region.

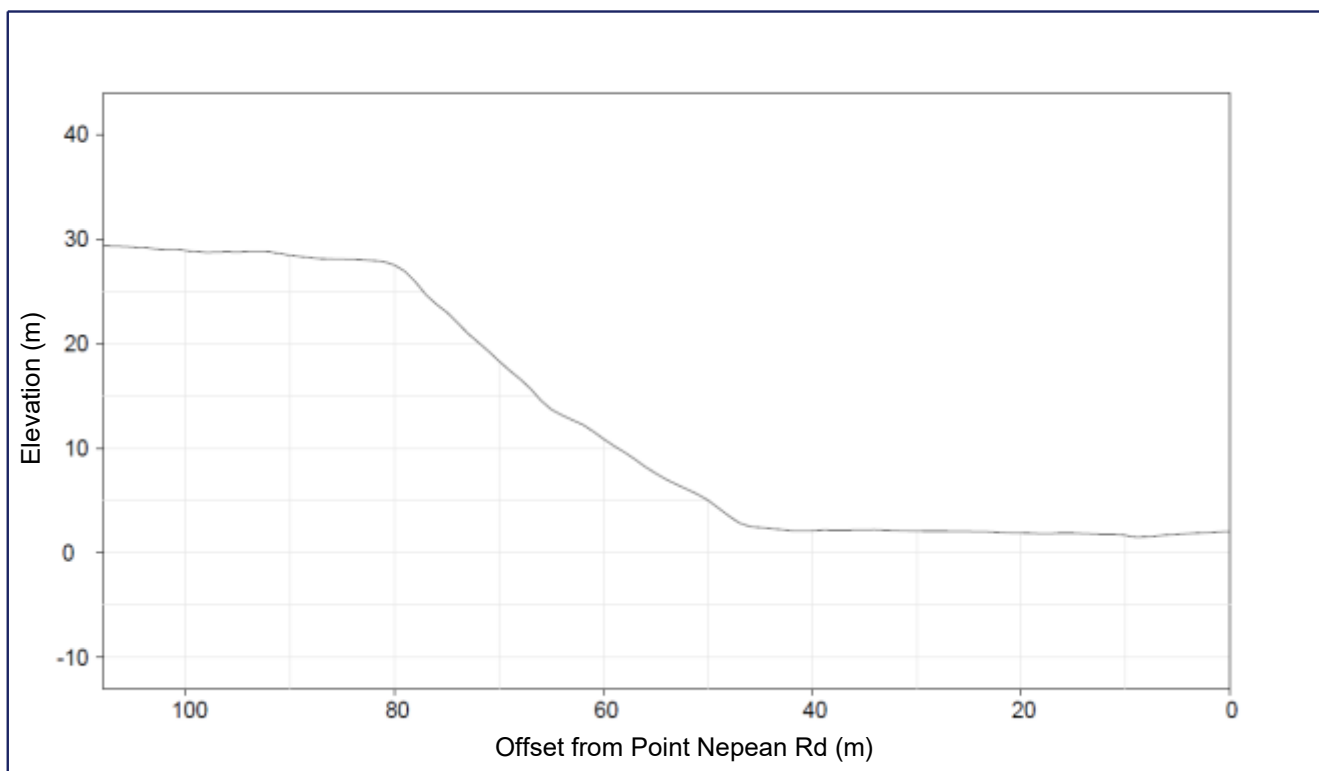
**Inset 7: Prefailure slope geometry through the centre of the Landslide from Coastal LiDAR 1 DEM**

- (a) 25 to 30 metres of relief between the toe of the escarpment and the crest of the escarpment.
- (b) A typical overall slope angle of 30 to 35°.
- (c) A concave slope profile with the upper half of the escarpment being steeper (typically 35 to 40°) than the lower half of the escarpment (typically 25 to 30°).
- (d) Pre-failure slope geometry of the Landslide is shown in Inset 7.
- (e) A lack of large-scale features other than gullies, that may indicate the presence of a large, full height slope failure mechanism.

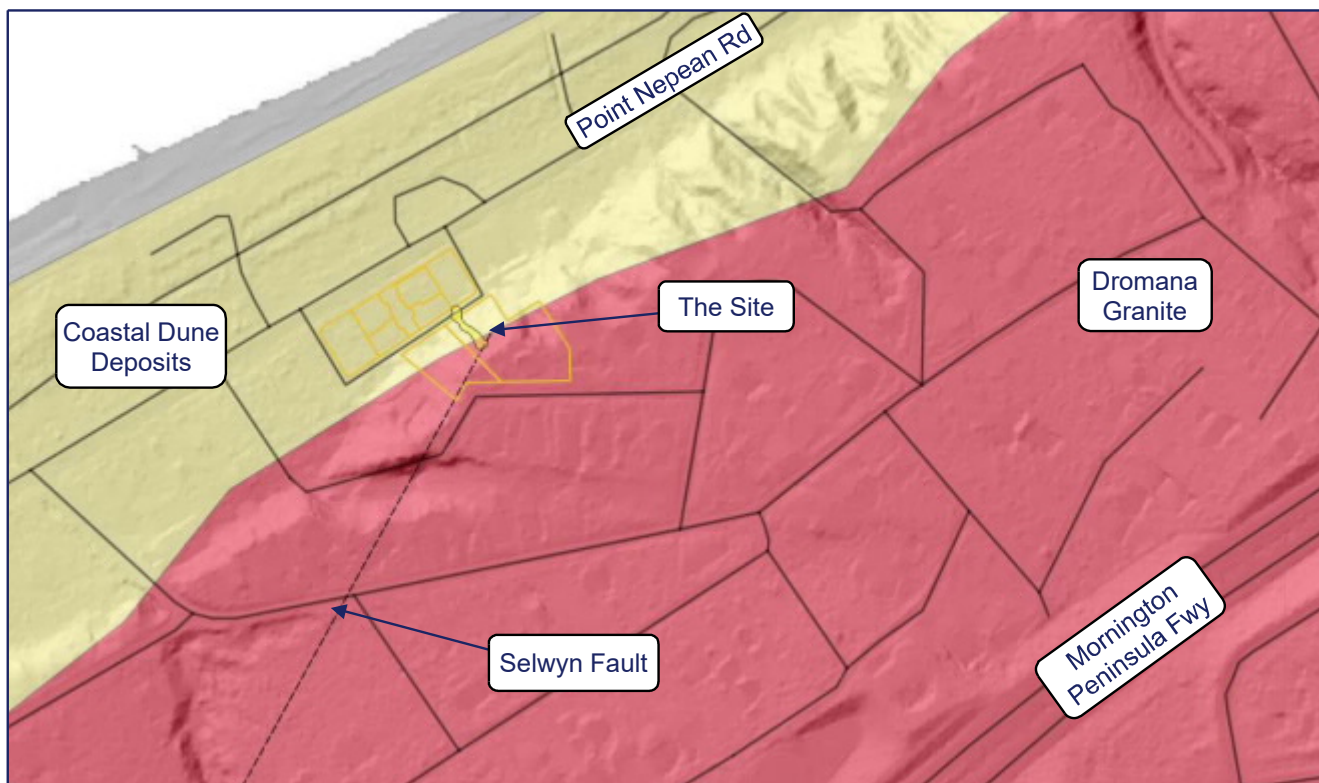
**Inset 8: Earth resources seamless geology map of the area, with Selwyn Fault highlighted.**

36. The Victoria Seamless Geology (Earth Resources publications (efirst.com.au), (2014)) model indicates that the Site is close to the boundary of Quaternary aged coastal dune deposits (with siliceous and calcareous sands) and Devonian aged Dromana granite. The Earth Resources mapping portal (GeoVic Anonymous (gsv.vic.gov.au), accessed 1 November 2023) indicates that the inferred location of the Selwyn Fault traverses the Site, Inset 8.

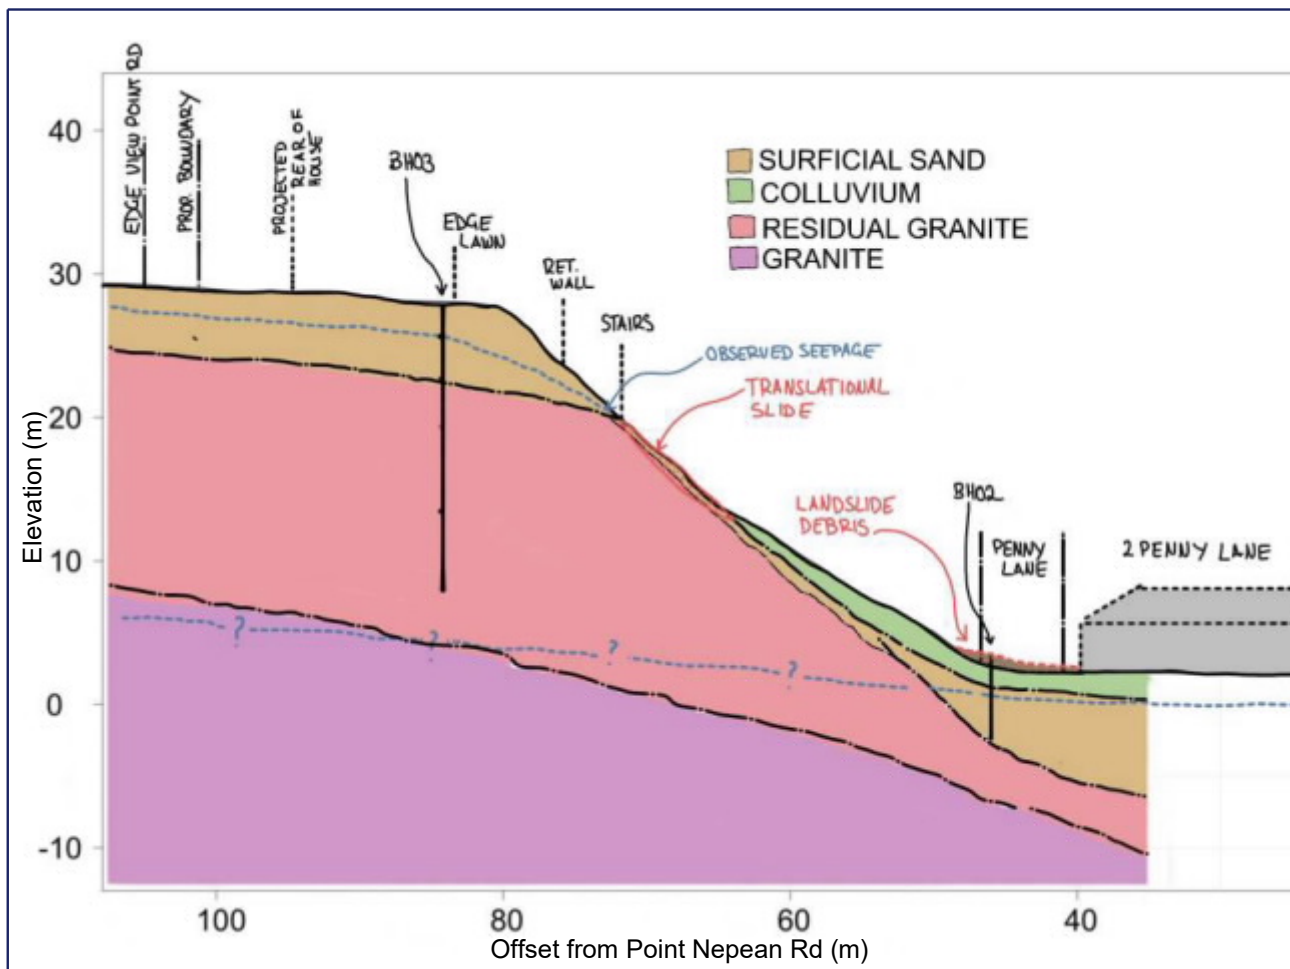
Inset 9: Cross section of my geotechnical model

38. My interpretation of the geological conditions is presented in Inset 9. With regards to the geotechnical model, I note the following key observations:

- (a) There is uncertainty regarding the contact between the SURFICIAL SAND and the RESIDUAL GRANITE owing to the likelihood of some of the parent material of the SURFICIAL SAND being derived from erosion of the Dromana Granite. I have assumed that the wet soils are an indicator of the contact between the two geotechnical units.
- (b) The laboratory testing indicates that all samples between 3 m and 19 m bgl have very similar Particle Size Distributions, Inset 10, and Atterberg limits indicate low plasticity CLAY fines.

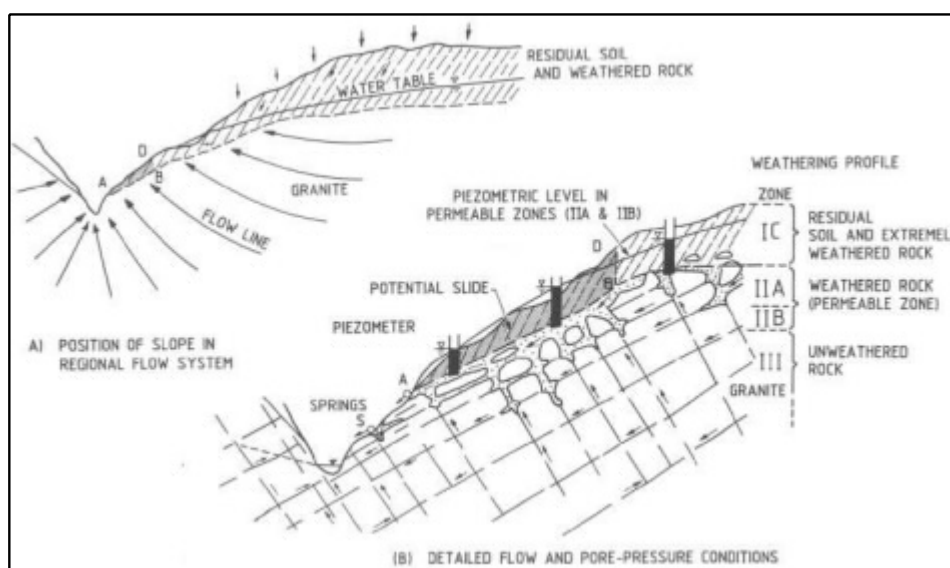
**Inset 11: Possible piezometric conditions in weathered granitic soils (Fell et al, 2004)<sup>1</sup>.**

- Furthermore, the CivilTest observation is consistent with published groundwater models in weathered granitic profiles, Inset 11.
  - Observations of seepage during the Site visit (refer to paragraph [29(c)]).

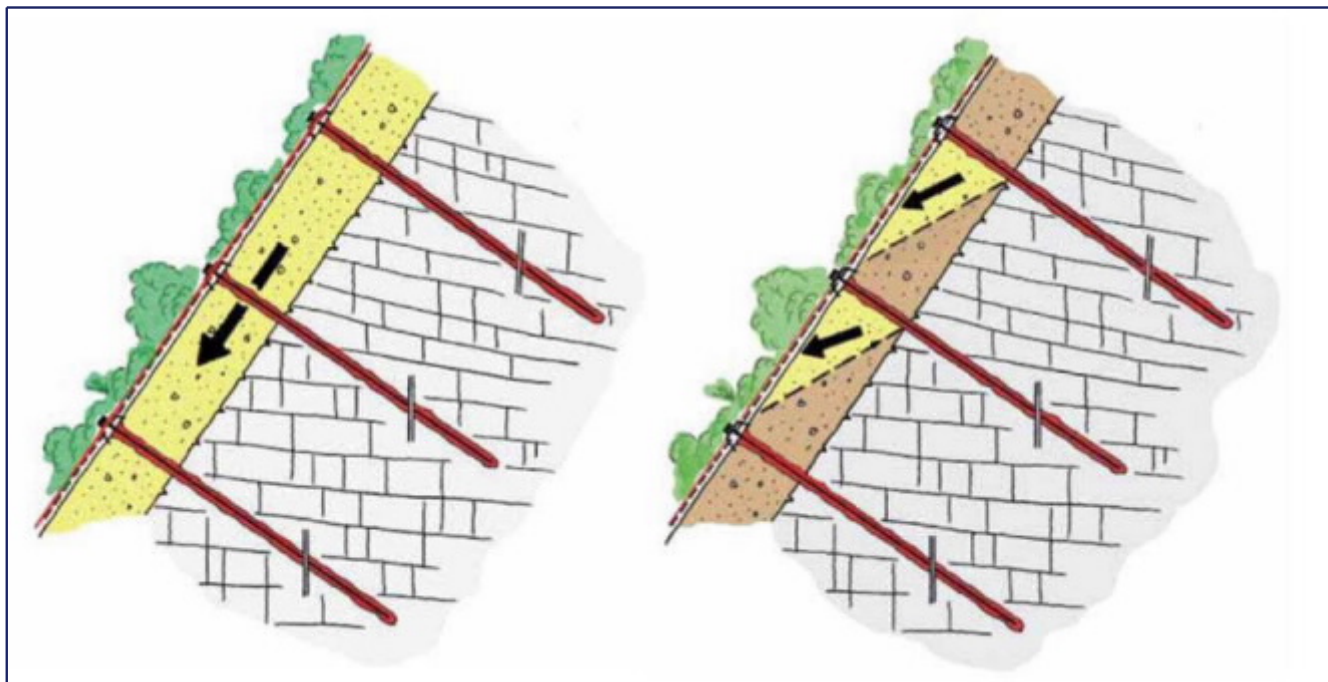
**Inset 12: Diagram of mechanisms assessed by Ruvolum (Geobrugg, 2019)<sup>2</sup>**

58. I have checked for sizing and spacing of the soil nail and steel netting system using Geobruigg's Ruvolum dimension tool ([www.geobruigg.com](http://www.geobruigg.com)). Ruvolum assesses superficial slope-parallel instabilities as well as local instability between individual nails, Inset 12. I have adopted a thickness of unstable material of 0.5 m parallel to slope.
59. Ruvolum is used to assess working soil nail loads, mesh load and to perform checks against component capacities. Ruvolum also provides a first pass of soil nail spacing. I note that this software package is used iteratively with SLIDE2, Section 8.3.4.
60. The analysis indicates for the spacings in Table 4, unfactored soil nail loads of 38 kN.

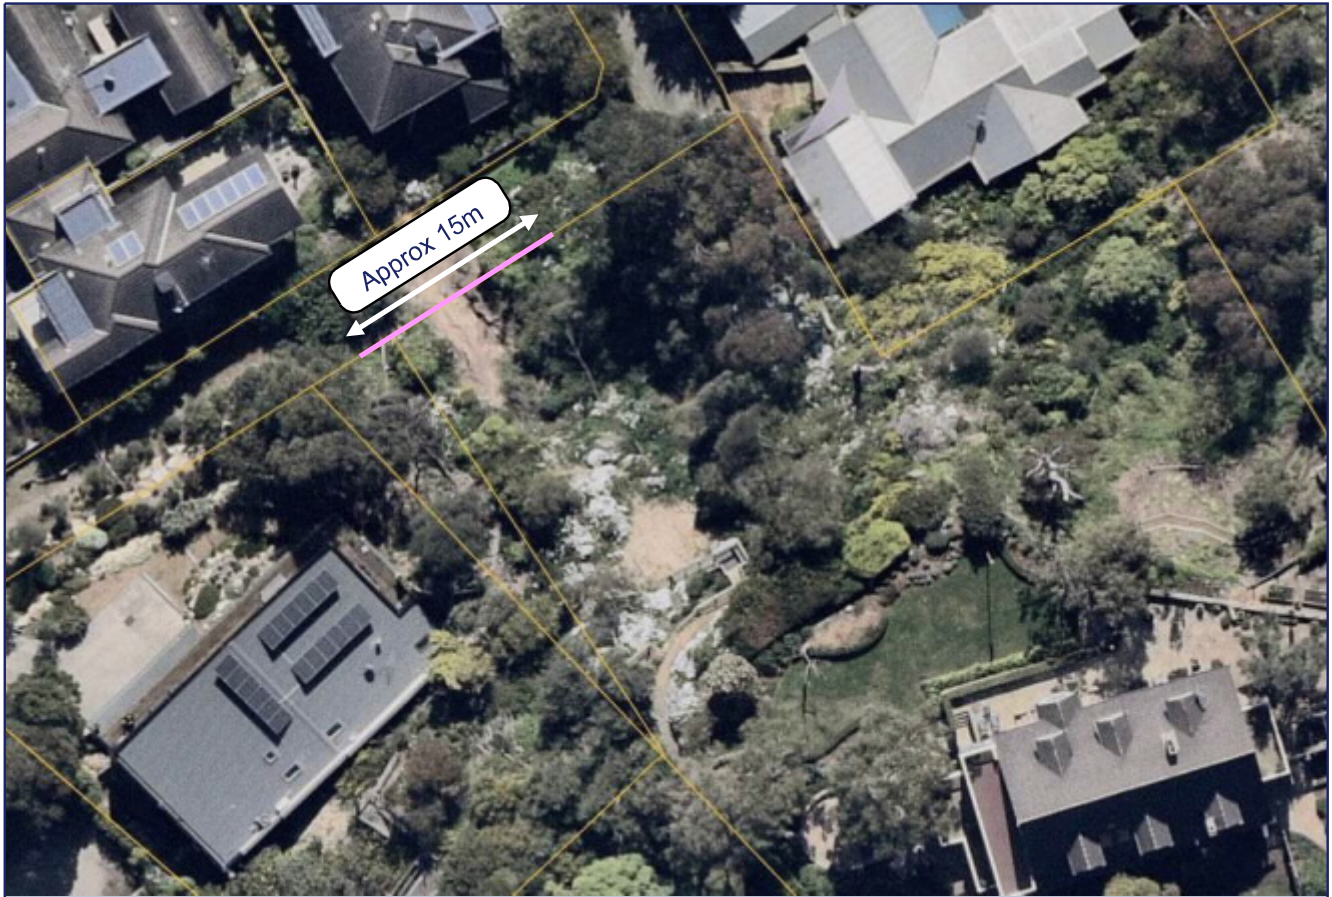
**Inset 17: Assumed extent of debris fence shown in pink (Aerial image from Nearmap)**

81. I have assumed the following:
- (a) The short-term solution (**STS**) as per my Brief is to consist of a debris fence installed at the toe of the slope below Property P1 in Penny Lane.
  - (b) The debris fence is to provide approximately 15 m in length of protection below Property P1, Inset 17.
  - (c) The debris fence is to be an appropriately designed and constructed shallow landslide barrier manufactured by Geobruigg.
  - (d) Landslide debris is cleared from the slope prior to the installation of the debris fence.
82. I note that a fundamental principle of the debris fence is to protect people and property below the landslide rather than to prevent a landslide from occurring. In my opinion the STS can be designed to reduce risk to properties P2 and P3 and risk to life of occupants of P2 and P3 to a tolerable level.

83. In my opinion the STS does not reduce risk to life and property for Property P1. As per paragraph [82], a debris fence does not prevent a landslide from occurring, therefore in my opinion landslides may still occur on Property P1. In my opinion a residual risk assessment post clean-up of Landslide and for:
- (a) A pedestrian on the slopes of P1 is likely to indicate an unacceptable risk to life for future landslide events as no controls have been introduced to control repeat landslides.
  - (b) The dwelling at P1 is likely to indicate a tolerable risk to the dwelling and occupants within the dwelling with risks unchanged owing to the offset to the Landslide.

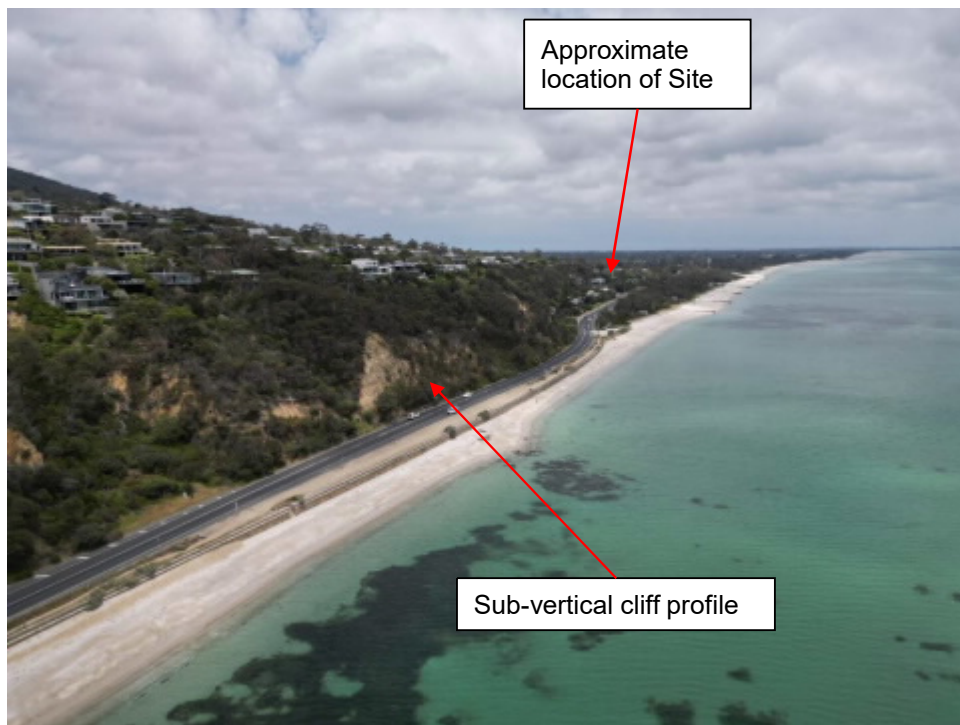
Photo 13 - Anthony's Nose

- i. Natural voids and internal erosion (i.e. piping) is common in upper soil profile, Photo 12 Appendix C.
    - ii. A sub vertical cliff profile in extremely weathered and highly weathered granite, Photo 13 Appendix C. I note this sub-vertical may be the result of road construction activities in the 1920's and 1930's.

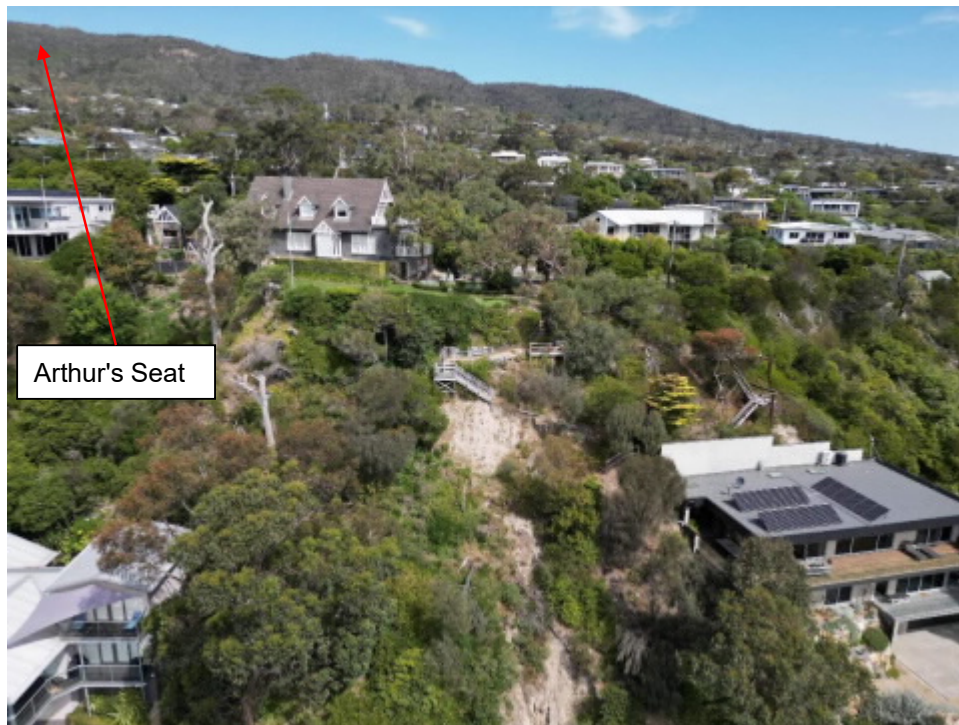
Photo 14 - Arthur's Seat in background

- (c) The Site is located on the lower slopes of Arthurs Seat where those slopes meet Port Phillip Bay and have formed an escarpment, Photo 14 Appendix C. In proximity to the Site the general topography of the areas slopes to the north west. There is extensive residential development above the Site on the lower slopes of Arthurs Seat.
