# Expert Opinion Report - Rectification

10-12 View Point Road, McCrae

PSM5226-005R 11 June 2024

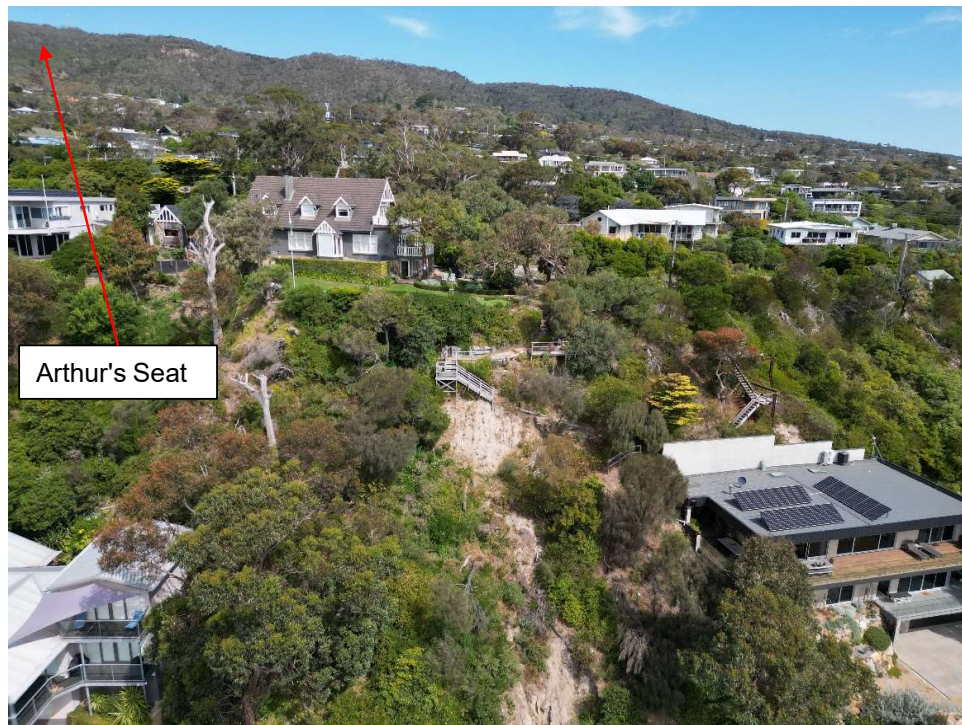
Photo 14 - Arthur's Seat in background

- (c) The Site is located on the lower slopes of Arthurs Seat where those slopes meet Port Phillip Bay and have formed an escarpment, Photo 14 Appendix C. In proximity to the Site the general topography of the areas slopes to the north west. There is extensive residential development above the Site on the lower slopes of Arthurs Seat.
