GEOTECHNICAL INVESTIGATION OF
STABILITY OF GULLY BETWEEN
THE EYRIE & POINT NEPEAN ROAD,
MCCRAE

MORNINGTON PENINSULA SHIRE
COUNCIL

SEPTEMBER 2007

REF NO: 207141Report01.1.doc

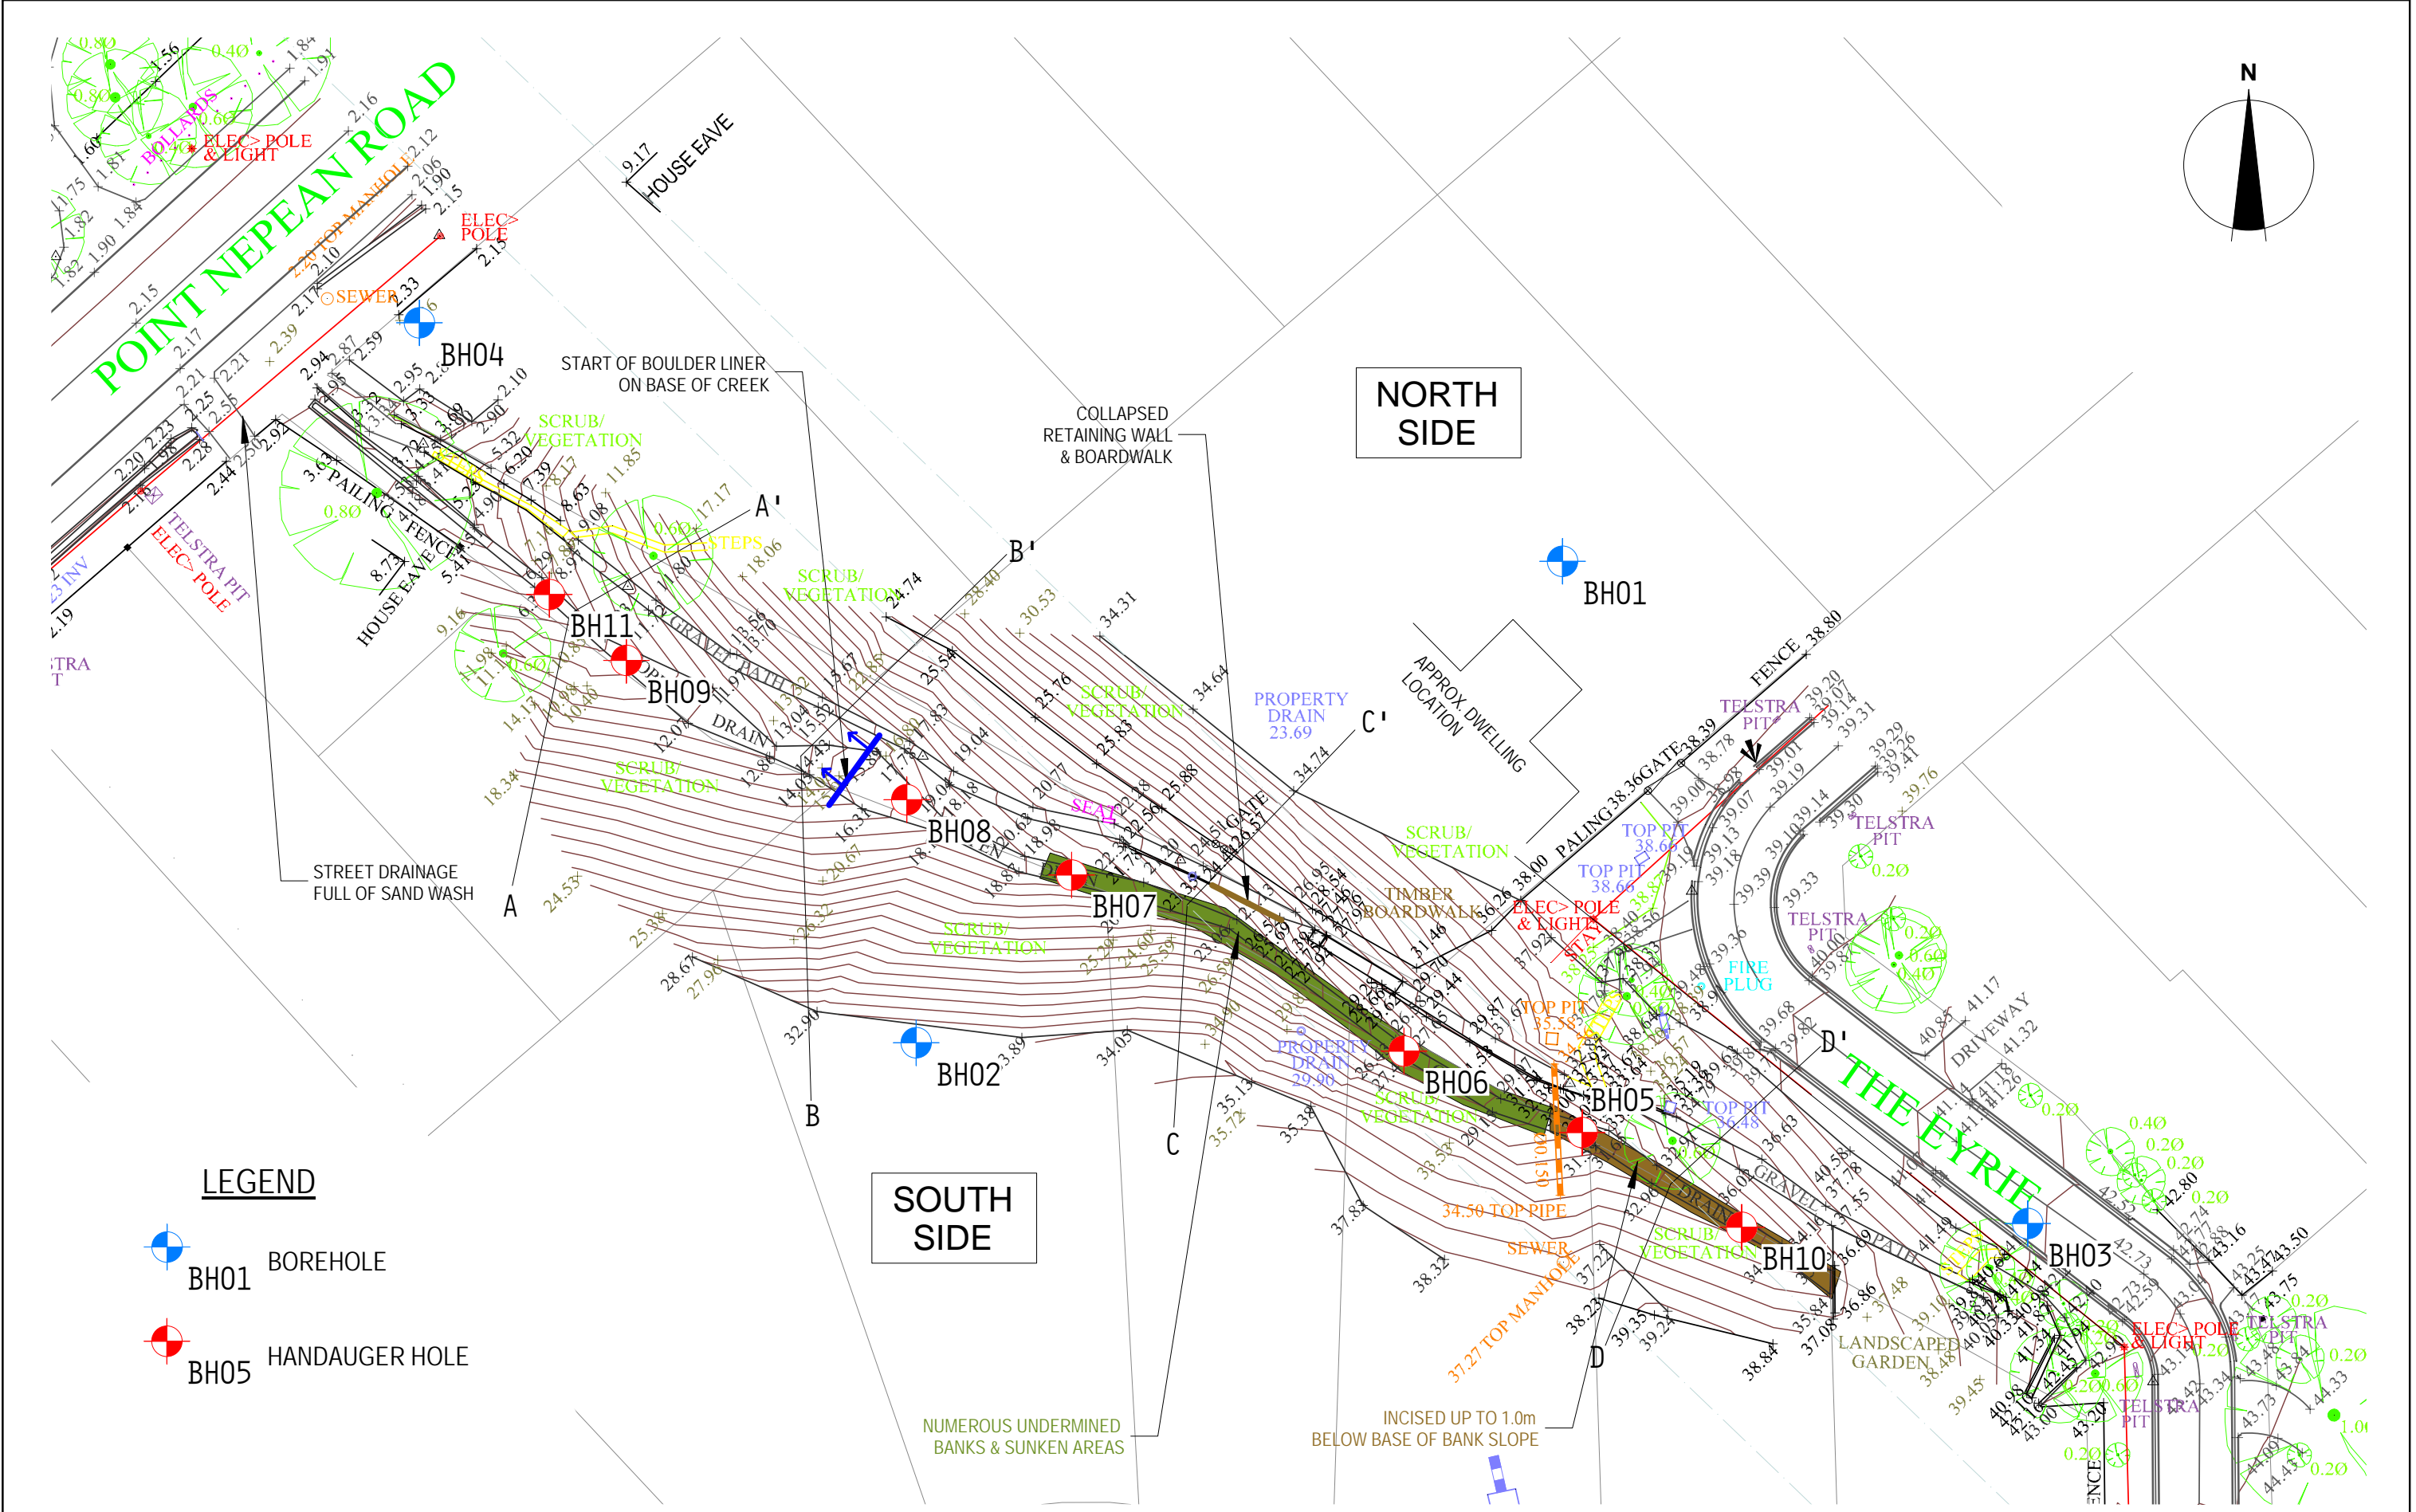
SCALE (A3)	1:500	DATE	3 SEP 2007
DRAWN	OBB	JOB NO.	207141
MEL REF:	159:B9	REV. NO.	1
		FIG. NO.	1

The first stage is the erosion of the more readily erodible layers of sands leaving in place the less erodible layers. This can result in very steep slopes, undermined areas, overhangs and caves being created where a lower layer is eroded and an upper layer remains in place. This process is currently occurring at several locations as indicated on Figure 1, Appendix A.

The adopted parameters were calibrated against four different cross sections along the gully. The locations of the sections are shown on the Site Plan, Figure No. 1.

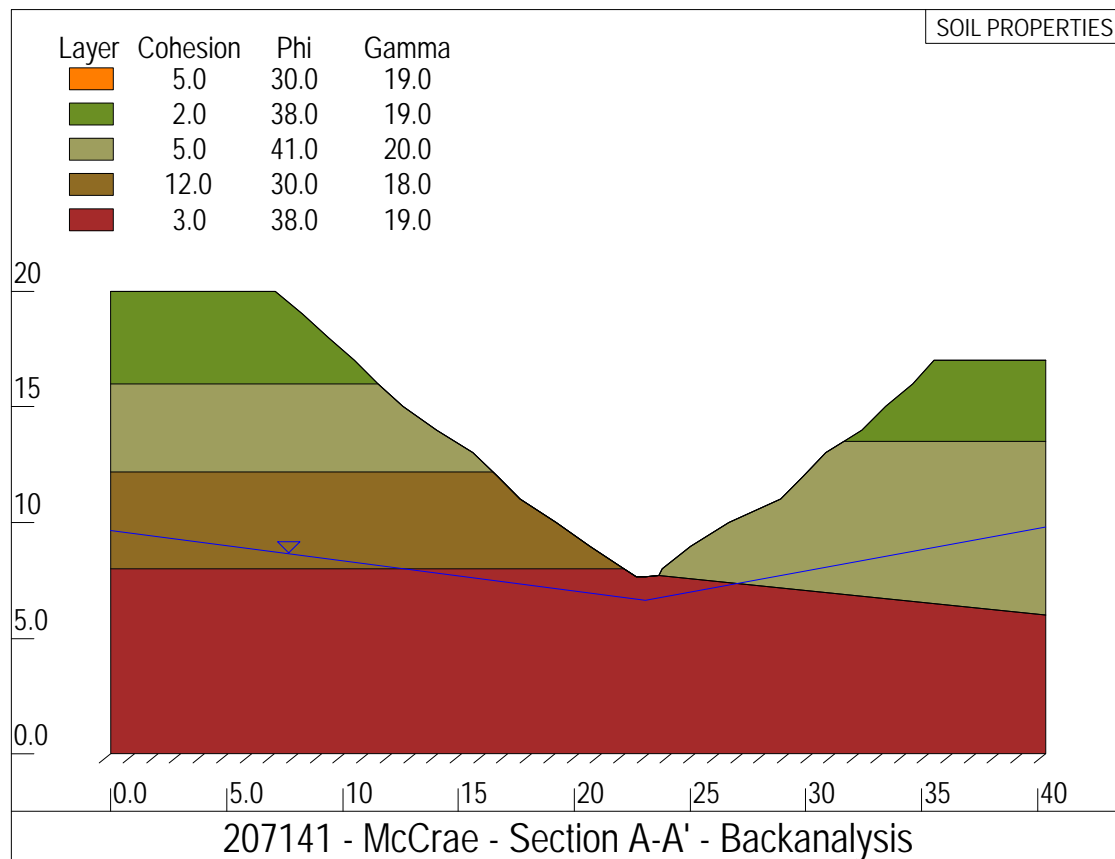
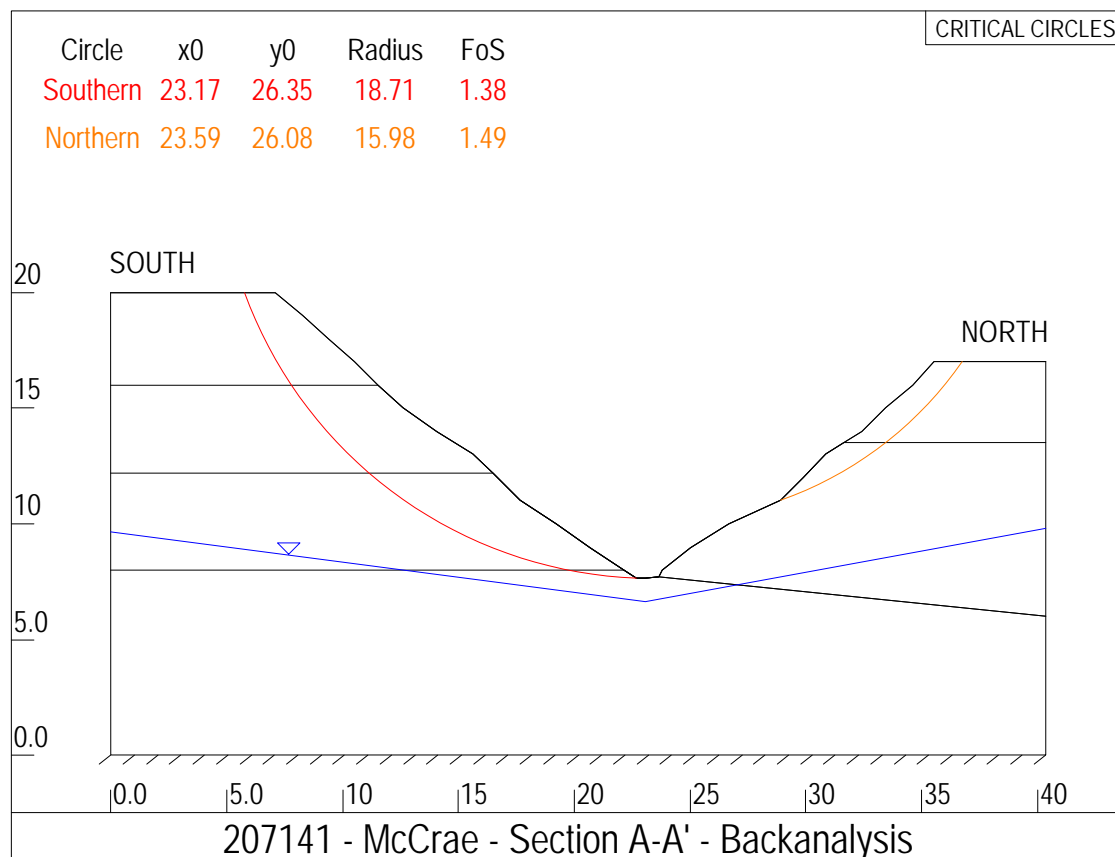
TITLE		XSLOPE OUTPUT	
SCALE (A4)	SHOWN	JOB NO	207141
DRAWN	DBS	DATE	3 SEP 2007
		REV.	0 FIG. 1
REF: 207141 XSlope Results

Three of the four sections (Sections 1 to 3) that were analysed in the model calibration were found to have factors of safety in both the southern and northern directions that were in the range of 1.00 to 1.49. i.e. marginally stable.
