McCrae Landslide

Causation

PSM5665-075R 21 July 2025

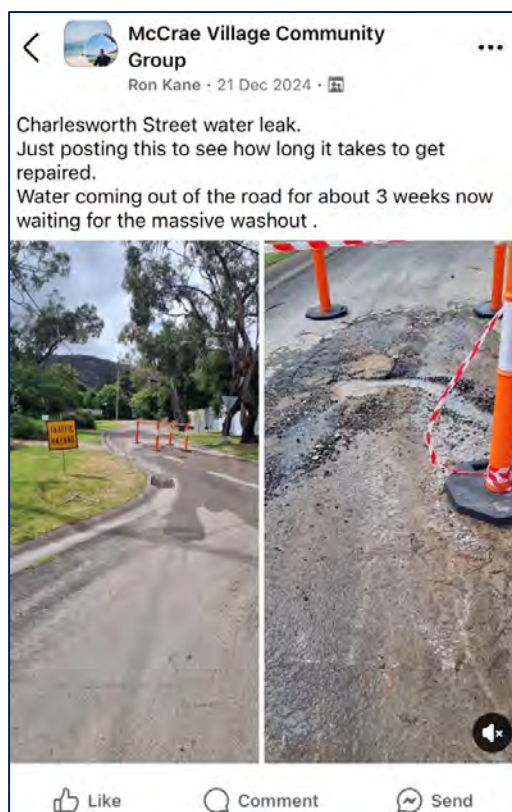
18. I note that a member of the community posted a photograph on a community forum on Facebook on 21 December 2024 of Charlesworth Street surface water issues, Inset 5. I note that they provided an estimate of how long that this had been observed.

Inset 5: McCrae Village Community Facebook post on 21 December 2024

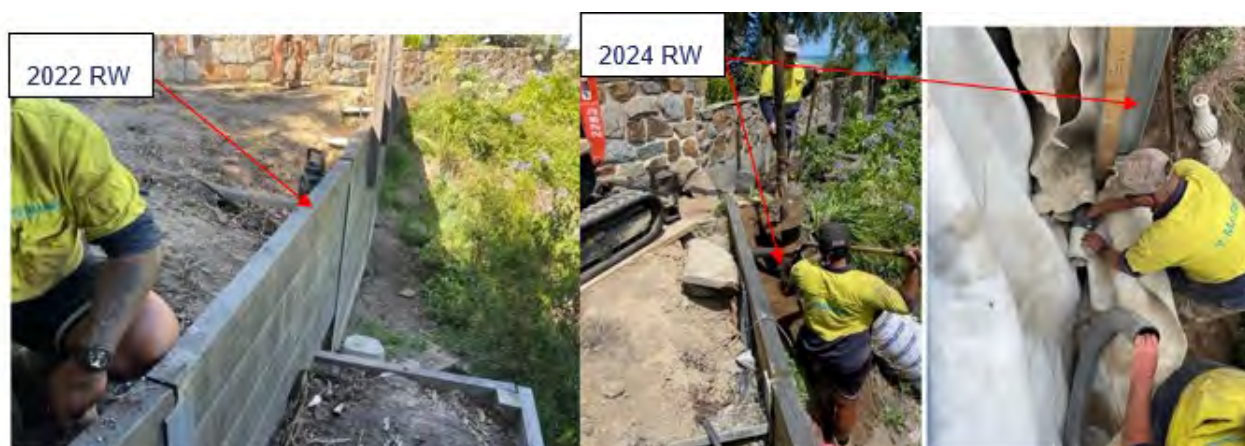
28. I note photographic evidence of contractors working on a RW immediately in front of the 2022 RW, Inset 12. I refer to this RW as “**the 2024 RW**” herein. I provide justification for the timing of construction in C21 and C22 of Appendix C. I have assumed that this contractor is MAW Civil.
29. I note that MAW Civil provided a quotation for RWs that I assume was for the remediation of 2022 Landslides (ref. Quote Retaining Wall 10-12 View Point Road, 2/9/2024). In that quote the proposed RWs included 150UC23 posts @ 1.8 m centres, 1.5 m deep, 1.0 m max upstand. I note that “upstand” is the equivalent of retained height.

Inset 12: Photographs of construction of the 2024 RW (produced by MPSC) with my mark ups in red.

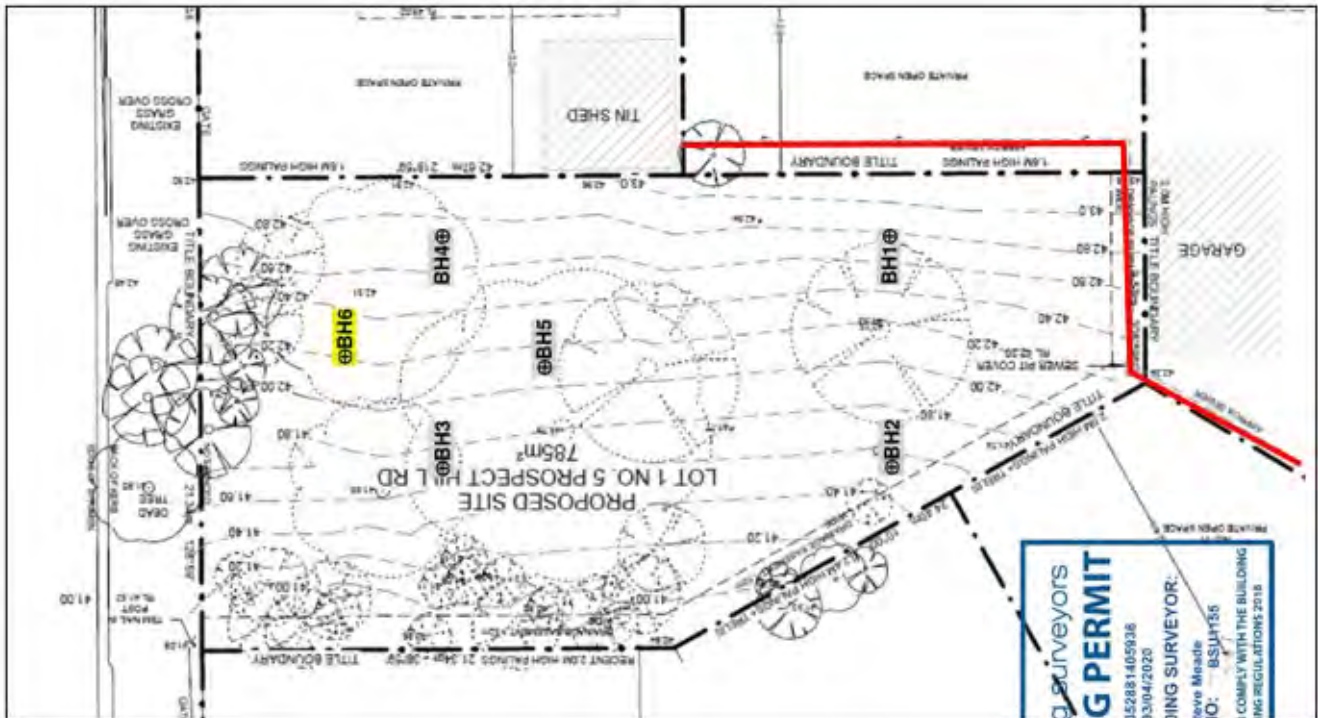
- (a) "Rapid groundwater ingress was encountered below 3 m during the investigation. A groundwater monitoring well was installed".
- (b) Between 0.5 to 2.20 m depth a dark grey/grey/dark brown "silty/sandy CLAY" was observed.
- (c) Between 2.20 to 4.50 m depth Clayey SAND and SAND was observed with trace gravel at depth. The lower portion of these soils were logged as wet.
- (d) From 4.5 m a silty and sandy CLAY of low or medium plasticity dark grey, grey and orange, moist and very stiff.

Inset 13: Excerpt from Hardrock report for 5 Prospect Hill Road with the location of BH6 highlighted by the author of that report. I have highlighted the sewer location in red.

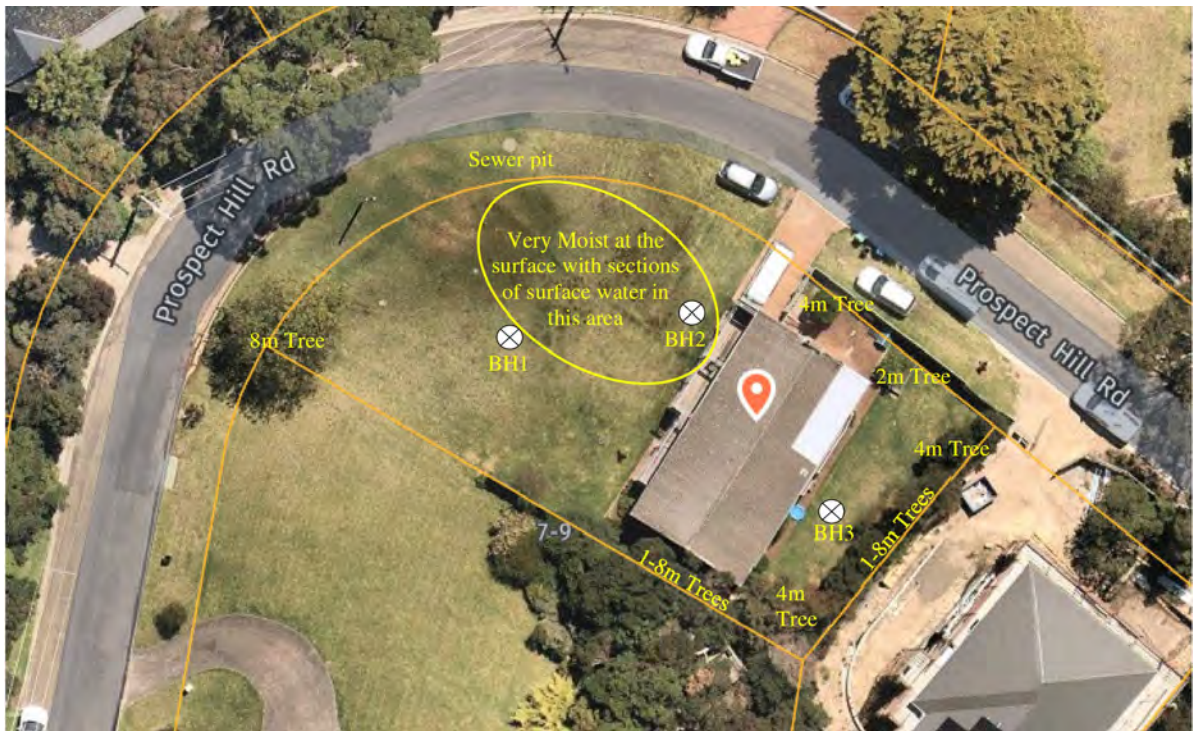
- 32. With regards to the Hardcore Geotech report for 7 Prospect Hill Road I note that:
 - (a) The investigation was completed on 3 March 2021.
 - (b) Abnormal moisture conditions were observed by the author of that report, Inset 14.
 - (c) Borehole 2 had "very moist" soils at surface, Inset 15.
 - (d) Site photographs show water at surface, below the sub-floor of the dwelling and an iron stained discharge, Inset 16 and Inset 17.

Inset 15: Excerpt from Site Plan of the Hardcore Geotech report for 7 Prospect Hill Road (pdf page 9 of 13)

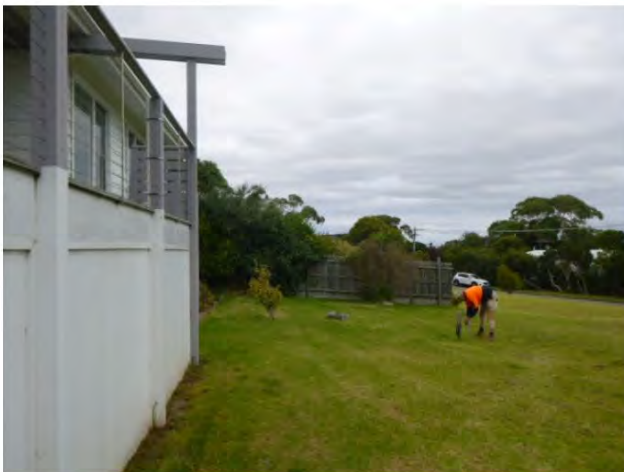
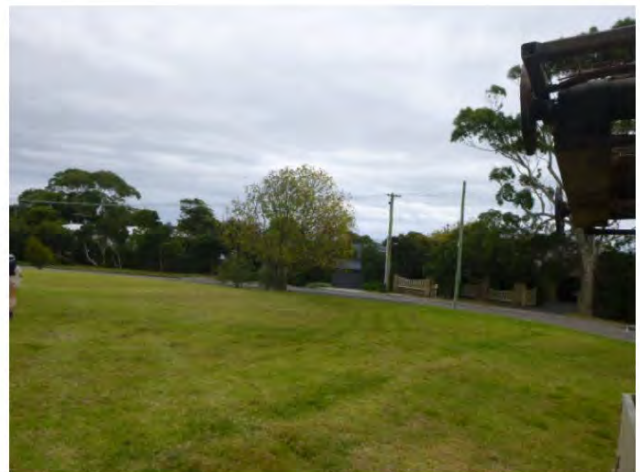
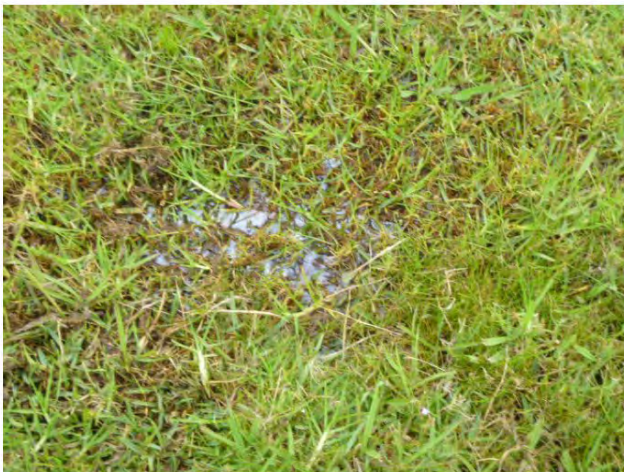
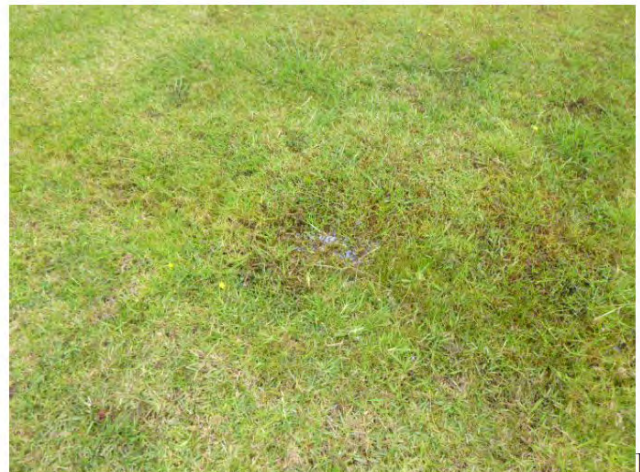
Inset 16: Excerpt from site photos of the Hardcore Geotech report for 7 Prospect Hill Road (pdf page 10 of 13)

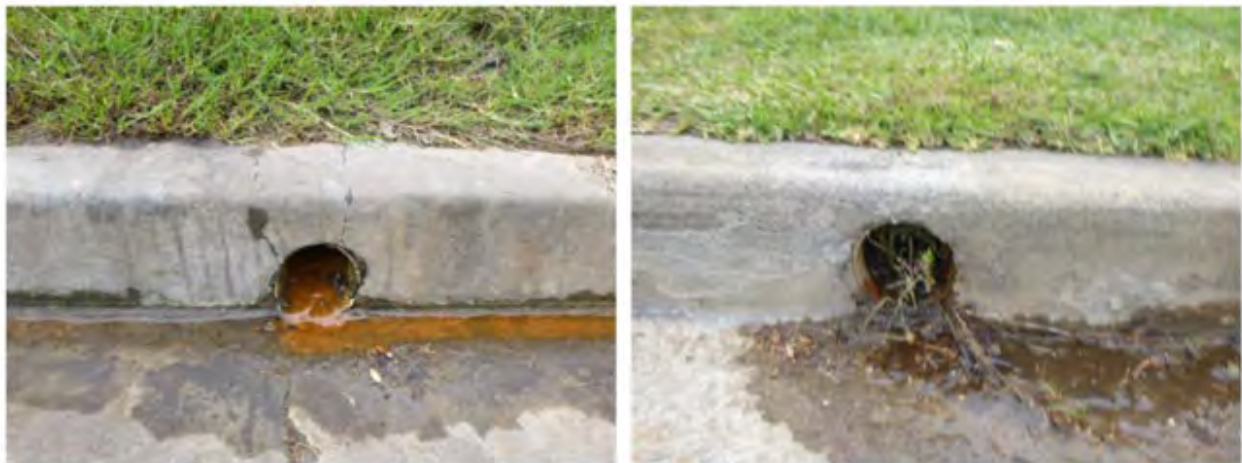
Inset 17: Excerpt from site photos of the Hardcore Geotech report for 7 Prospect Hill Road (pdf page 12 of 13)

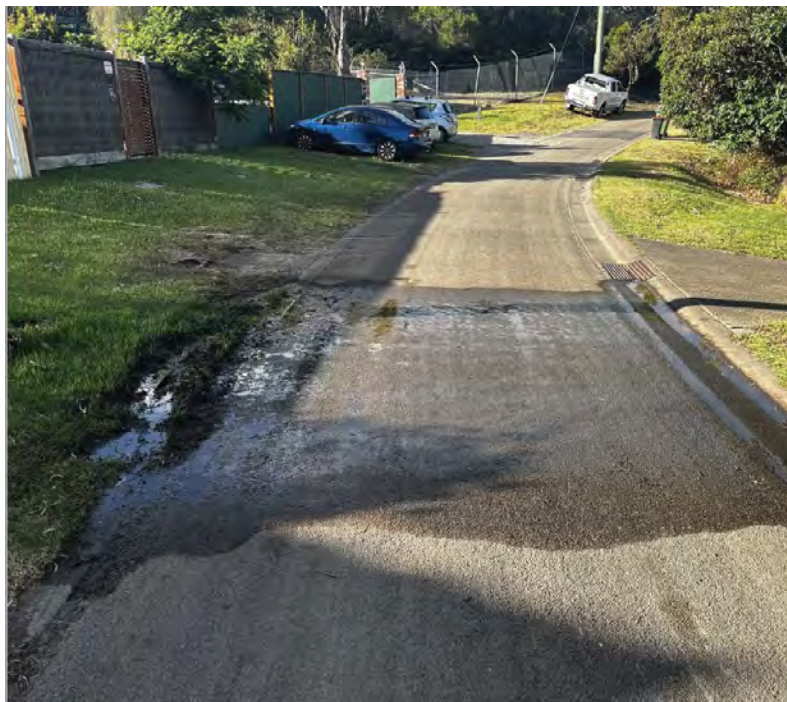
- (a) At some point between 31 December 2024 and 1 January 2025 the near surface soils in Waller Place and Charlesworth Street were saturated and with flow/exfiltration observed in several places, Inset 22 and Inset 23 respectively.

Inset 22: 1 Waller Place looking south west (pdf page 175 of MPSC SEW FOI request May 2025)

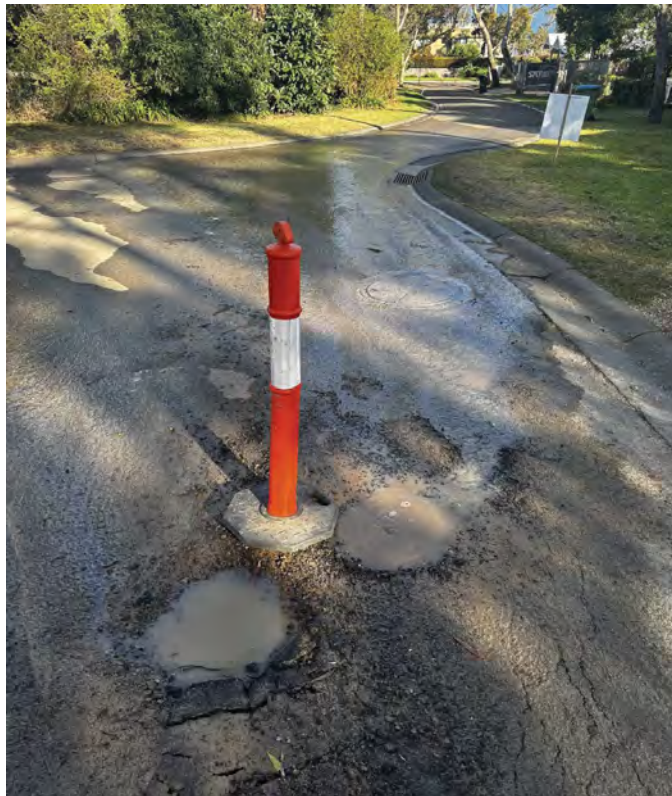
Inset 23: 3 Charlesworth Street looking north west (pdf page 177 of MPSC SEW FOI request May 2025)

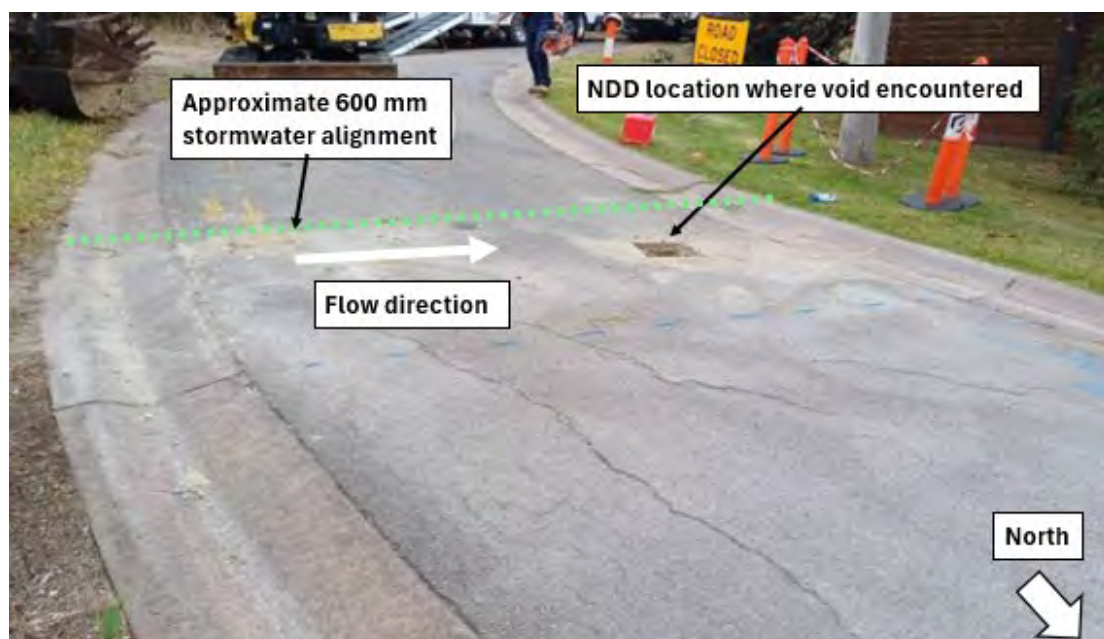
59. I understand that MPSC identified a defect in a 600 mm diameter stormwater pipe at the intersection of Browne Street and Coburn Avenue that was known to cross over a 900 mm diameter water main (referred to herein as the **"Dromana to Portsea water main"**, Inset 28).
60. I note that the defect described in Paragraph 59 is Defect 1 in Appendix E. This defect is referred to herein as the **"Browne Street Stormwater Defect"**.
61. I understand that on 6 May 2025 MSPC undertook non-destructive drilling (**NDD**) adjacent to the Browne Street Stormwater Defect to positively identify the Dromana to Portsea water main, and that during the NDD works a void (the **"Void"**) was identified beneath the pavement immediately north of the 600 mm stormwater pipe, Inset 29.

Inset 29: Browne Street stormwater NDD location

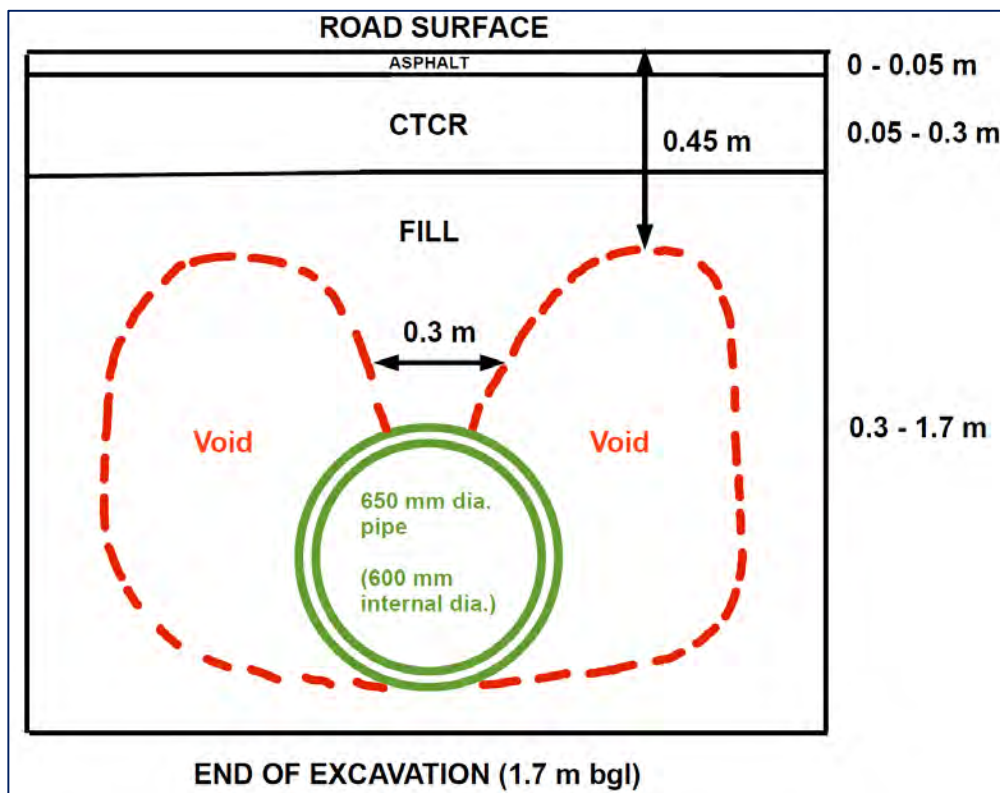
Inset 32: Section A-A showing approximate Void geometry

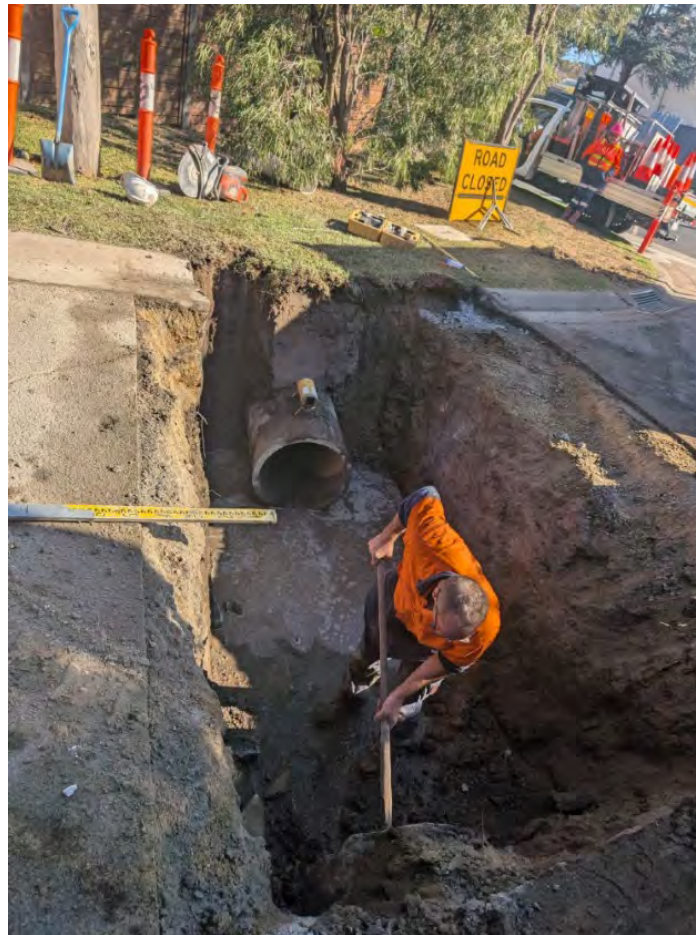
Inset 33: Pondered water from stormwater pipe flows

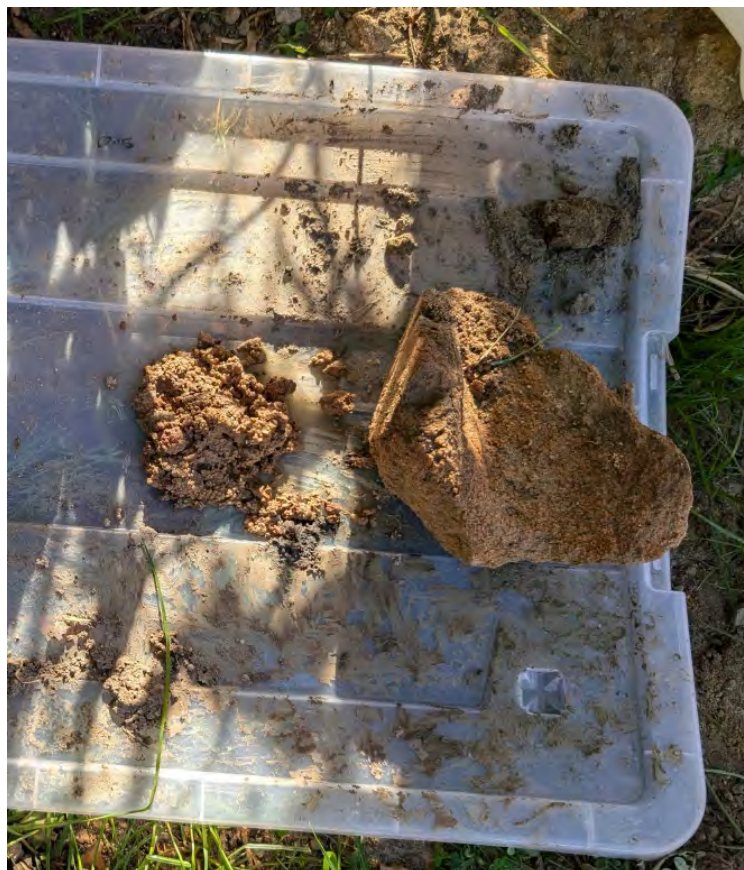
Inset 38: Inferred Colluvium recovered from NDT13 showing SAND and a BOULDER

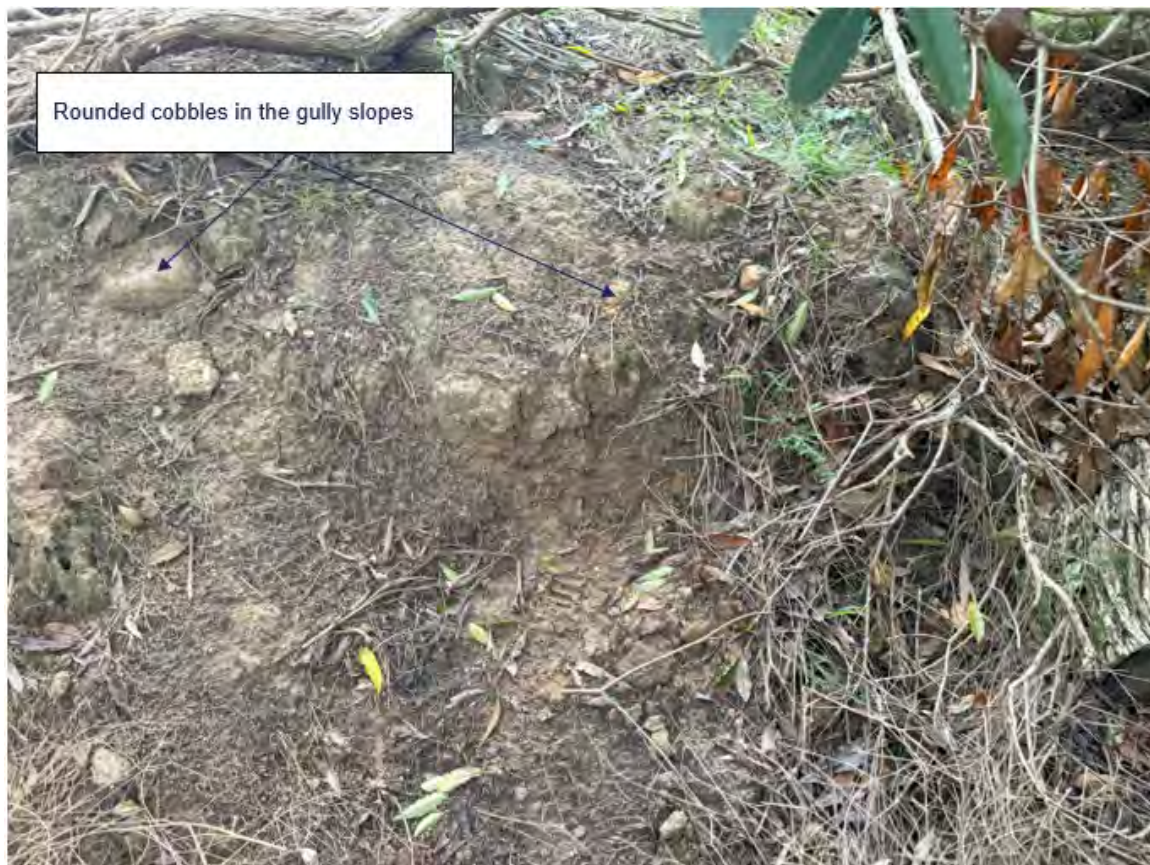
Inset 39: Inferred Colluvium at surface of the gully between Bayview Road and MPF. Refer to Inset 27 for location.

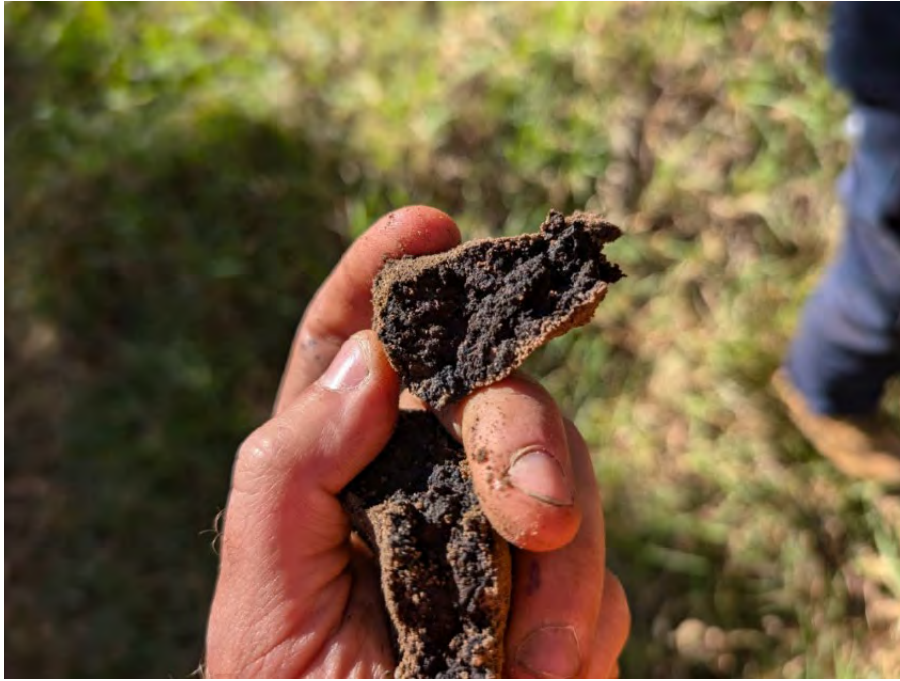
- (c) In borehole BH14A and BH14B of the PSM sewer and stormwater investigation (Refer to Appendix A of PSM5665-070R) from 2.2 m below surface level, Inset 40.

Inset 40: Inferred Gully Alluvium encountered at NDT14A

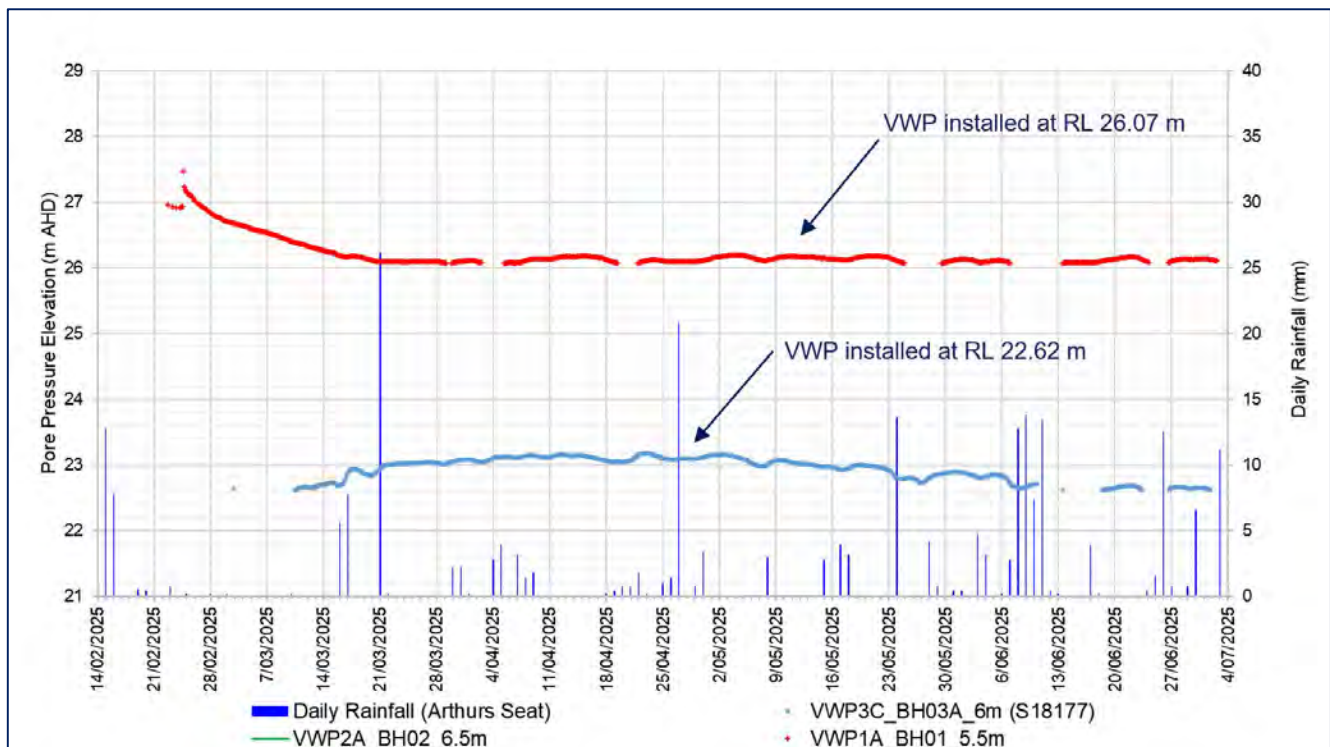
Inset 43: Shallow groundwater in VWP monitoring on the escarpment

99. I provided my groundwater model in Section 5.2 of the PSM LRA. I have updated the groundwater plots in Insets Inset 43 and Inset 44. Note that I refer to shallow groundwater that is observed in the upper surficial soils (such as FILL, COLLUVIUM, ALLUVIAL/MARINE deposits, Table 3 of the PSM LRA) above the Residual Soil and XW Granite as the **"Leaky Surficial Aquifer"**.

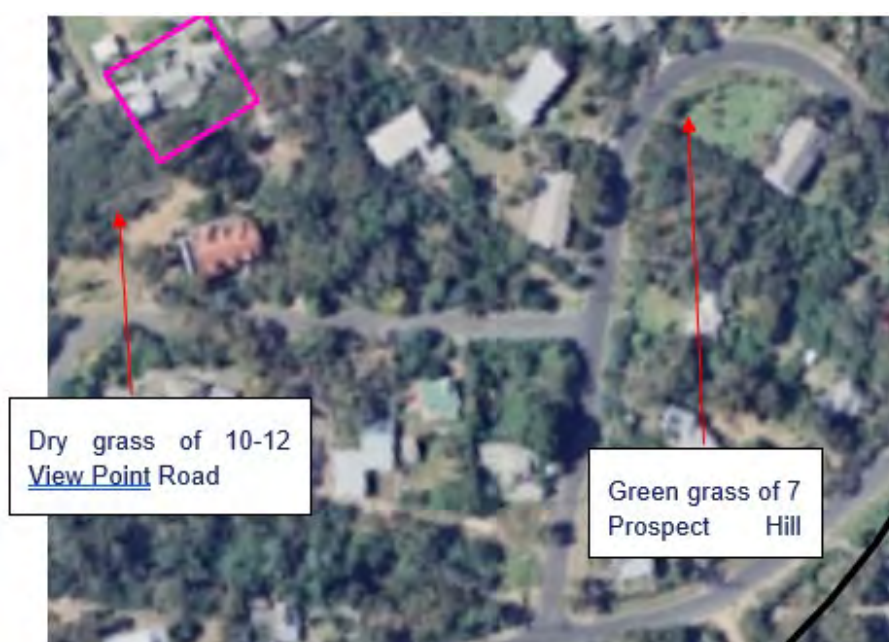
Inset 45: 1970 Aerial with inferred near surface soil moisture

102. I note that the northern portion of 7 Prospect Hill Road is consistently green in aerial photographs and this trend extends back to the earliest colour aerial photographs of 1970, Inset 45. It is my opinion that the consistent observations of near surface seepage and shallow groundwater on 5 and 7 Prospect Hill Road are most likely associated with a spring. The contribution of leaky services should be investigated further in this area as in 2025 this seepage was at least partially influenced by a private water main leak on 5 Prospect Hill Road.

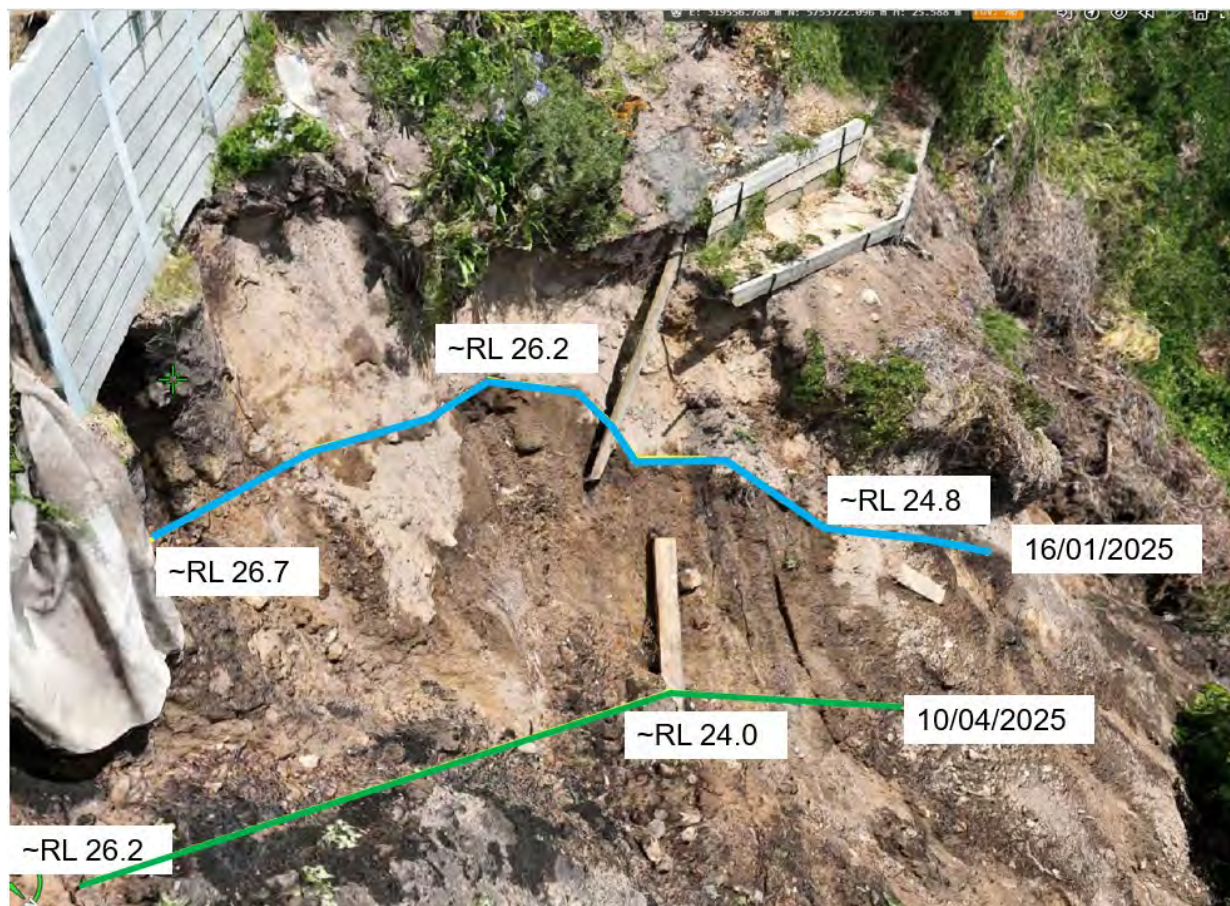
Inset 47: Western flank of the 2025 Landslides with interpretation on Pointerra Reality Model of the change in levels of seepage points with time

103. I measured flow rates of the seepage from the 2025 Landslide:
- (a) 6 January 2025 – no less than 0.15 to 0.2 litres per second measured with a 600 mL bottle. This approximates to 13,000 to 17,000 litres per day.
 - (b) 16 June 2025 – no less than 50 litres per day. I note that I had to use a 12 mL syringe to measure this rate.
104. I note that neither of these seepage measurements represent the maximum seepage at those times. These rates represent what was practical to measure at those times.
105. My routine photographs of seepage points in the 2025 Landslide headscarp progressively show a decrease in the elevation of the seepage points with time. The seepage lines are discussed further in Section 6.3. This change is illustrated on the Pointerra Reality Model on the eastern flank of the 2025 Landslide, Inset 46 and the western flank of the 2025 Landslide, Inset 47.

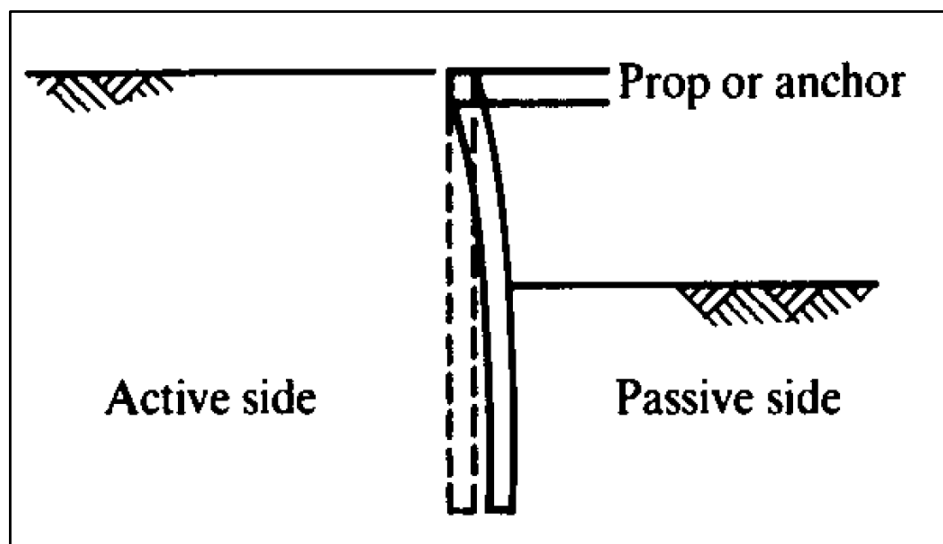
Inset 48: Characteristics of a RW, excerpt from Atkinson (2007)⁴

110. I introduce the broad mechanisms of failure of the 2025 Landslides in Section 7 of the PSM LRA.
111. This section provides an extension of those details. In this section I refer to the active and passive wedges of the RW, Inset 48. I provide a sketch of the mechanism of failure and regression in Inset 49.

- (A) The 2024 RW was vulnerable to global failure as the stresses from the active wedge of the RW could not be distributed to the competent materials, such as XW Granite, on the passive side of the RW.

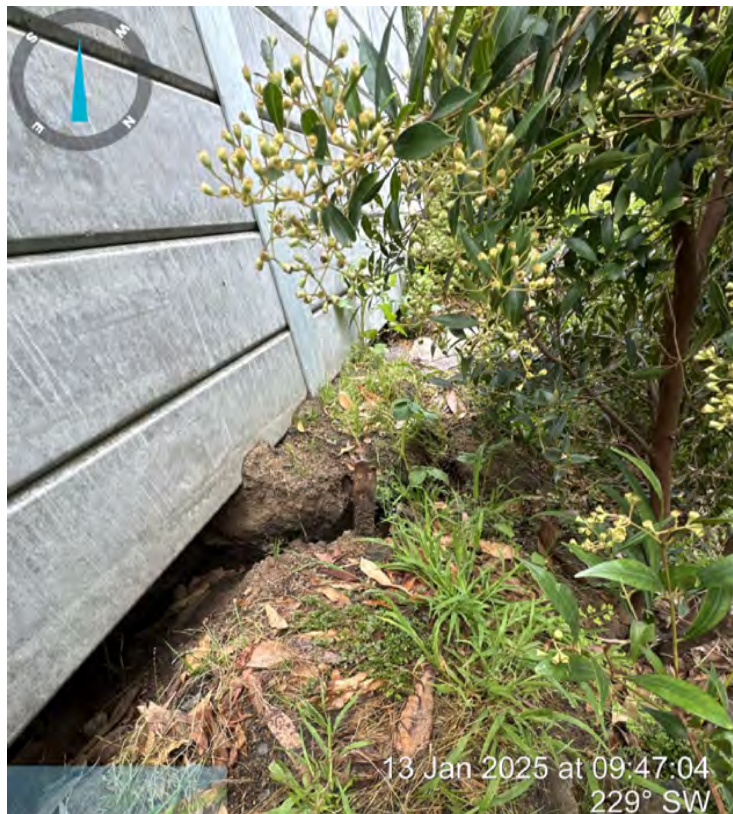
Inset 51: 2024 RW on 13 January 2025 (source:MPSC)

- (b) The 5 January 2025 failure extended back to the 2024 RW, Inset 50. On the 6 January 2025 there were no apparent tension cracks behind the 2024 RW. Movement continued at the tension crack location, Inset 51 on 13 January 2025. At this time, tension cracks behind the 2024 RW had not been observed or reported by others.

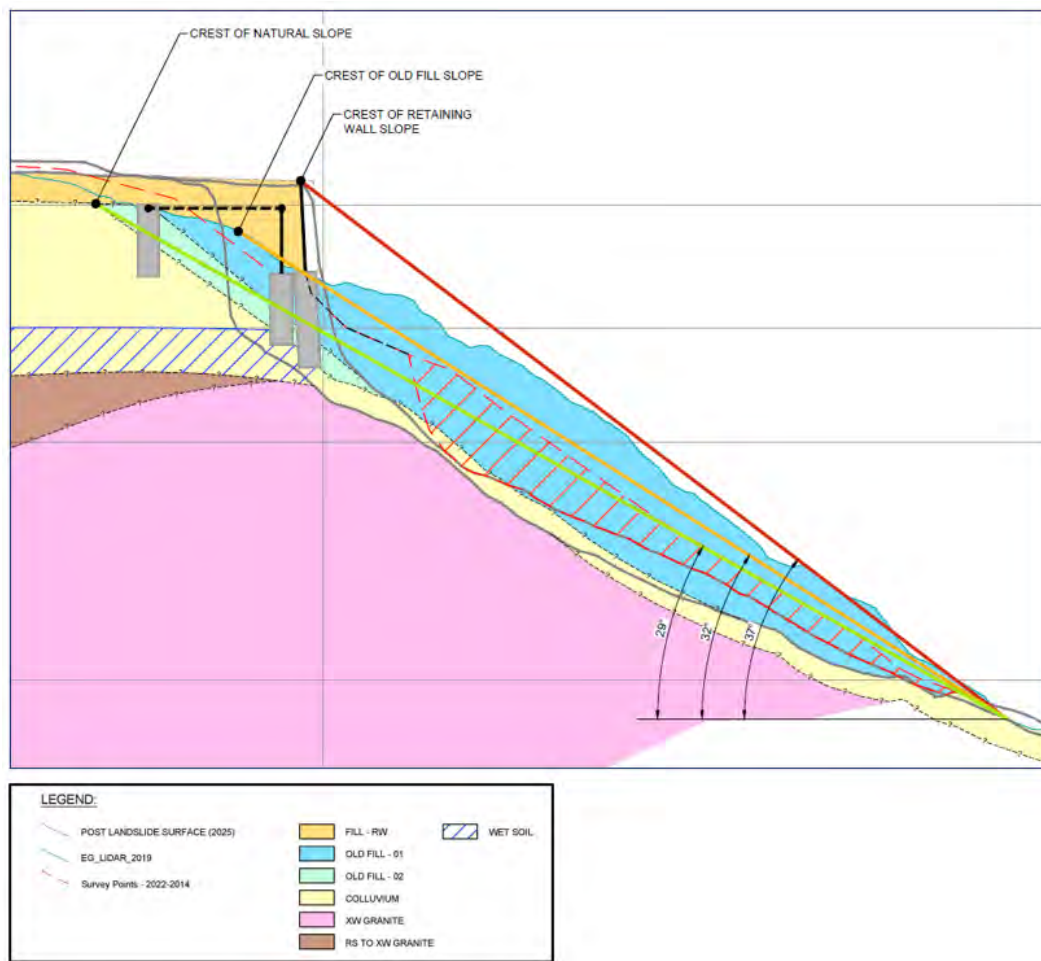
Inset 52: Increase in slope angles

- i. The overall natural slope angle of the gully (measured from the crest of the slope to the toe of the 2025 Landslide was approximately 29°.
 - ii. The overall slope to the crest of the OLD FILL was 32°.

- iii. The overall slope to the crest of the 2024 RW was 37°.
 - (f) In my opinion this increase in overall slope angle to more than the typical angle of repose of end tipped fills without effective resisting forces from the piers of either the 2022 RW or the 2024 RW has resulted in the overall slope being fundamentally unstable. This is based on engineering principles and my experience with uncontrolled fill performance in mining and quarrying operations (Refer to Norwich Park, Burton Coal Mine and Wollert Quarry in my CV, Appendix B). In my opinion, without the need for stability analysis, the ultimate slope constructed with the 2024 RW was fundamentally unstable with or without any groundwater. Nonetheless, I provide supporting evidence of this opinion in the form of stability analysis in Section 7.3.

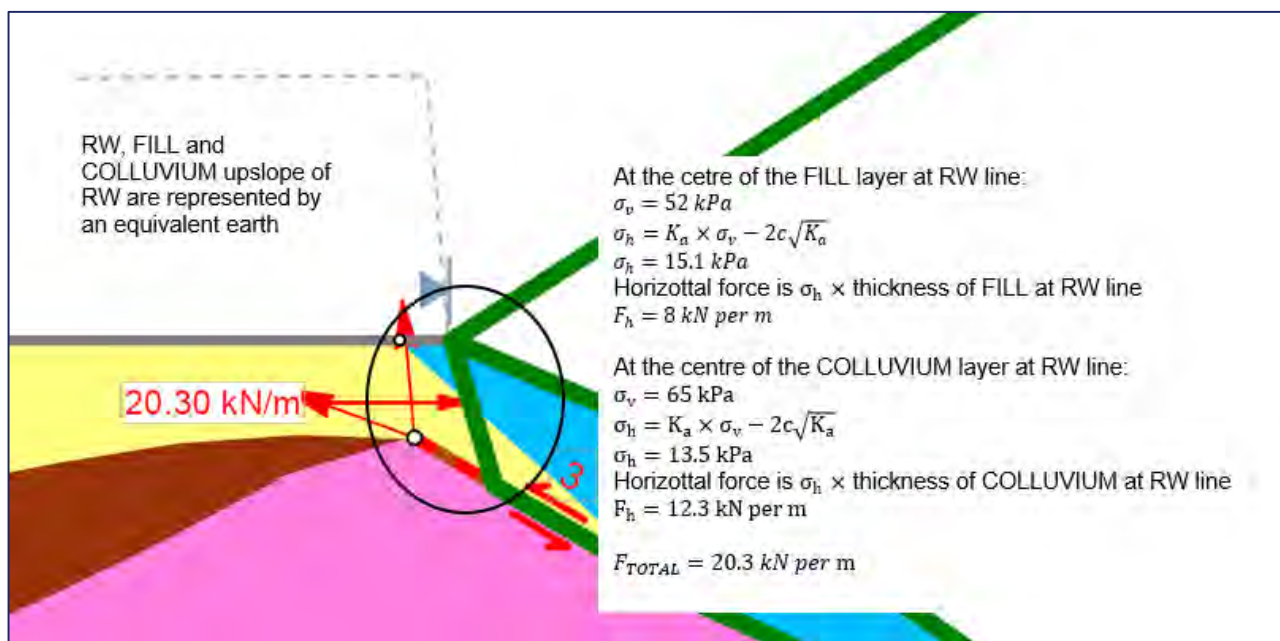
Inset 53: Calculation of equivalent horizontal force

115. With regards to modelling of the 2024 RW failure, the observed tension crack was immediately adjacent to the sub-vertical panels of the RW, Inset 49. To ensure that the failure initiated at this location, I adopted the equivalent horizontal stresses developed by the soils above this point and applied this as an equivalent horizontal force, Inset 53.

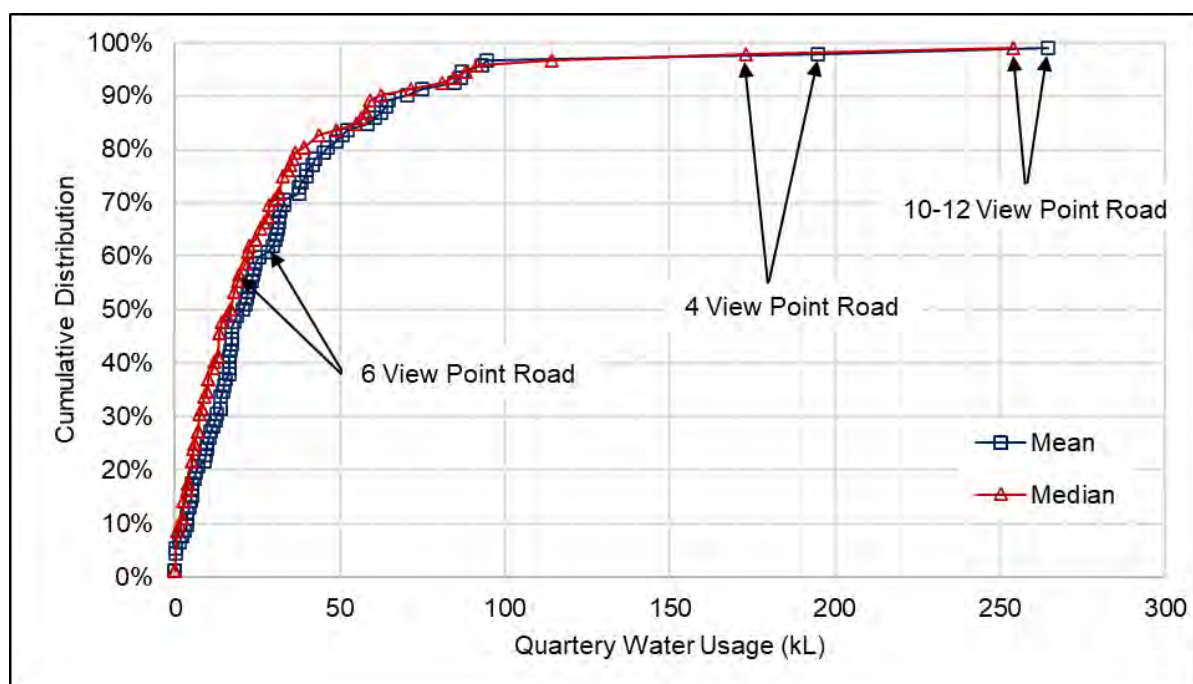
Inset 62: Cumulative distribution of McCrae area water usage between November 2021 and June 2025

144. I have prepared cumulative distributions showing the average and median quarterly water usage, Inset 62.
145. I note that the median quarterly water usage at 10-12 View Point Road and 4 View Point Road are 254 kilolitres (kL) and 173 kL per quarter respectively. This is 15 and 10 times greater than the median property in the area respectively. In my opinion a significant proportion of infiltration could potentially reach the 2025 Landslide location due to:
- Vegetable gardens immediately behind the 2024 RW.
 - Deep sewer trenches on 4 View Point Road, Figure 4, that fall towards the southern boundary of 6 View Point Road.

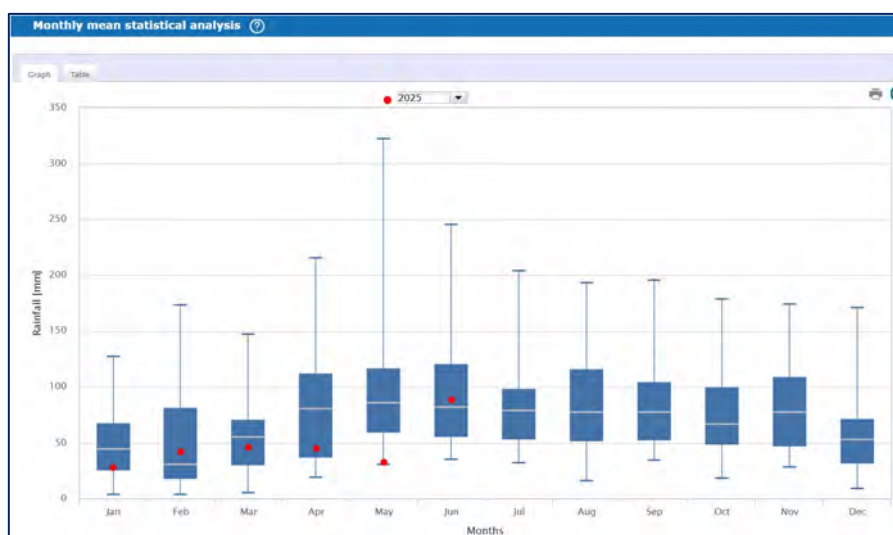
Inset 63: Arthurs Seat (Station ID 586202) monthly statistical analysis

172. The groundwater monitoring completed to date in the SEW or MPSC trenches on View Point Road has not captured evidence of piezometric pressures to date. It is well established that below average rainfall has been observed in 2025 (ref. Arthurs Seat weather station monthly statistical analysis, Inset 63). Further groundwater monitoring is required to established contributions from the backfill of service trenches.
