McCrae Landslide

Causation

PSM5665-075R 21 July 2025

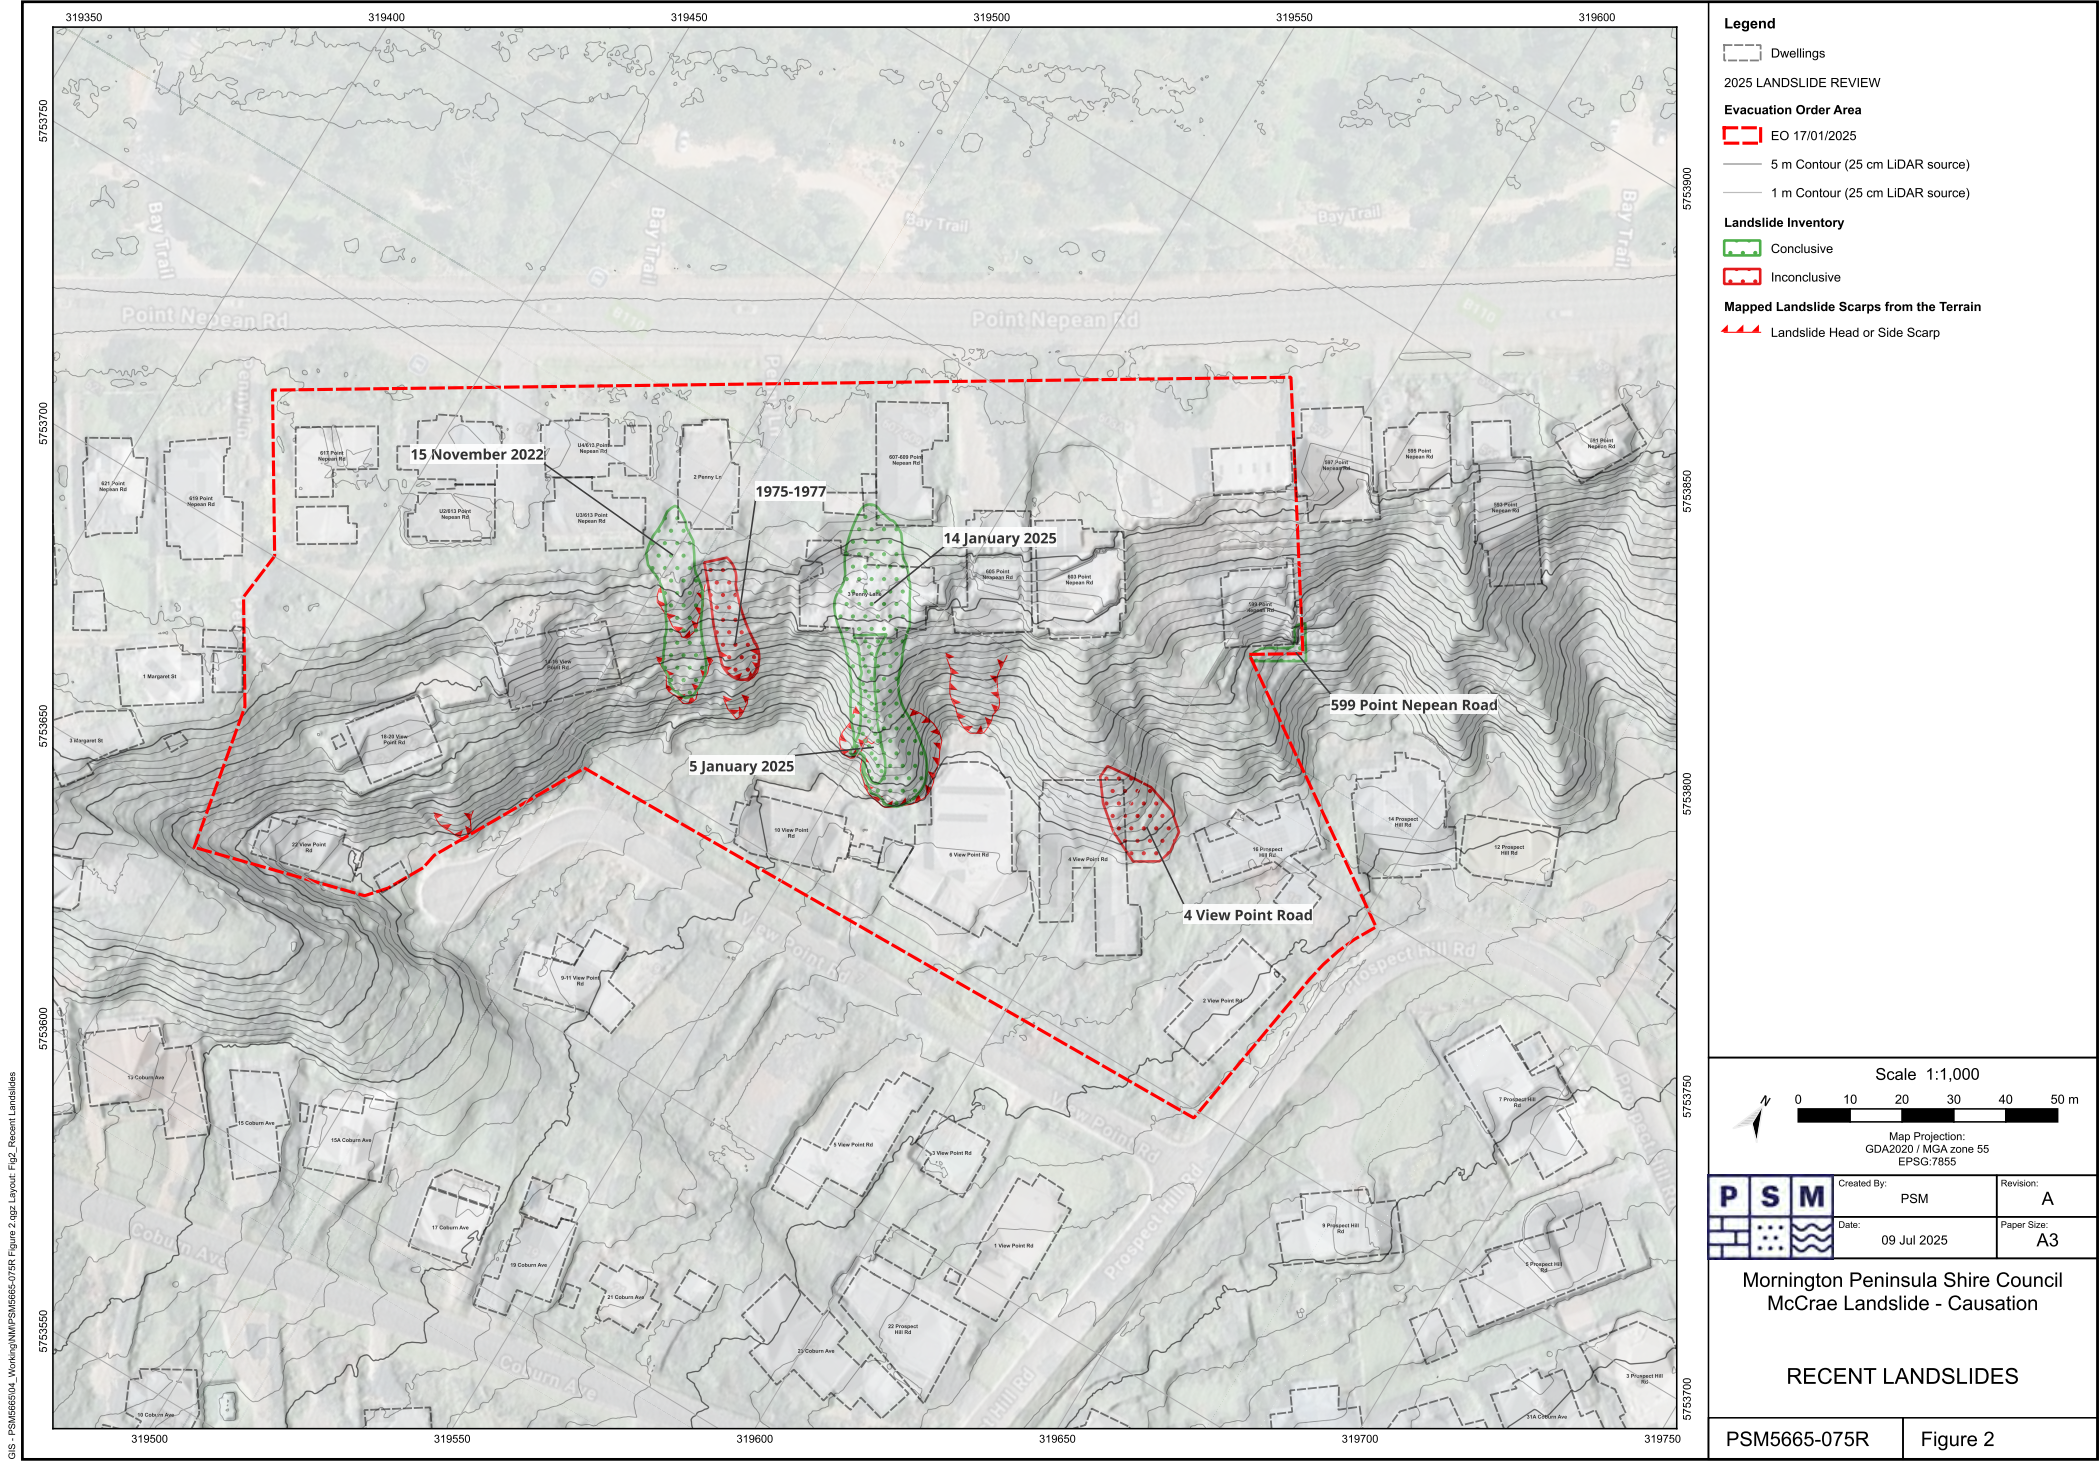
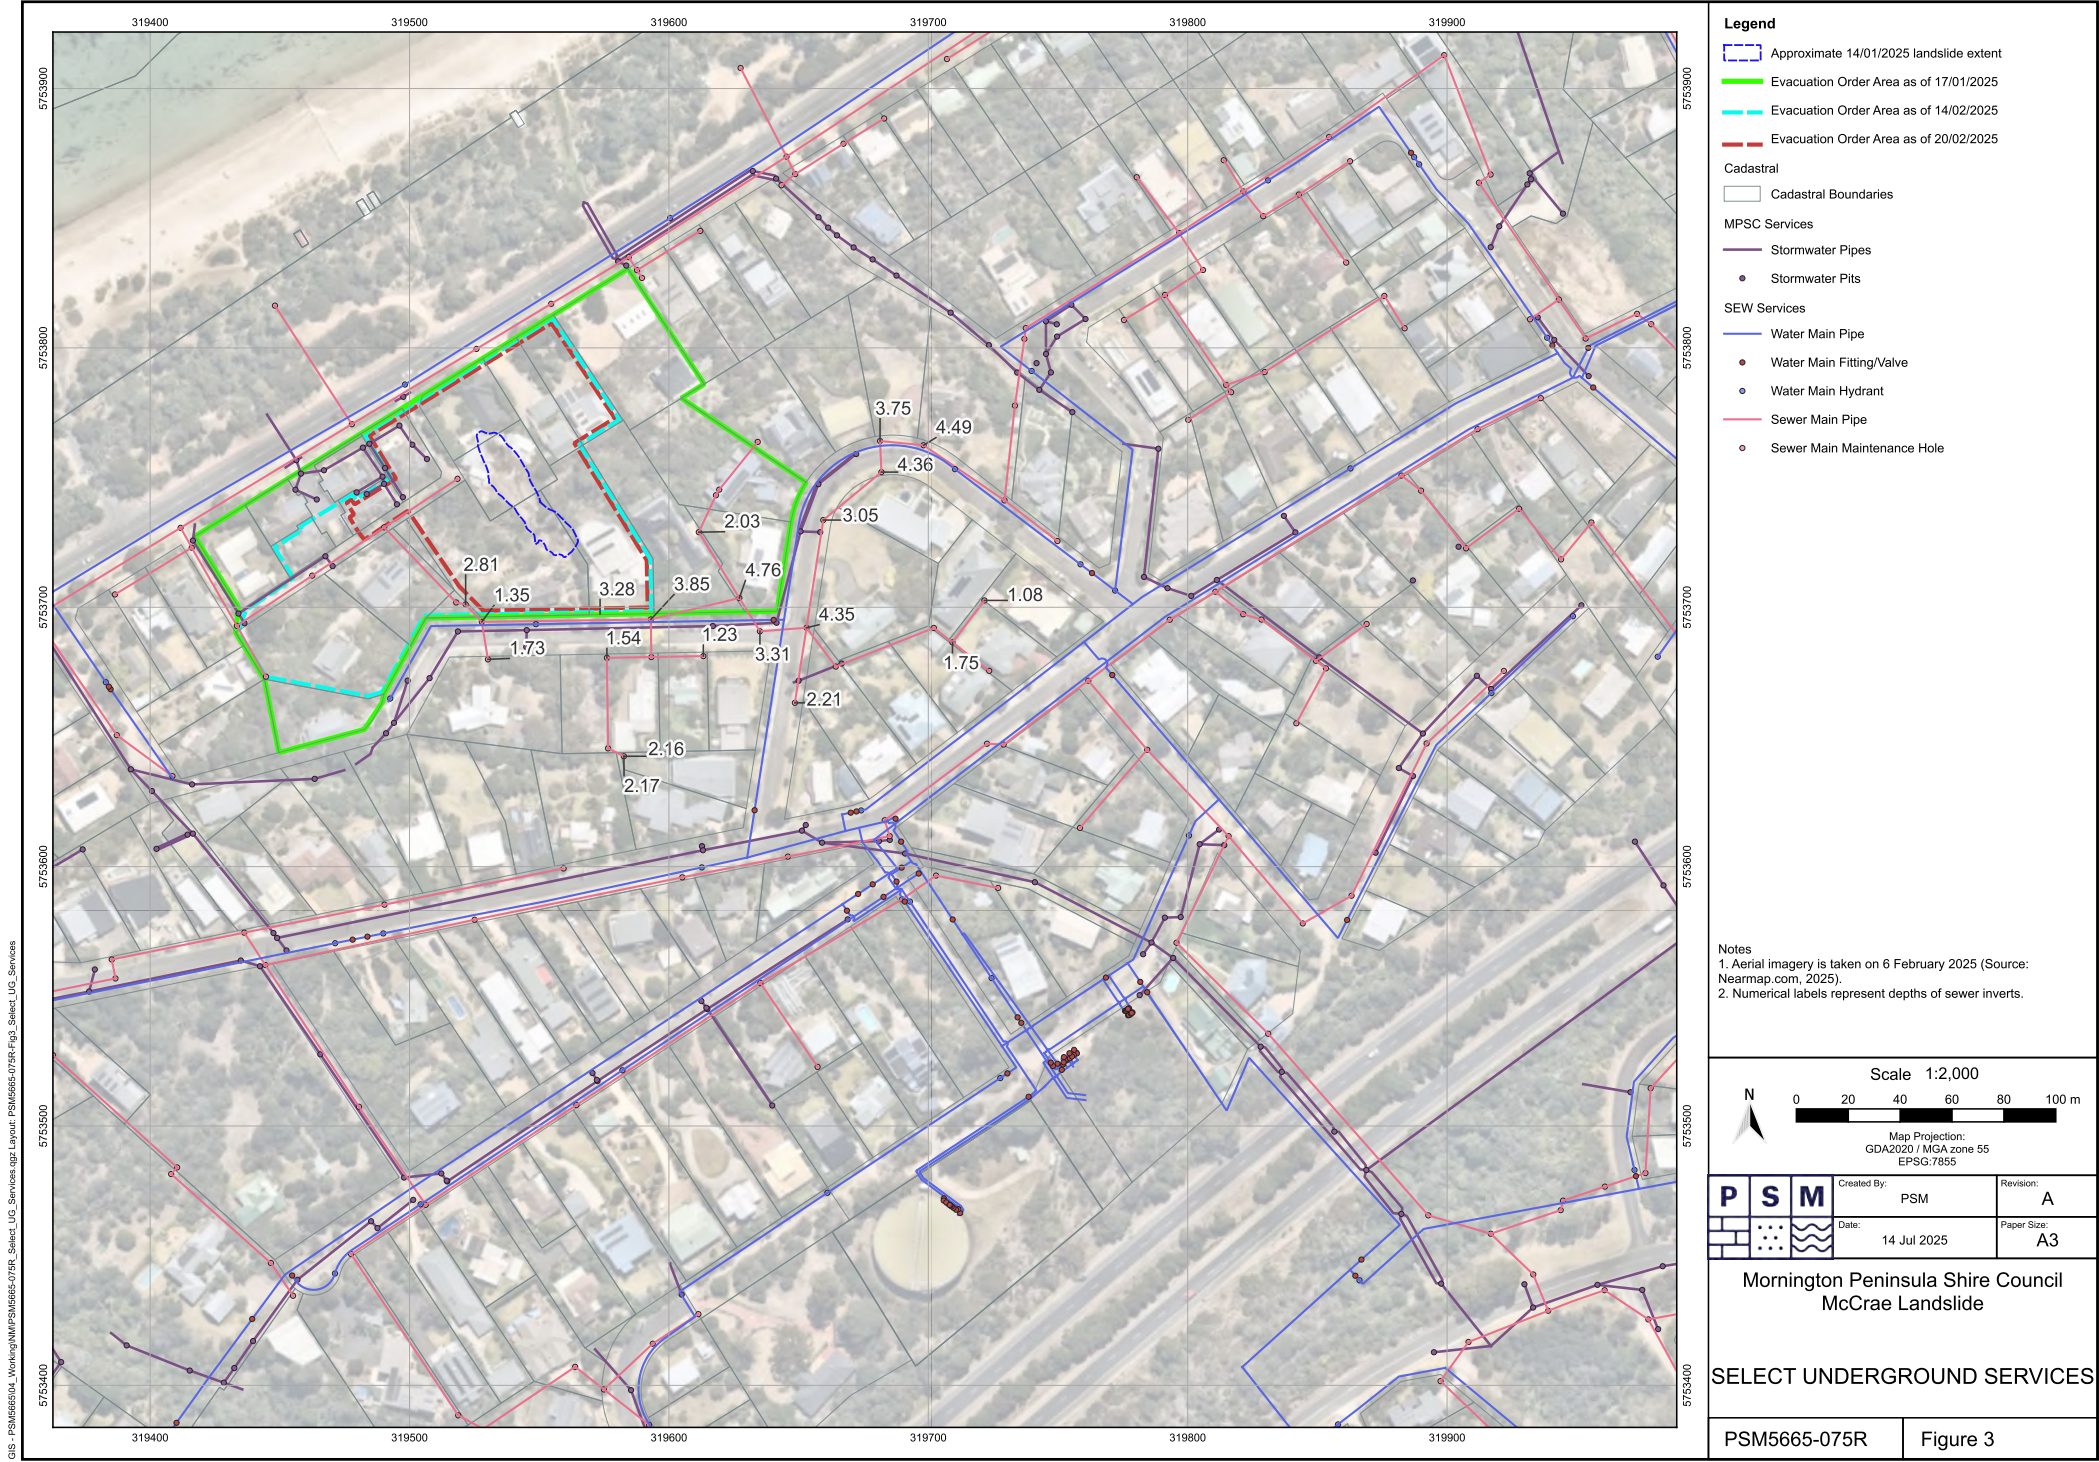
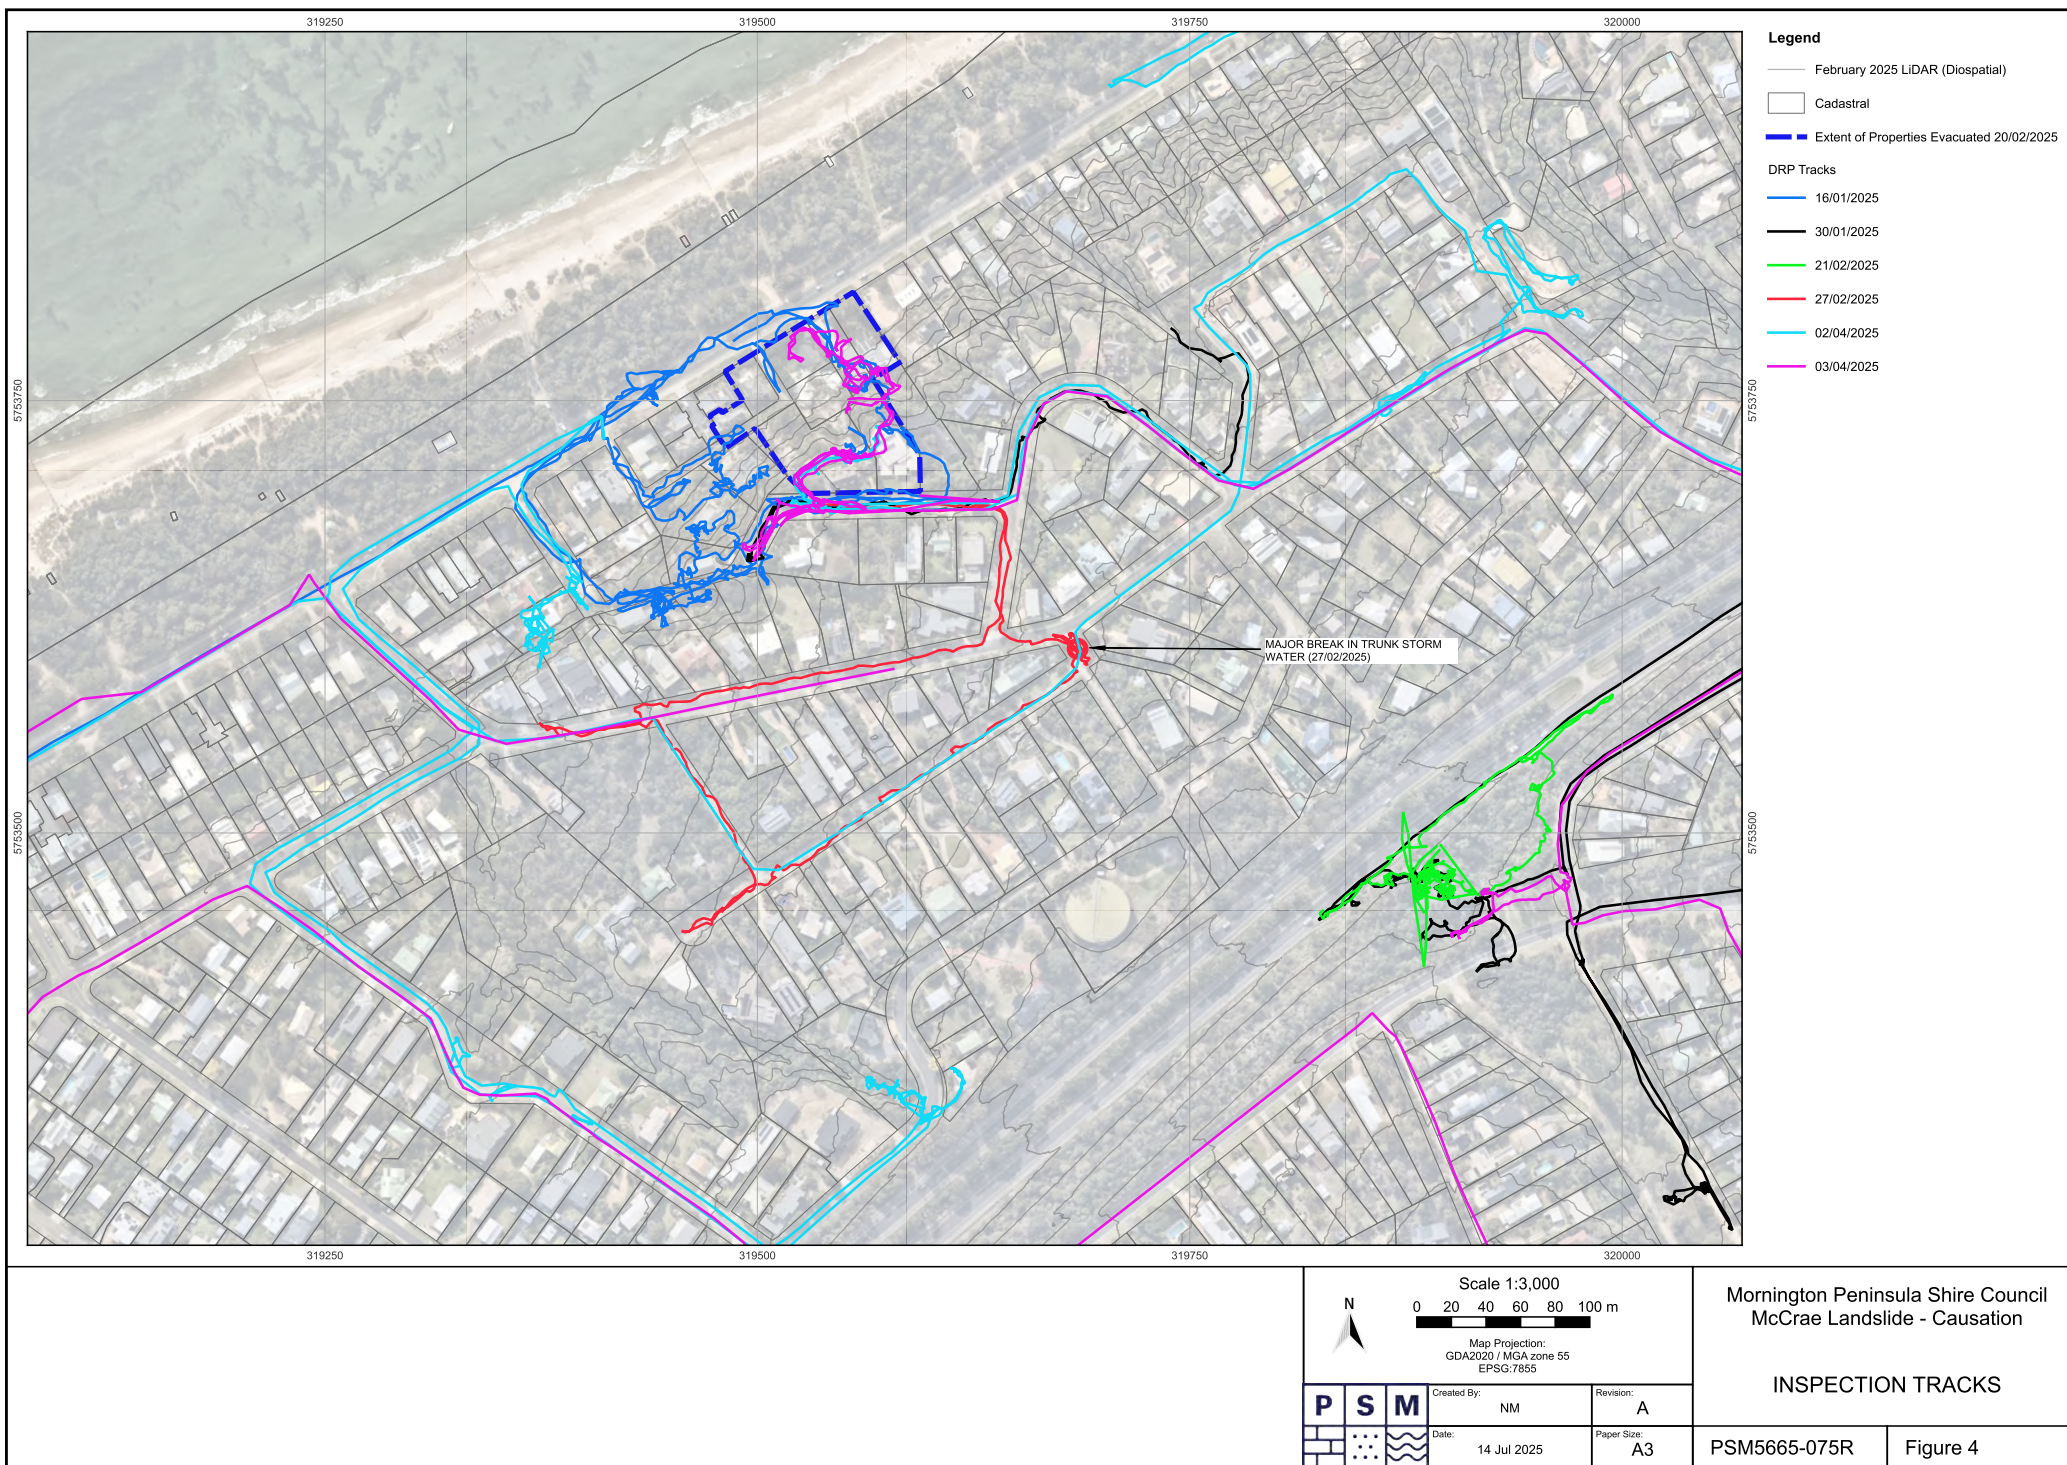
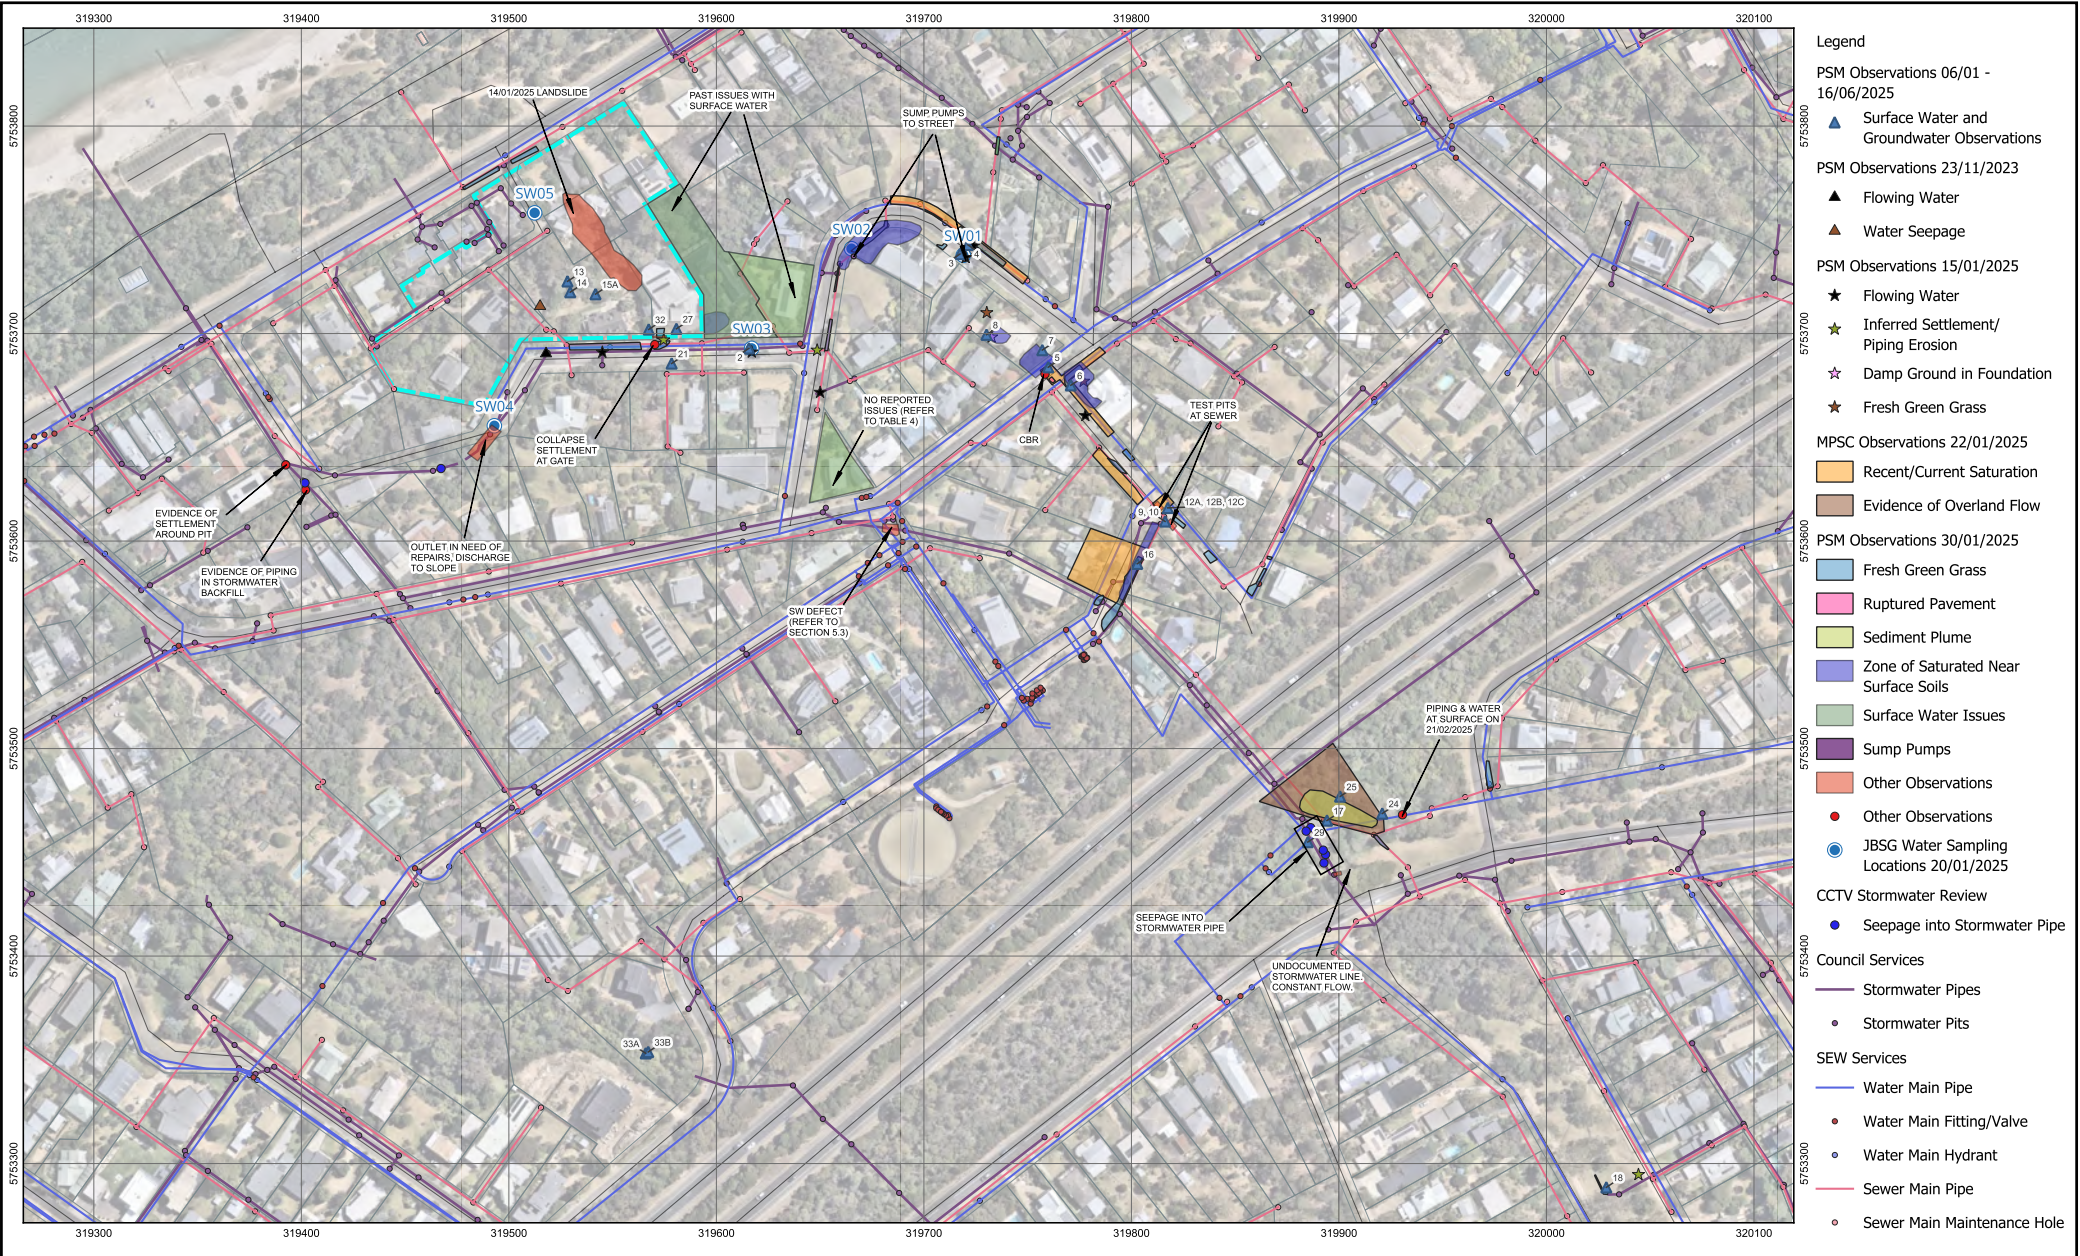
FIGURE 5

167. I have observed direct evidence of groundwater flowing in the backfill of service trenches in:
- (a) Test pits on Charlesworth Street.
 - (b) Seepage into the trunk stormwater main upstream of the MPF, Figure 5.

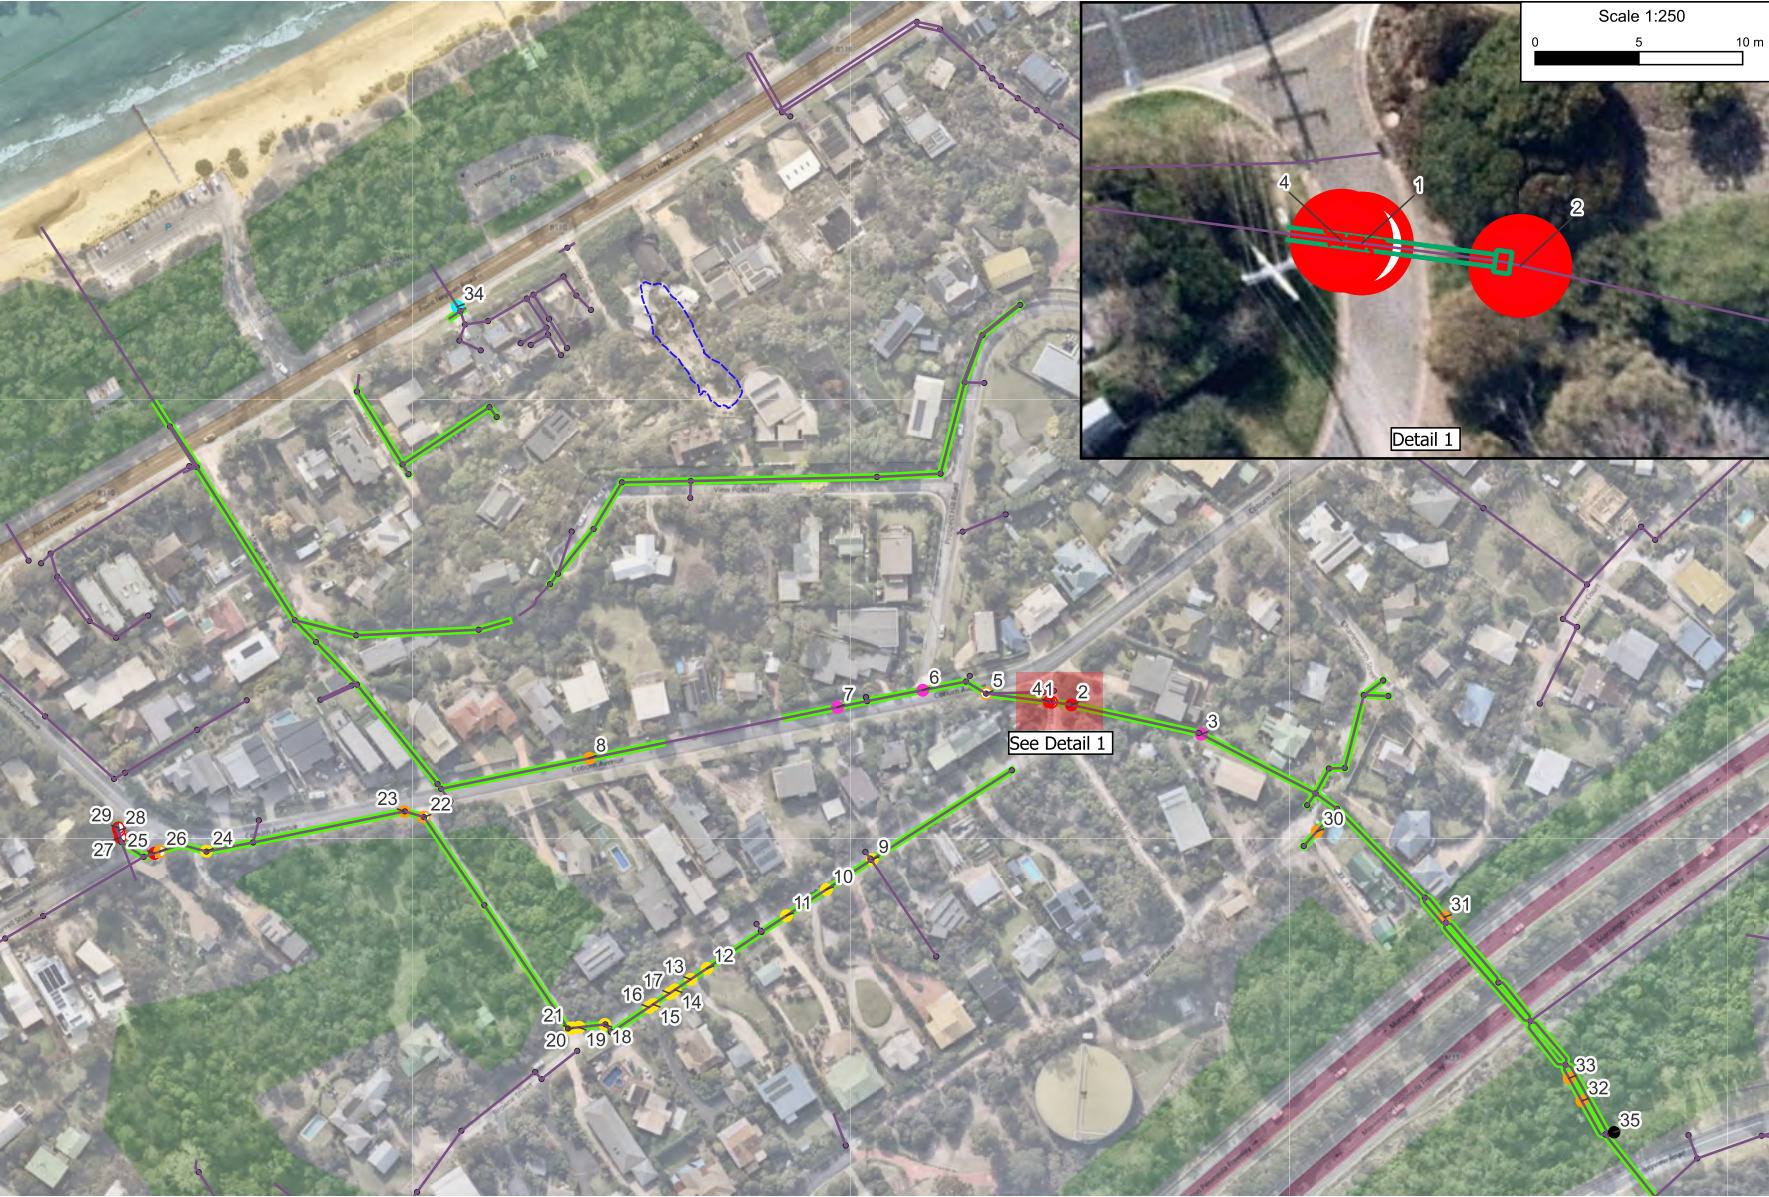
FIGURE 6

156. In my opinion water losses through defects 8, 22 to 29, and 34, Figure 6, are not plausible to have contributed to groundwater conditions at 10-12 View Point Road.

- (b) Stormwater base flows are in the order of 3 litres per minute or approximately 4300 litres per day.
164. In my opinion there are no significant defects in the stormwater system between 2 View Point Road and 10-12 View Point Road, Figure 6. I note a general lack of longitudinal fall on Prospect Hill Road/2 View Point Road.

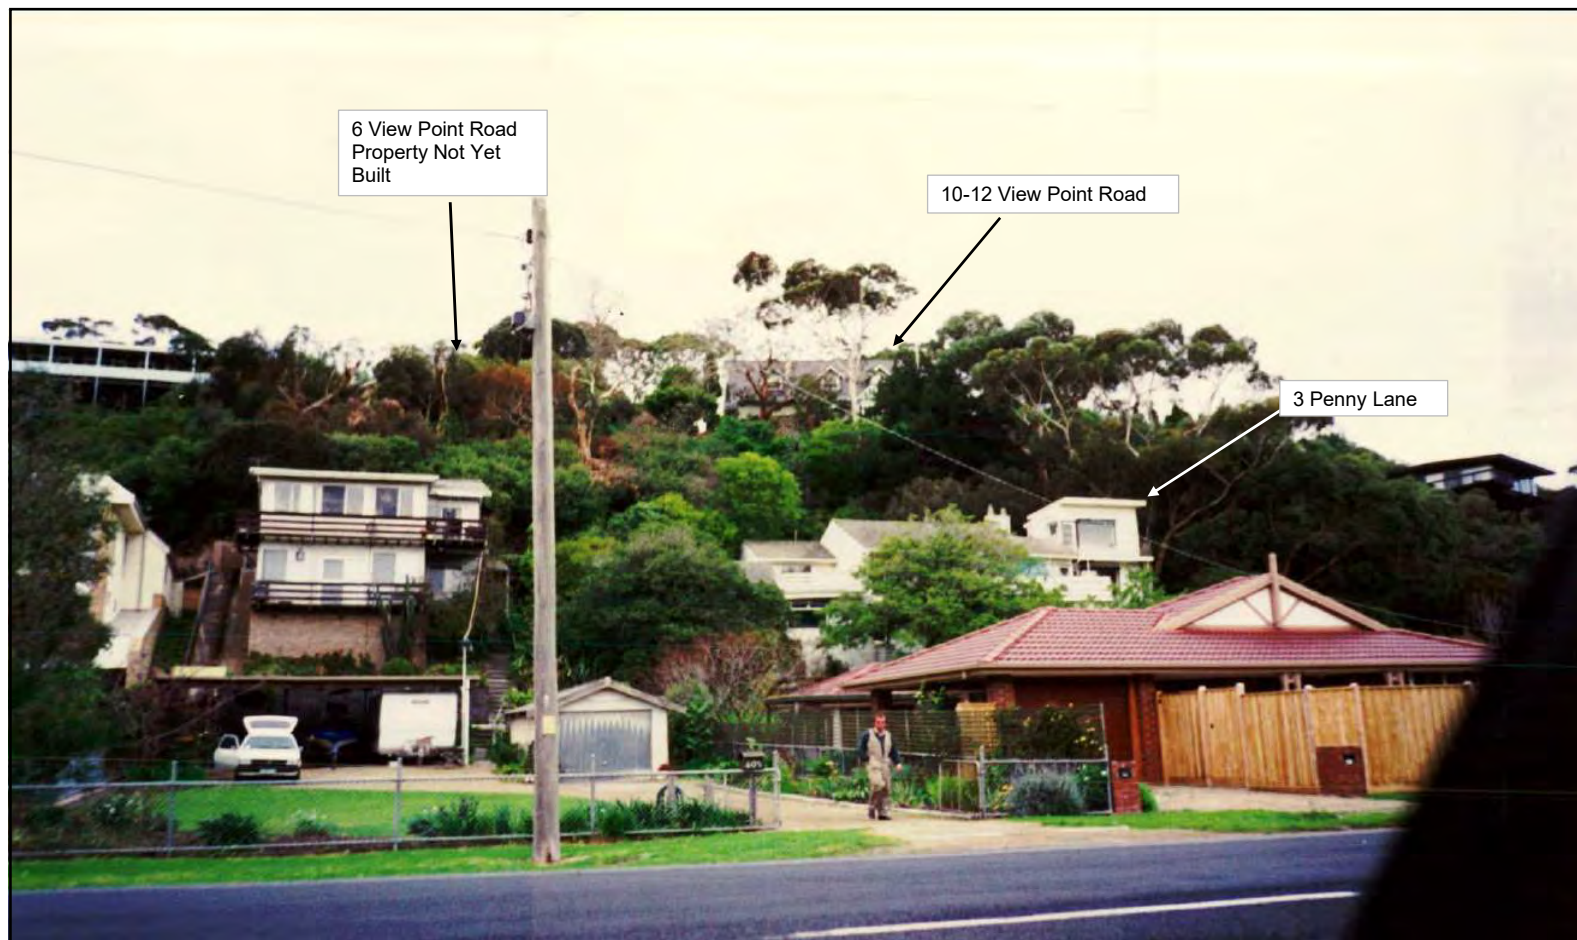
Photo of gully from Point Nepean Road. Gully and crest of slope on 10-12 View Point Road is well vegetated, dated June 1996. Source: MPSC Scanned Property File (148726 - A13522532)

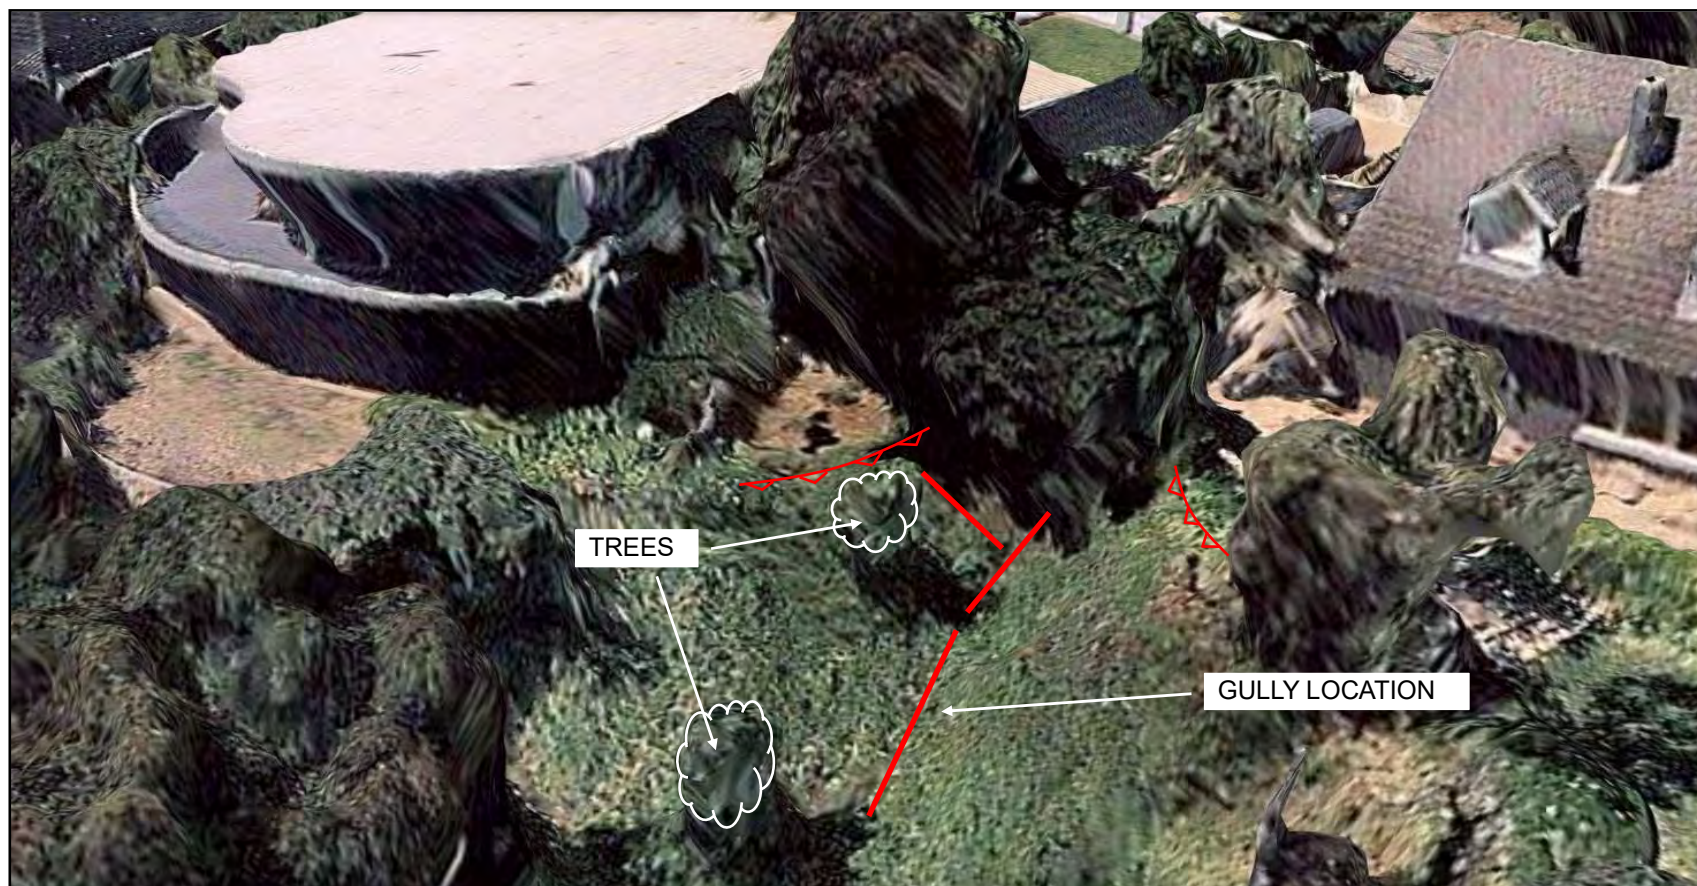
Trees removed from adjacent to 2022 Retaining Wall location on 10-12 View Point Road, dated February 2021. Source: Nearmap.

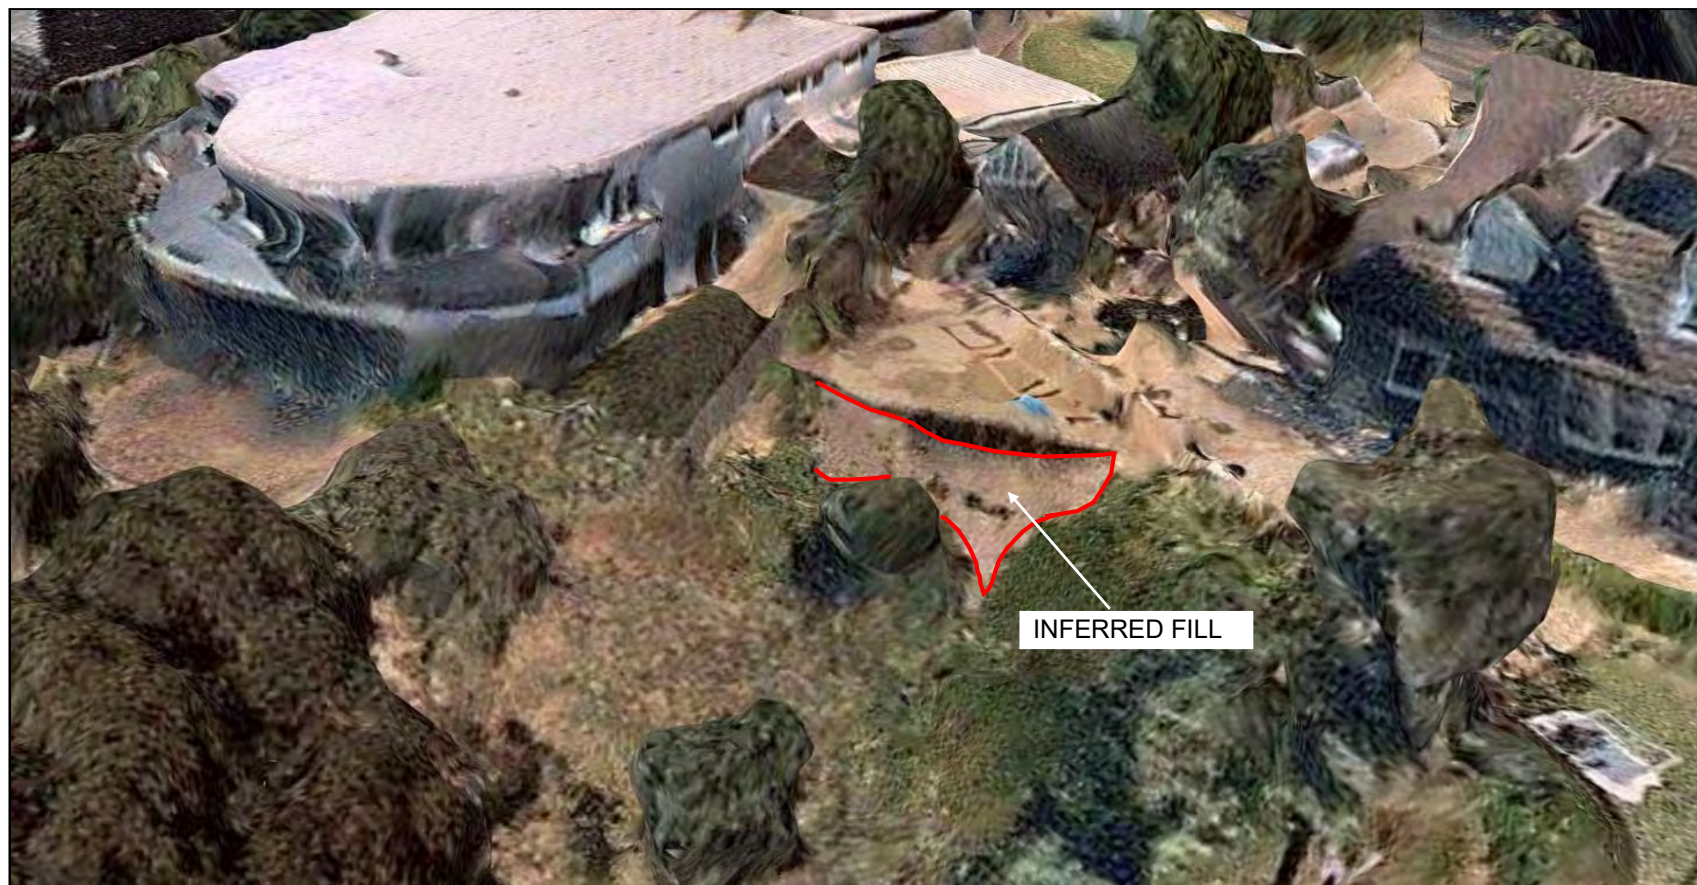
Trees removed from adjacent to 2022 Retaining Wall location on 10-12 View Point Road, dated January 2022. Source: Nearmap.

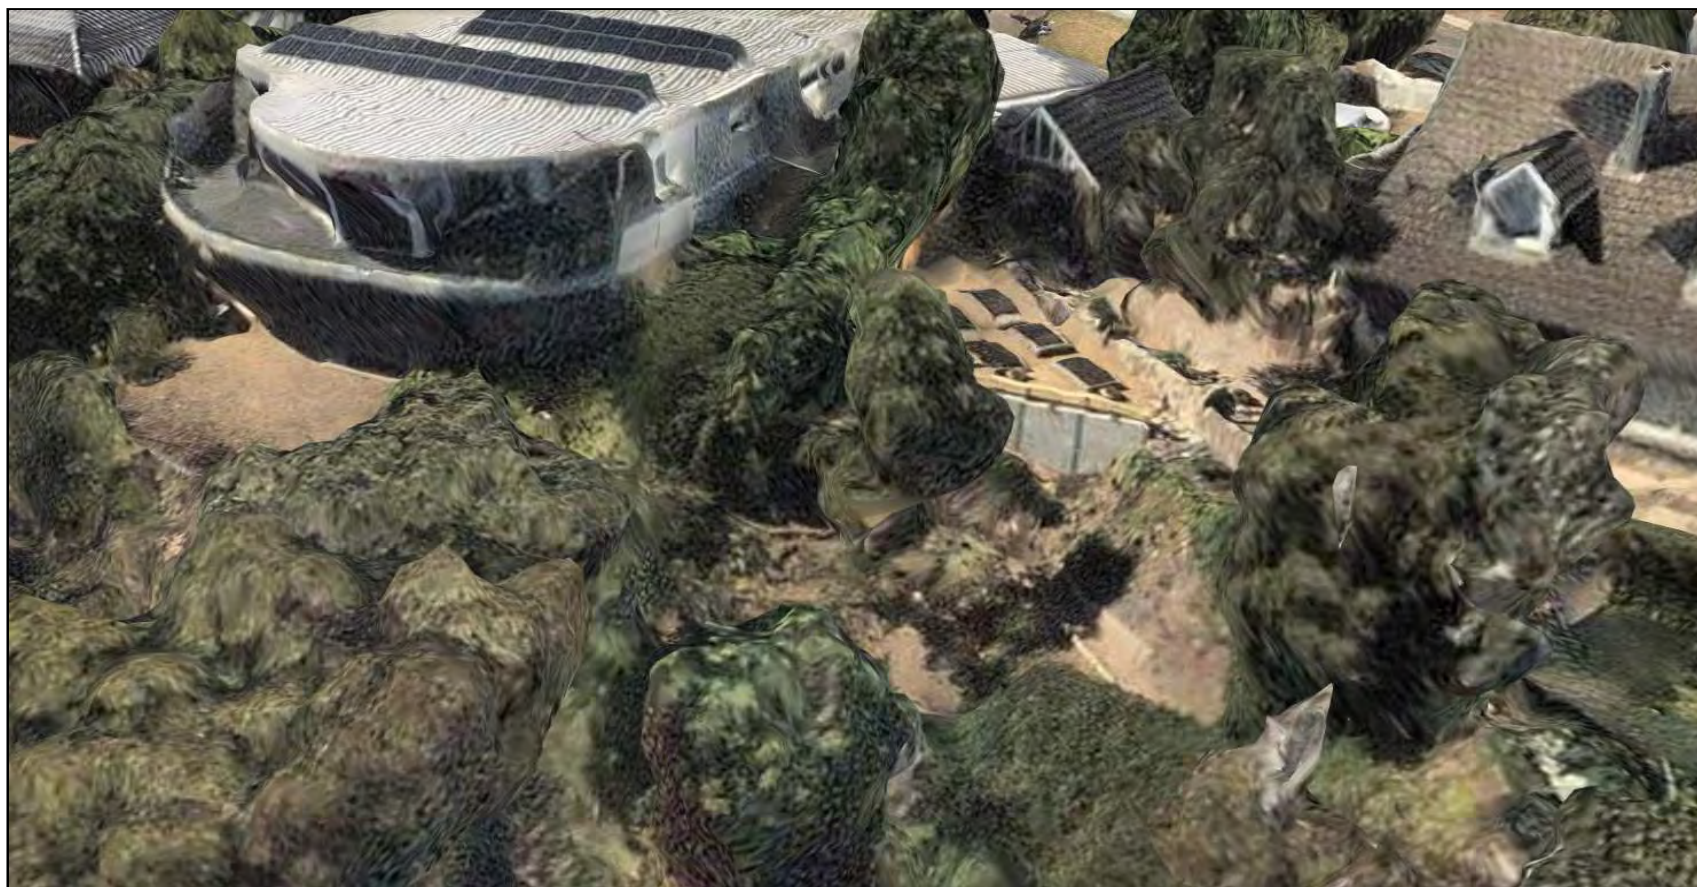
Trees removed from adjacent to 2022 Retaining Wall location on 10-12 View Point Road, dated December 2023. Source: Nearmap.

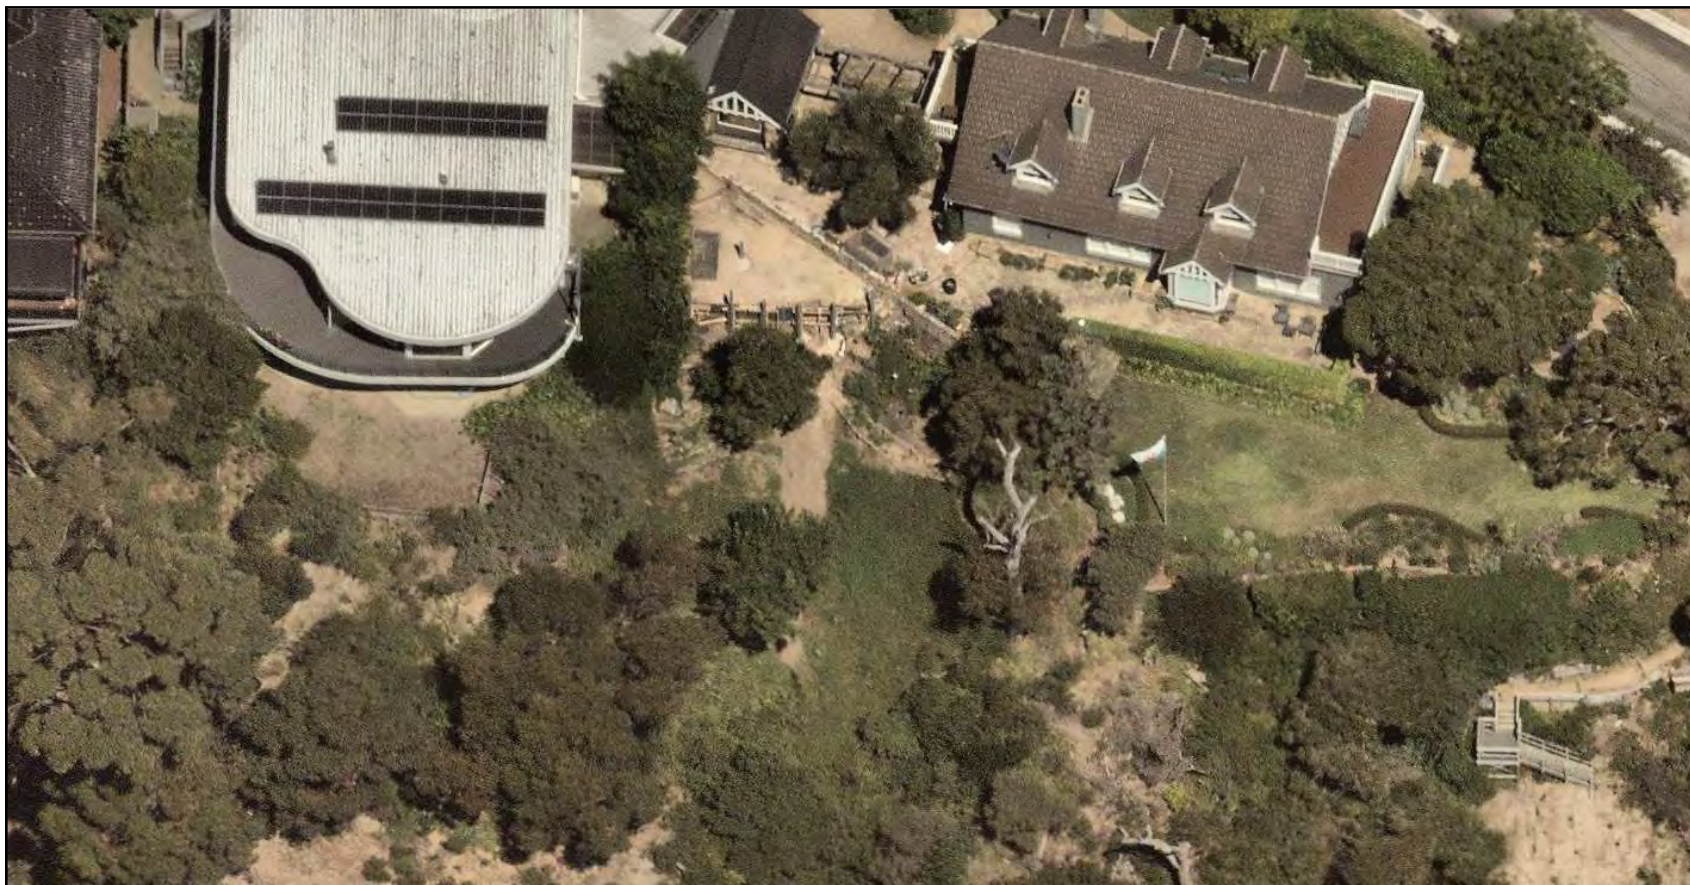
Trees removed from adjacent to 2022 Retaining Wall location on 10-12 View Point Road, dated 29 January 2024. Source: Nearmap.

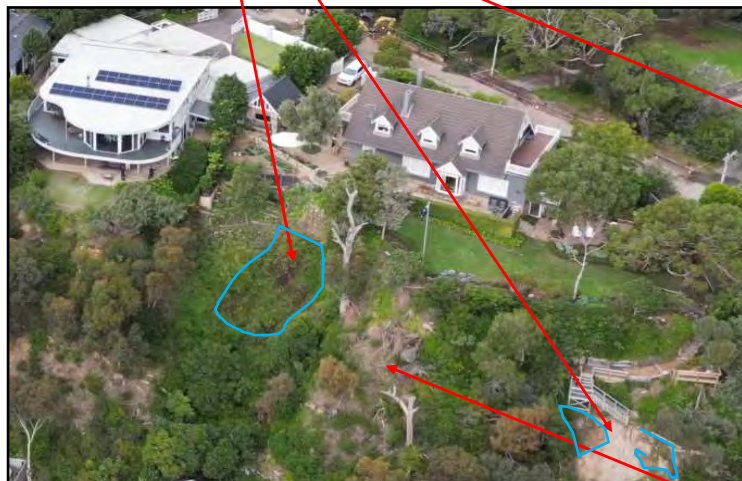
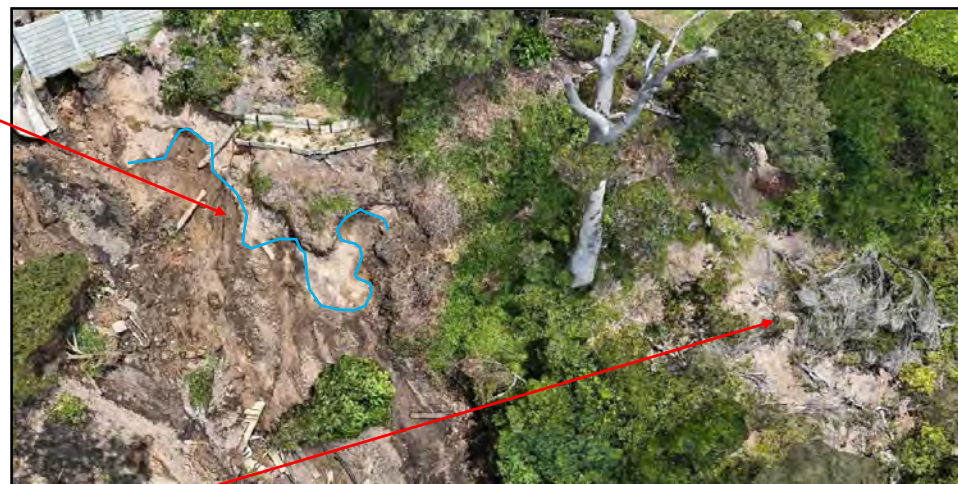
Appendix C27

Inferred Wet Soils

Dry soils
