McCrae Landslide

Causation

PSM5665-075R 21 July 2025

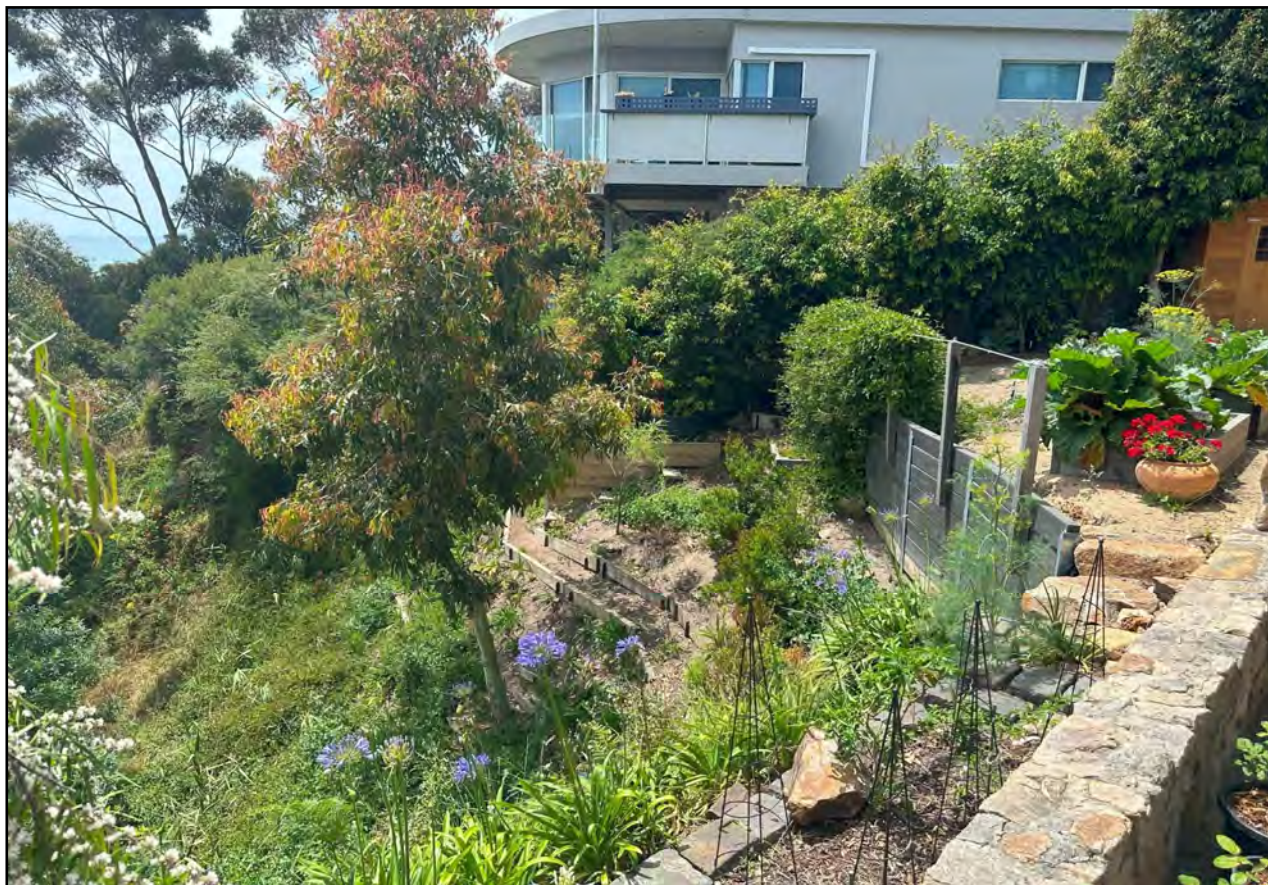
Appendix C28

PSM inspection by AW, 2022 Retaining Wall condition dated 23 November 2023.

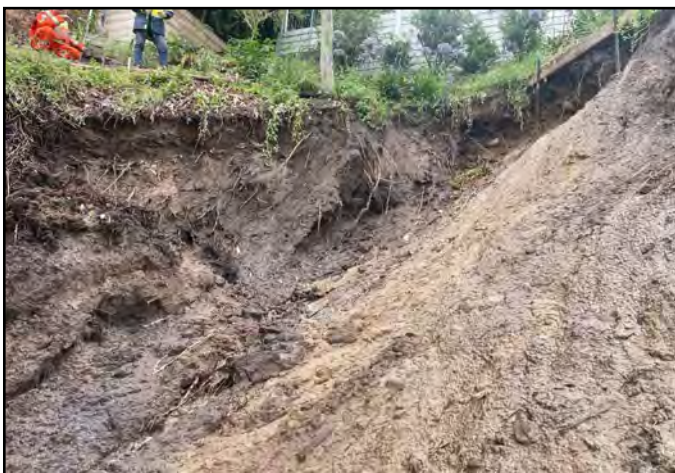
Photo 1 - Seepage at XW Granite contact and partially saturated fills of headscarp (06/01/2025)

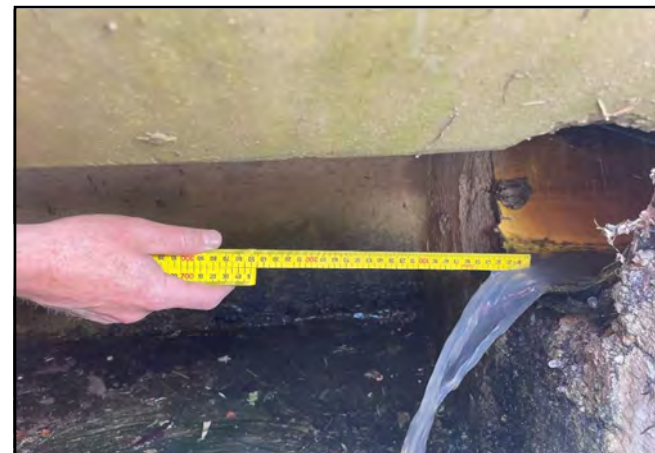
Photo 2 - Depth of flow in View Point Road stormwater (06/01/2025)

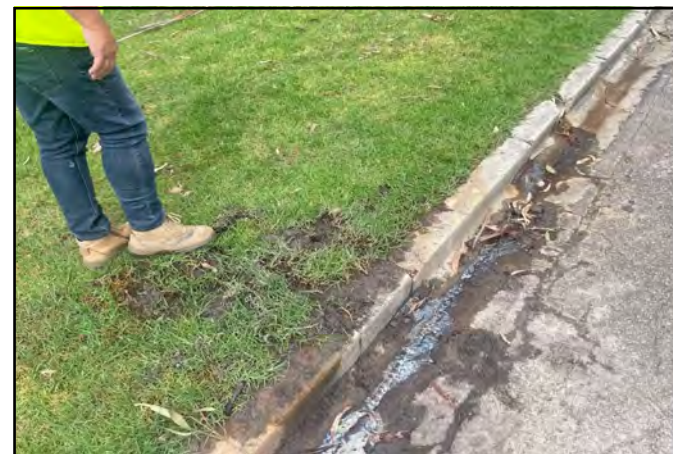
Photo 4 - 4 Prospect Hill Road seepage (15/01/2025)

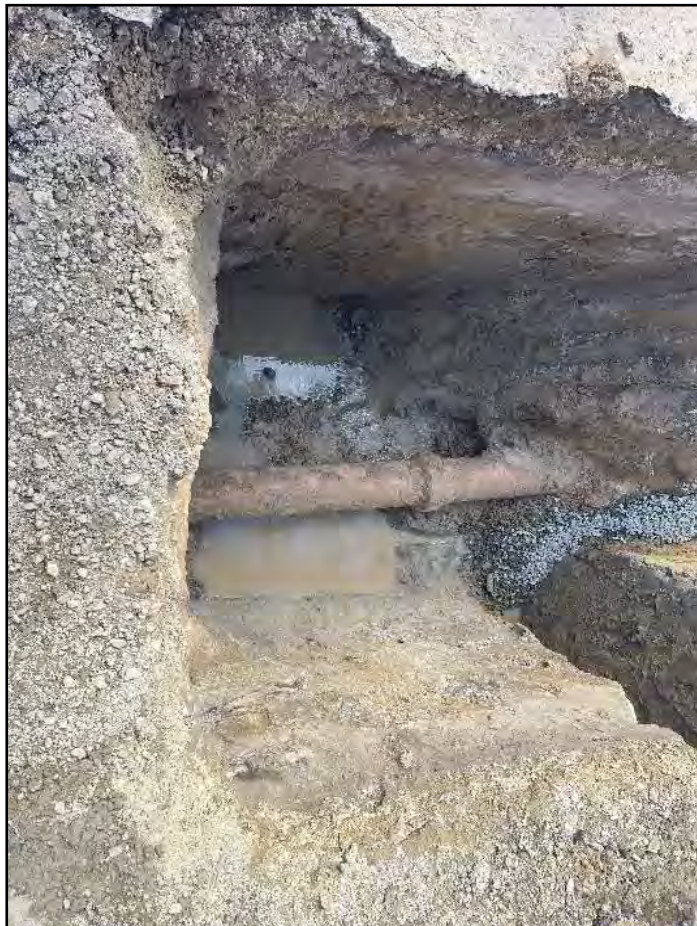
| Contributing Factor | Discussion | Relative Contribution |
|---|--|---|
| Trench backfill | <ul style="list-style-type: none"> • I note the following evidence of groundwater in service trenches: <ul style="list-style-type: none"> - Observations of groundwater in two test pits dug into the sewer trench of Charlesworth Street, Figure 5 and Photos 9 to 10 of Appendix D. - Evidence of seepage into the trunk stormwater line under the MPF, Section 8.5 and Figure 5. - Boreholes NDT10 and BH14A of PSM5665-070R. - Inferred collapse settlement above sewer trenches, Figure 5 and Appendix C27. • Due to the depth of the sewer in the proximity of Prospect Hill Road and View Point Road, Figure 3, these trenches are in my opinion likely to act as cut off drains for groundwater in the COLLUVIUM and the Leaky Surficial Aquifer. The base of these trenches can then traverse buried channels in the Residual Soils and XW Granite, promoting flow to the escarpment. • Standpipes and VWPs in the vicinity of View Point Road do not indicate the presence of water within service trenches. • For the above reasons it is my opinion that: <ul style="list-style-type: none"> - Infiltration and flow through trench backfill is unlikely to be meaningfully to groundwater recharge of the Leaky Surficial Aquifer under below average rainfall conditions and in the absence of significant anthropogenic water sources. - Service trenches may contribute significantly to groundwater recharge of the Leaky Surficial Aquifer when surcharged by significant anthropogenic water sources. - The contribution of service trenches under above average rainfall conditions should be assessed further. | <p>Minor to negligible under groundwater conditions corresponding to below average rainfall.</p> <p>Significant when surcharged by anthropogenic water source and potentially extensive during longer term above average rainfall</p> |

Photo 9 - MPSC excavation on Charlesworth Street (16/01/2025)

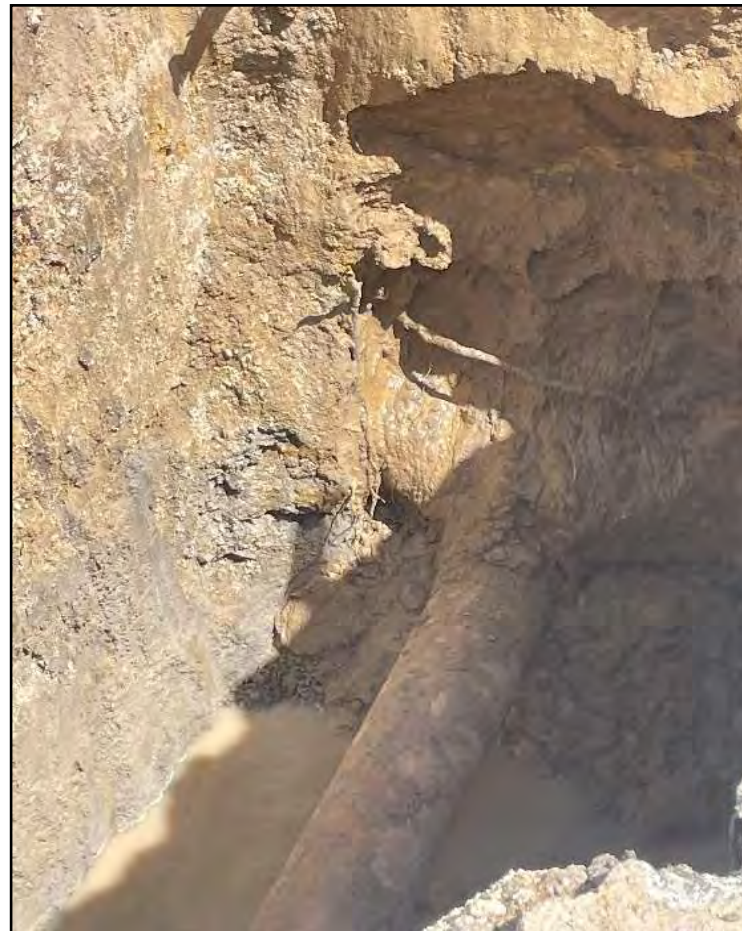
Photo 10 - MPSC excavation on Charlesworth Street (16/01/2025)

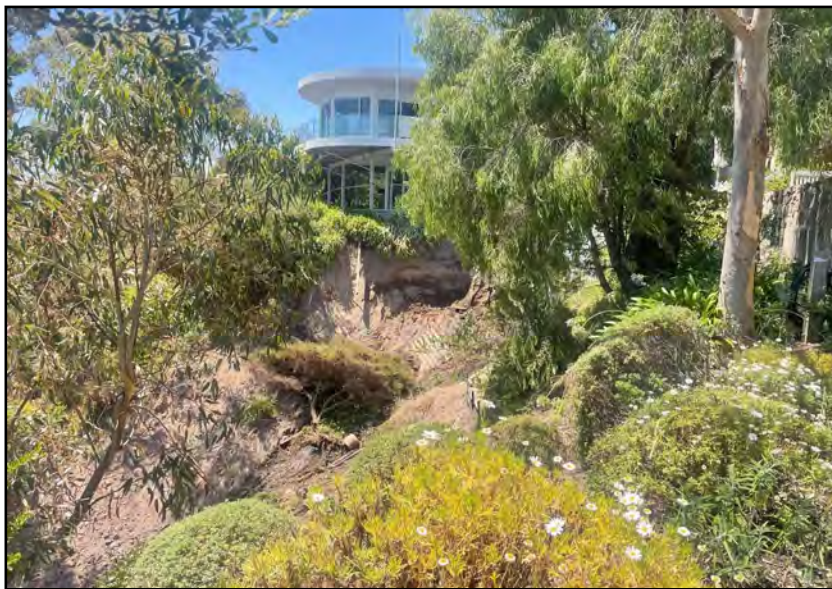
Photo 11A - Seepage line of Eastern flank (21/01/2025)

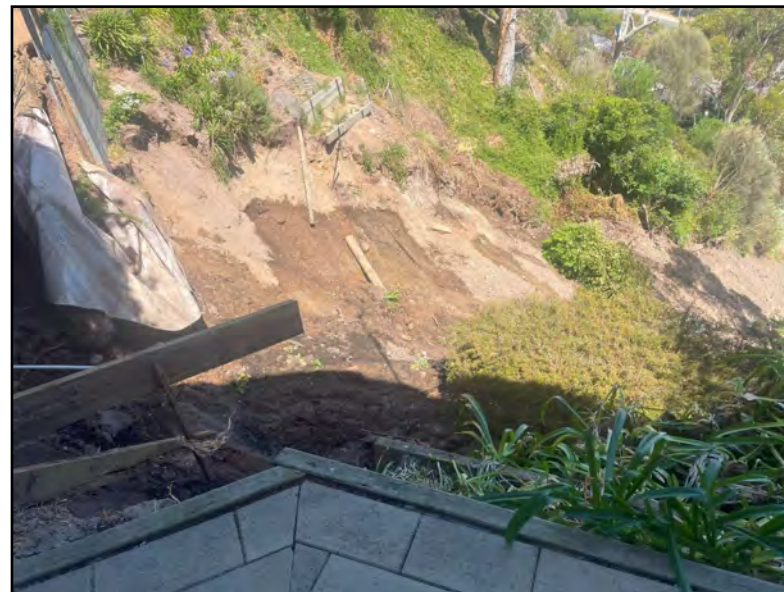
Photo 11B - Seepage line of Western flank (21/01/2025)

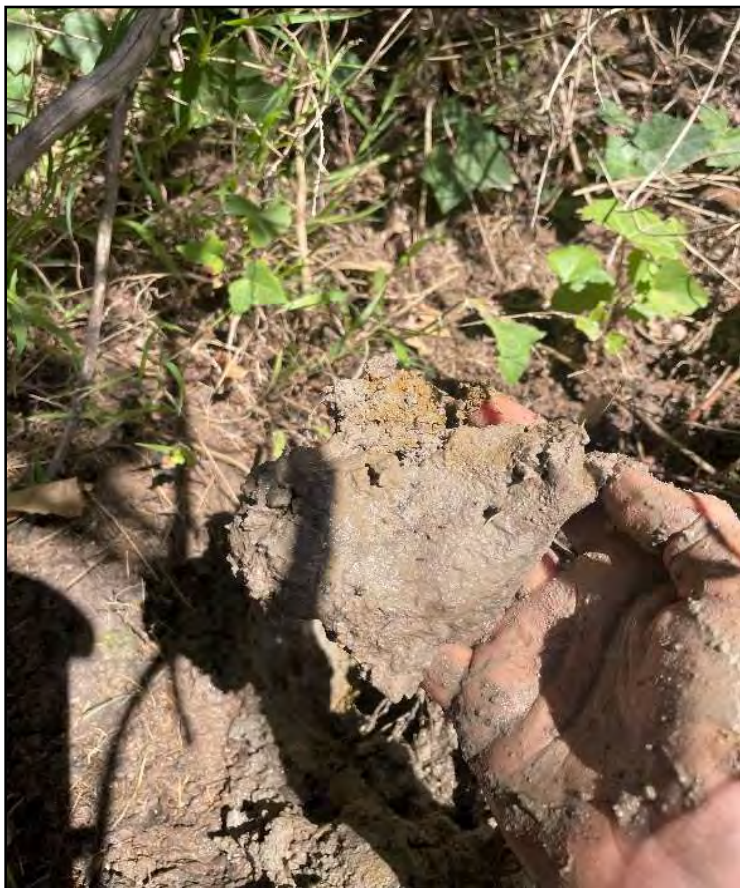
Photo 13 - Saturated soils immediately North-East of stairs on 10-12 View Point Road (24/01/2025)

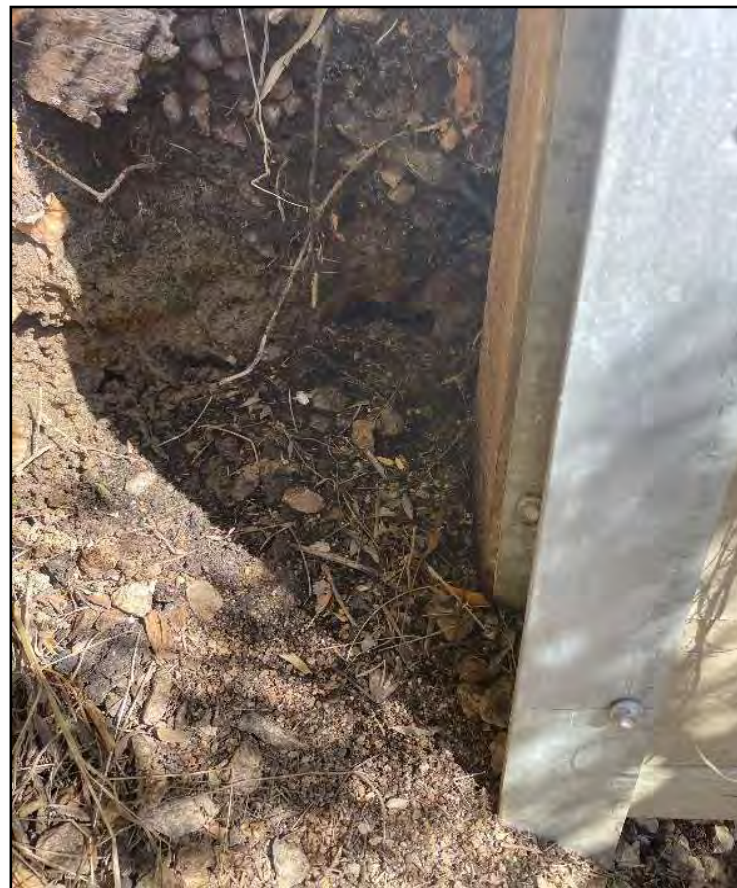
Photo 14 - Saturated soils adjacent to retaining wall at stairs on 10-12 View Point Road (24/01/2025)

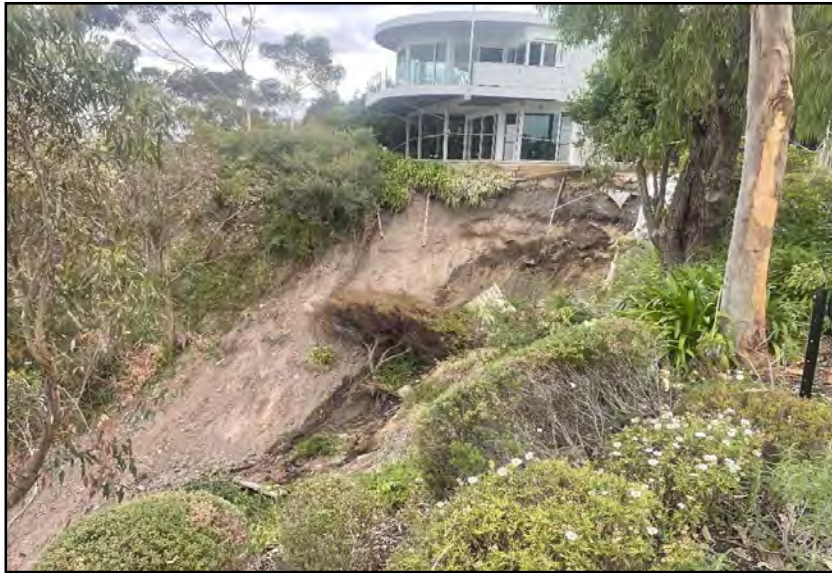
Photo 15A - Seepage line of Eastern flank (30/01/2025)

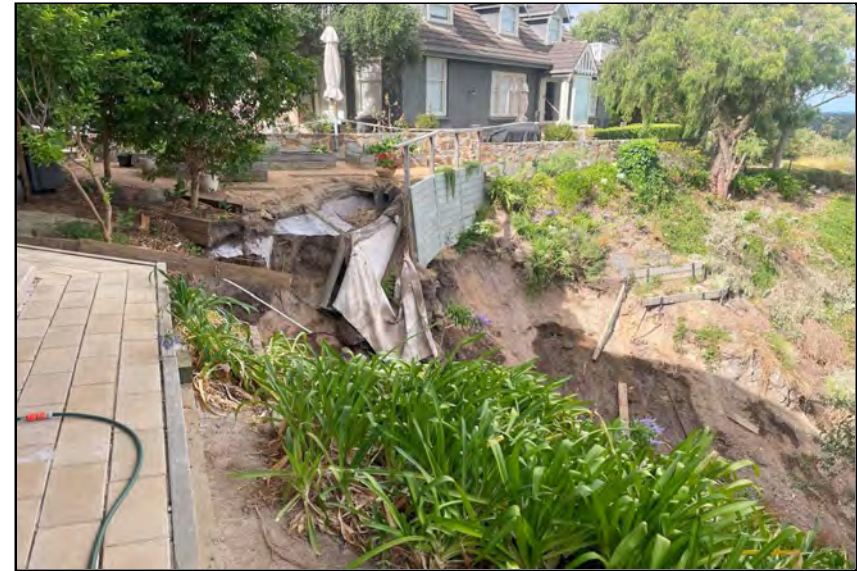
Photo 15B - Seepage line of Western flank (30/01/2025)

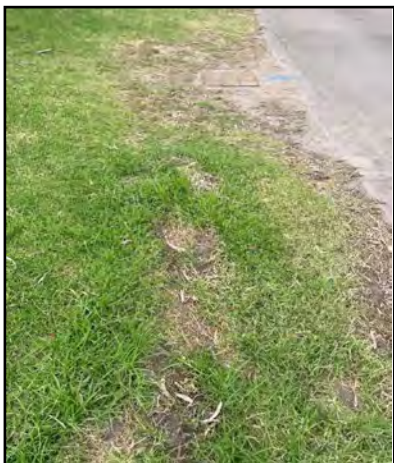
Photo 16 - Waller Place wet soils and rutting (30/01/2025)

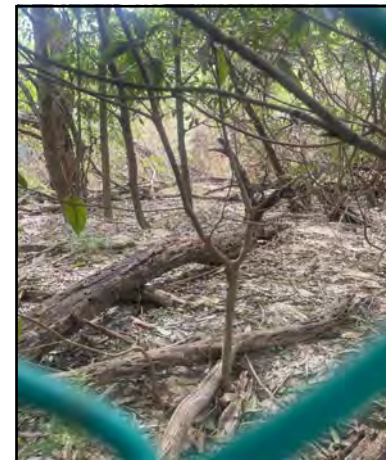
Photo 17 - Sediment plume downstream of Outlook Road water main failure (30/01/2025)

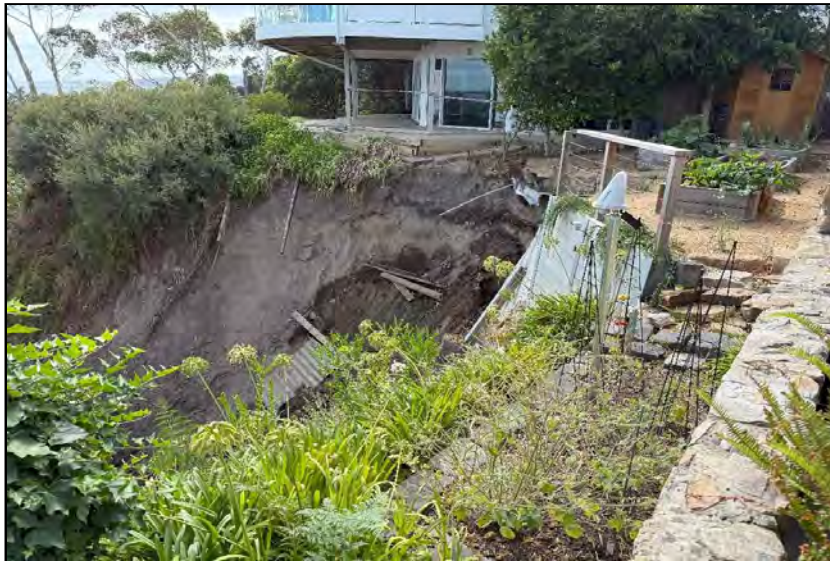
Photo 26A - Seepage line of Eastern flank (28/02/2025)

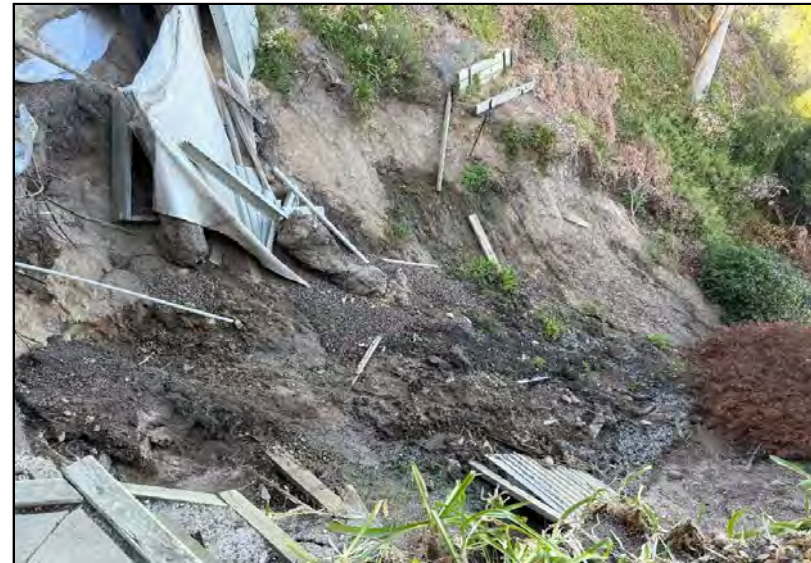
Photo 26B - Seepage line of Western flank (28/02/2025)

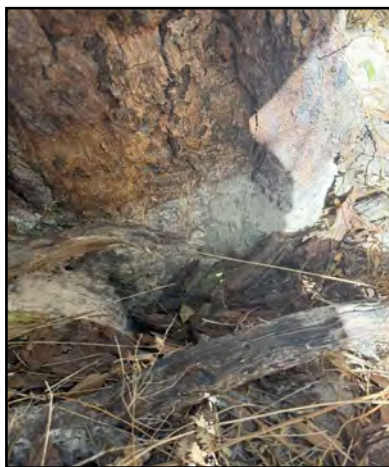
- (l) On 7 March 2025, inferred sediment staining was observed on tree stumps downstream of the Outlook Road water main failure, Photo 29 of Appendix D.

Photo 29 - Inferred sediment staining on trees on Outlook Road reserve (07/03/2025)

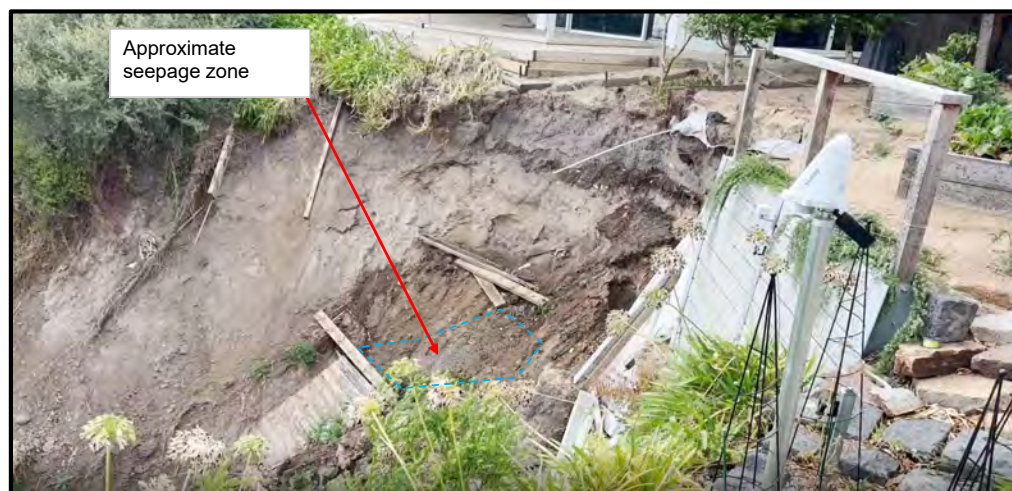
- (m) Seepage points in the 2025 Landslide were observed on the 7 March 2025 (Photo 30 of Appendix D).
- (n) Seepage points in the 2025 Landslide were observed on the 20 March 2025 (Photos 31A and 31B of Appendix D).

Photo 31A - Seepage zone of Eastern flank (20/03/2025)

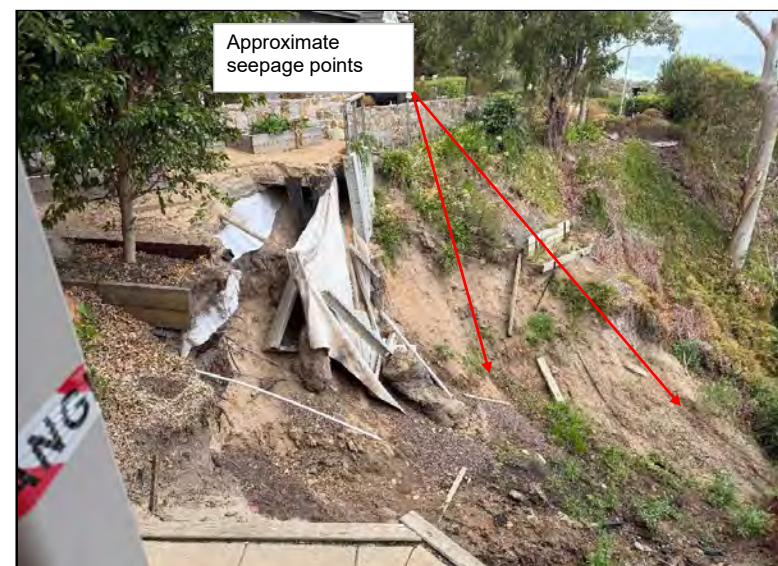
Photo 31B - Seepage line of Western flank (20/03/2025)

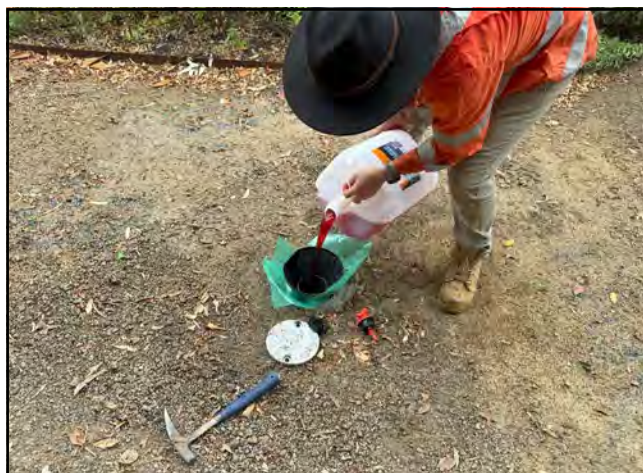
- (o) Red dye was added to borehole BH01A on 20 March 2025 (Photo 32 of Appendix D). Refer to Table 7 for further details.
- (p) On 2 April 2025 the invert of Coburn Creek was inspected. Inferred XW Granite was observe at the base of the gully, Photos 33A and 33B of Appendix D.

Photo 32 - Red dye tracing of Borehole BH01A (20/03/2025)

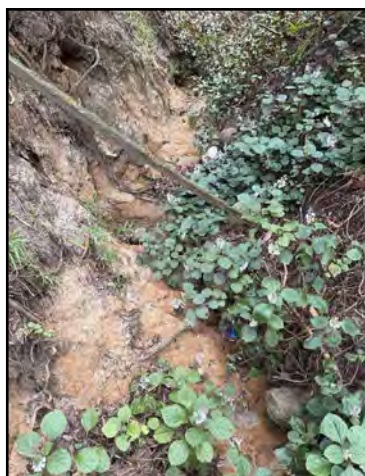
Photo 33A - Coburn Avenue creek invert near Waller Place (02/04/2025)

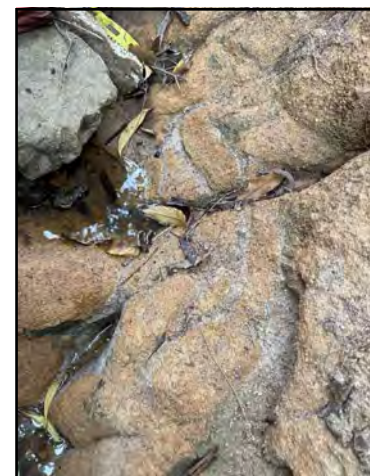
Photo 33B - Exposed XW Granite at invert of Coburn Avenue creek (02/04/2025)

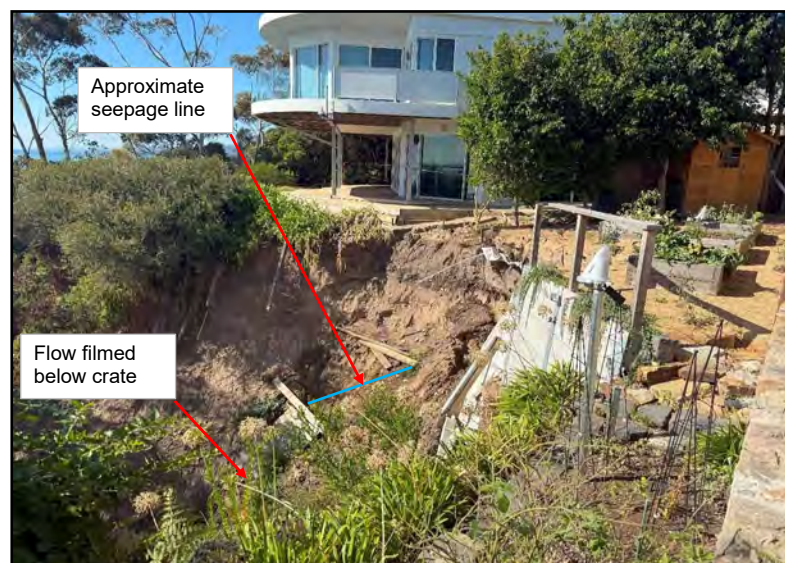
- (q) Seepage points in the 2025 Landslide were observed on:
 - i. The 10 April 2025 (Photos 34A and 34B of Appendix D).
 - ii. The 20 May 2025 (Photos 35A and 35B of Appendix D).

Photo 34A - Seepage line of Eastern flank (10/04/2025)

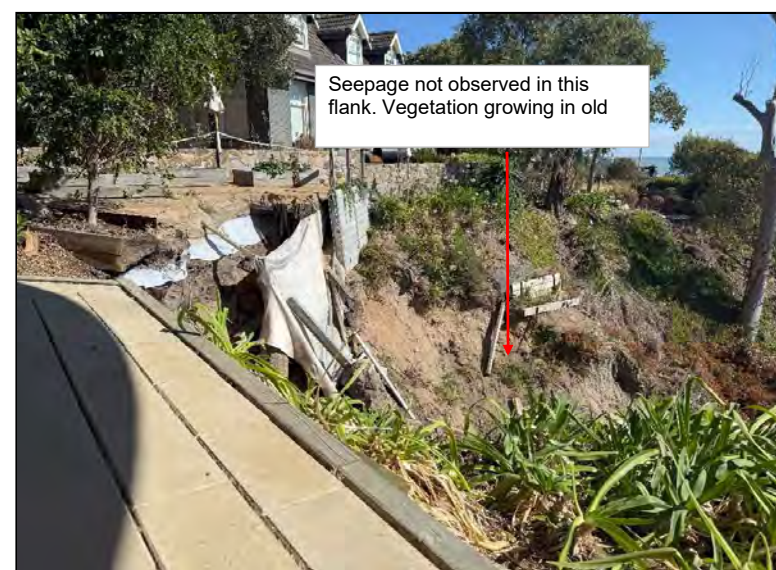
Photo 34B - Seepage line of Western flank (10/04/2025)

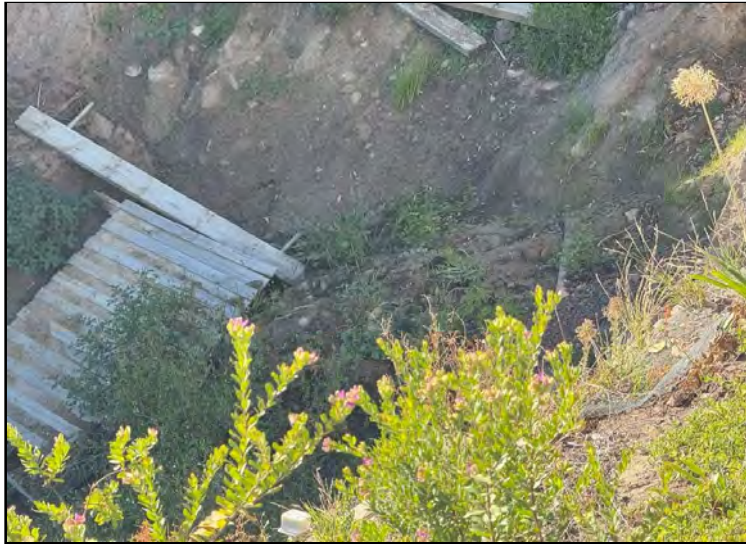
Photo 35A - Seepage line of Eastern flank (20/05/2025)

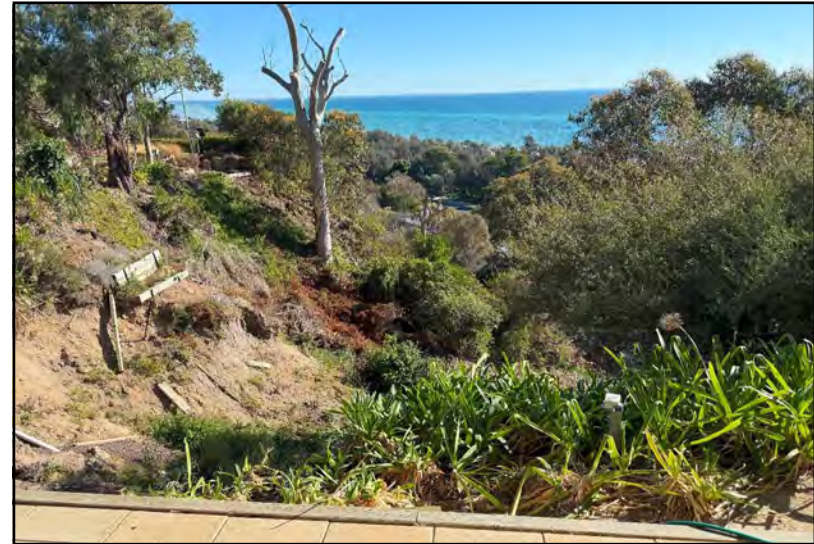
Photo 35B - Seepage line of Western Flank (20/05/2025)

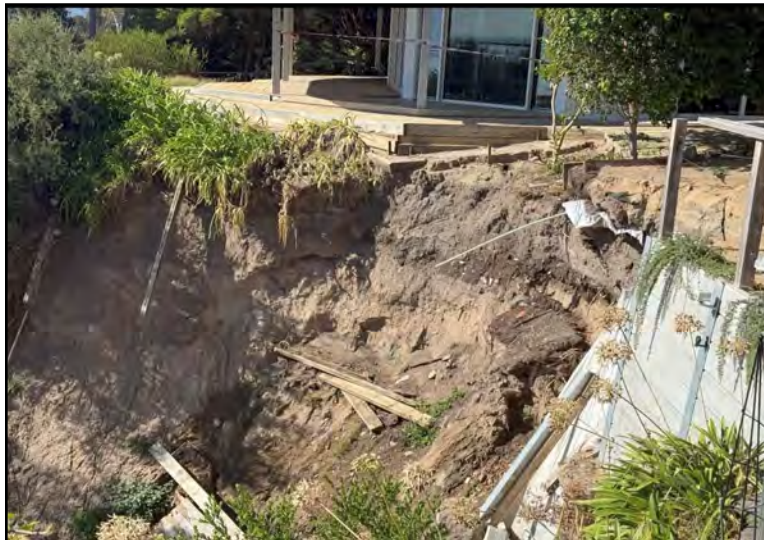
- iii. The 16 June 2025 (Photos 36A and 36B of Appendix D).

Photo 36A - Seepage line of Eastern Flank (16/06/2025)

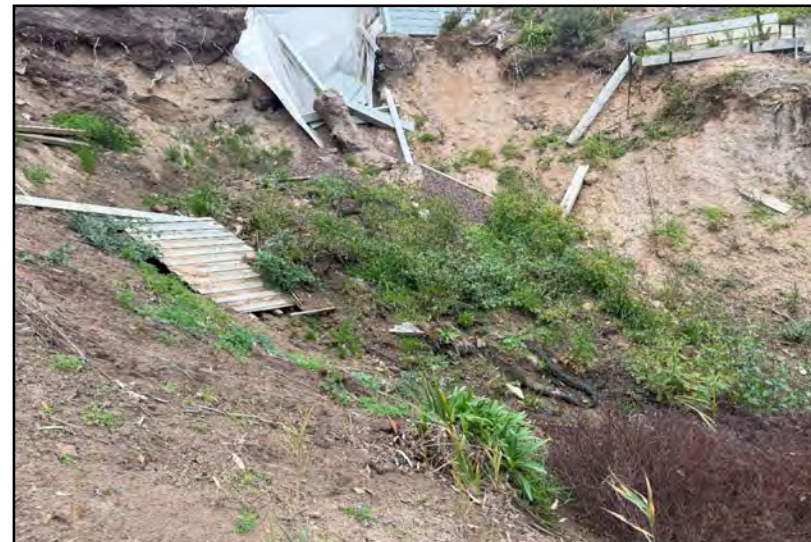
Photo 36B - Seepage line of Western Flank (16/06/2025)

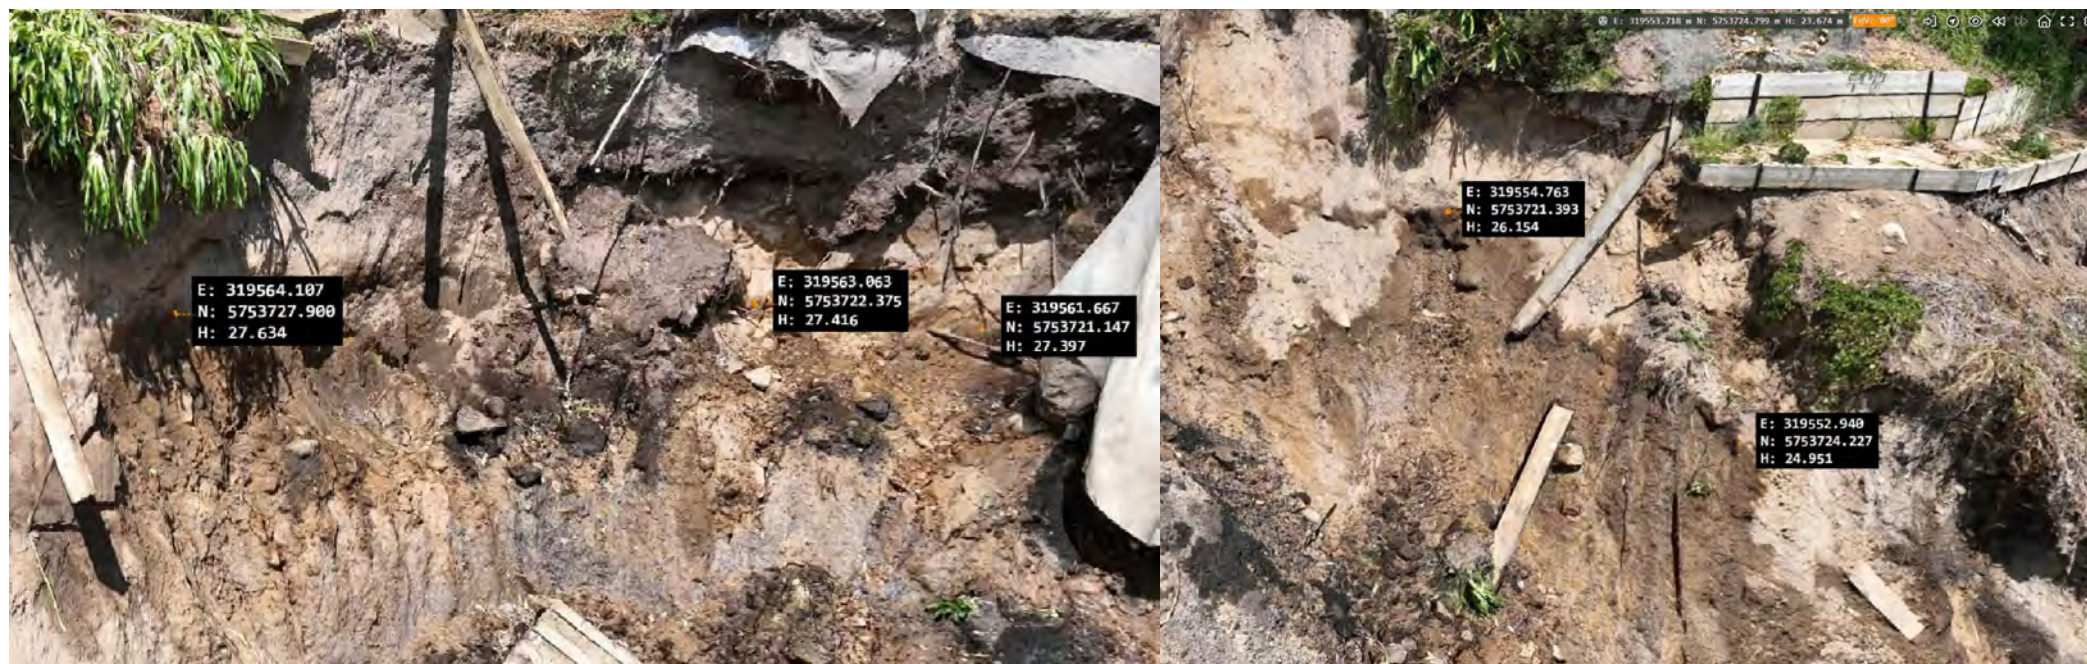
Seepage on 16/01/2025

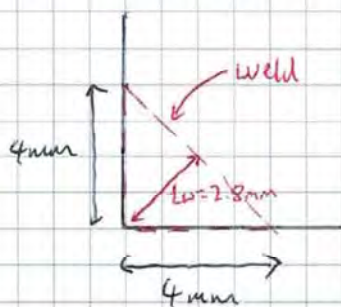
Fig 2. Fillet schematic

Assuming equal leg fillet for thicknesses less than 6mm to AS4100 9.6.3.3 the fillet weld along an edge shall be the material thickness. In this case $t_w = 2.8\text{mm}$ (Fig 2)
