McCrae Landslide

Causation

PSM5665-075R 21 July 2025

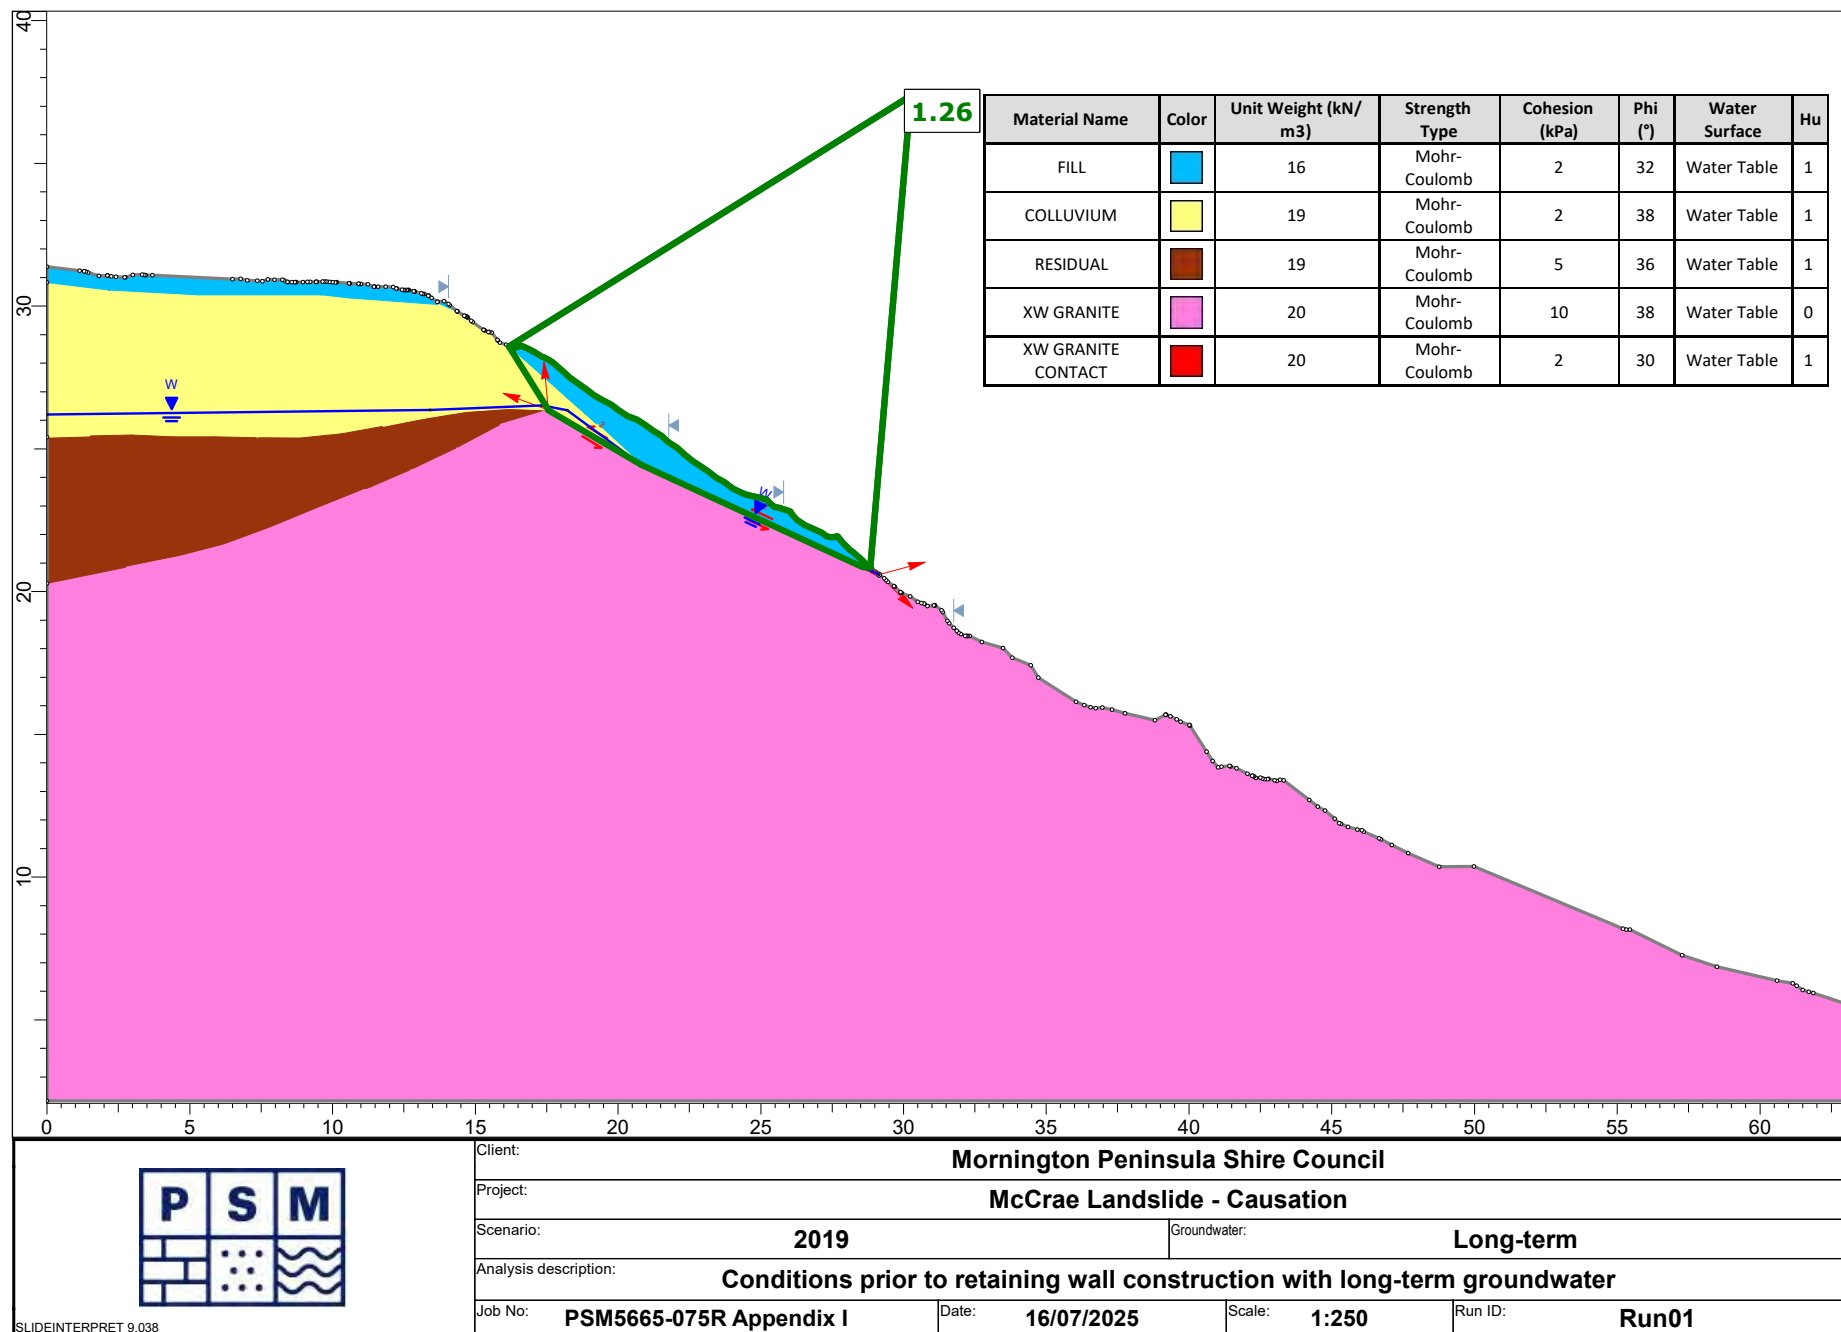
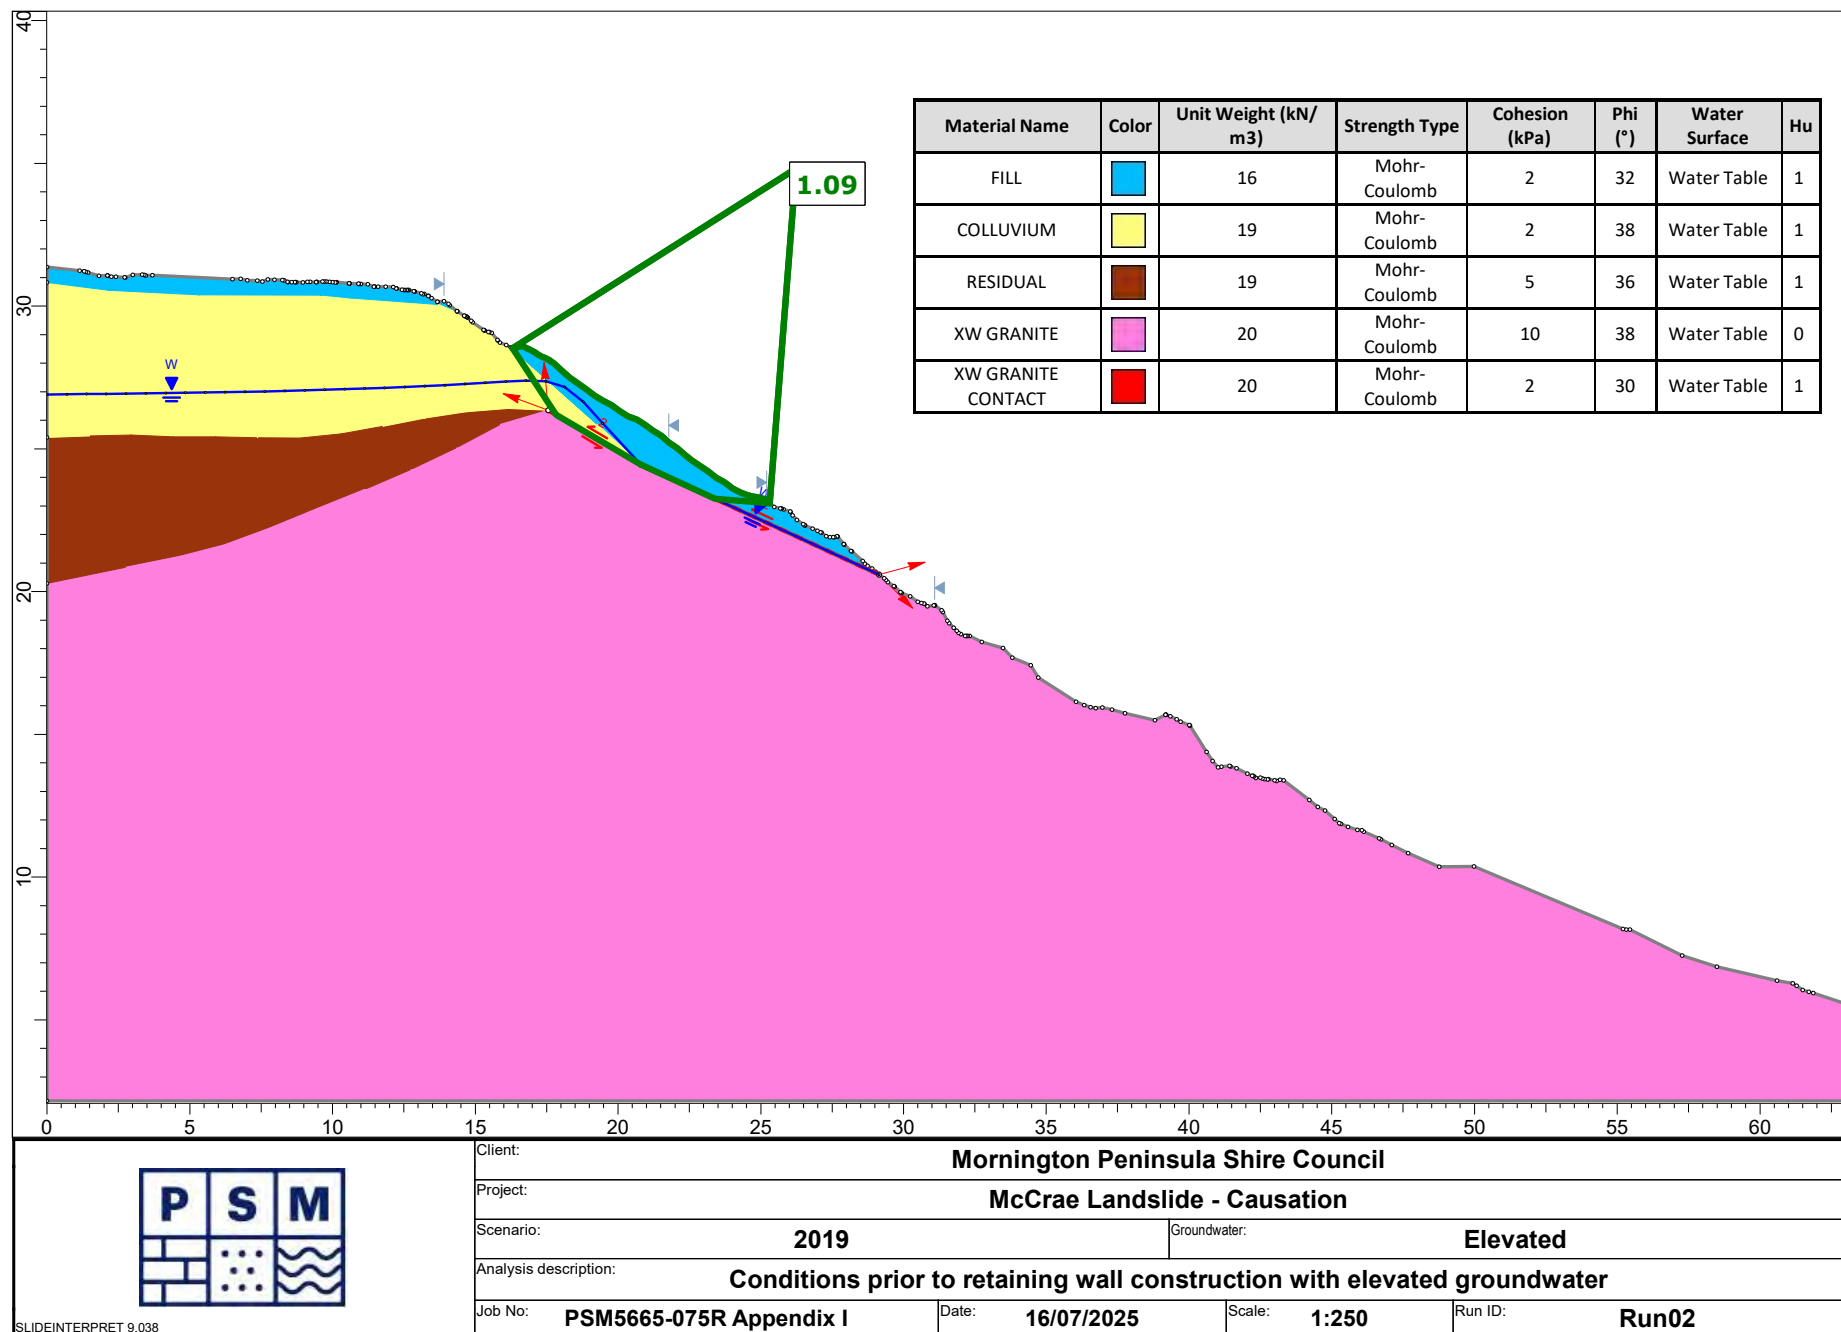
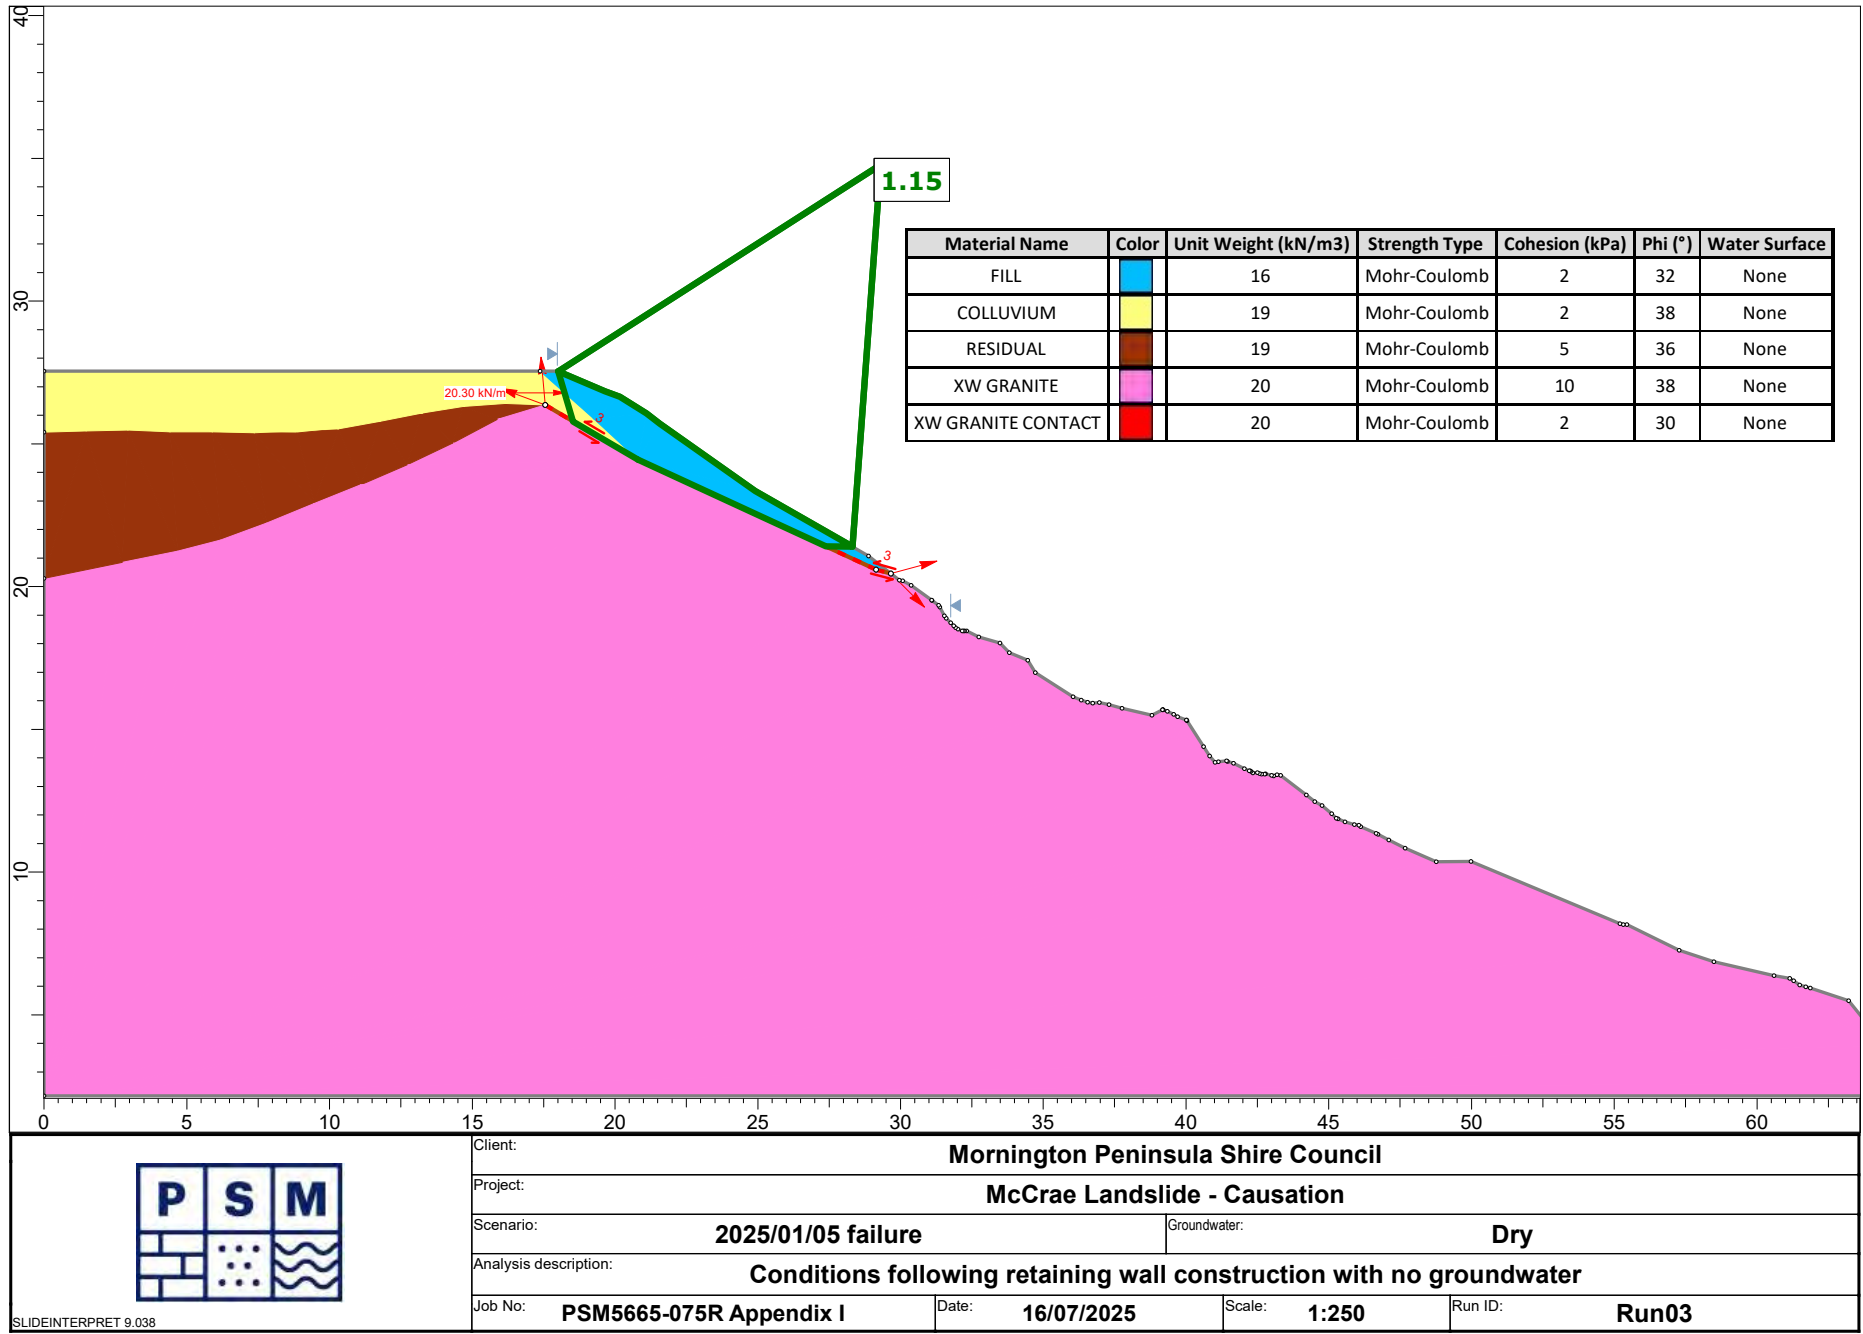
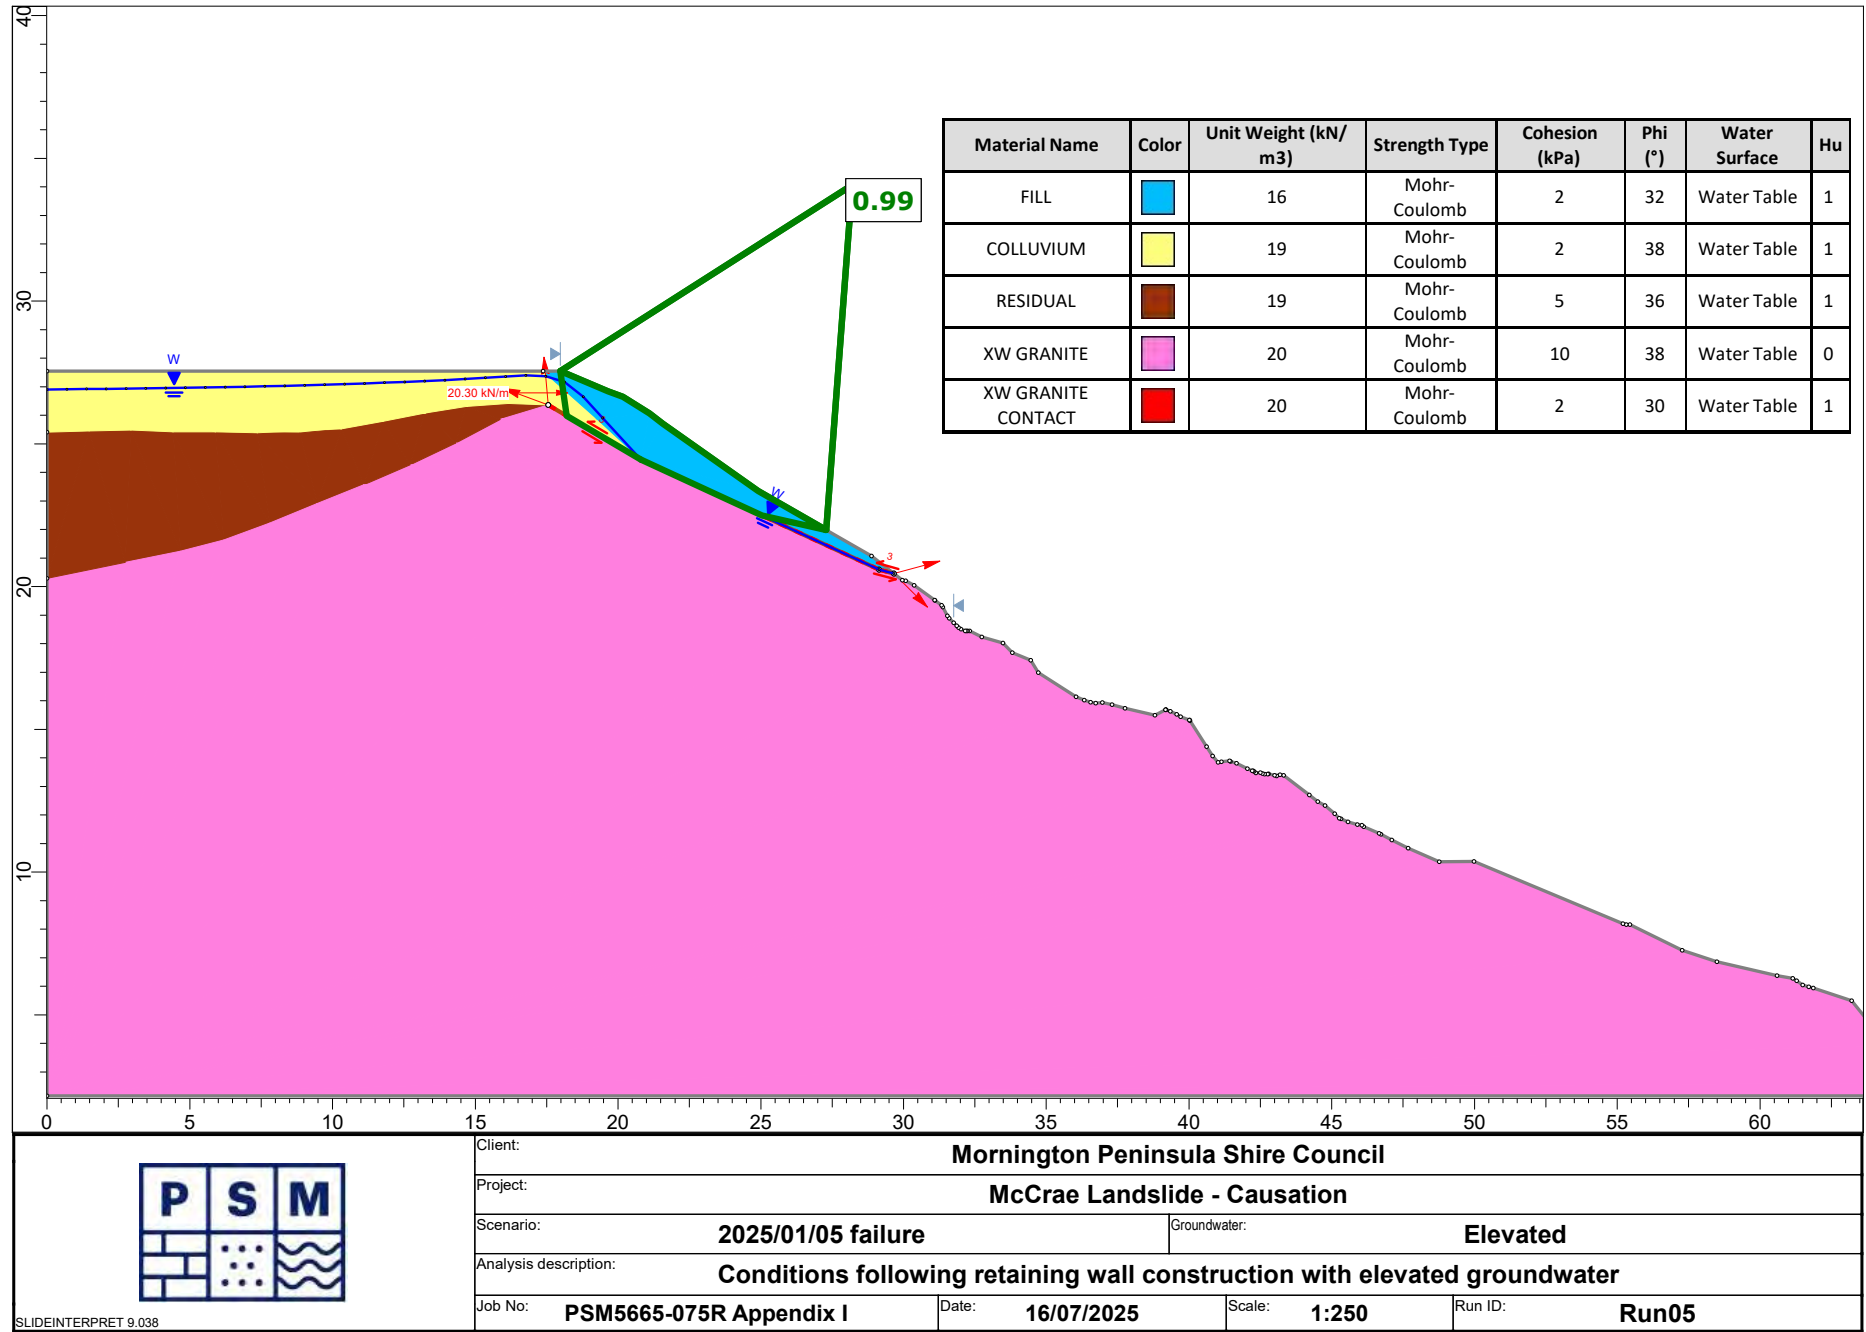
| Scenario: | 2025/01/05 failure | Groundwater: | Elevated |
| Analysis description: | Conditions following retaining wall construction with elevated groundwater | | |

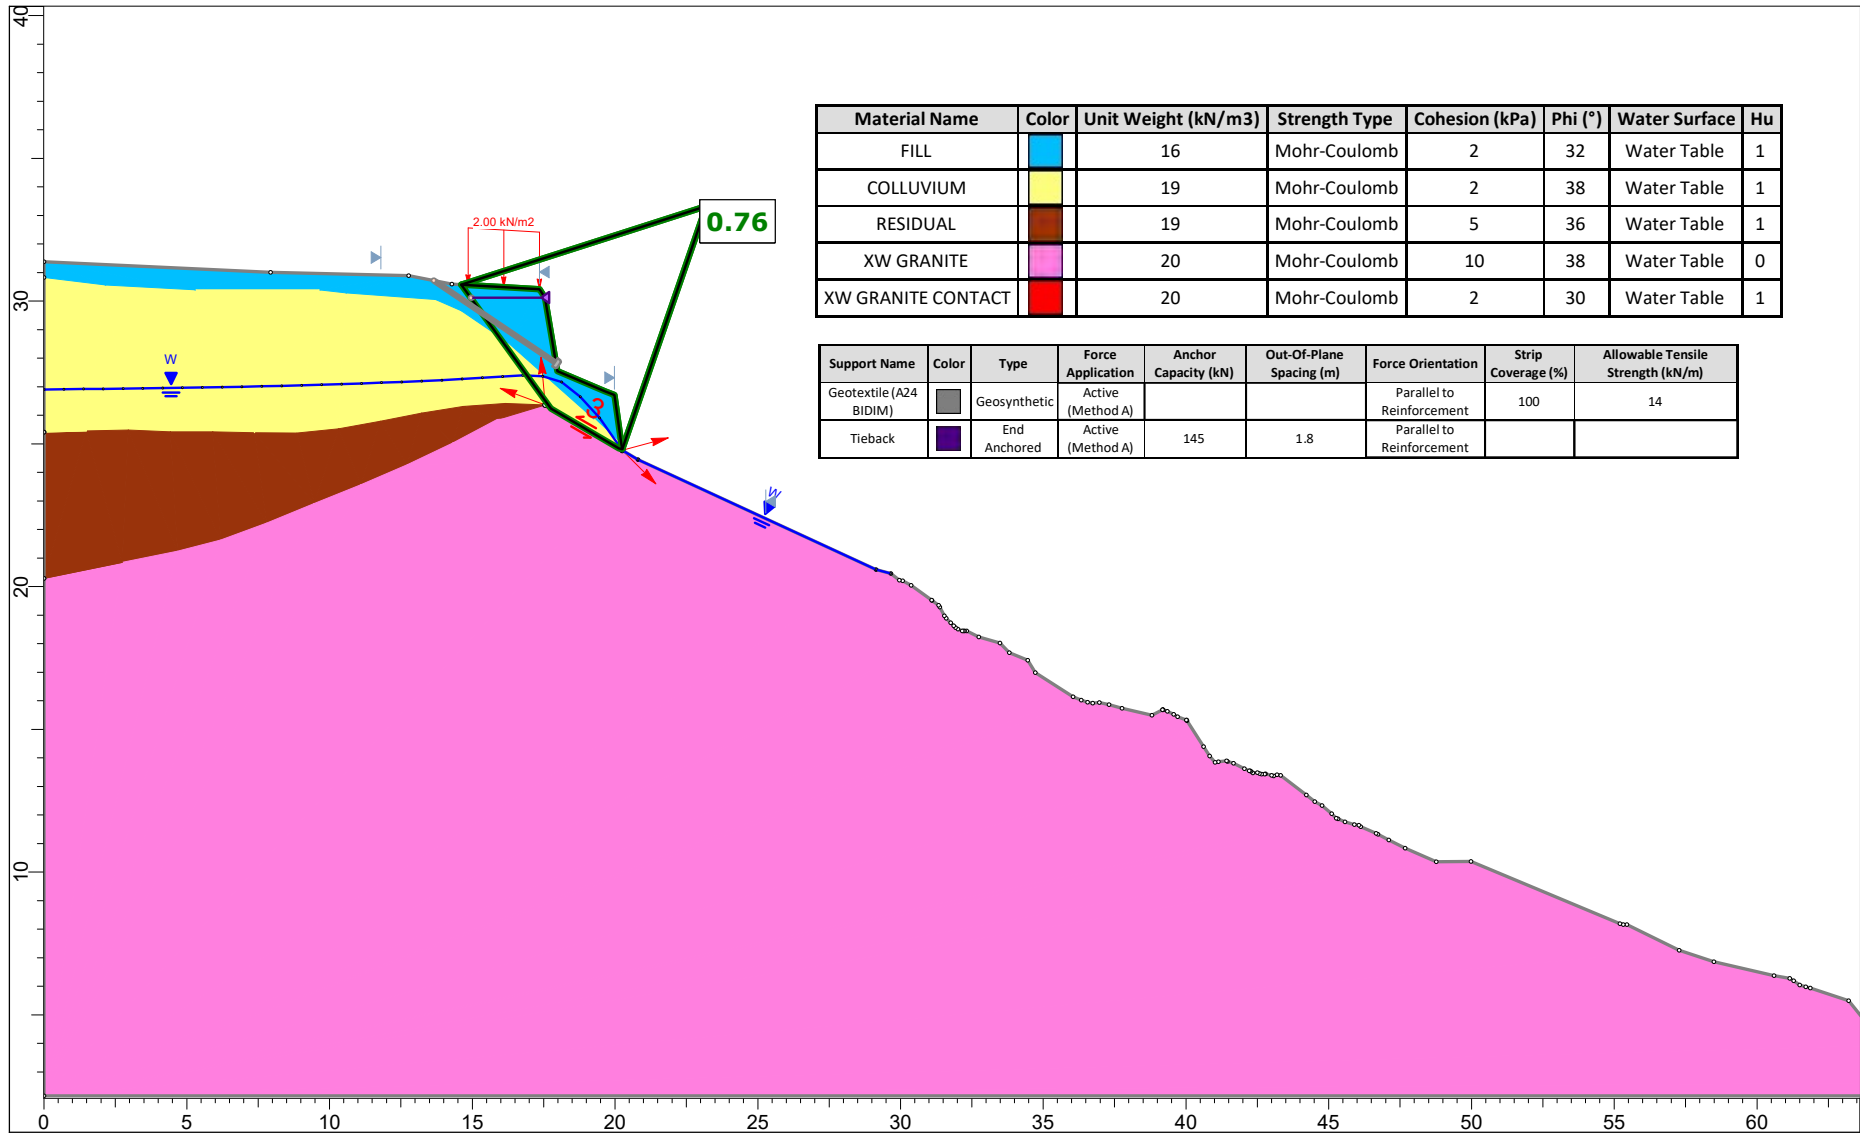
| Scenario: | 2025/01/14 failure | Groundwater: | Elevated |
| Analysis description: | Conditions of retaining wall following loss of passive wedge at the toe | | |
