**Task Number:**1295094/001**Task Address:**4 WALLER PLACE, MCCRAE VIC 3938 MapRef : 159B10**Program Name:****Task Work Type:**Planned Maintenance - Repair**Source Of Work:****Facility:****Permit Not Required:**No**Permit Pre Approved:**No**Permit Reason:**Other**Permit Other Reason:**

**Task Address:**4 WALLER PLACE, MCCRAE VIC 3938 MapRef : 159B10

# Leak Report

**Failure Details:**1 Water Main - Longitudinal split - Fatigue

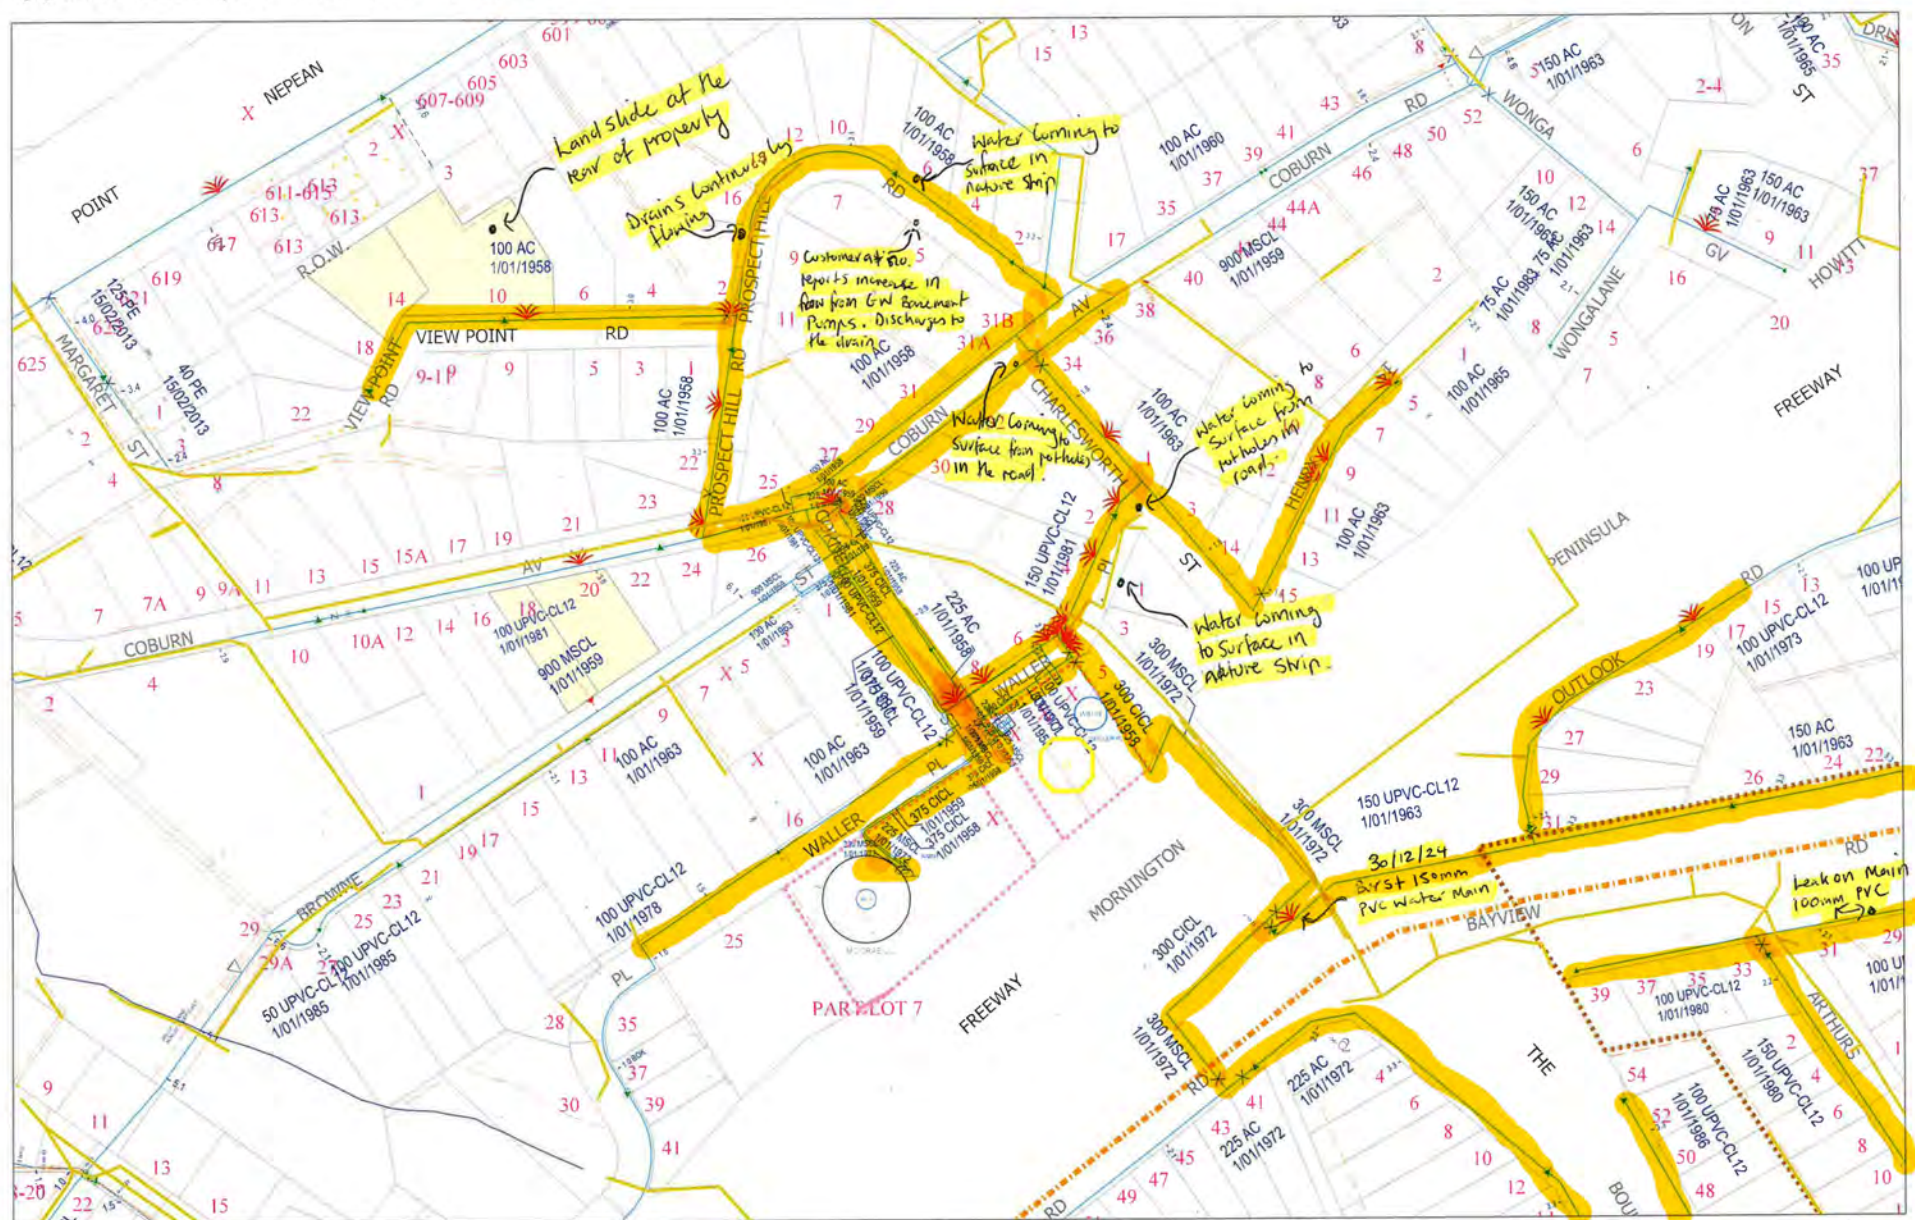
Observations from Site Visit 7/1/25.

Areas surveyed by Leak Detection
