Task Number:1295094/001**Task Address:**4 WALLER PLACE, MCCRAE VIC 3938 MapRef : 159B10**Program Name:****Task Work Type:**Planned Maintenance - Repair**Source Of Work:****Facility:****Permit Not Required:**No**Permit Pre Approved:**No**Permit Reason:**Other**Permit Other Reason:**

Task Number:1295094/002

Task Number:1295094/006

Request Details:Burst on the 150UPVC main opp 2 the boulevard. water Ops located leak

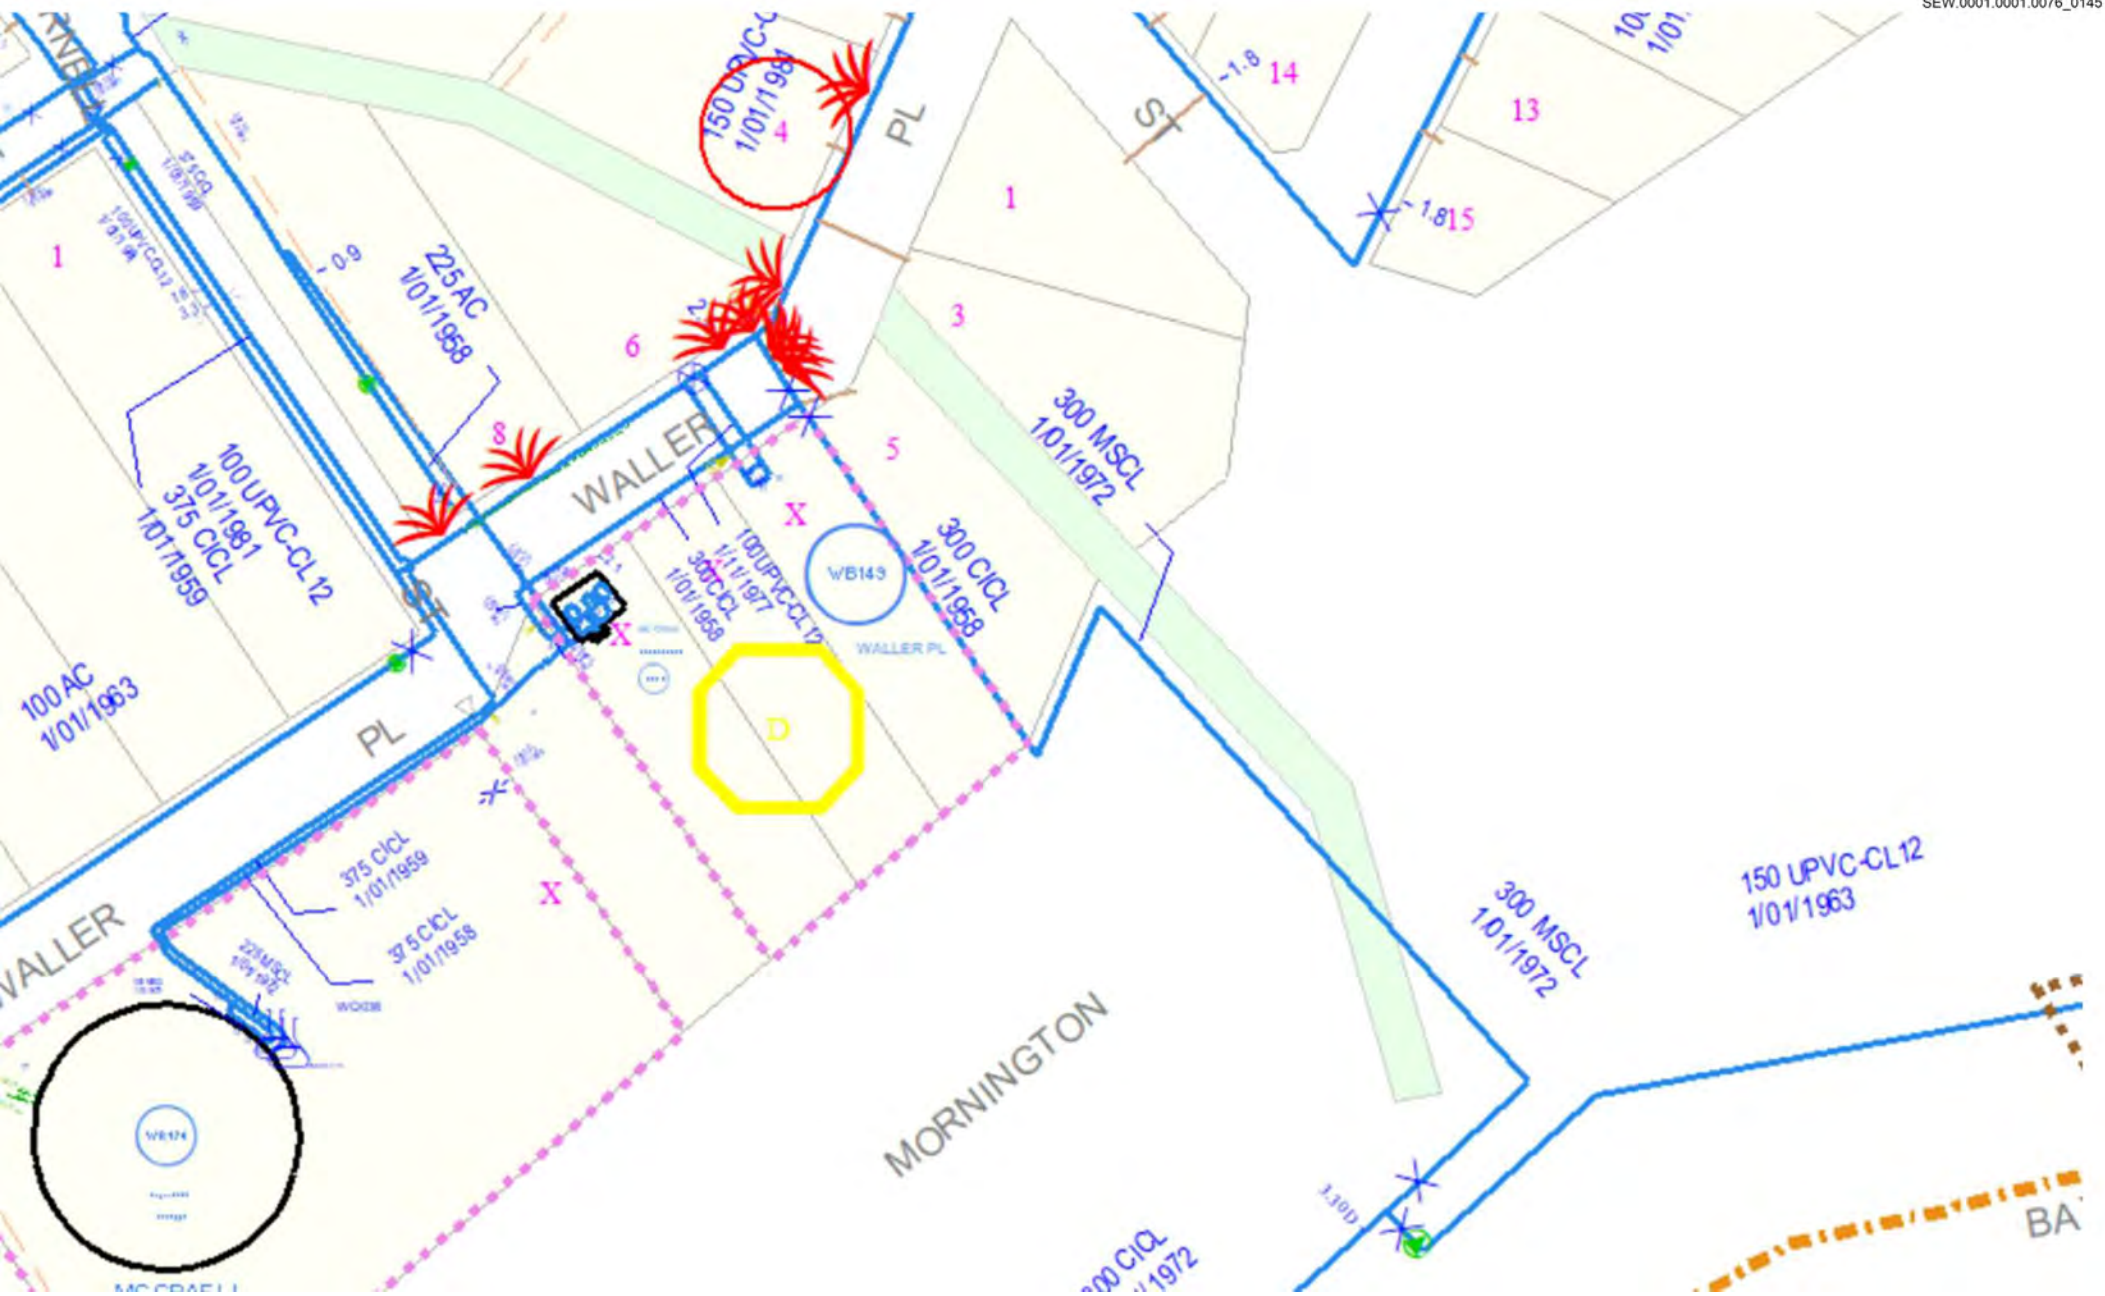
3 Jan 2025 11:12:02 am
38.34754873998463S 144.93807205930352E
3 Charlesworth Street
McCrae
Mornington Peninsula Shire
Victoria

Task Story:[FT] [SSf0010] [2/1/2025 17:56] [ON SITE] Arrived back on site & water is still coming out of the road opp no-3 Charlesworth st & the n/strip at no-1 Waller Pl. I then went to the other side of the freeway to do some leak detection as per Jason Marsh from SEW & found water is seeping out of the middle of the d/way at no-29 Bayview rd & where the d/way meets the road. I tested the water & it did turn pink. There is a 100mm UPVC main that runs along there. I picked up a few faint sounds on nearby service's. Will notify Jason Marsh on my findings. I have spoke to the owner at no-29 Bayview rd & he did report the leak awhile ago. I gave him a calling card. [FT] [SSf0010] [8/1/2025 14:38] [ON SITE] Arrived back on site & water is still coming out of the road opp no-3 Charlesworth st & the n/strip at no-1 Waller Pl. I then went to do some more leak detection & got diverted to another job. [Marsh,Jason] [9/1/2025 07:43] [OFF SITE] Team, Spent the last 2 days checking storm water drains and walking streets sounding services around Waller Pl and BAYVIEW ROAD. Checked WR174 water tank site and all Air valves hydrants ect. I thought I found a good leak, water coming to surface at presser, after probing. Tested at EC 500 and after 10 minuets stopped. It was a backed-up Agi pipe. Hayden and Eathen from operation also assisted checking surveying for leaks yesterday, correlating some sections of the water pipe. Detection services are on site surveying zone from BAYVIEW ROAD up. Took sample on storm water pit outside 6 Waller Pl as requested by Charles, it had a site EC reading over 600. Dropped sample at ALS. Will get results today. Note: this storm water drain has been sampled previously 30-12-24 before repair to water main on Bayview. It still has a good flow 10l per minute, see attached. [Castle,Ken] [9/1/2025 16:09] [OFF SITE] Pulse case 08556065 raised. [FT] [SSf0010] [13/1/2025 11:10] [ON SITE] Arrived on site & water has now stop seeping across the road at no-1 Waller Pl & the front lawn at the fence at no-1 is now not pooling & starting to dry out but water is still coming out of the middle of the road at no-3 Charlesworth st. [Selliah,Sam] [14/1/2025 17:56] [OFF SITE] Caller Debbie Lightfoot from 34 Coburn Ave advised she is currently in the middle of a new build and there is water sitting all over the front. Said she was concerned about the foundations to the property. I have advised customer after discussing this further that we are doing daily tests here and it is still found to be ground water. Council have also been on site. Advised customer to take this up with the council. Looks like she has called several times previously as she was aware of where all the leaks were and testing done. Caller is on PH: PI

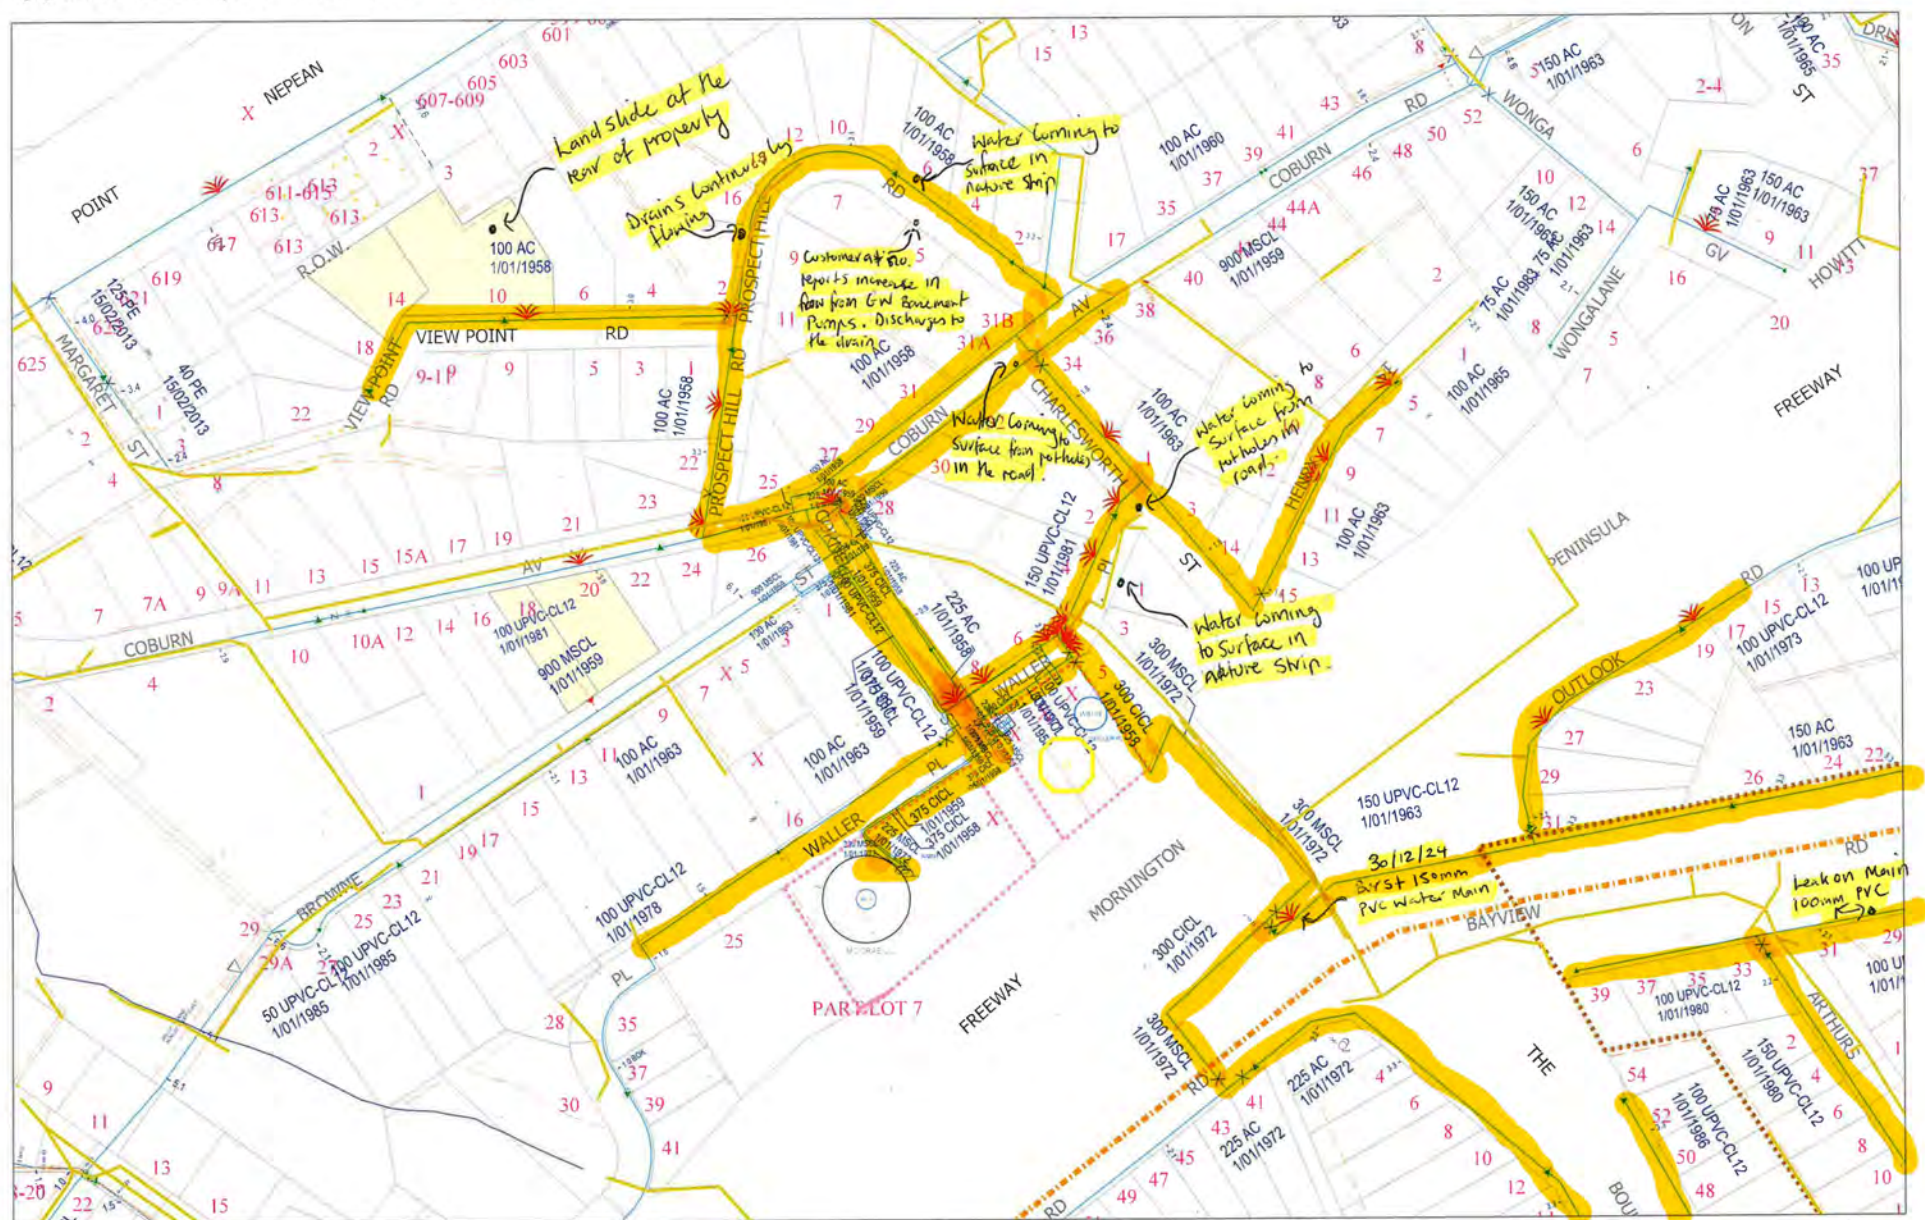
Observations from Site Visit 7/1/25.

Areas surveyed by Leak Detection
